Pre Demolition Asbestos Survey

**Retail Spaces
90 -96 Westchester Avenue
White Plains, NY 10601**

October 31, 2012

Project Title: Pre Demolition Asbestos Inspection Report

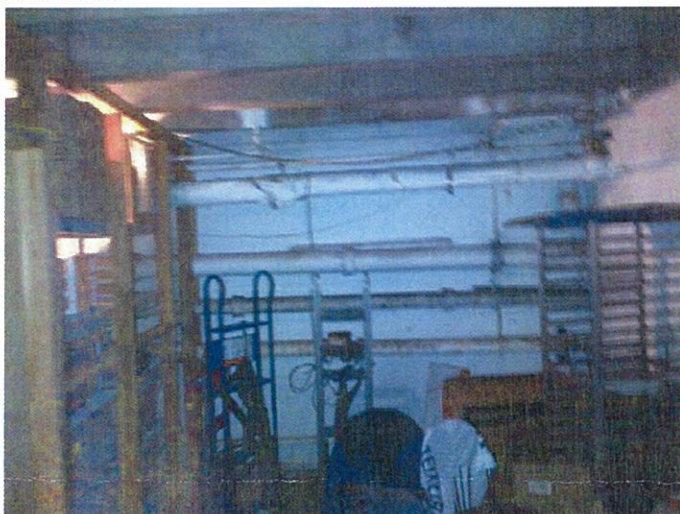
Pizza Parlor basement pipe insulation

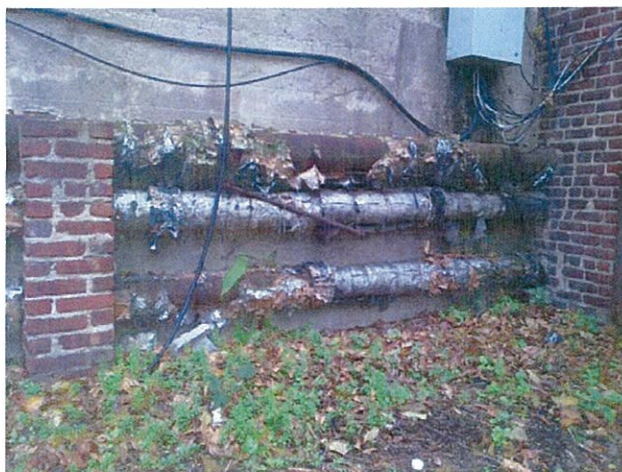
Client No. / HGA	Lab No.	Asbestos Present	Total % Asbestos
4	12-3632-4	YES	6.1% (by NYS ELAP 198.6) NOB-PLM
Location: Rear of Building on Exterior Pipe Sample Description: Black Pipe Caves Analyst Description: Black, Non-Friable, NonHomogeneous Asbestos Types: Chrysotile Other Material: Non-fibrous 7.7%			
NOB-TEM Results (Final)			NA (by NYS ELAP 198.4) NOB-TEM
5	12-3632-5	NO	NAD (by NYS ELAP 198.1) PLM-Friable
Location: Bead Store Near Wall Sample Description: Plaster Wall Analyst Description: Tan, Granular, NonHomogeneous Asbestos Types: Other Material: Tr.Cellulose, Non-fibrous 100% Comments:			
NOB-TEM Results (Final)			NA (by NYS ELAP 198.4) NOB-TEM
6	12-3632-6	NO	NAD (by NYS ELAP 198.1) PLM-Friable
Location: Bead Store Near Wall Sample Description: Plaster Wall Analyst Description: Tan, Granular, NonHomogeneous Asbestos Types: Other Material: Tr.Cellulose, Non-fibrous 100% Comments:			
NOB-TEM Results (Final)			NA (by NYS ELAP 198.4) NOB-TEM

Rear of building, black tar covering on exterior pipe
