PHASE I
ENVIRONMENTAL SITE ASSESSMENT REPORT
FOR

SBL #: SEC 142.22 BLOCK 1 LOT 30
204 IRVING AVENUE
PORT CHESTER, NEW YORK 10573
(0.12 ACRE)

INSPECTION DATE: APRIL 15TH, 2022

REPORT DATE: APRIL 25TH, 2022

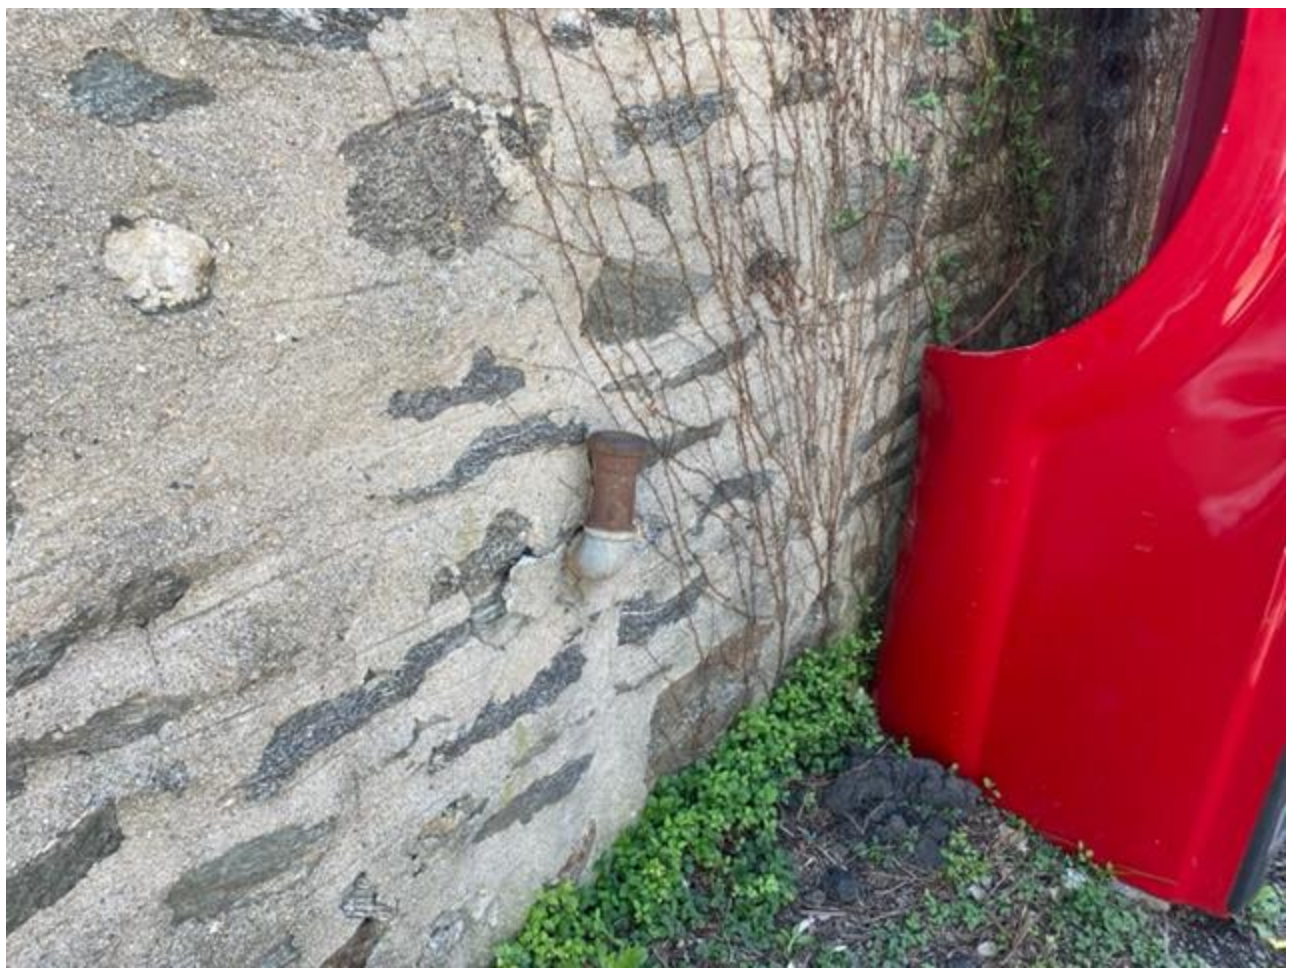
Unknown pipe protruding from structure

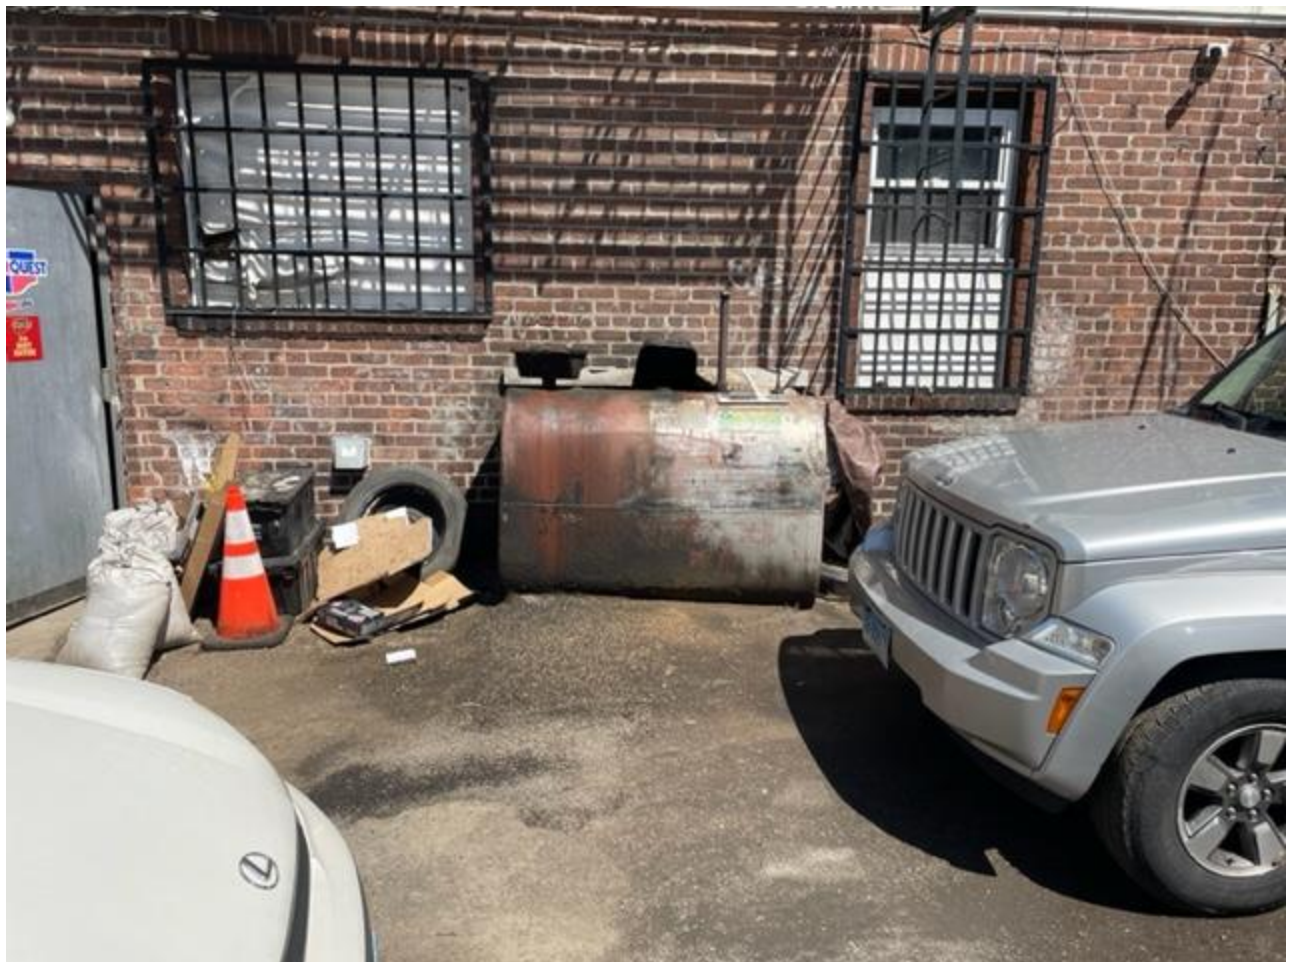
Aboveground storage tank in rear lot

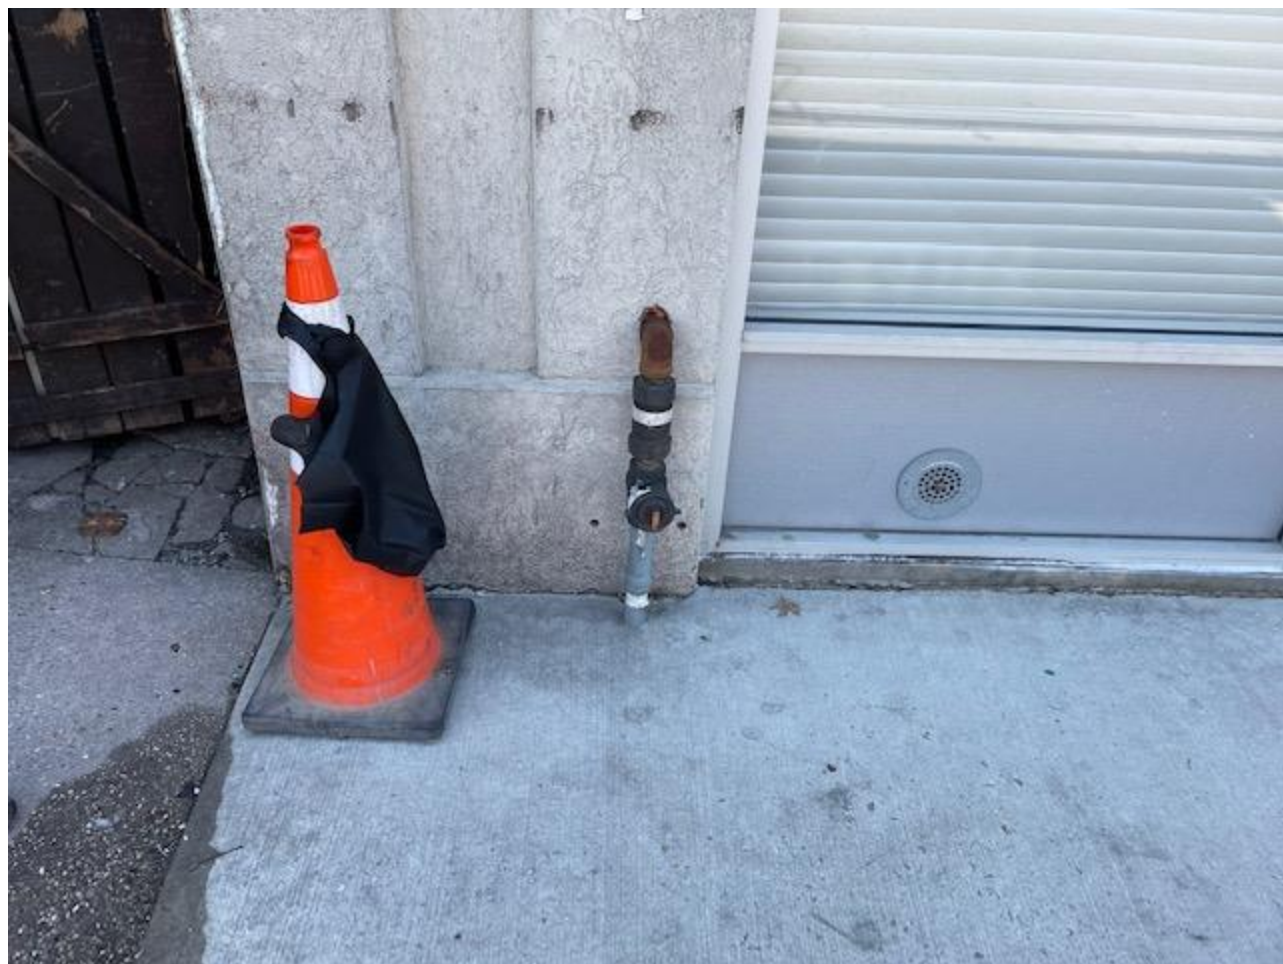
Unknown pipe protruding from structure

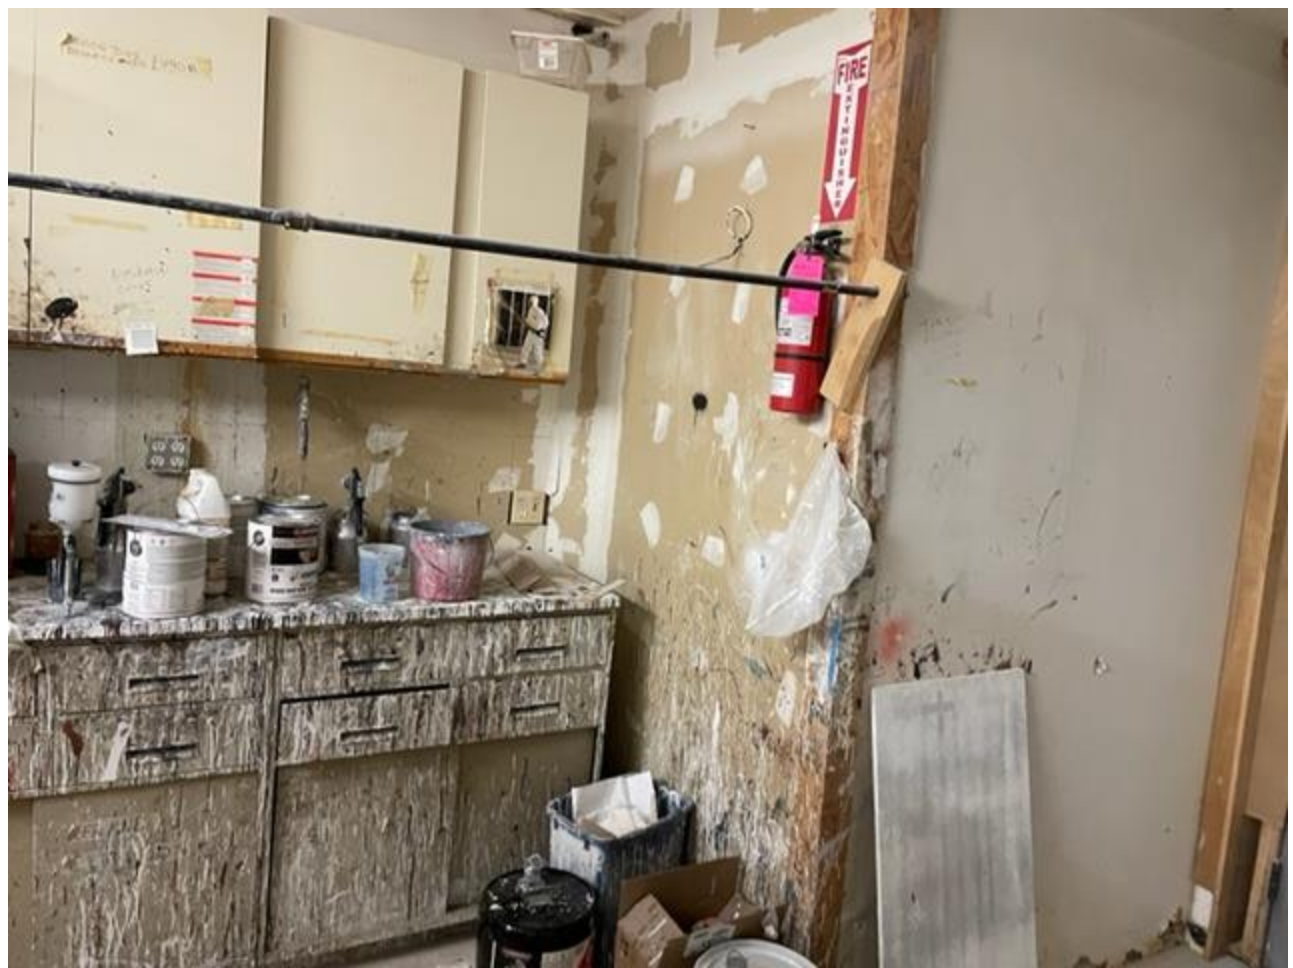
- During the Site inspection, spray-booths were identified on-Site. Air emissions fall under state and/or federal guidance, dependent on material type used and their quantities.

Paint shop

C2G recommends determining if the spray-booths will continue being used. Upon determining if this use will continue, C2G recommends confirming the air emissions are within state and/or federal guidelines.

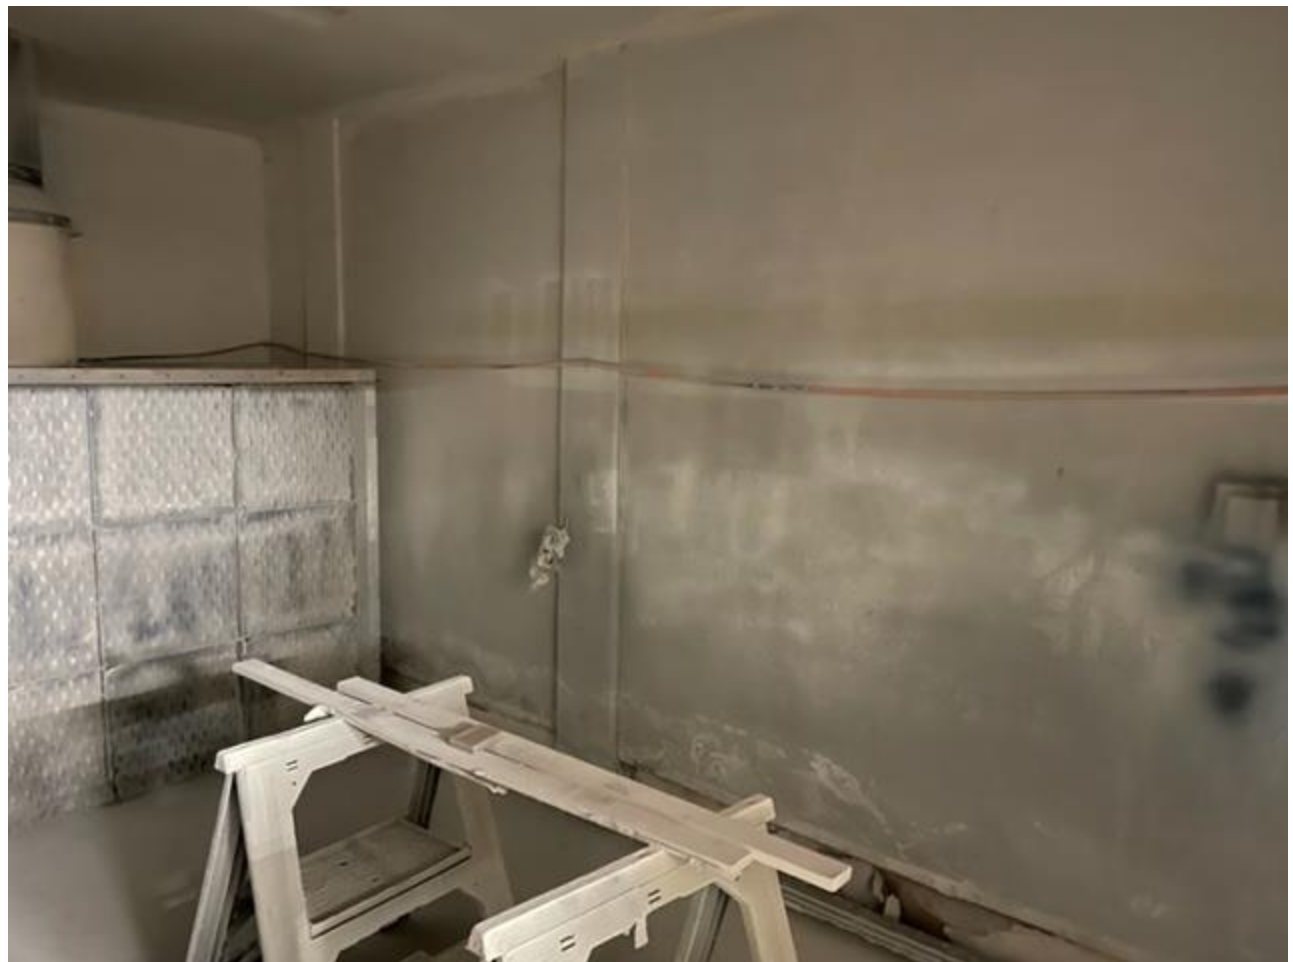
Paint room

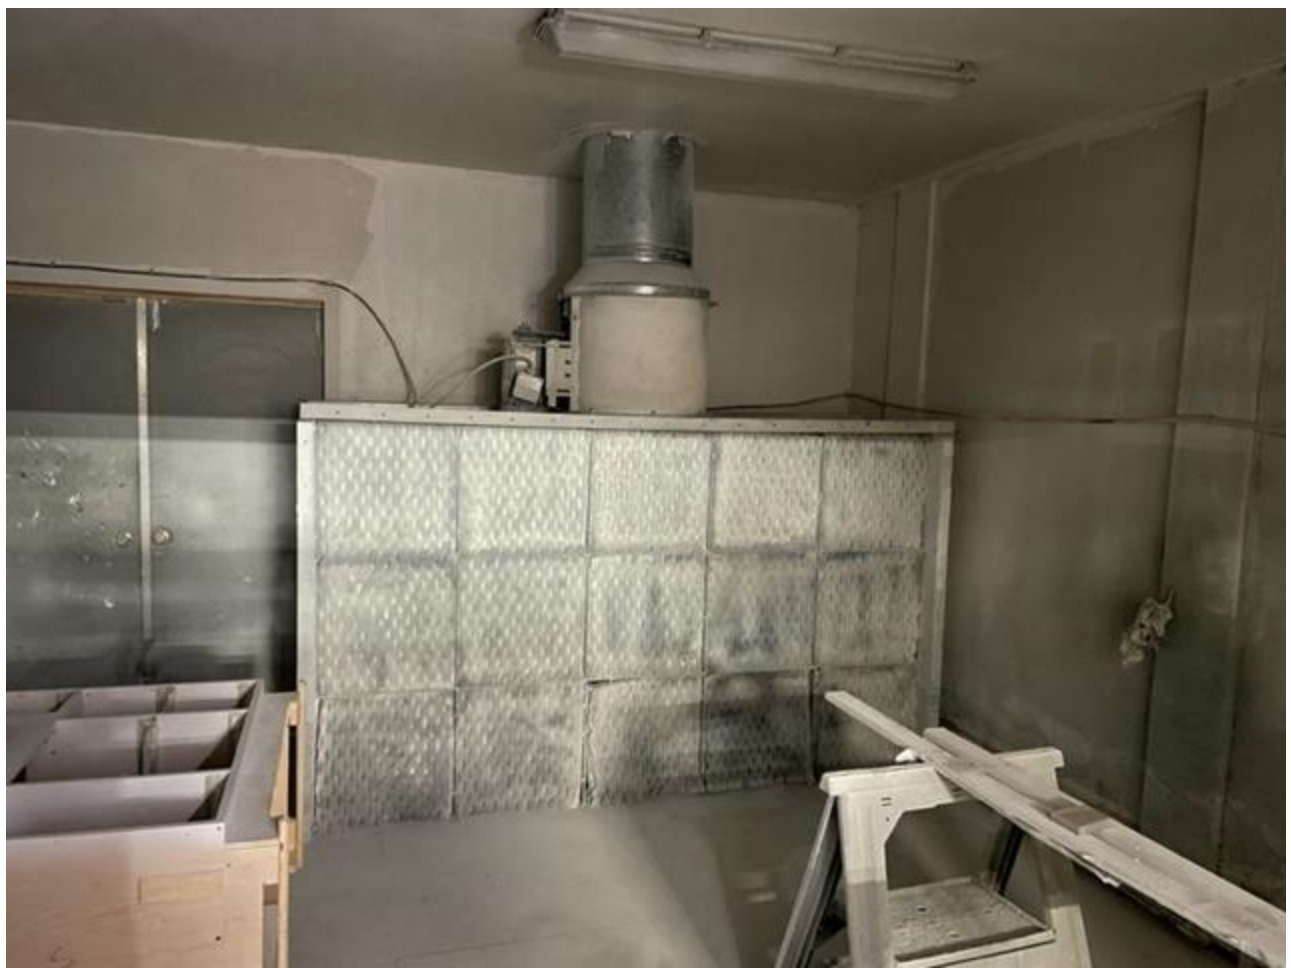
Paint room and air mover

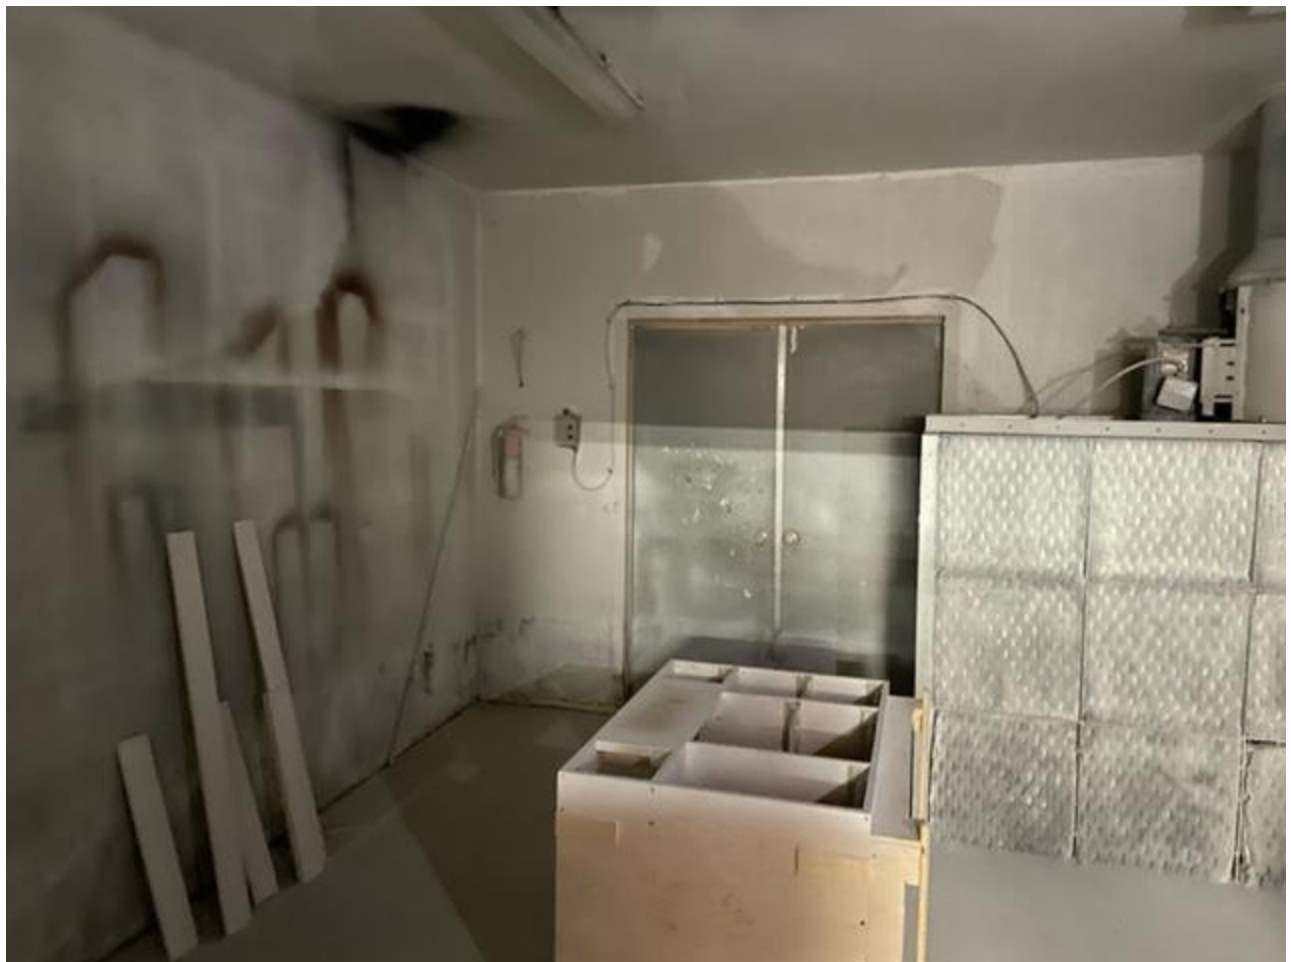
Paint room
