# Phase I Environmental Site Assessment

34 State Street, 17-25 James Street, & 27 Hunter Street - (Sec.  
97.07; Lots 17, 18, 68)  
Ossining, New York

EBI Project No. 1117000093

January 18, 2016

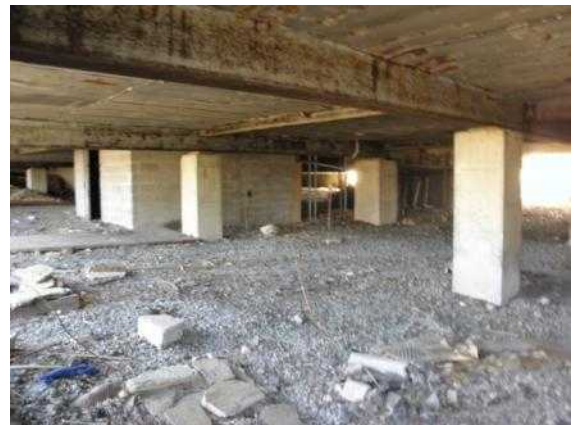
**11.** Crawl space beneath southern building.

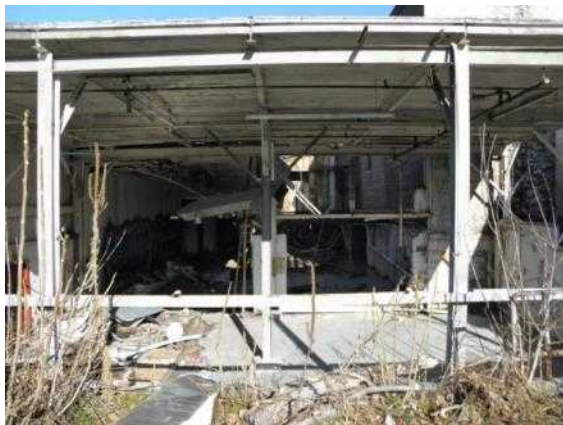
**14.** Looking north into lined concrete area (former lagoon?) next to northern building.

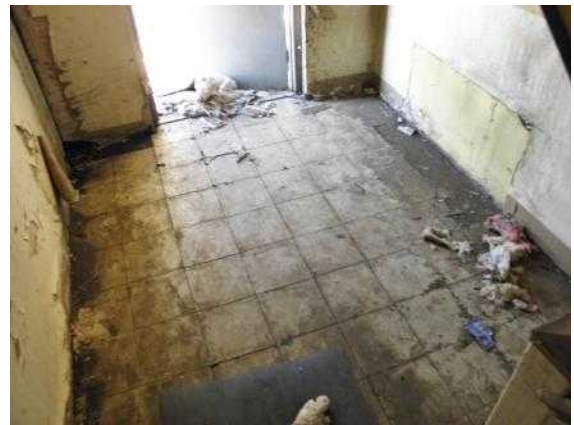
**17.** Vinyl floor tile in southern building.

- (2) It is recommended that an asbestos inspection be performed in accordance with all applicable federal, state, and local regulatory requirements prior to renovation, demolition, or other activities that could cause a material disturbance. Any removal or disturbance of ACM or suspect ACM should be performed by properly trained personnel and in compliance with federal, state, and local regulations.

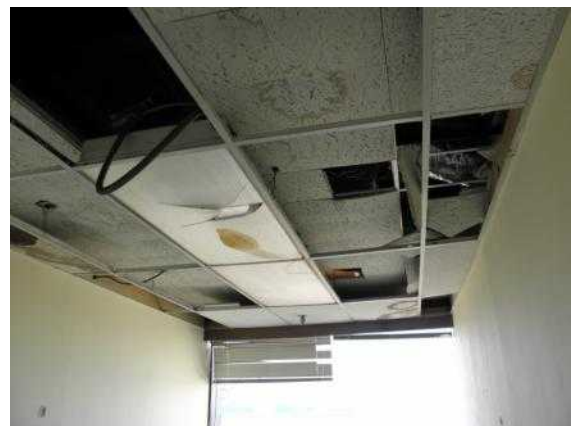
**18.** Ceiling tiles in former office area of southern building.

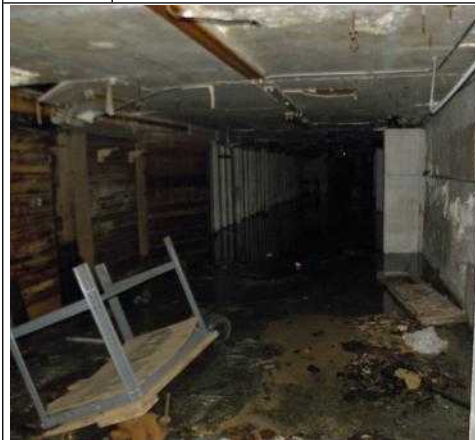
**23.** Flooded portion of basement of northern building.

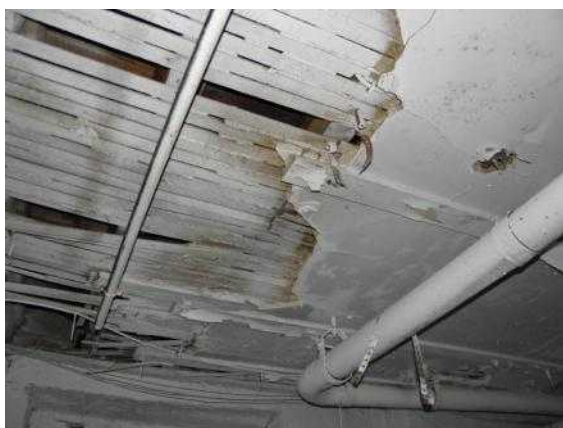
**21.** Lath and plaster system in basement ceiling.

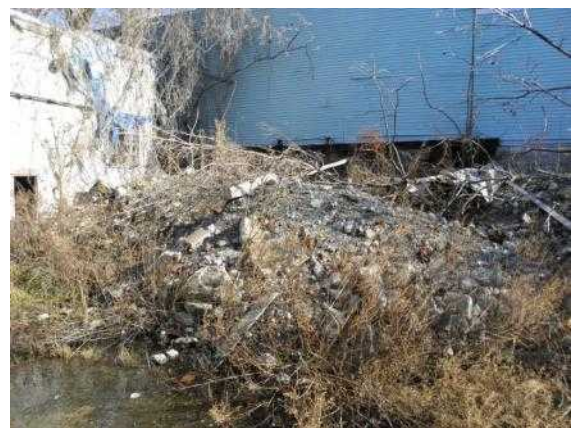
**24.** Debris piles along western part of developed portion of site.

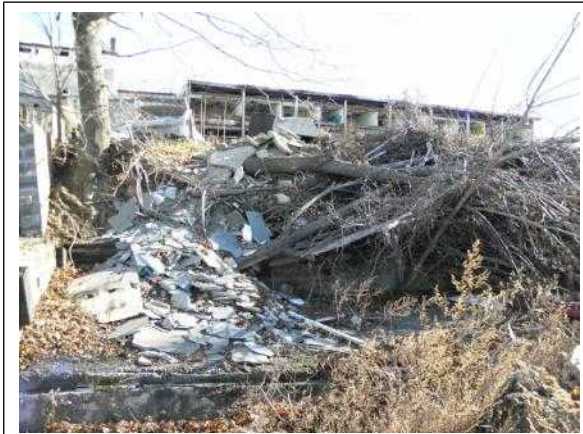
**25.**

Debris piles along western part of developed portion of site.
