## DAILY PHOTOGRAPH LOG

**Project:** Troy Belting RAWP Injections

**STERLING**  
Sterling Environmental Engineering, P.C.

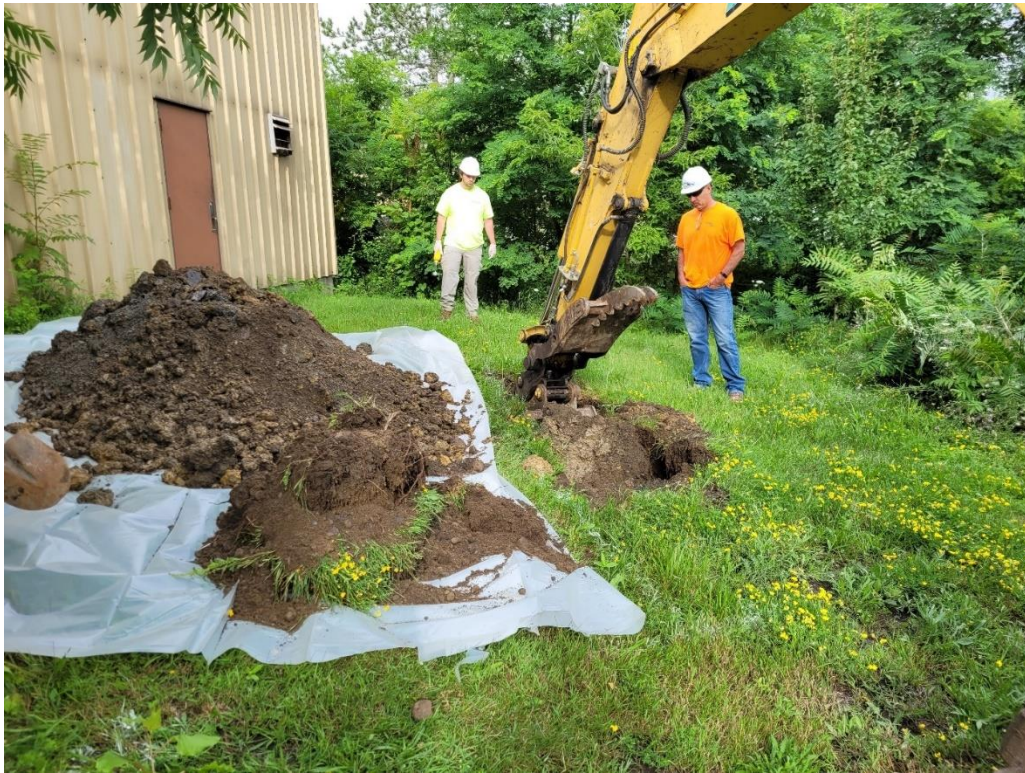
**Photograph 1:** Test Pit for collection of non-hazardous waste characterization sample. View looking west-southwest. (Photo taken 7/14/21).

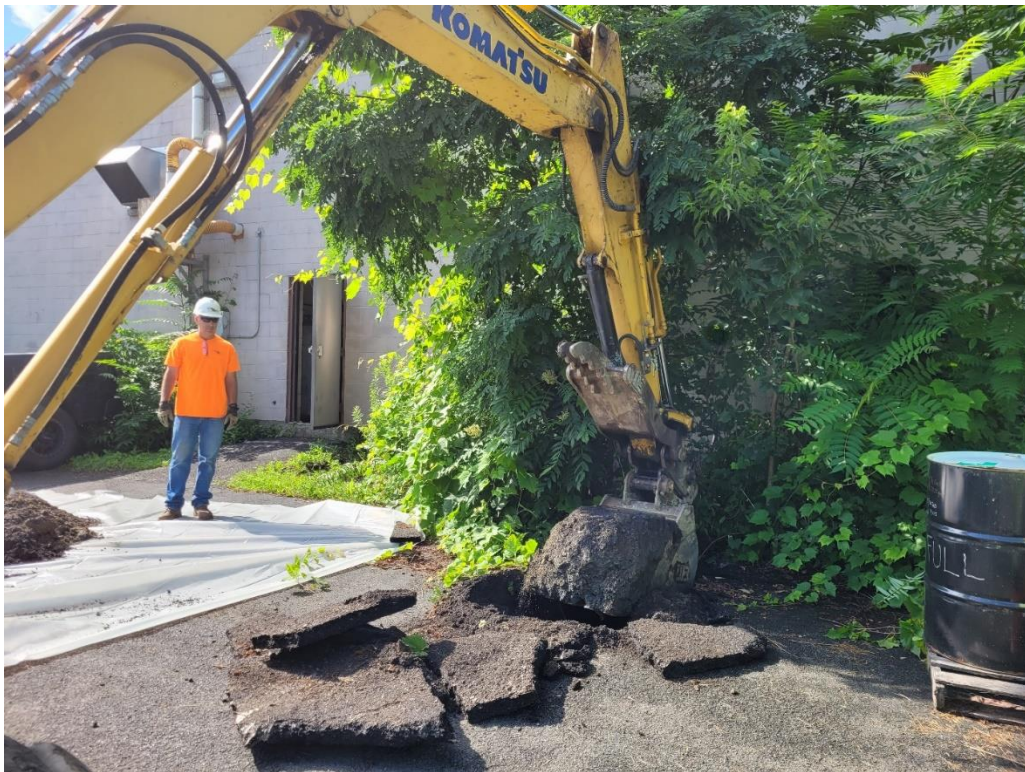
**Photograph 2:** Test Pit for collection of hazardous waste characterization sample. View looking southeast. (Photo taken 7/4/21).

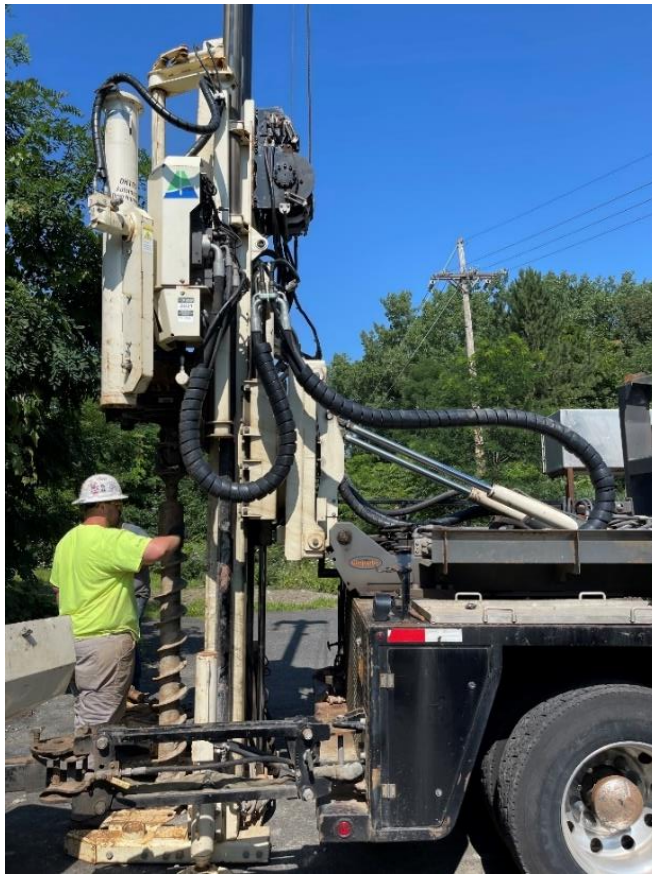
**Photograph 3:** Abandonment of Monitoring Wells MW-2S and 5S within the IRM soil excavation area. View looking west-northwest. (Photo taken 7/23/21).

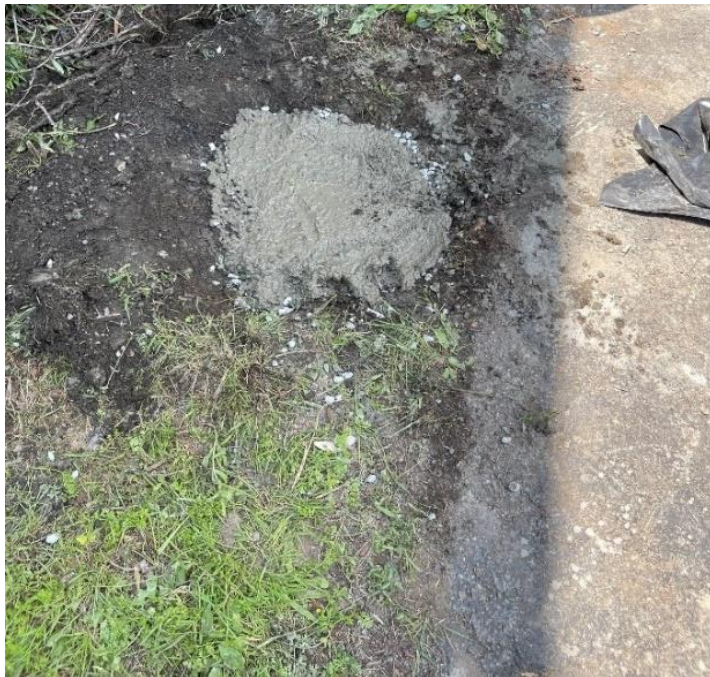
**Photograph 4:** Representative view of completed abandonment of Monitoring Well MW-5S. View looking west. (Photo taken 7/23/21).

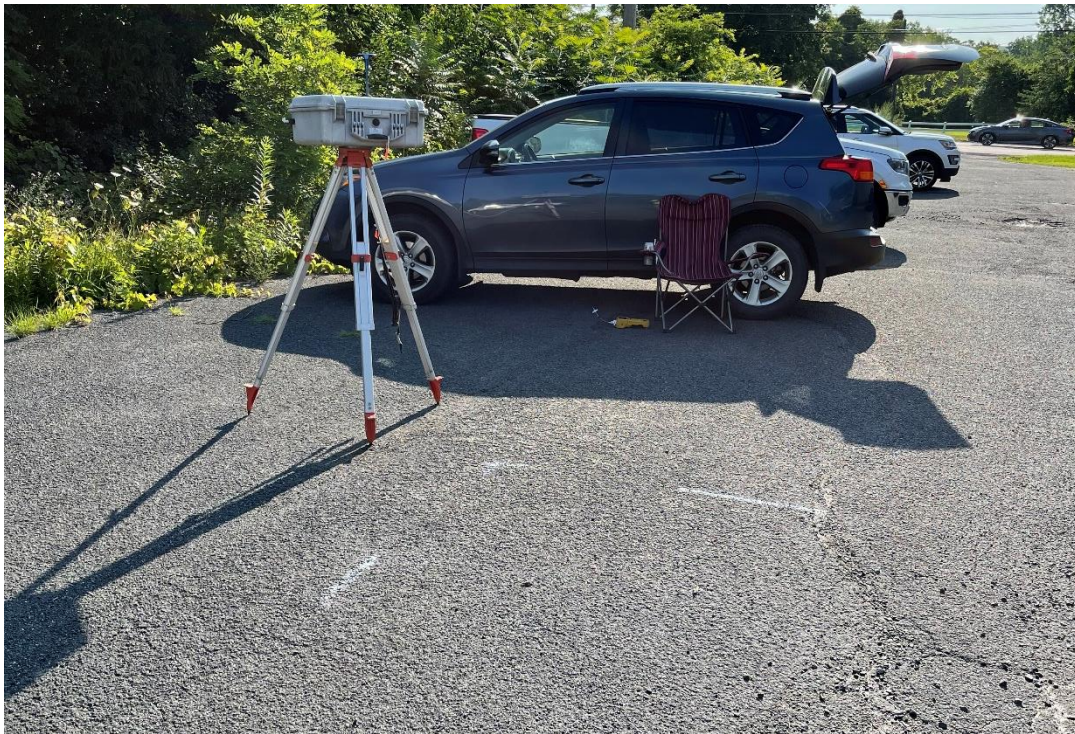
**Photograph 5:** Representative photograph of perimeter air monitoring equipment used throughout IRM construction during ground intrusive activities. View looking east. (Photo taken 7/23/21).

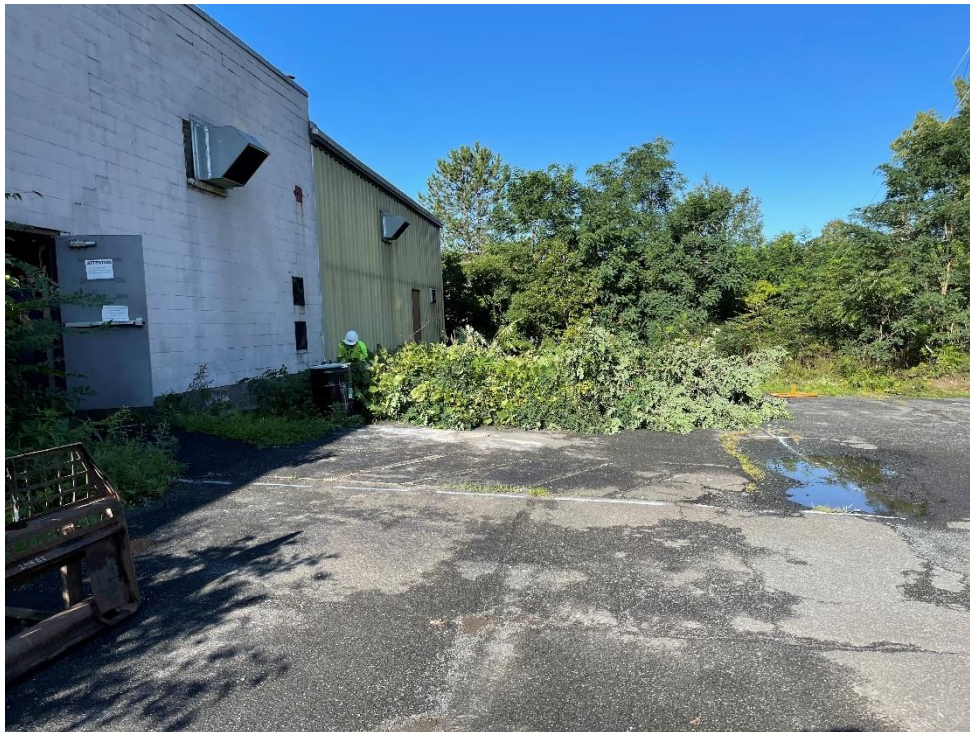
**Photograph 6:** Site Preparation – vegetation removal within soil excavation limits. View looking west. (Photo taken 9/2/21).

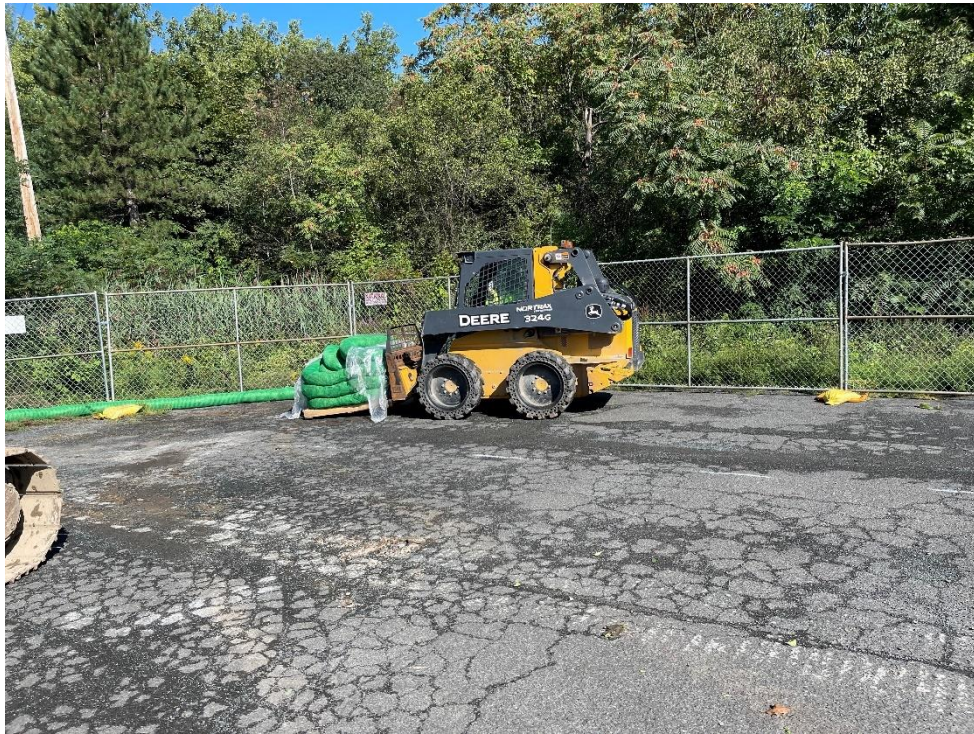
**Photograph 7:** Site Preparation – Installation of perimeter fencing and erosion controls. View looking northwest. (Photo taken 9/2/21).

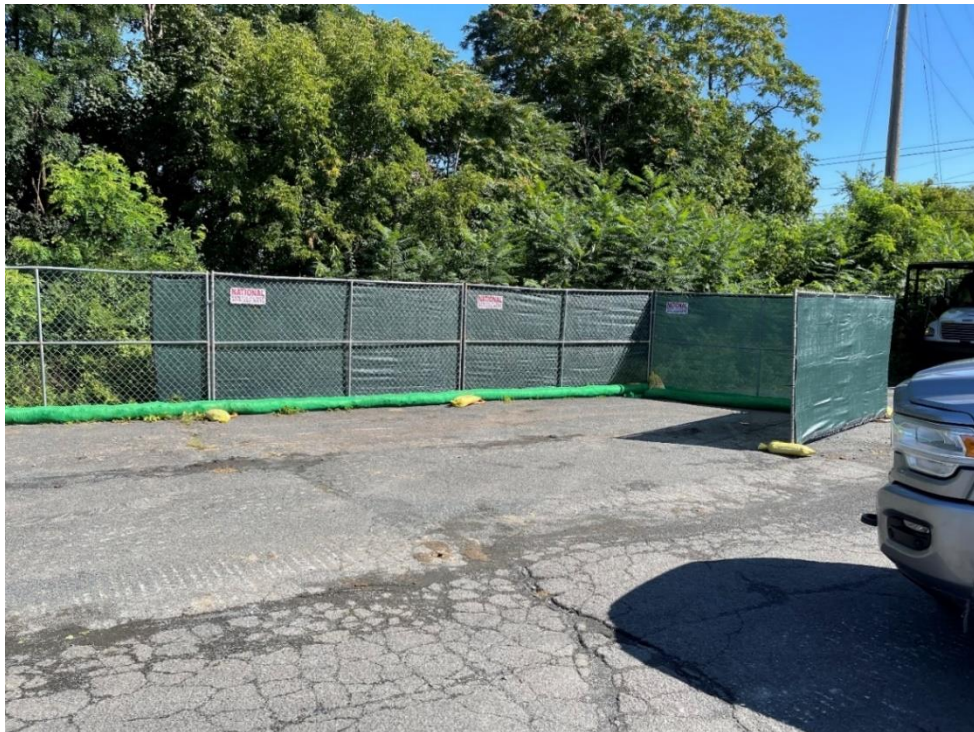
**Photograph 8:** Site Preparation – Installed perimeter fence and erosion controls. View looking northeast. (Photo taken 9/2/21).

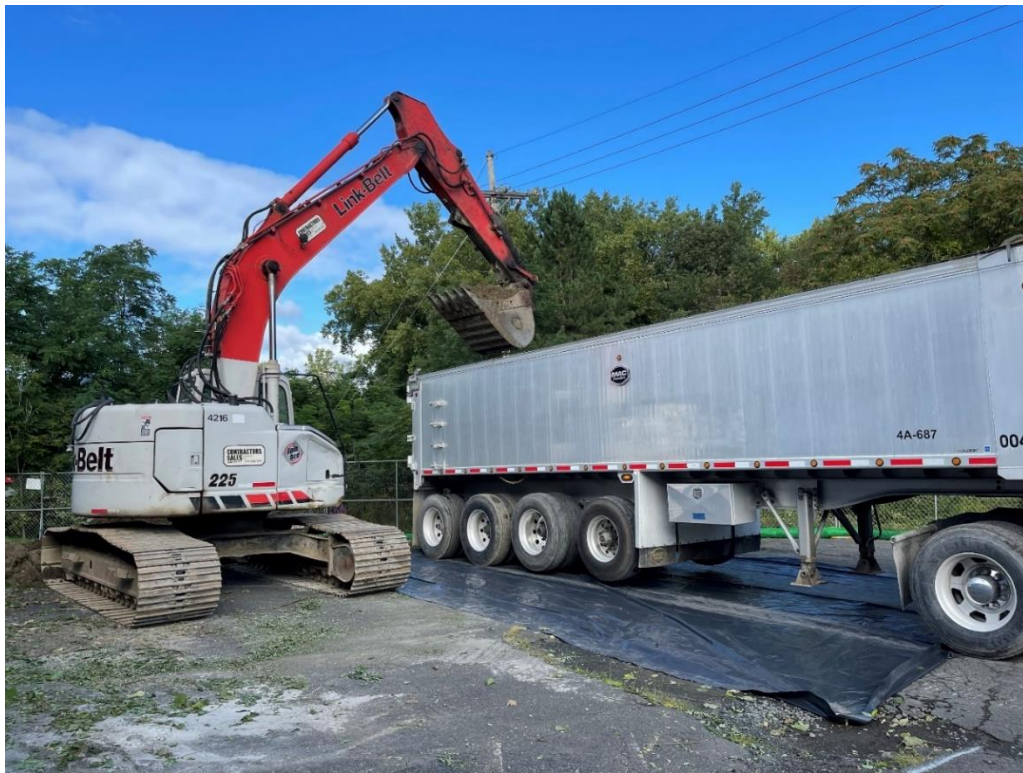
**Photograph 9:** Excavation and loading of non-hazardous soil for offsite disposal at the Green Ridge Landfill in Gansevoort, NY. View looking northwest. (Photo taken 9/3/21).

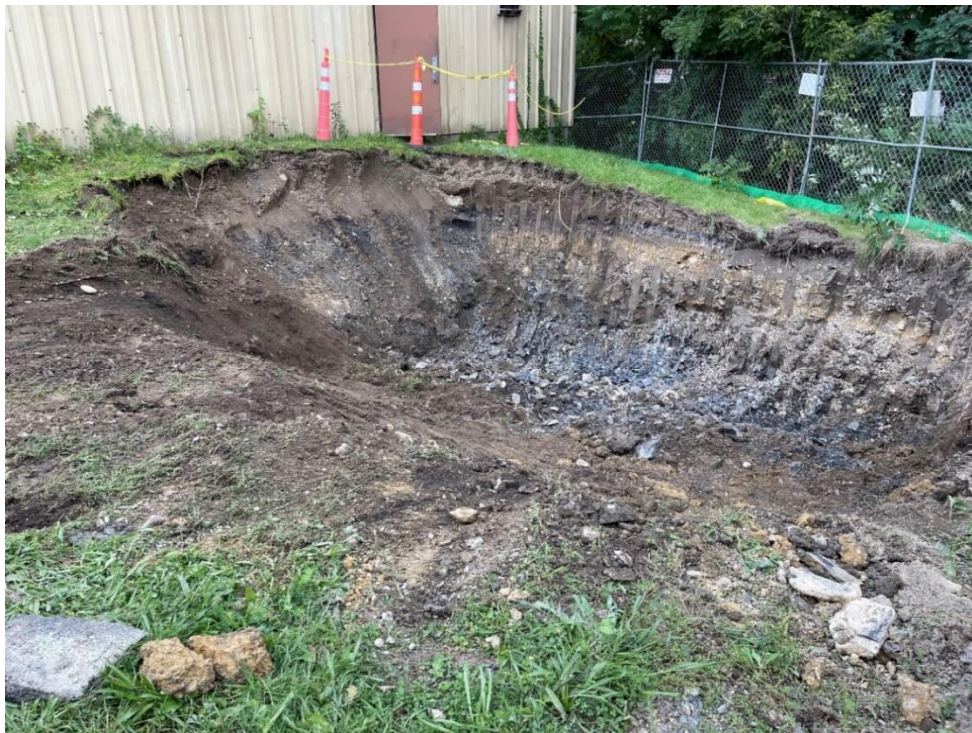
**Photograph 10:** Excavation of non-hazardous soil in southwest portion of the IRM excavation area. Excavation sidewall was sloped along the building to protect its foundation. View looking southwest. (Photo taken 9/3/21).

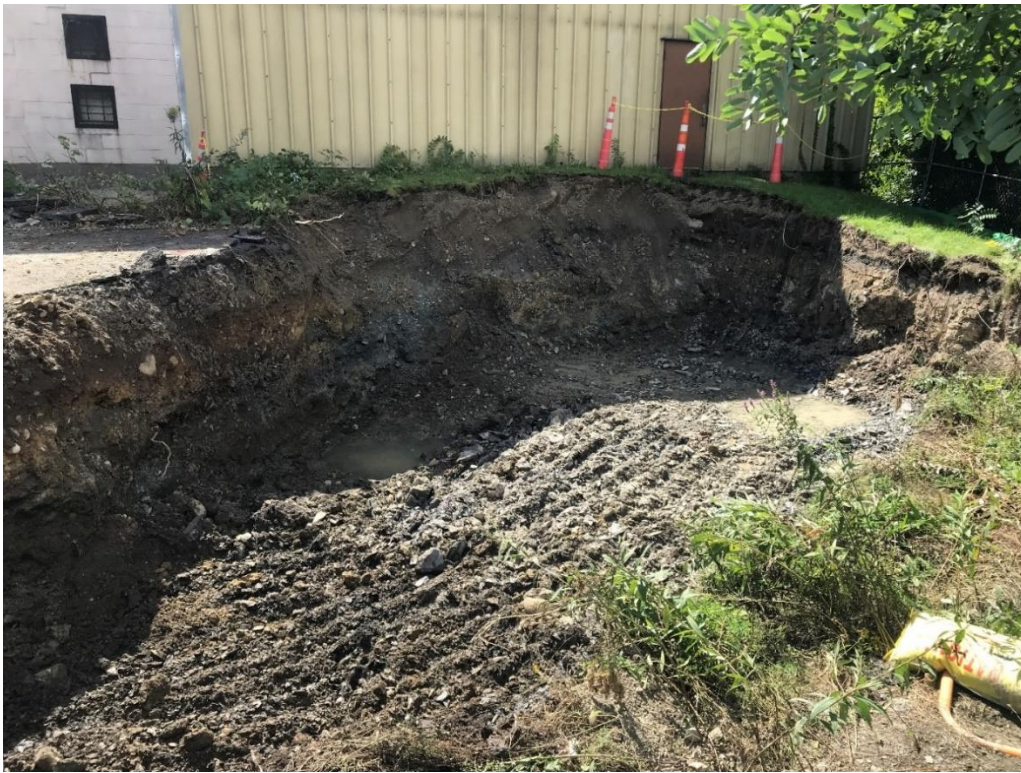
**Photograph 11:** Completed excavation of non-hazardous soil and weathered bedrock in the southwest portion of the IRM excavation area. View looking southwest. (Photo taken 9/7/21).

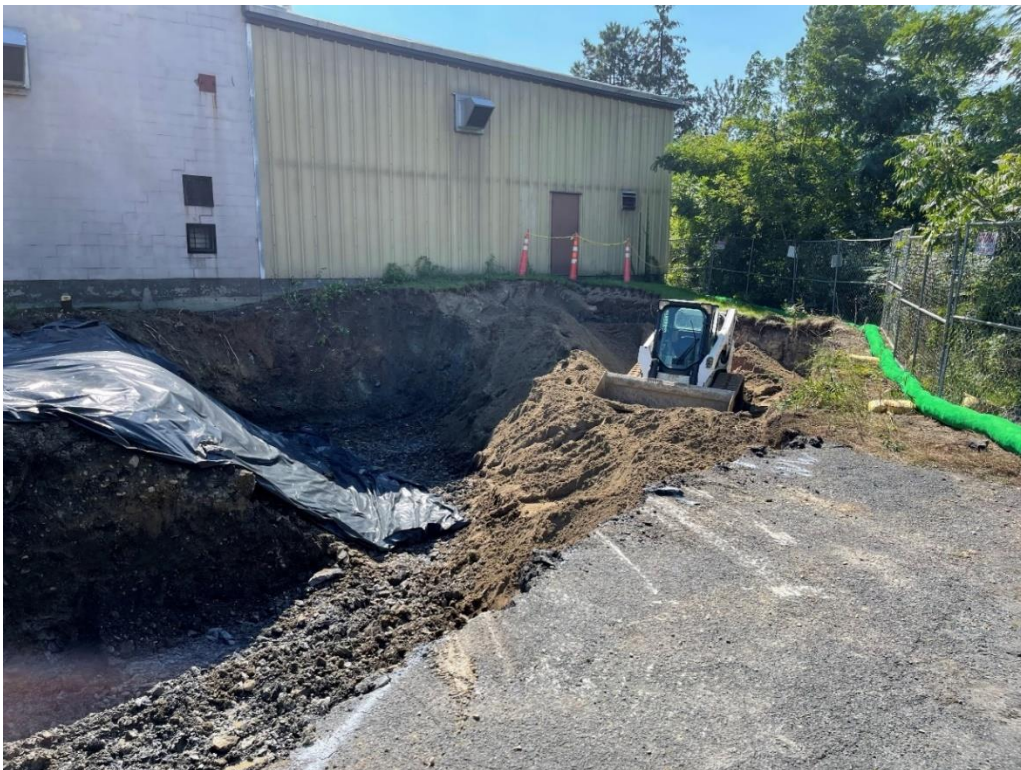
**Photograph 12:** Placement of approved backfill in completed excavation area. Poly sheeting placed over impacted soil to prevent cross contamination. View facing southwest. (Photo taken 9/8/21).

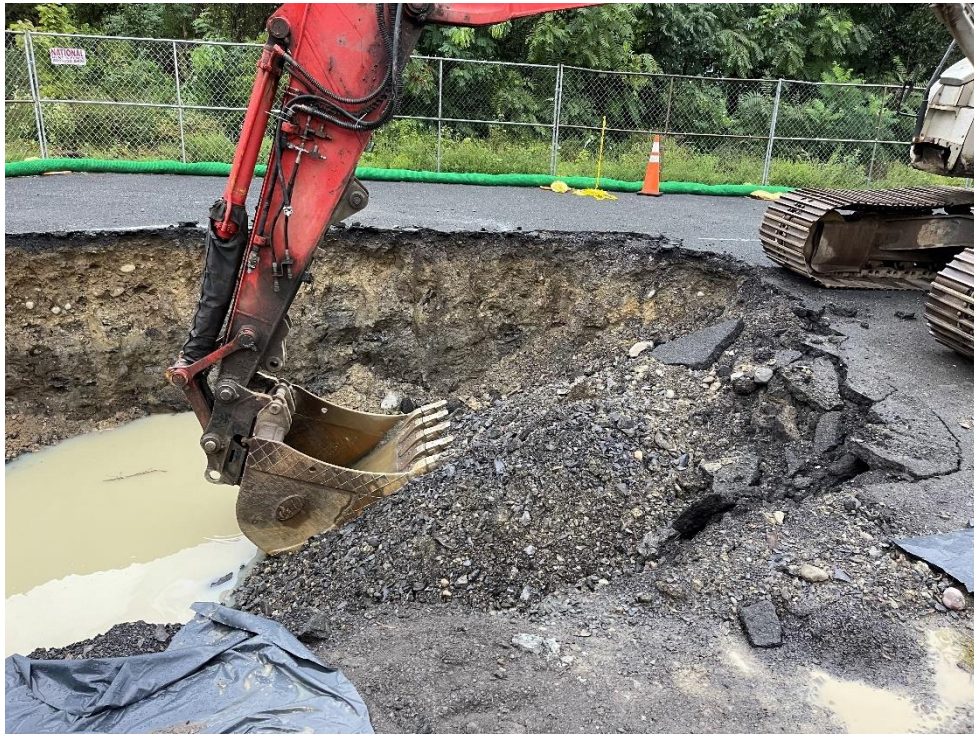
**Photograph 13:** Excavation of non-hazardous soil along the northern limit of the IRM excavation area. View looking north. (Photo taken 9/8/21).

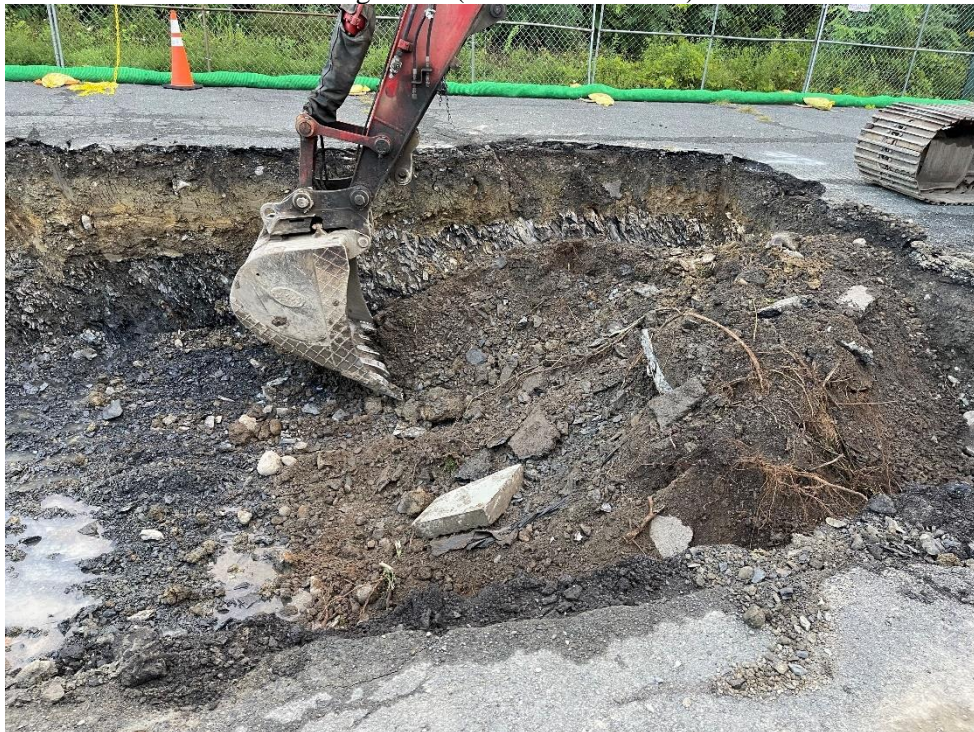
**Photograph 14:** Excavation of non-hazardous soil up to the northeastern limit of the IRM excavation area. View looking northeast. (Photo taken 9/10/21).

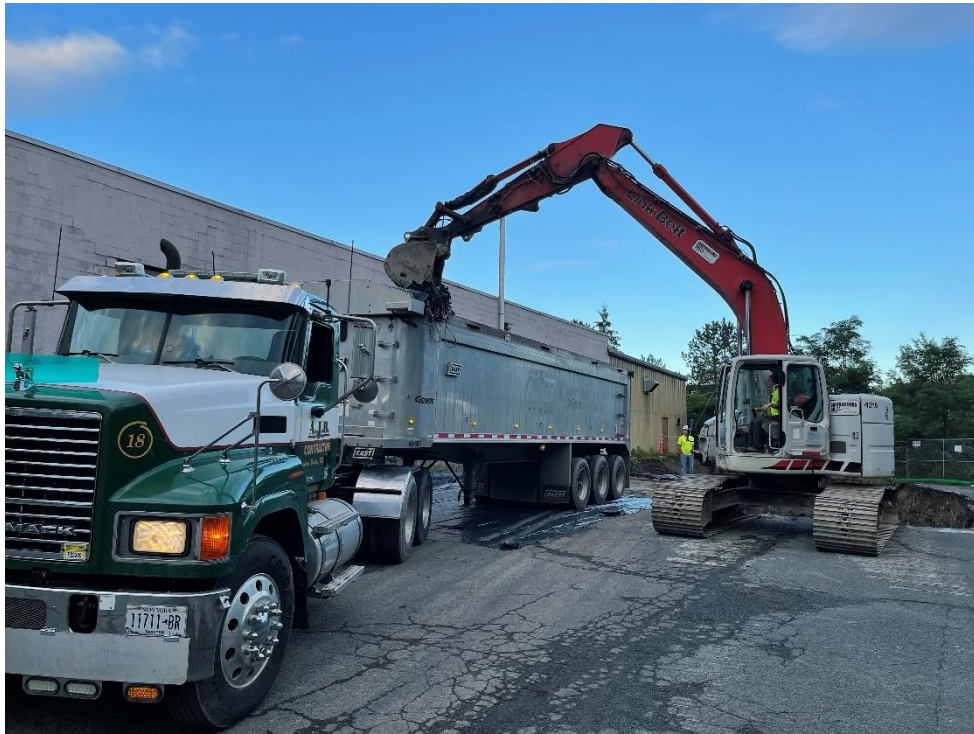
**Photograph 15:** Representative photograph of loading non-hazardous soil for offsite disposal. View looking west-southwest. (Photo taken 9/10/21).

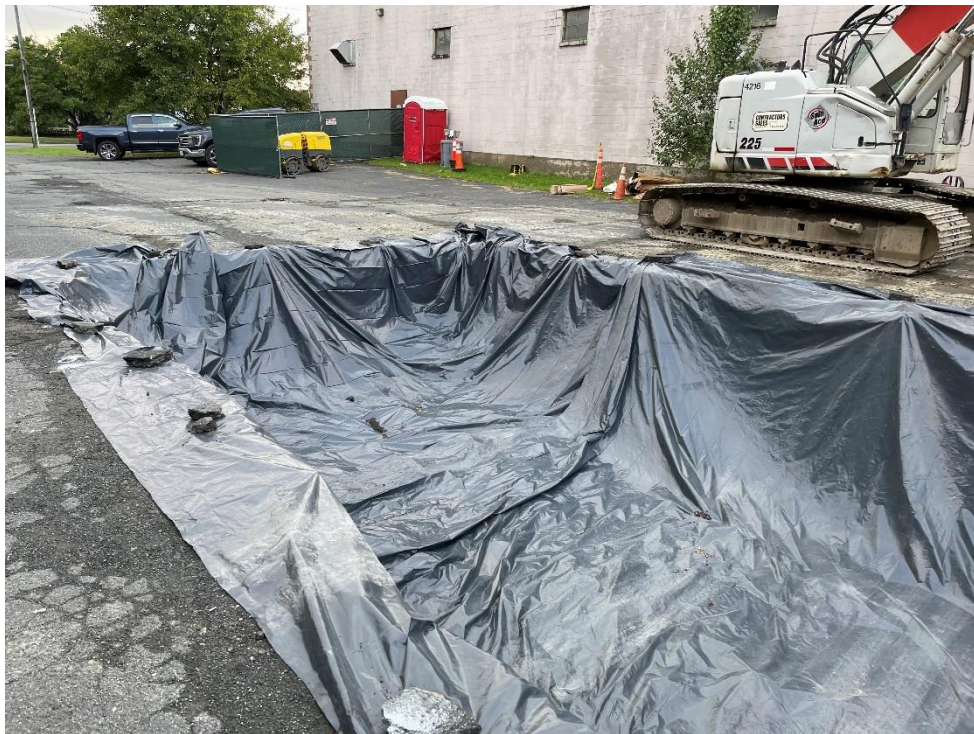
**Photograph 16:** Lined area within IRM excavation area limits to stockpile hazardous soil to facilitate truck loading. View looking east-southeast. (Photo taken 9/10/21).

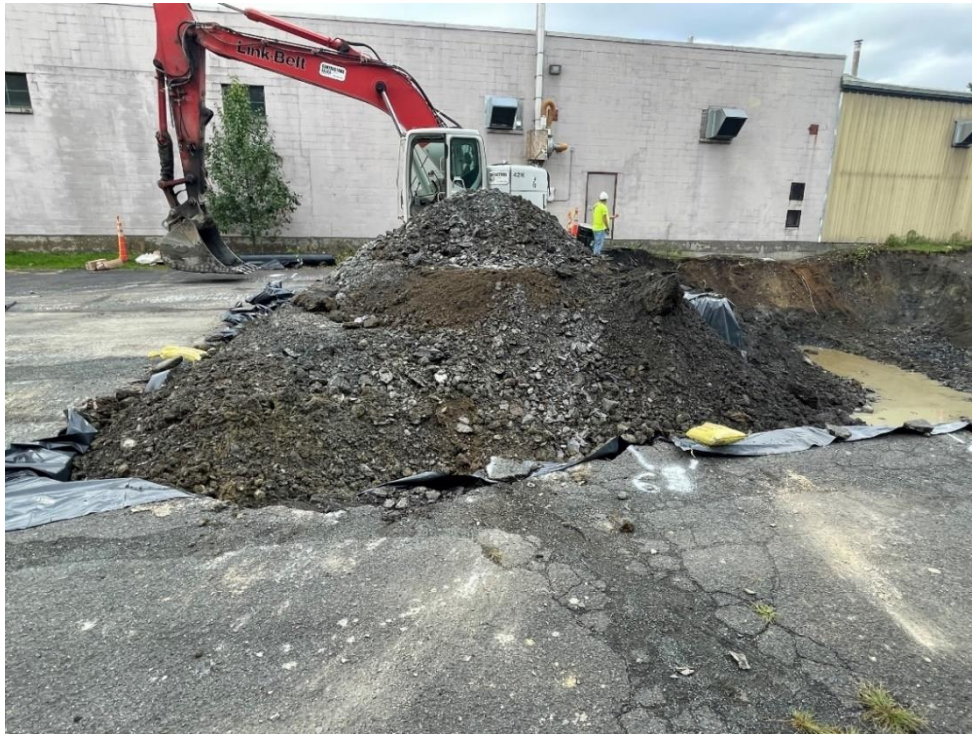
**Photograph 17:** Hazardous soil stockpiled within lined portion of IRM excavation area pending loading for offsite disposal. View looking south. (Photo taken 9/10/21).

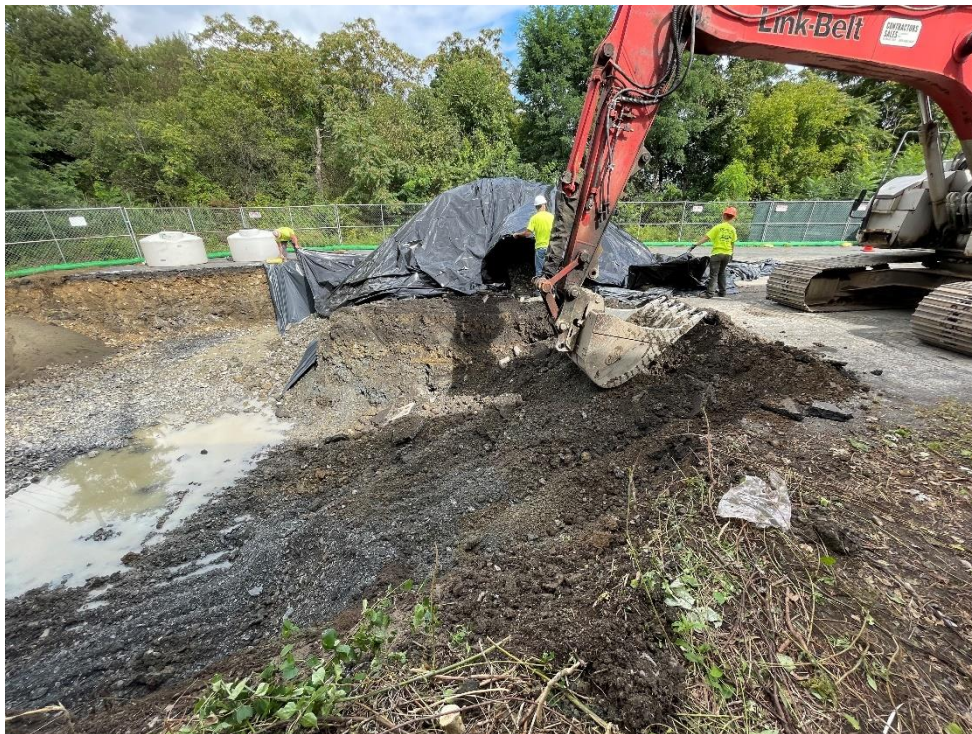
**Photograph 18:** Placement of poly sheeting over temporarily stockpiled hazardous soil within lined portion of IRM excavation area pending loading for offsite disposal. View looking north. (Photo taken 9/10/21)

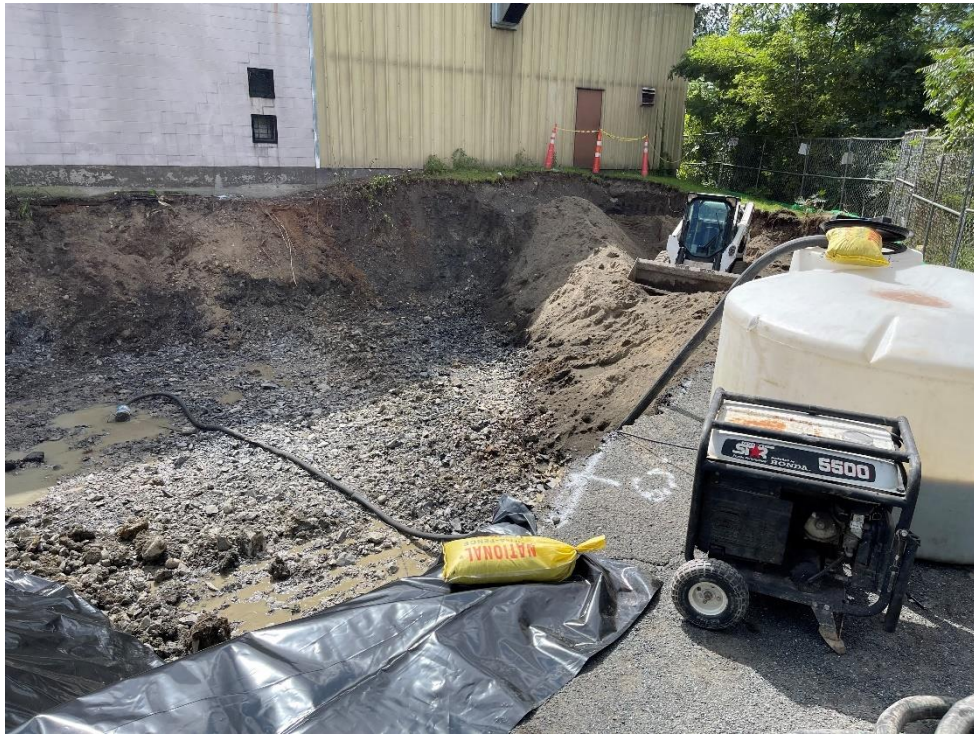
**Photograph 19:** Removal of remediation contact water with visible sheen from the hazardous soil excavation area for temporary storage pending characterization and offsite disposal. View looking southwest. (Photo taken 9/10/21)

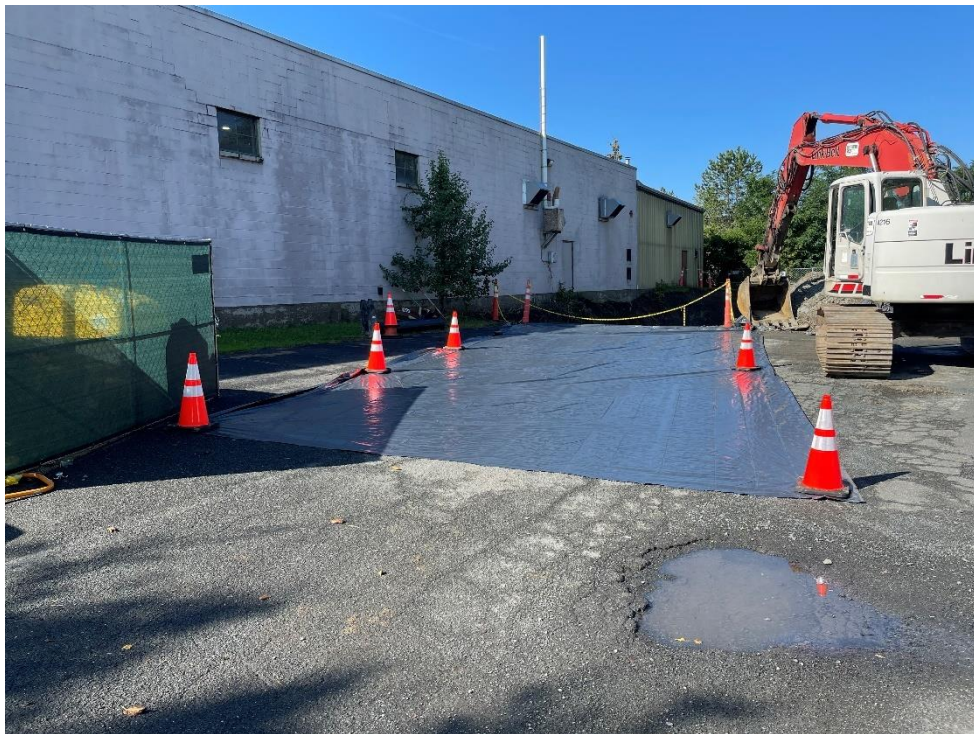
**Photograph 20:** Representative photograph of prepared truck loading area to prevent tracking of excavated soil. View facing west-southwest. (Photo taken 9/13/21).

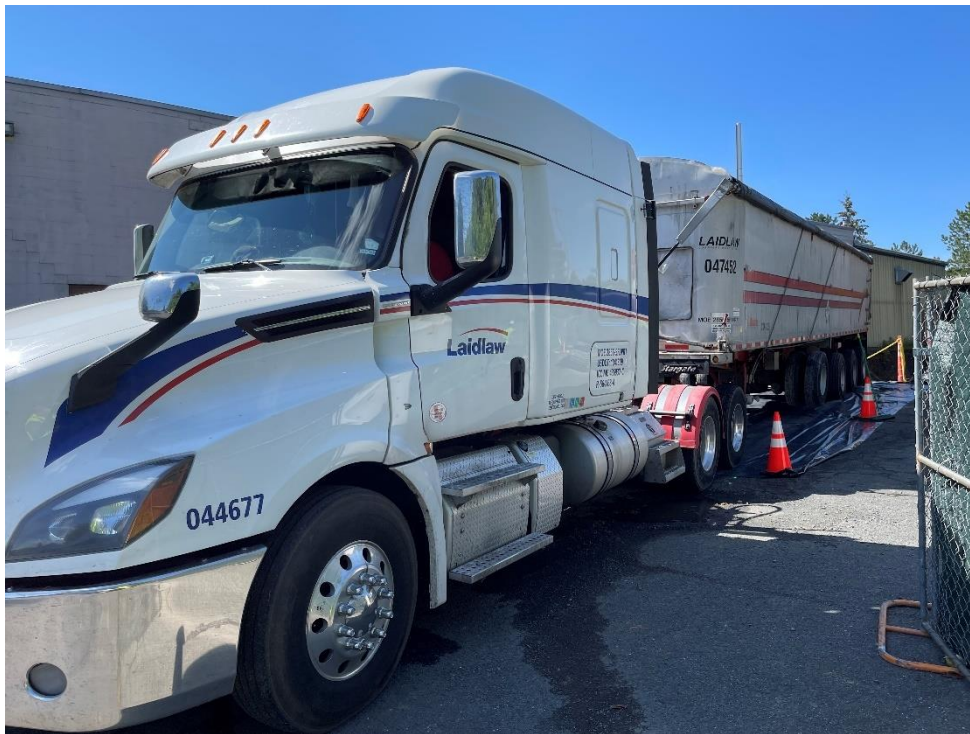
**Photograph 21:** Representative photograph of transport truck prepared to be loaded with hazardous soil for disposal to Signaterre Environmental, Inc. in Quebec, Canada. View facing southwest. (Photo taken 9/13/21).

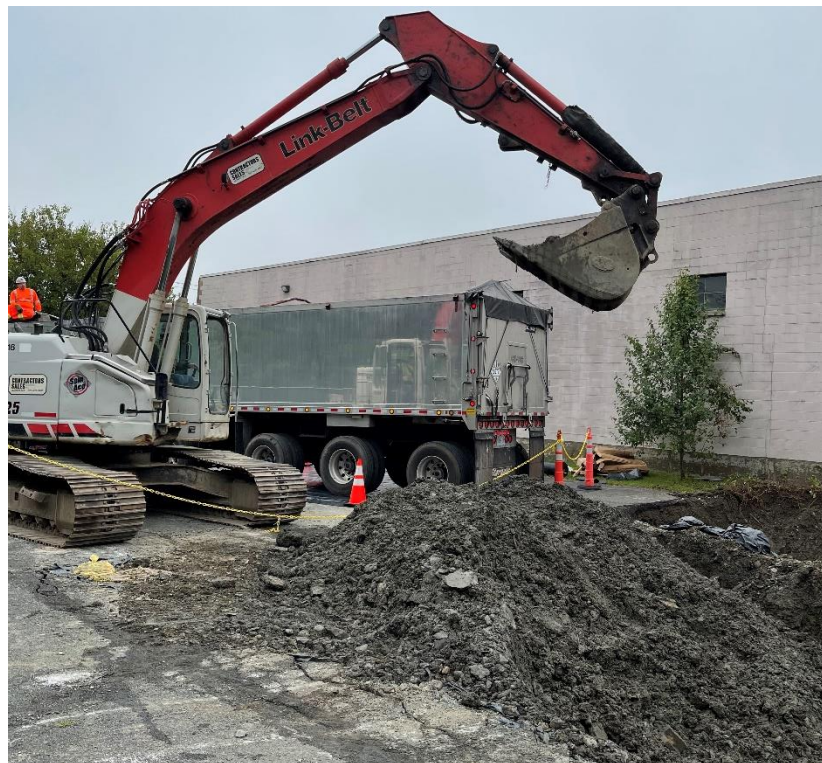
**Photograph 22:** Loading stockpiled hazardous soil within lined portion of IRM excavation for offsite disposal to Signaterre Environmental, Inc. in Quebec, Canada. View looking southeast. (Photo taken 9/14/21)

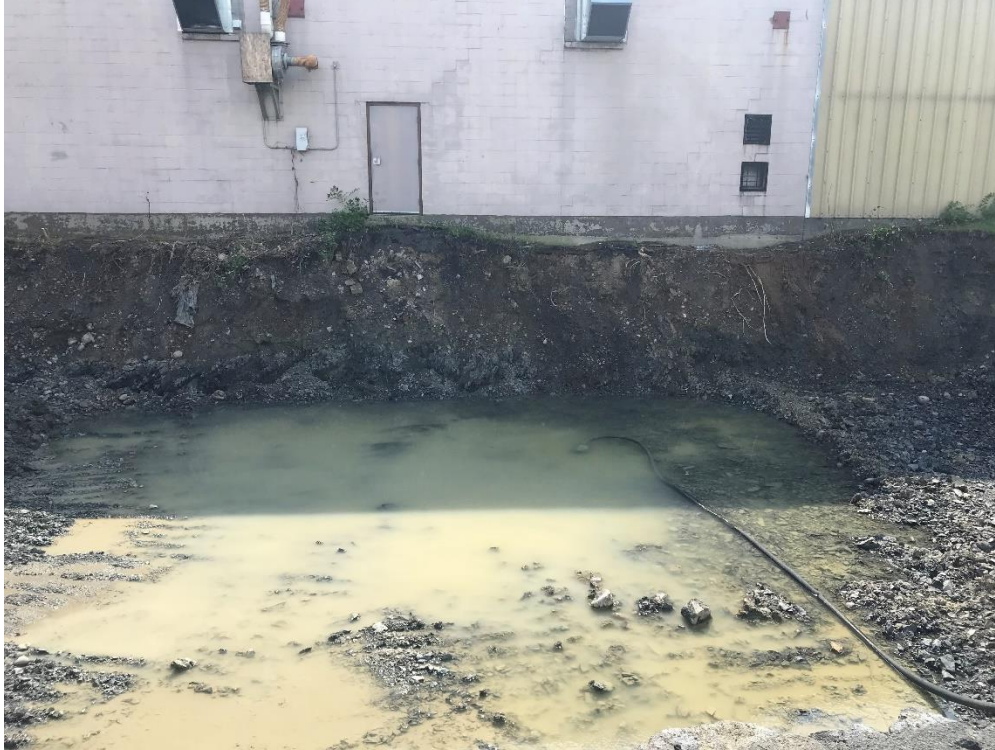
**Photograph 23:** Excavation floor completed to two feet into weathered bedrock surface within central portion of IRM excavation area. Accumulated remediation contact water prepared to be pumped to temporary holding tanks pending characterization and offsite disposal. View facing south. ( Photo taken 9/15/21).

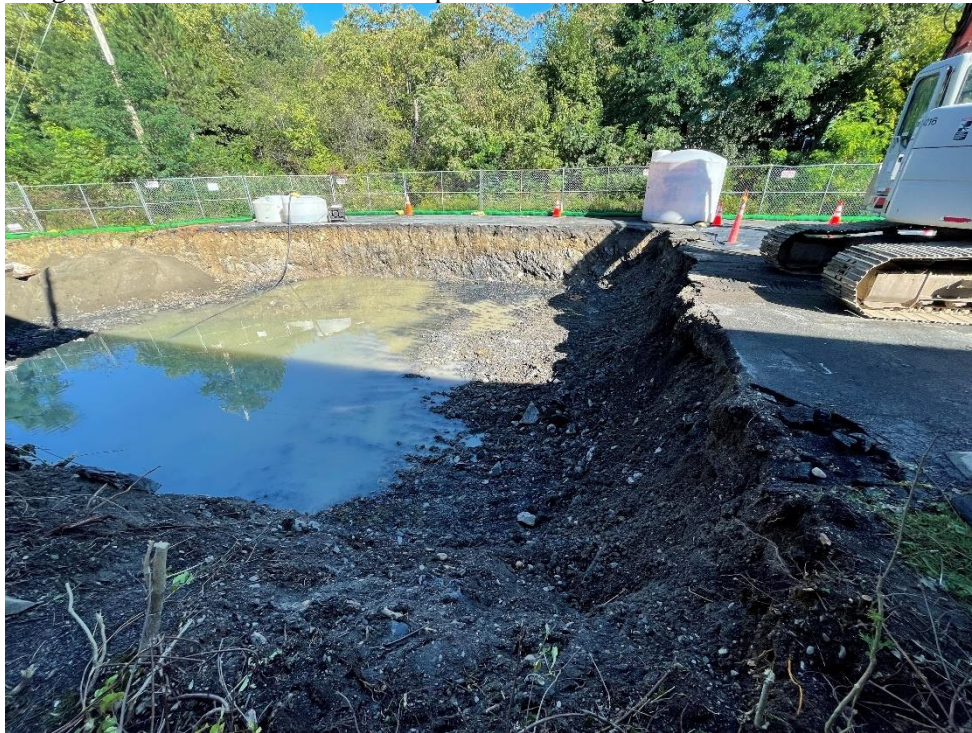
**Photograph 24:** Excavation floor completed to two feet into weathered bedrock surface up to eastern IRM excavation area limit. Accumulated remediation contact water prepared to be pumped to temporary holding tank pending characterization and offsite disposal. View facing south. ( Photo taken 9/16/21).

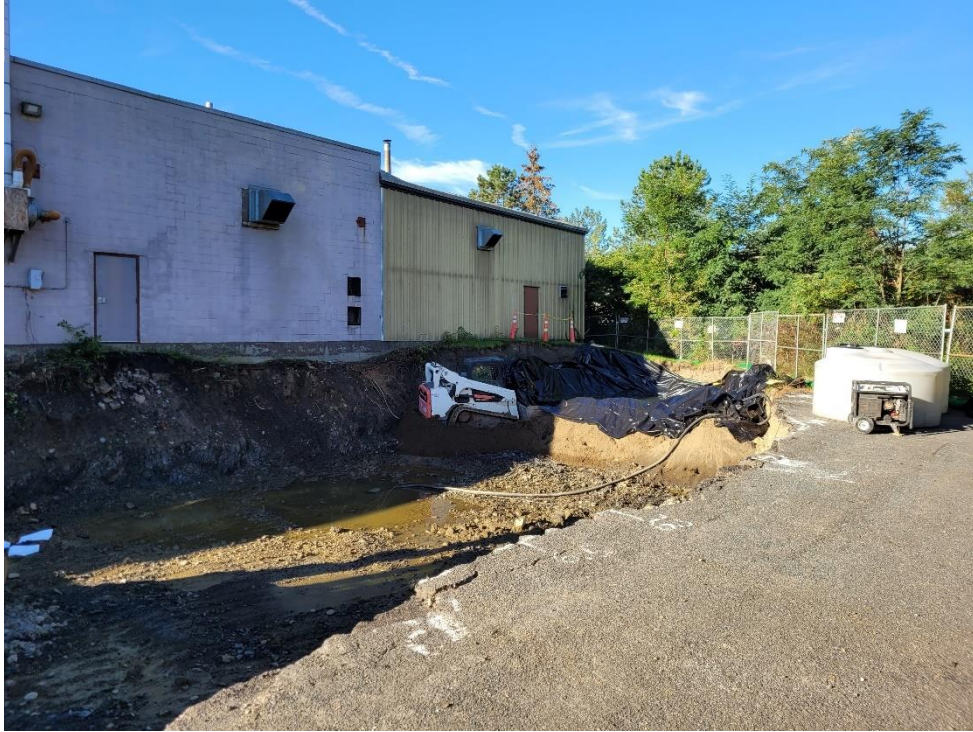
**Photograph 25:** Dewatered excavation area prior to placement of additional approved backfill. Remediation contact water was pumped to temporary holding tanks pending characterization and offsite disposal. View facing southwest. ( Photo taken 9/21/21).

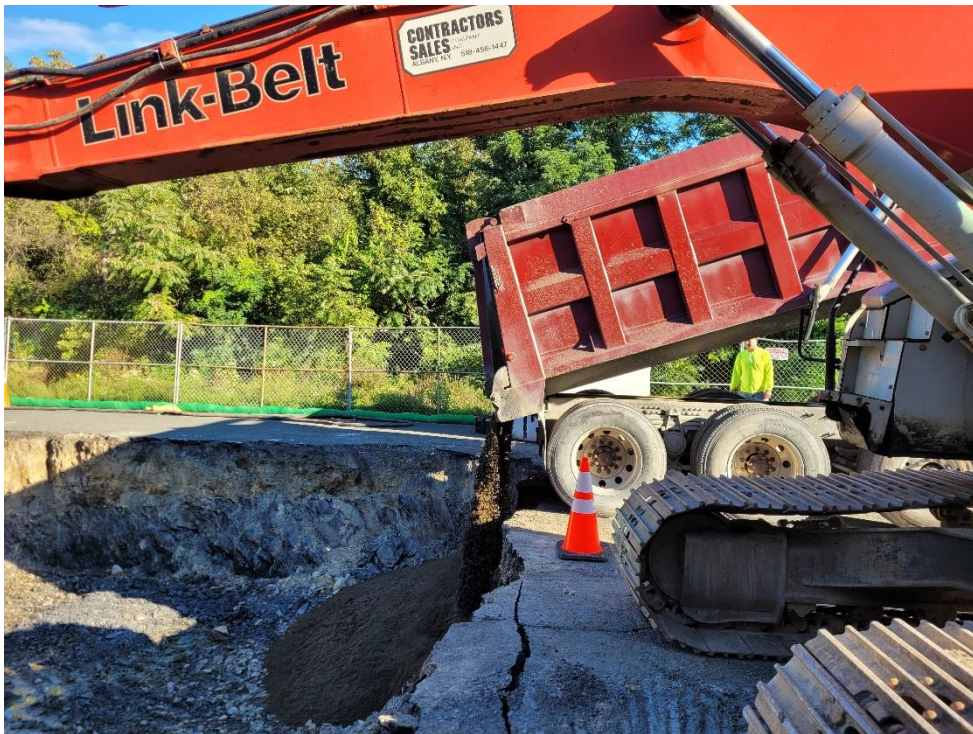
**Photograph 26:** Placement of approved backfill within IRM excavation area. View facing north. ( Photo taken 9/21/21).

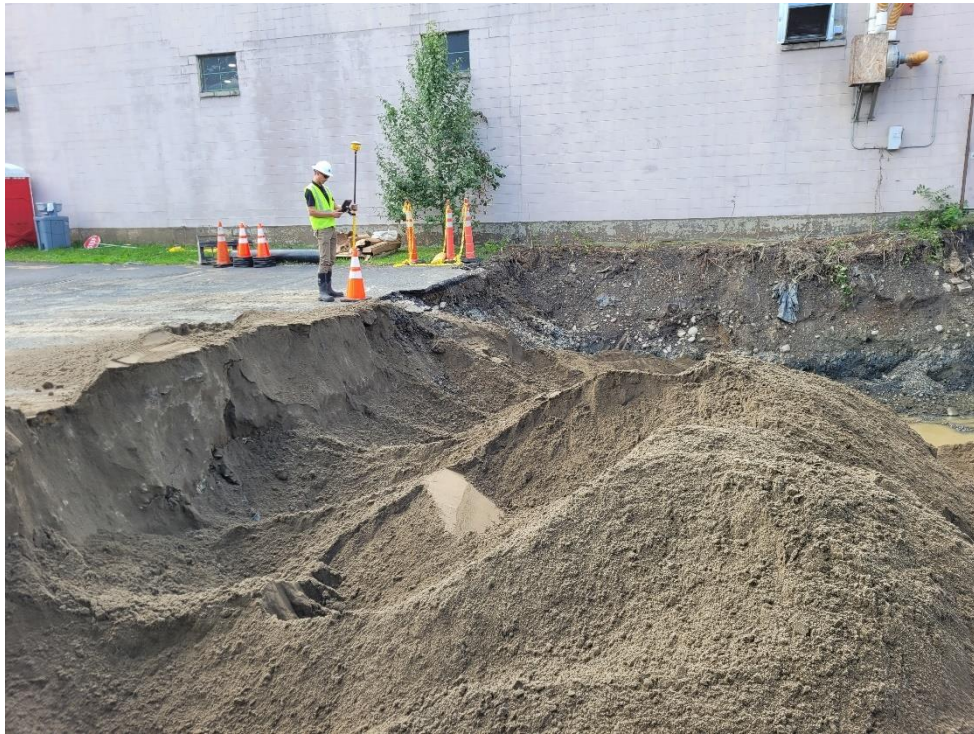
**Photograph 27:** GPS documentation of completed excavation limits. View facing south. ( Photo taken 9/21/21).

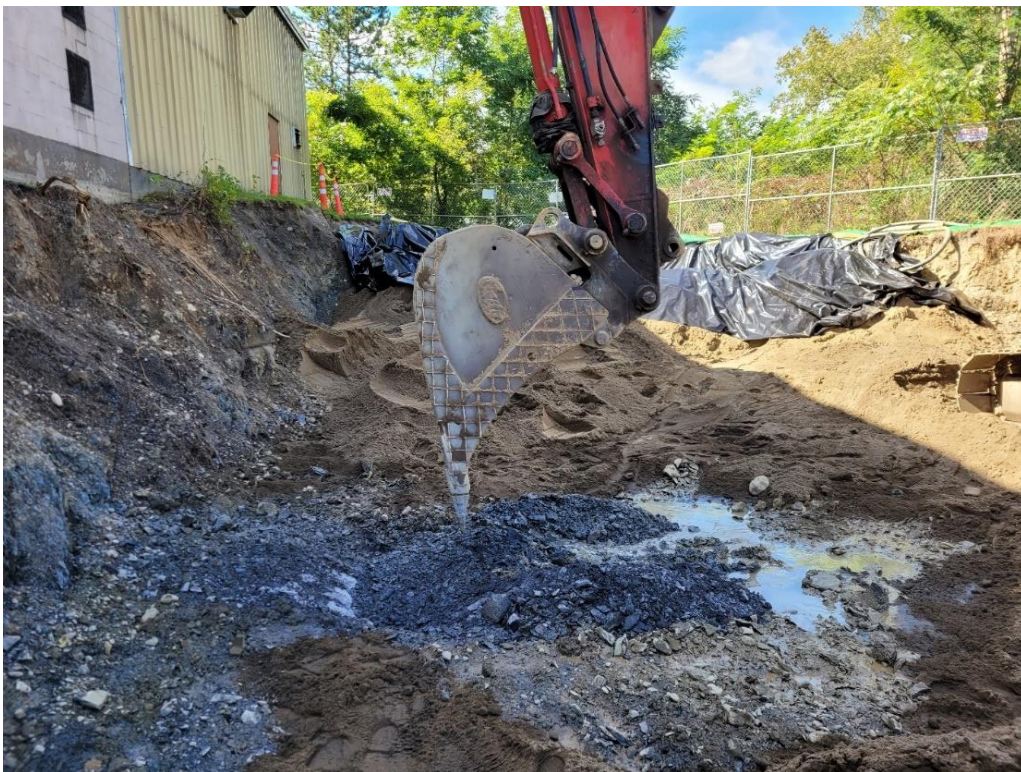
**Photograph 28:** Location of attempted excavation of competent bedrock for visual assessment and sample collection. Excavation was unsuccessful and rock sample collected with a drill rig on 10/8/21. View facing west. (Photo taken 9/21/21).

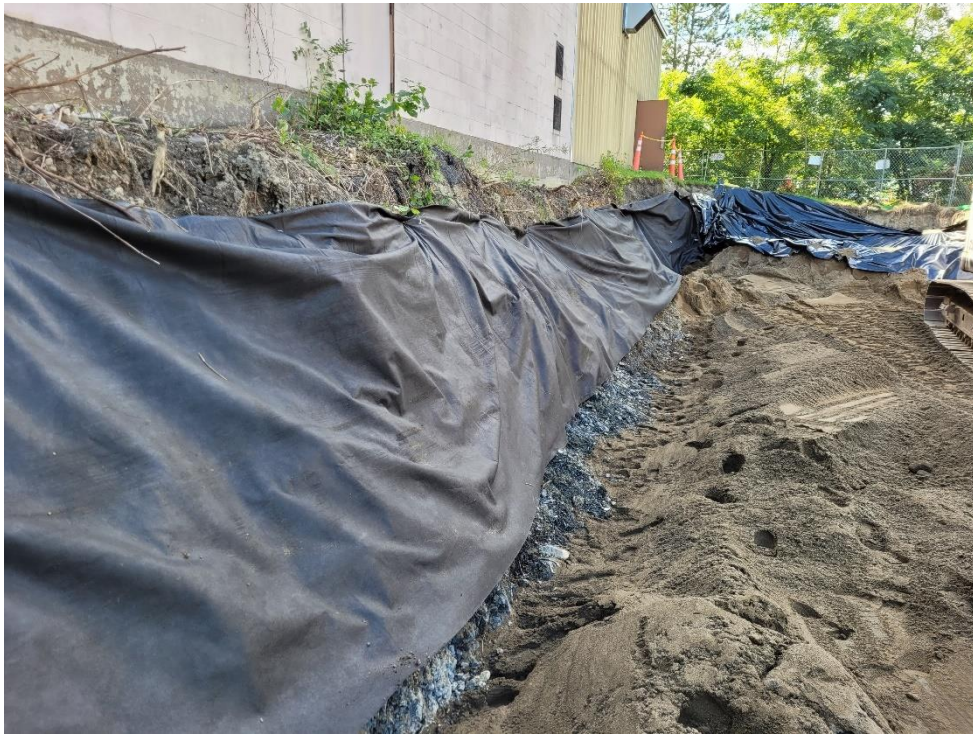
**Photograph 29:** Geotextile fabric demarcation layer between unexcavated soil beneath building foundation and clean backfill. View facing west. (Photo taken 9/21/21).

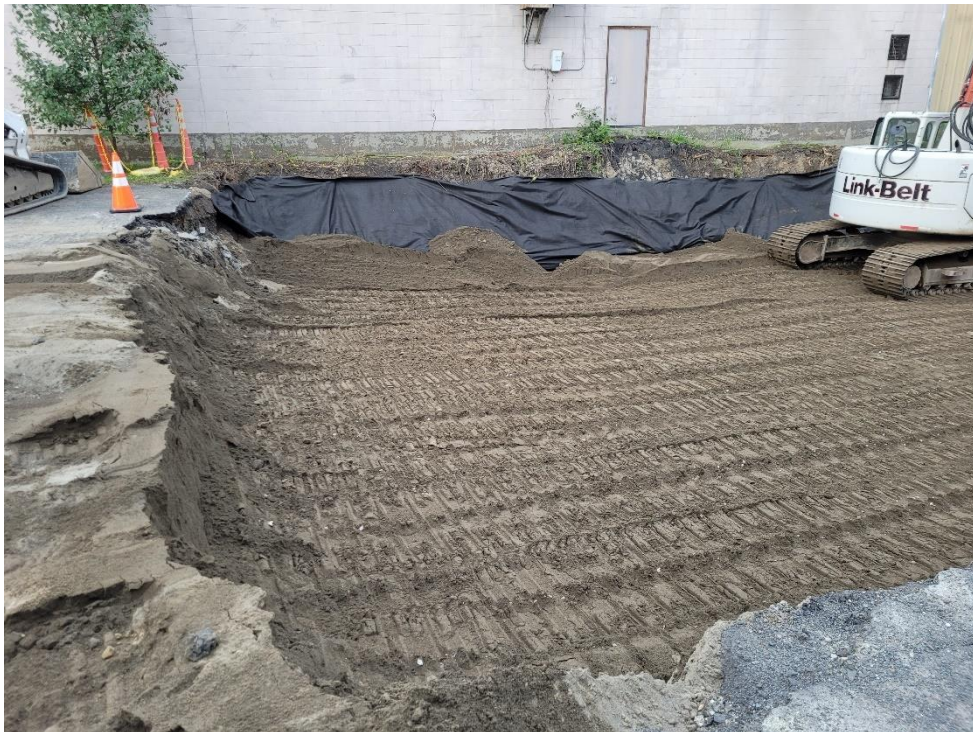
**Photograph 30:** Placement and compaction of approved backfill. View facing south. (Photo taken 9/22/21).
