## DAILY PHOTOGRAPH LOG

**Project:** Troy Belting RAWP Injections

**STERLING**  
Sterling Environmental Engineering, P.C.

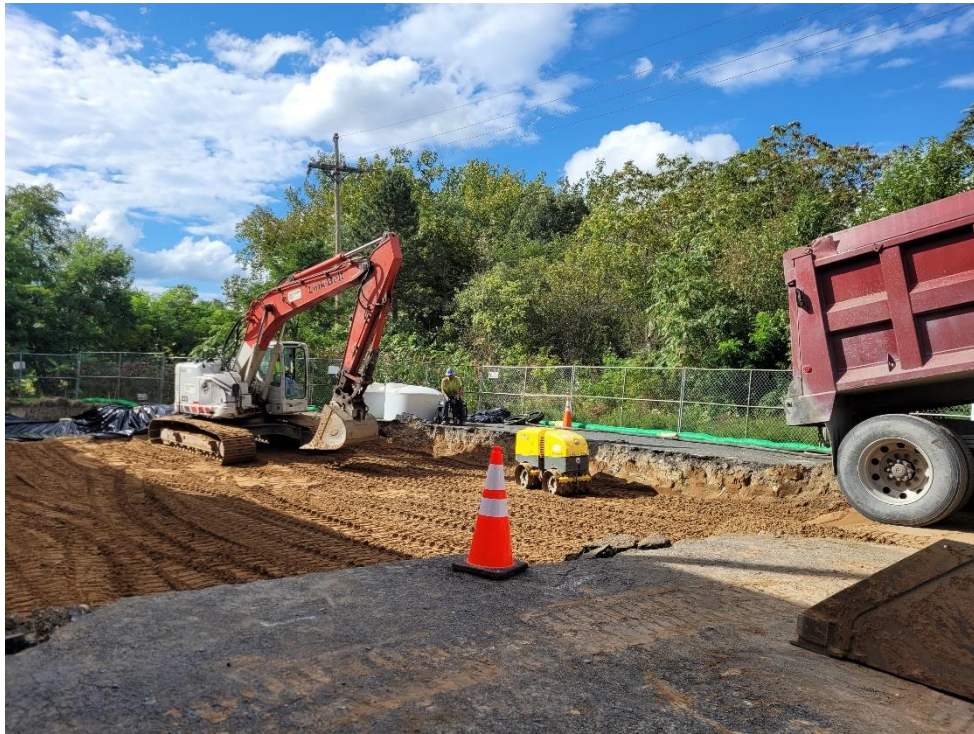
**Photograph 31:** Placement and compaction of approved backfill. View facing northwest. (Photo taken 9/24/21).

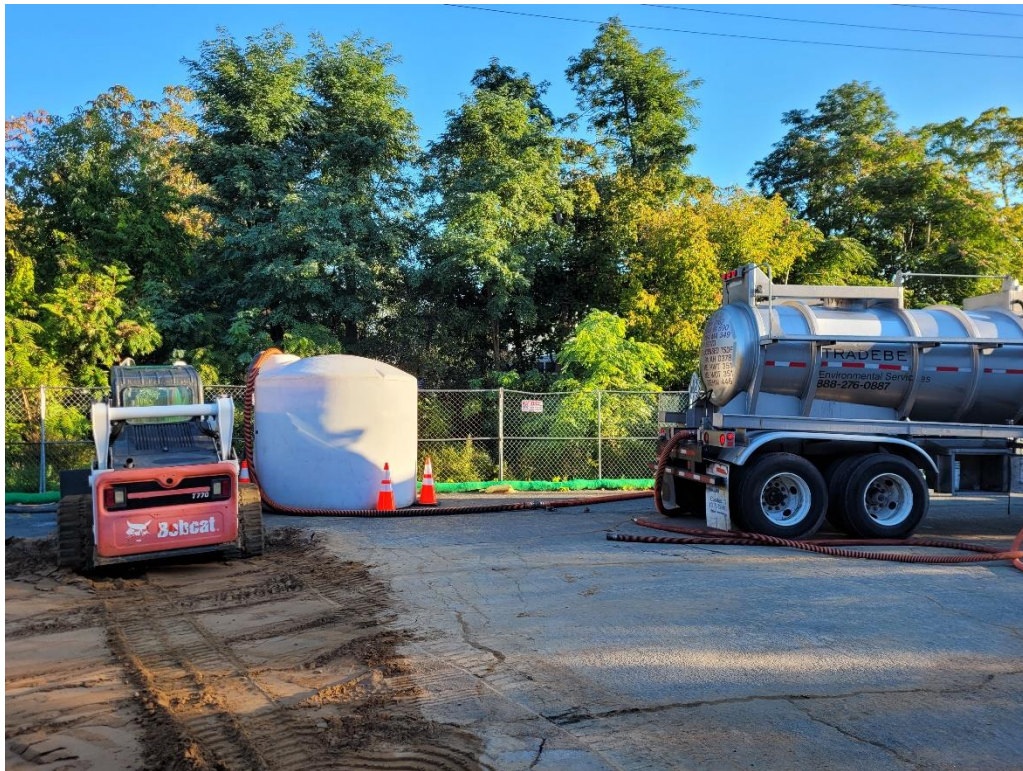
**Photograph 32:** Removal of remediation contact water from onsite holding tanks for disposal by Tradebe Treatment and Recycling, LLC. View facing north. (Photo taken 10/1/21).

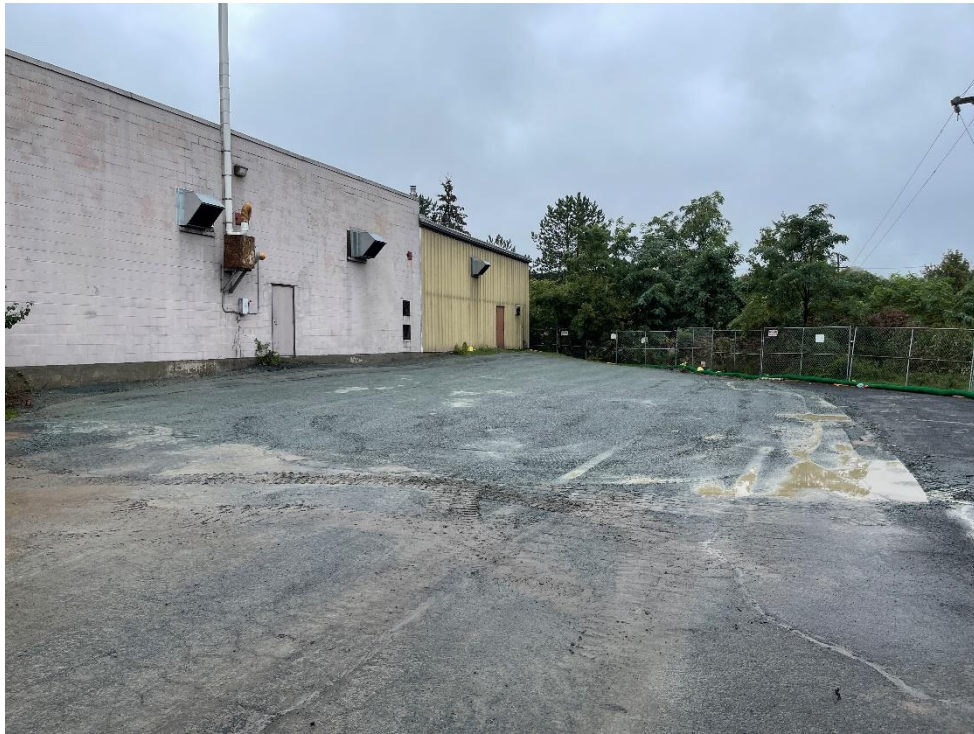
**Photograph 33:** Completed backfill of IRM excavation area with six inches of approved stone backfill. View facing west-southwest. (Photo taken 10/5/21).

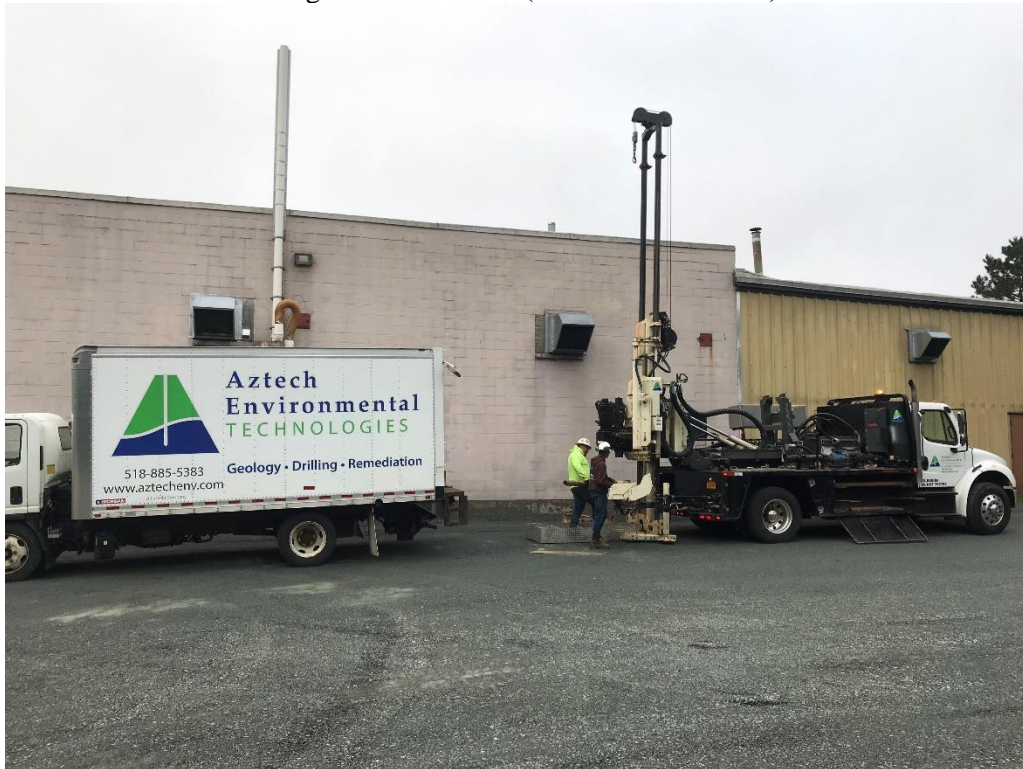
**Photograph 34:** Collection of 5-foot rock core from source area. View facing south. (Photo taken 10/8/21).

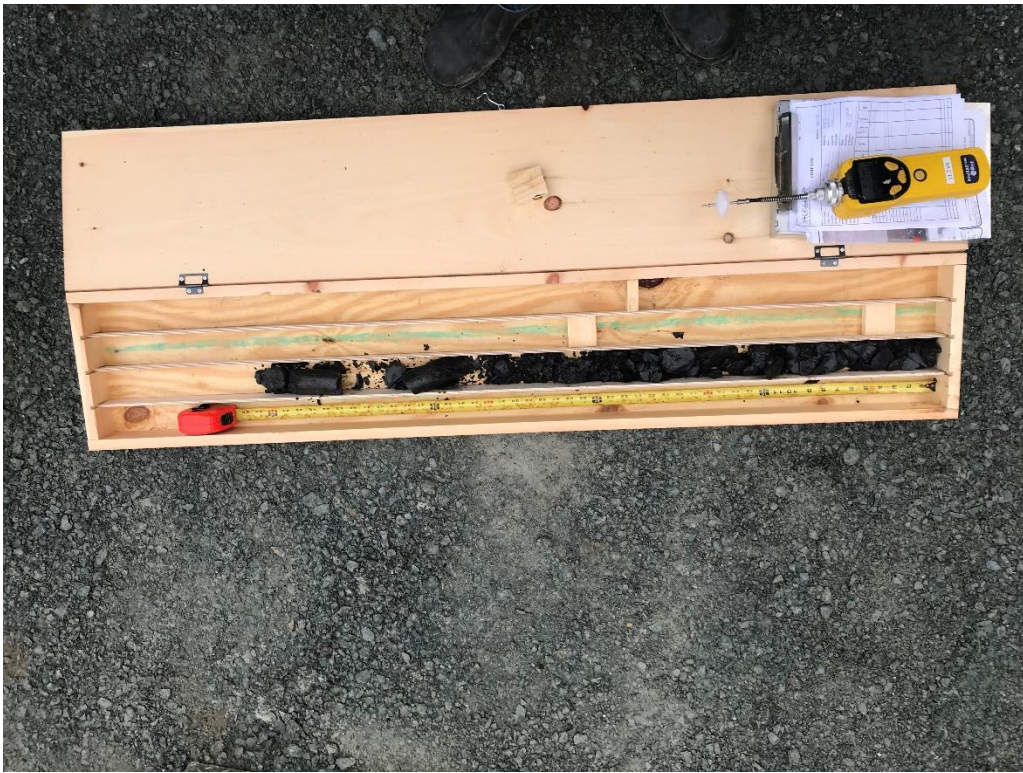
**Photograph 35:** Collected 5-foot rock core of shale bedrock. (Photo taken 10/8/21).

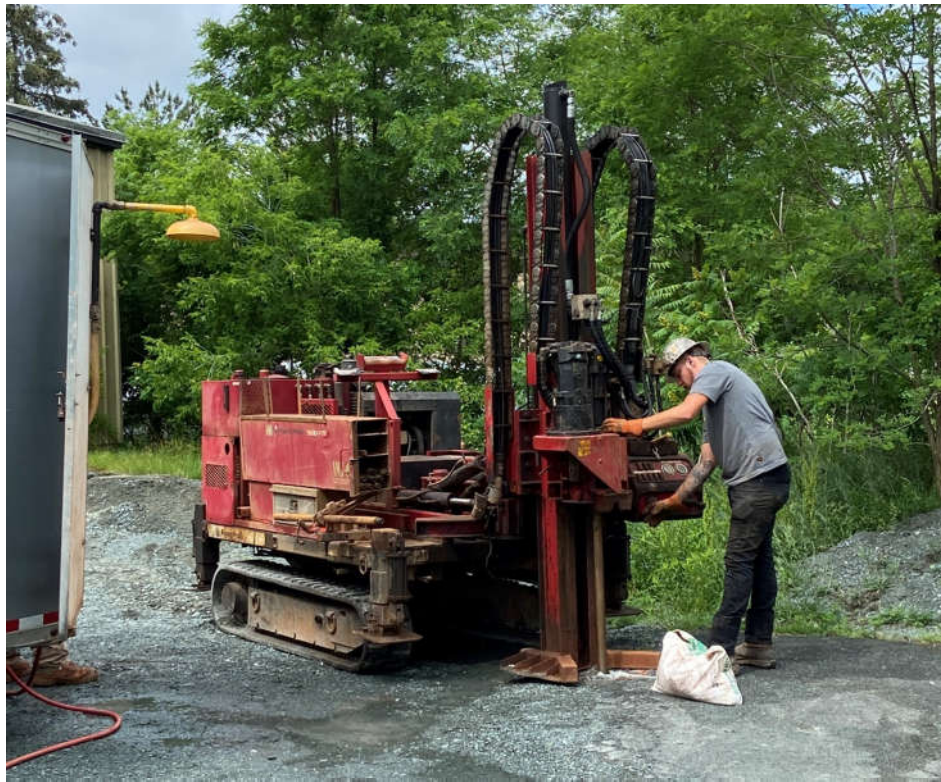
Photo No.	Date	Time
1	6/13/23	10:23 am
<b>Direction Looking:</b>	Southwest	
<b>Comments:</b>		
Direct push injection rod being inserted at location 3

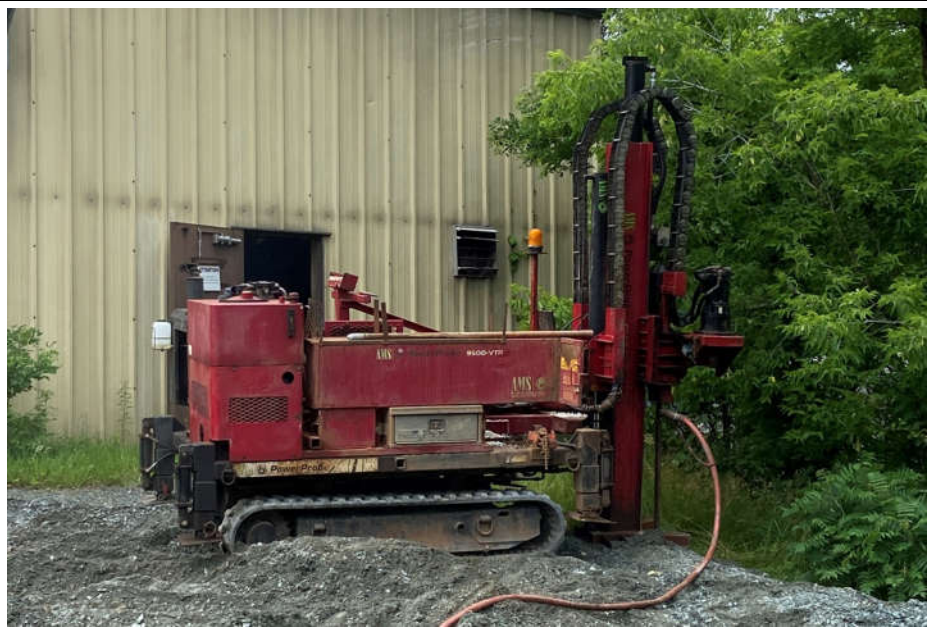
Photo No.	Date	Time
2	6/13/23	11:00 am
<b>Direction Looking:</b>	Southwest	
<b>Comments:</b>		
Injection being performed at location 4.

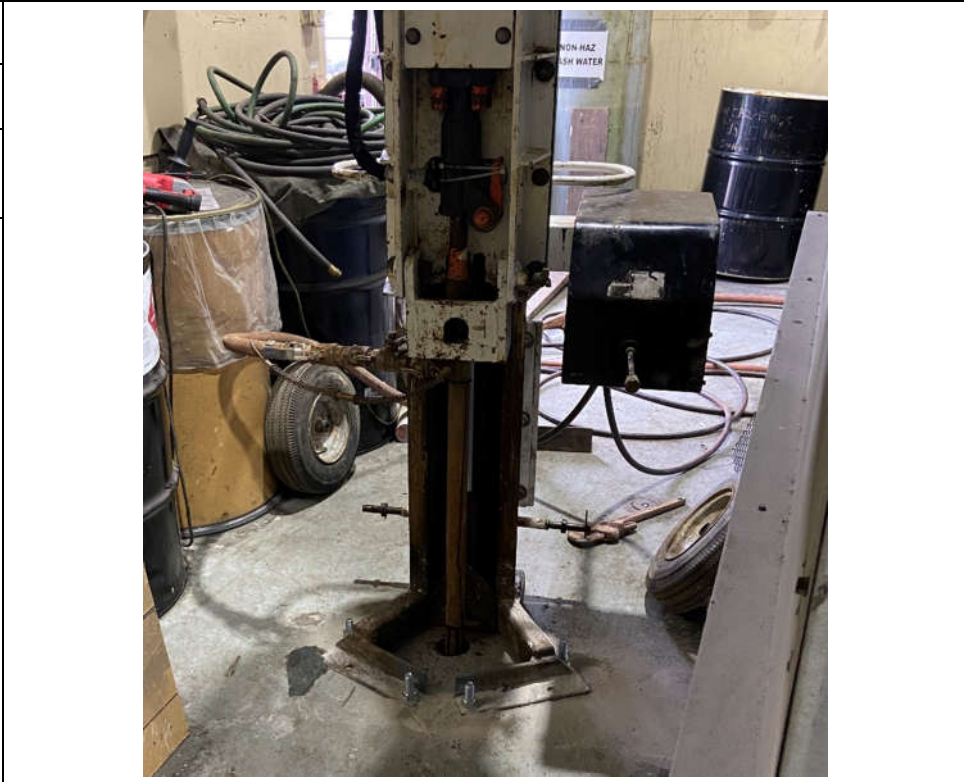
<b>Photo No.</b>	<b>Date</b>	<b>Time</b>
3	6/14/23	1:28 pm
<b>Direction Looking:</b>	East

**Comments:**  
Sub-slab injection being performed at location 17.

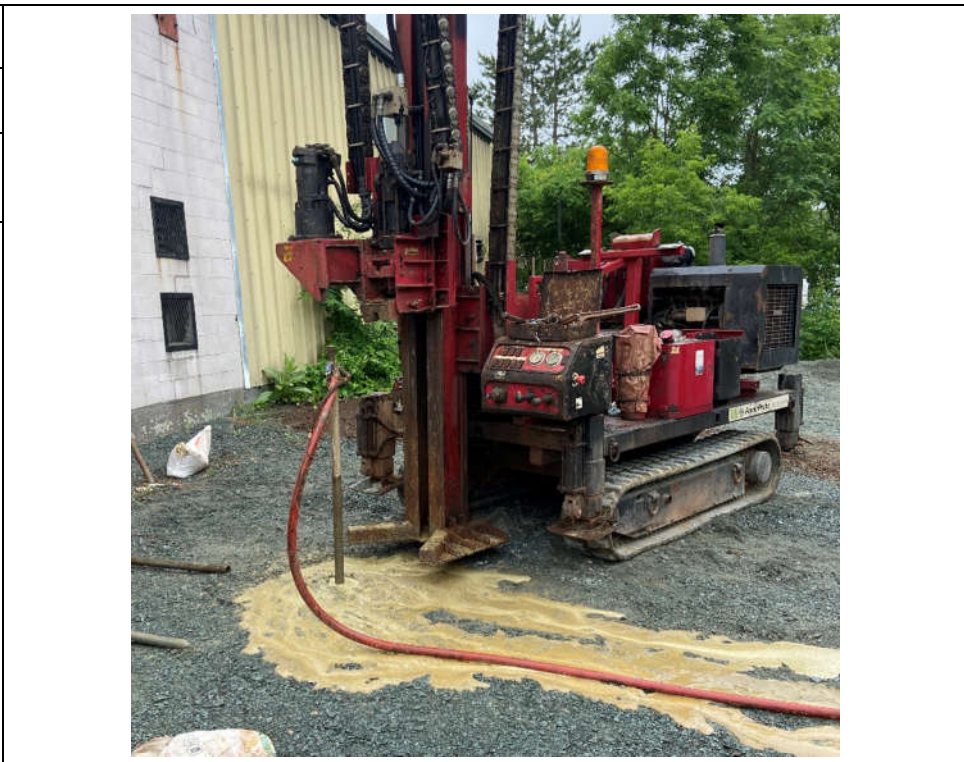
<b>Photo No.</b>	<b>Date</b>	<b>Time</b>
4	6/14/23	3:36 pm
<b>Direction Looking:</b>	Southwest

**Comments:**  
Injection being performed at location 19 with visible daylighting of injectant.
