PHASE I
ENVIRONMENTAL SITE ASSESSMENT UPDATE REPORT
FIRST PRIZE CENTER
EXCHANGE STREET
CITY OF ALBANY/TOWN OF COLONIE
ALBANY COUNTY, NEW YORK

JULY 30, 1990

C. T. MALE ASSOCIATES, P.C.
50 Century Hill Drive
P.O. Box 727
Latham, New York 12110
(518)785-0976
CTMA Project No.: 90.3039

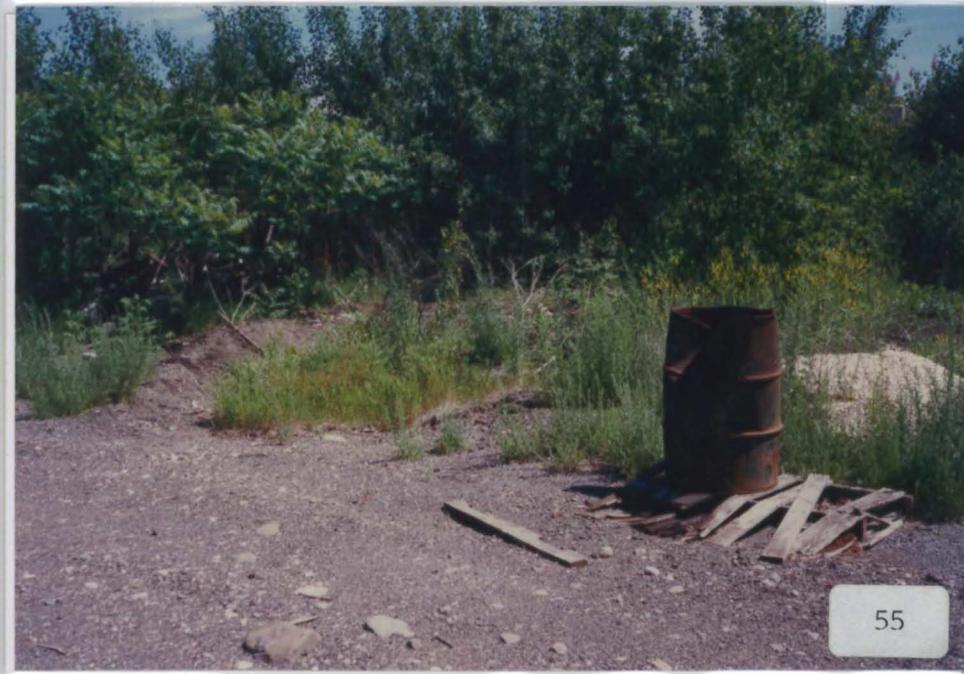
- 55 Drum of waste grit blasting material, and
 small soil area excavated by Domermuth
 Environmental Services.

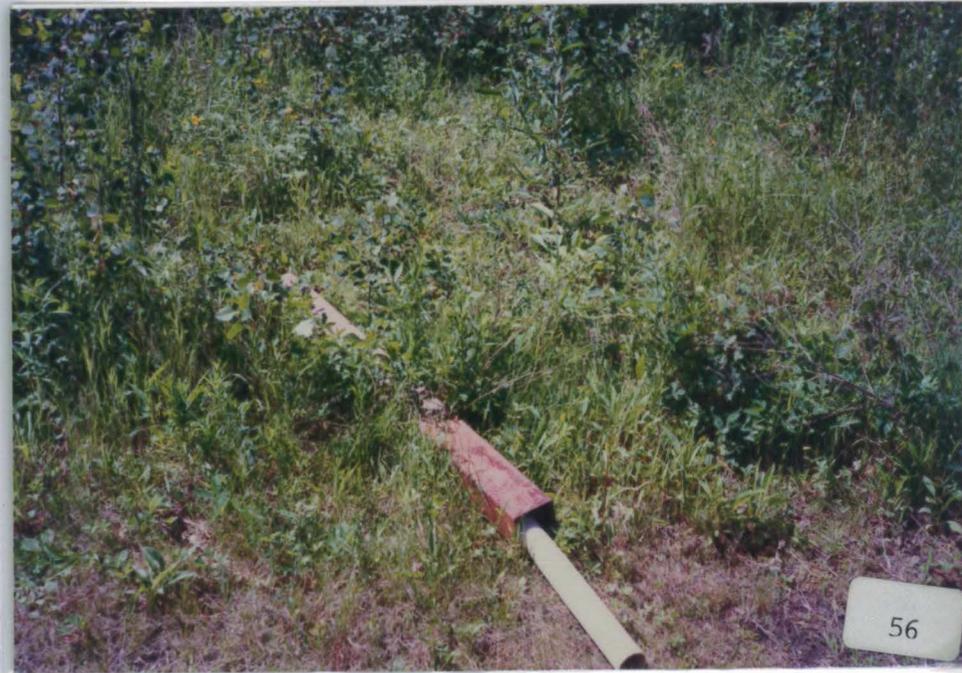
- 56 Destroyed monitor well on northwest corner of
 site property.
