**Crawford & Associates Engineering, P.C.**  
**Engineering Consultants, Planners, Geologists**

April 25, 2009

**Re: Von Ritter Parcel, Tanners Lane**  
**Phase 2 Environmental Assessment**  
**C&A# 3369.01**

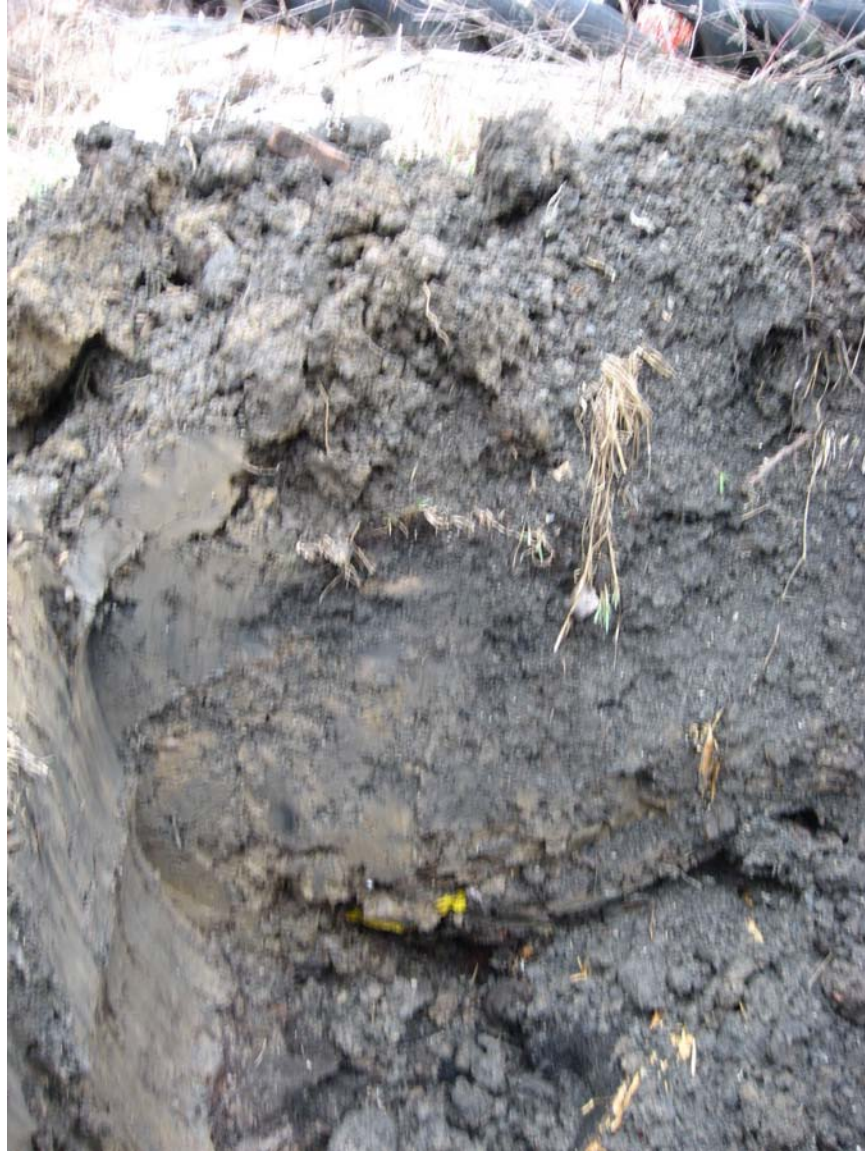
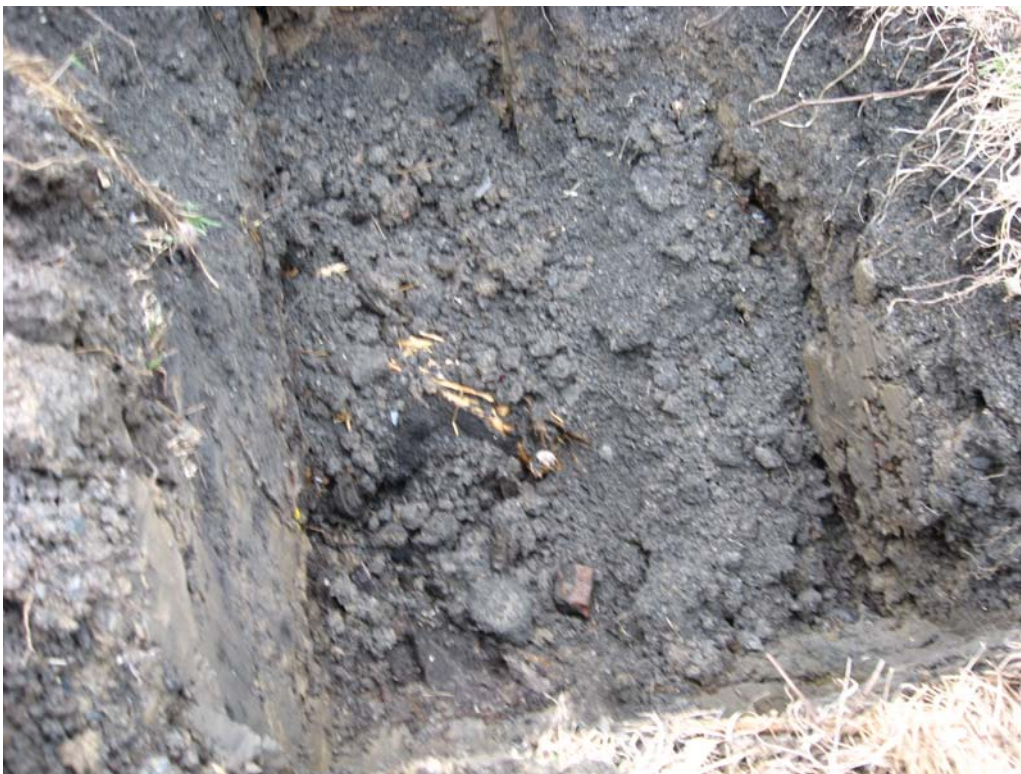
**Photo 1 – TP-1**

TEST PIT	LOCI	TOTAL DEPTH (inches)	DEPTH TO NATIVE SOILS (inches)	DEPTH TO WATER TABLE (inches)	CHARACTERIZATION	PHOTOS
TP-1	SE	57	Not reached – Telephone Pole	N/A	Sheet plastic, gravel fill, telephone pole	1-2
TP-2	S	60	54	48	Wood debris, brick, gravel fill, coal	3-4
TP-3	SW	60	60	60	Brick and wood debris layer (22") metal pipe, plastic bags (48")	5-6
TP-4	W	60	38	N/A	Minor wood and brick, gravel	7-8
TP-5*	W	38	33	N/A	Wood debris, brick, gravel fill	9-10
TP-6	NW	56	30	N/A	Gravel, sand, minor wood debris	11-12
TP-7	NW	60	44	43	Sand, gravel, coal layer (43")	13-14
TP-8	N	42	32	24	Concrete, wood and brick debris, gravelly sand	15-16
TP-9	Center	28	Not reached - Concrete slab	N/A	Shale, sand, gravel, minor brick, plastic bags, metal conduit	17-18
TP-10*	Center-S	48	48	30	Shale, sand, gravel, aluminum siding, metal roofing, wood debris, metal cans, plastic bags, plastic bottles. Petroleum odor and sheen on standing water	19-20

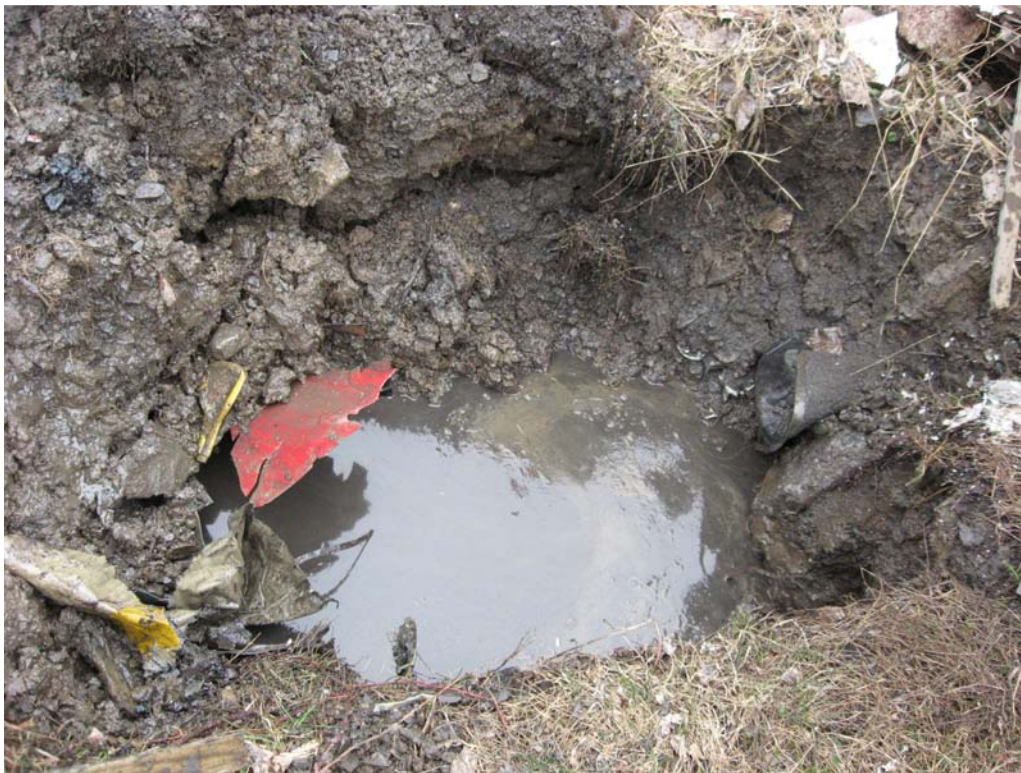
**Photo 21 – TP-12**

TP-11	Center-S	24	Not reached - Concrete slab	N/A	Gravel, sand, minor wood debris, rock	-
TP-12*	Center-S	43	43	32	Shale, Gravel, sand, metal pipe, metal roofing, sheet plastic, petroleum sheen on standing water	21
TP-13*	SW	34	30	28	Tarping (20%), coal, wood debris, rock gravel, clay	22-23
TP-14	Center-S	50	29	N/A	Laminate particle board, metal pipe, rubber belt, wood and brick debris	24-25

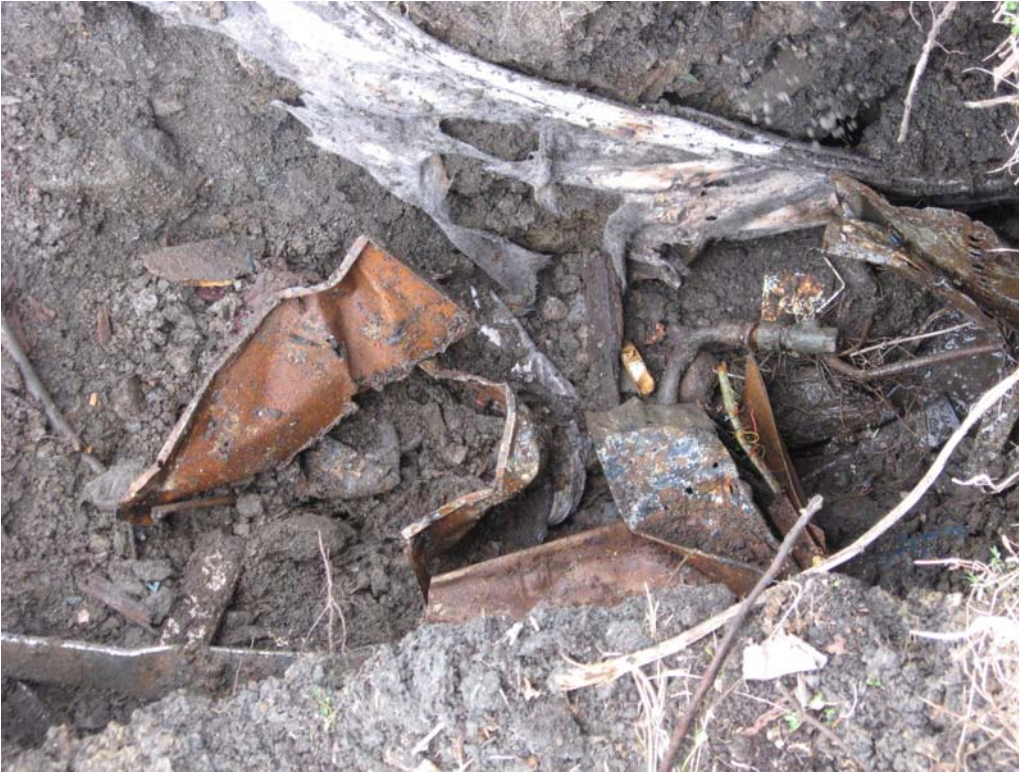
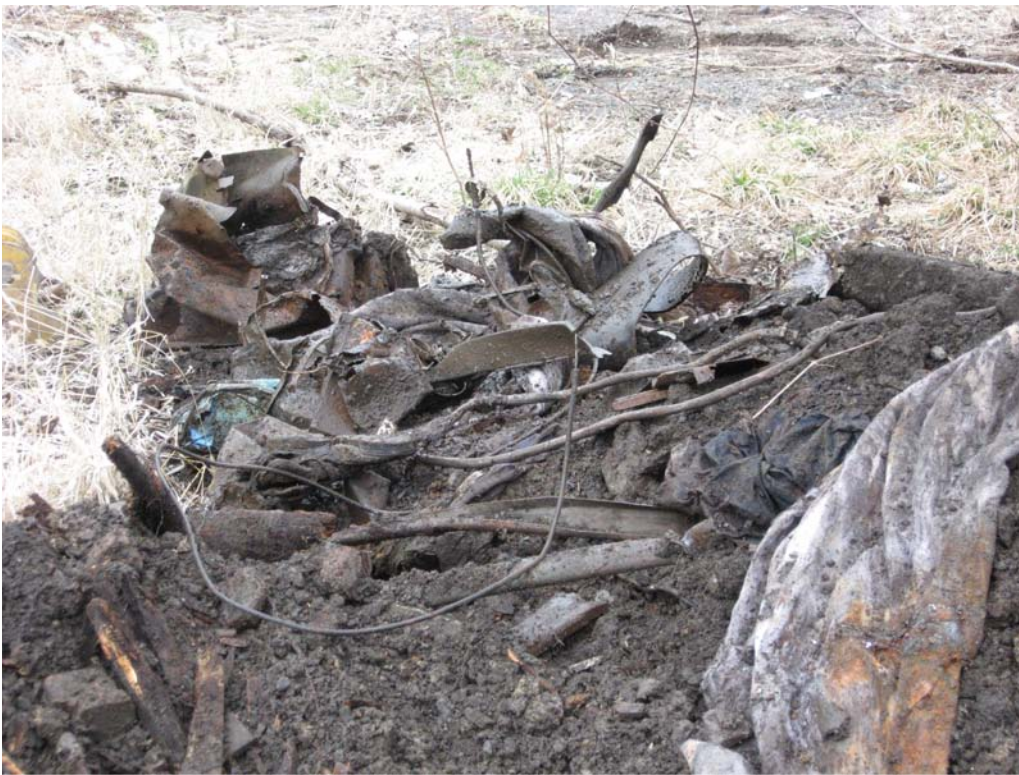
**Photo 26 – TP-15**

TP-15*	SE	80	75	N/A	Brick, metal plate, plastic grates, car seat, clothing, plastic drum, blankets, lawn mower bag, metal conduit, iron plumbing, rubber belts, speaker parts, carpet, sub-carpet foam, steel cable - (starts at 32")	26-27
TP-16	E	50	40	N/A	Rock, sand, gravel, coal, plastic sheeting, plastic bags, angle iron	28-29
TP-17	E	65	62	N/A	Sand, gravel, rubber belts, plastic containers, styrofoam, plastic bags, a toilet, springs, metal flex conduit, muffler, plywood, brick.	30-31
TP-18	E	63	61	N/A	Gravel, sand, rock, logs, plastic bags, plywood, aluminum track, sheet metal, toilet	32-33
TP-19*	NE	35	Not reached - Concrete slab	N/A	Gravel, sand, vinyl sheet, sheet metal, car parts, hub cap, car frame, scrap metal, rubber tubing, styrofoam, carpeting, plastic gas cans, car radiator, aluminum cans, clothing, misc. plastics, angle iron	34-38
TP-20	NW	78	78	N/A	Sand, gravel, all fill	39-40
TP-21	N	60	24	N/A	Sandy loam, gravelly, all native	41-42

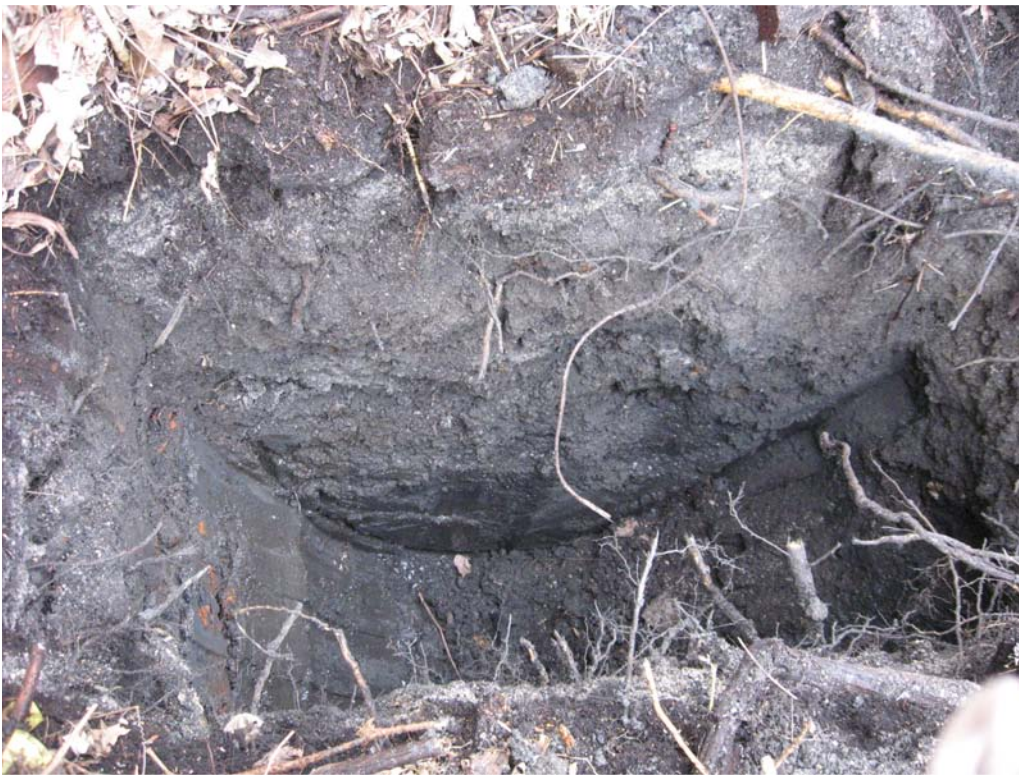
**Photo 43 – TP-22**

TP-22	NE	52	24	N/A	Sandy clay loam - dark, misc brick	43
TP-23	NE	48	8	N/A	Gravelly sandy loam, clay, brick, rock	44
TP-24*	NE	16	Not reached - Concrete slab	14	Sandy gravel, some brick. Sheen on standing water	45-46
