## MONTHLY STATUS REPORT

BCP No.:	C546047	PVE Project No.:	561231	Date:	4/28/2021
Project Name:	42 Gates Avenue, Village of Victory, Saratoga County, NY

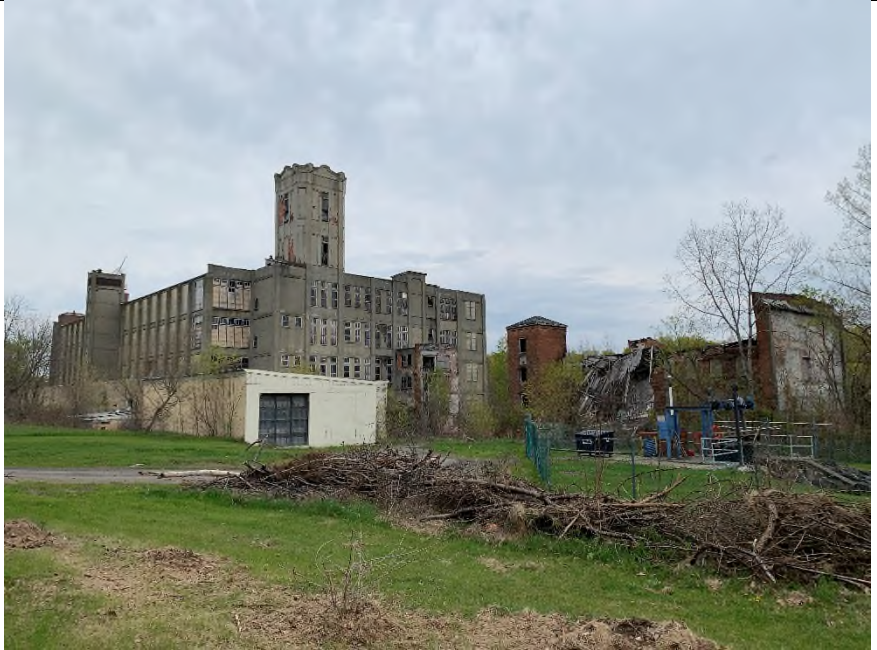
Photo 1 –

Overview of BCP Site.

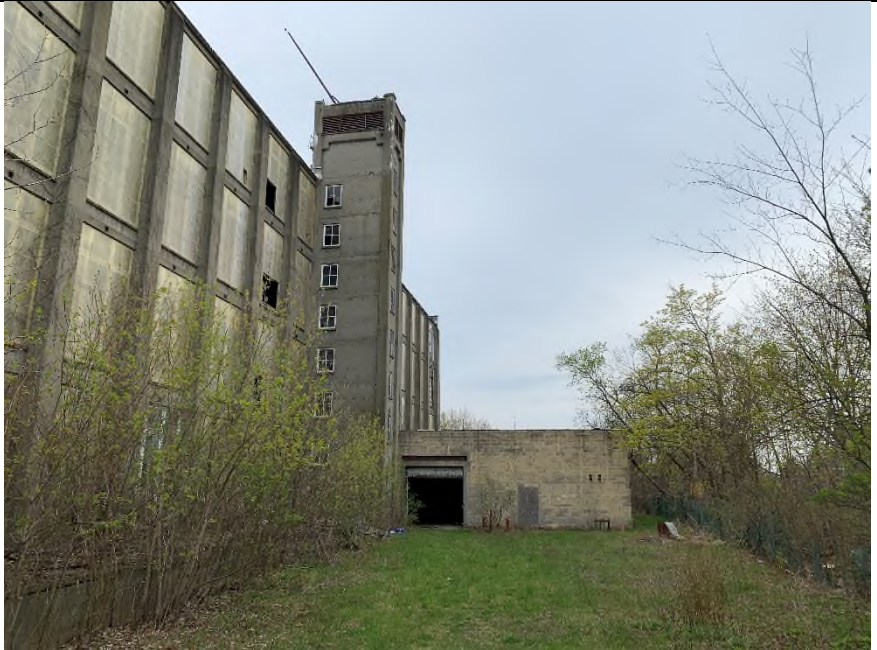
Photo 2 –

View of northwestern side of main structure.

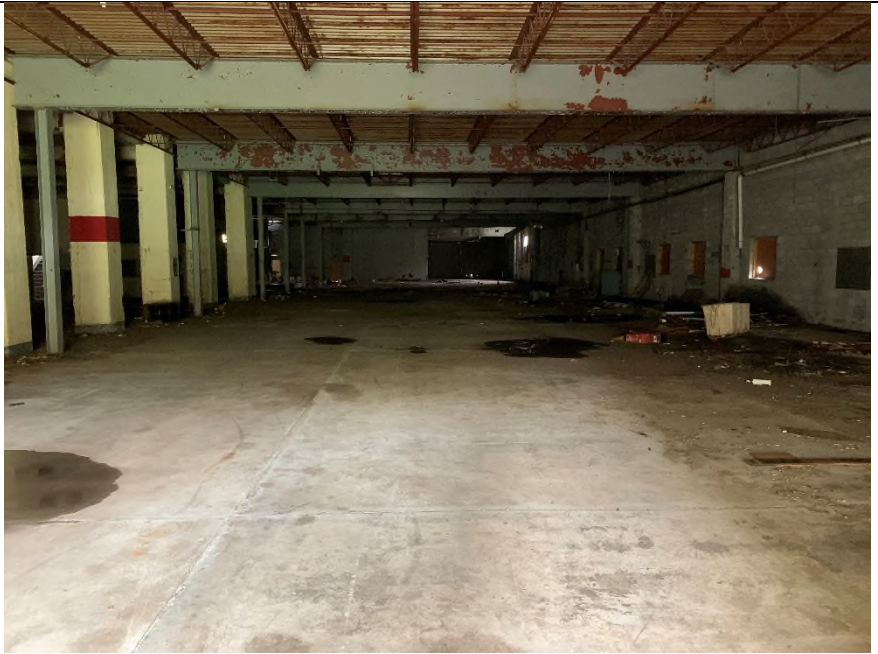
Photo 3 –

Interior of main structure.

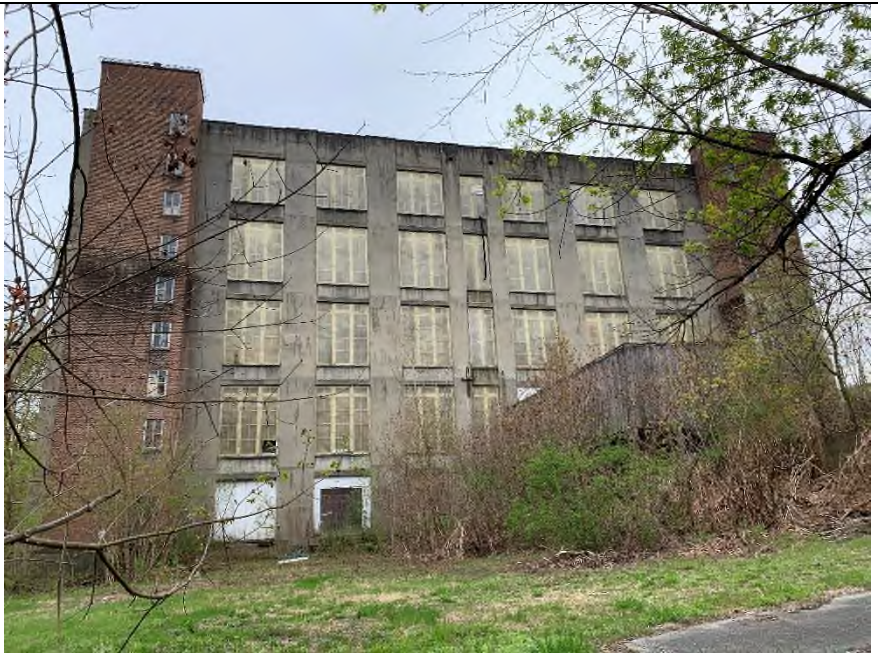
Photo 4 –

View of northern side of main structure.

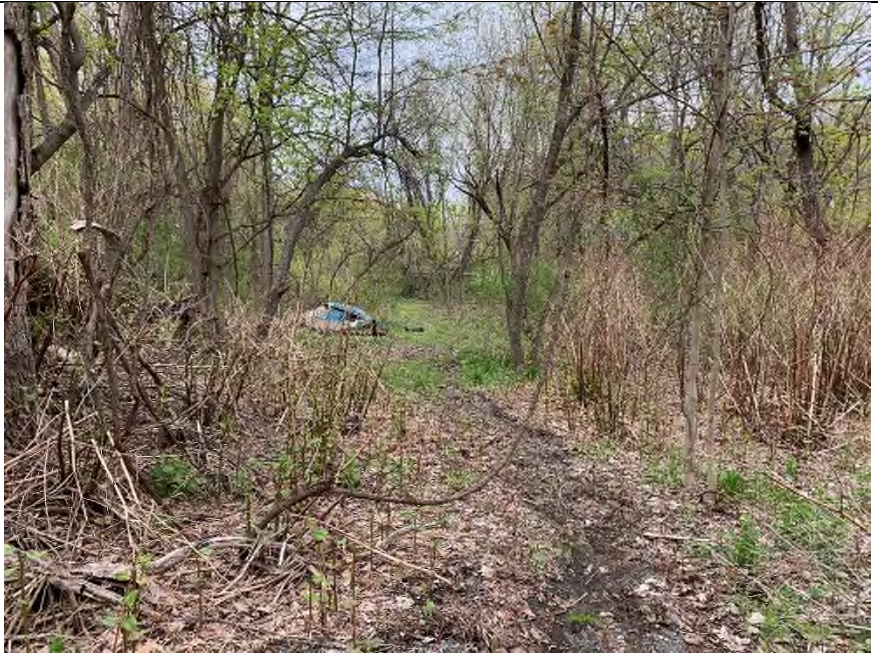
Photo 5 –

View of northern wooded area.

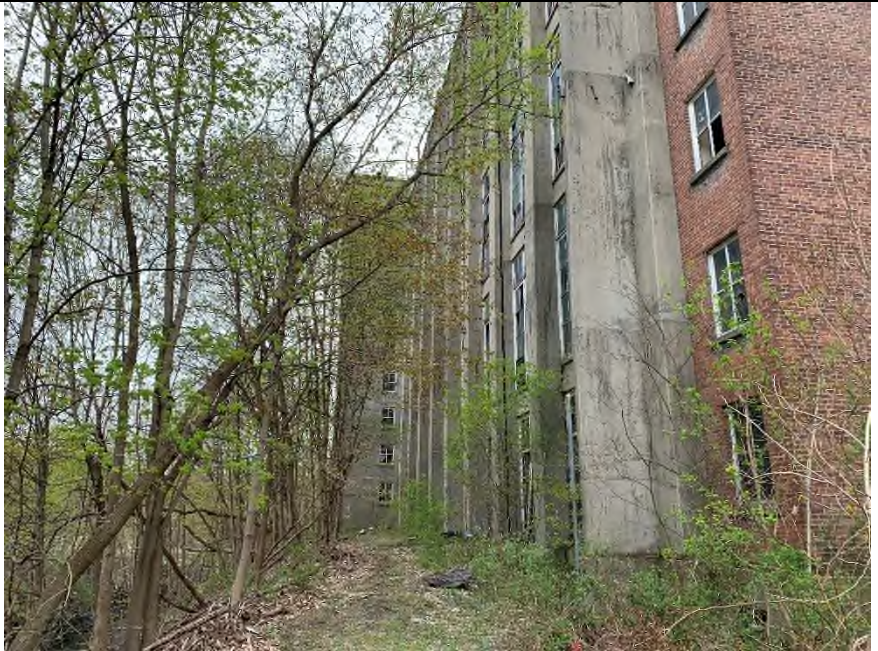
Photo 6 –

View of eastern side of main structure.

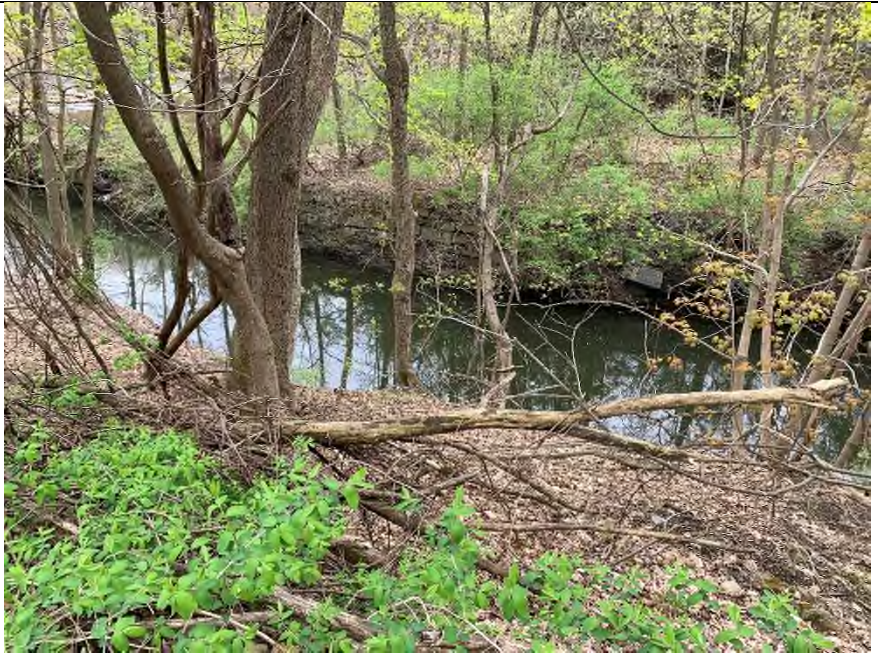
Photo 7 –

Typical view of adjoining stream along eastern side of BCP Area.

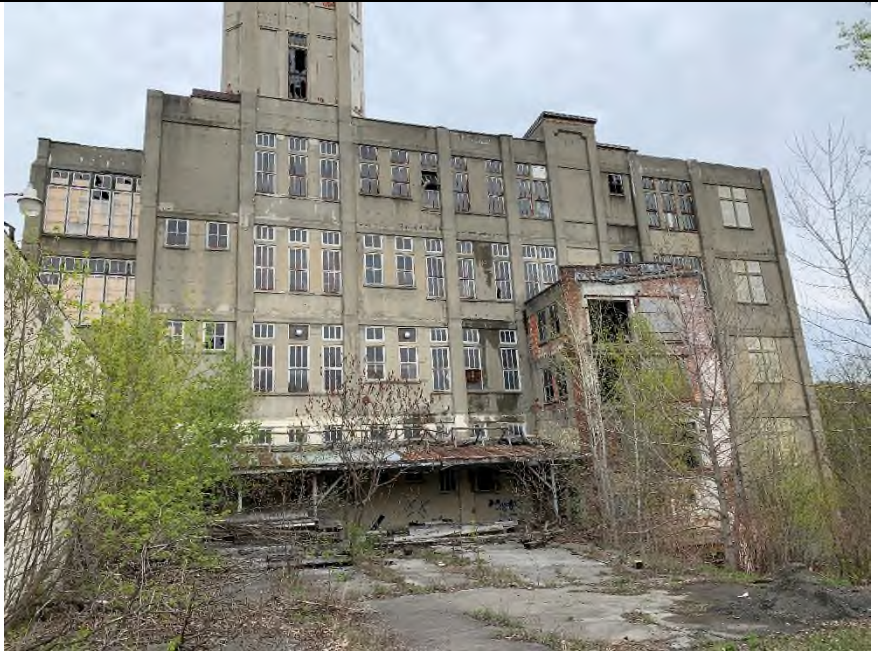
Photo 8 –

View of southern side of main structure.

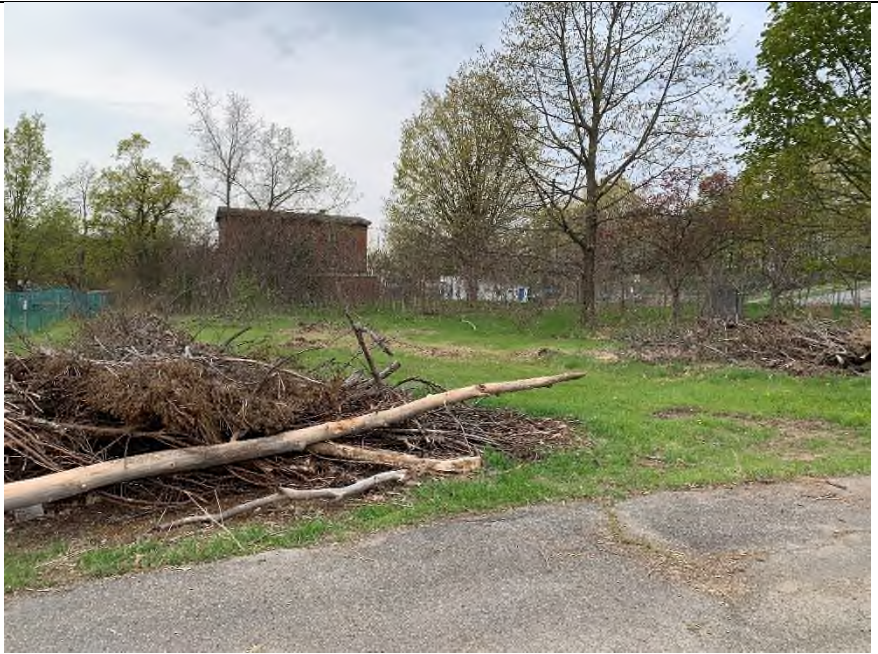
Photo 9 –

Typical view of southern grassed area.

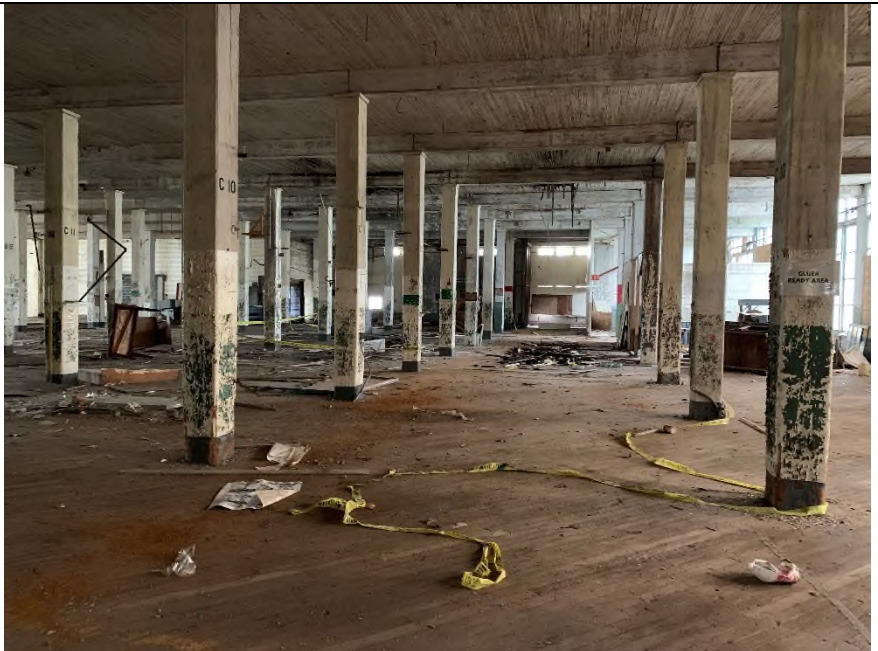
Photo 10 –

Typical interior view of main structure.

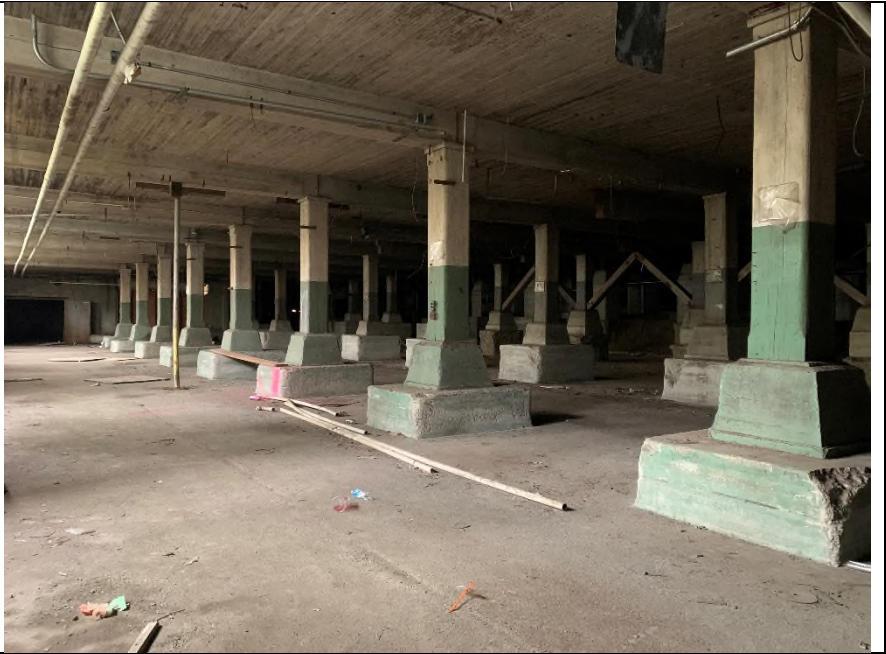
Photo 11 –

Typical basement view of main structure.
