## MONTHLY STATUS REPORT

BCP No.:	C546047	PVE Project No.:	561231	Date:	7/28/2021
Project Name:	42 Gates Avenue, Village of Victory, Saratoga County, NY

Consultant: PVE	Consultant On-Site: Trevor Treglia
General Contractor: N/A	General Contractor Contact: N/A

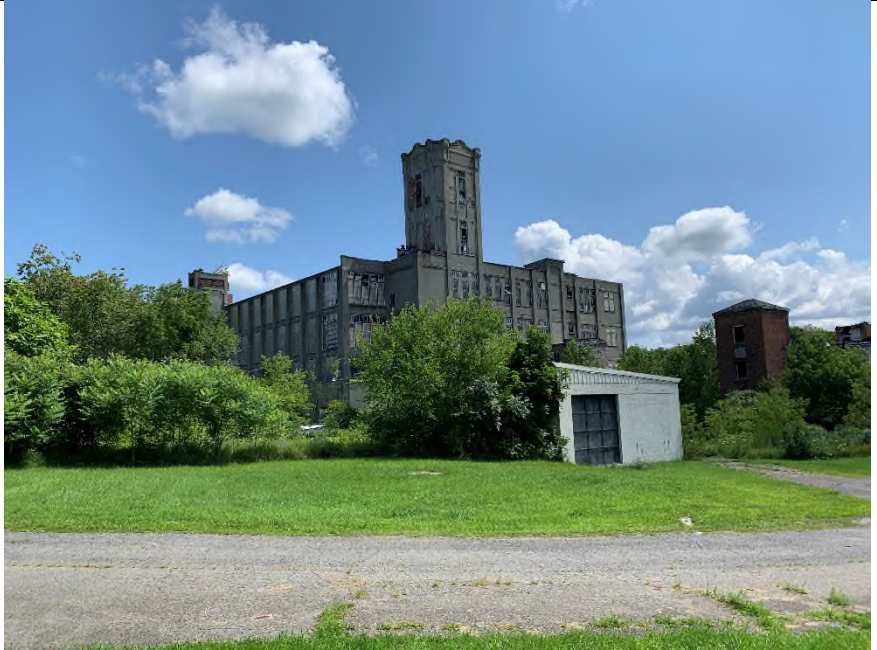
Photo 1 –

Overview of BCP Site.

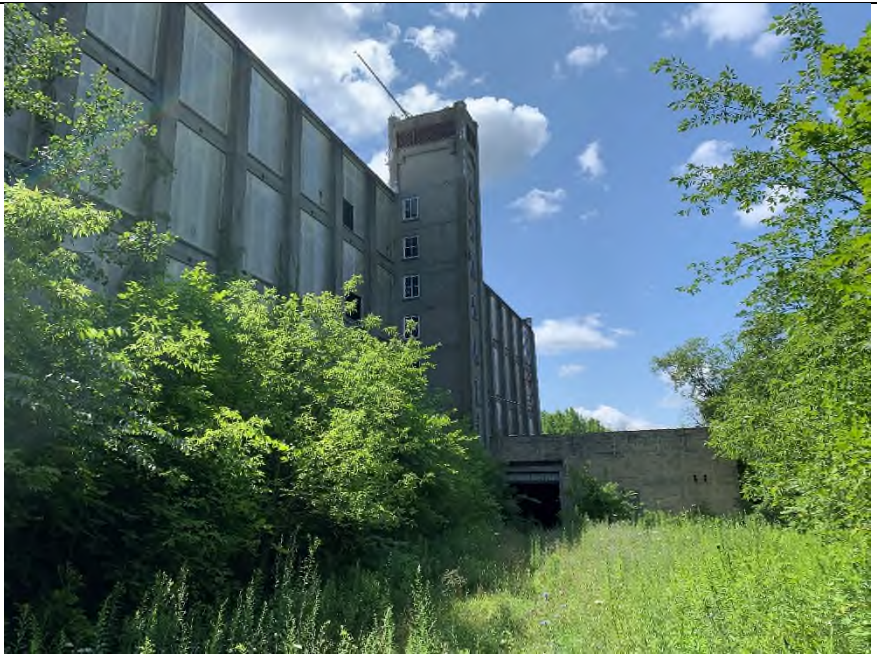
Photo 2 –

View of northwestern side of main structure.

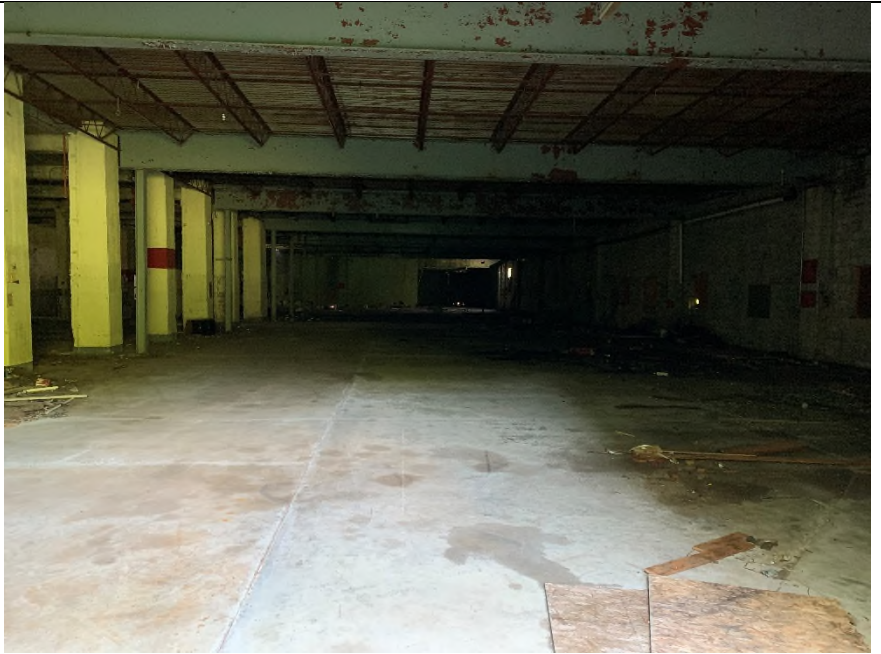
Photo 3 –

Interior of main structure.

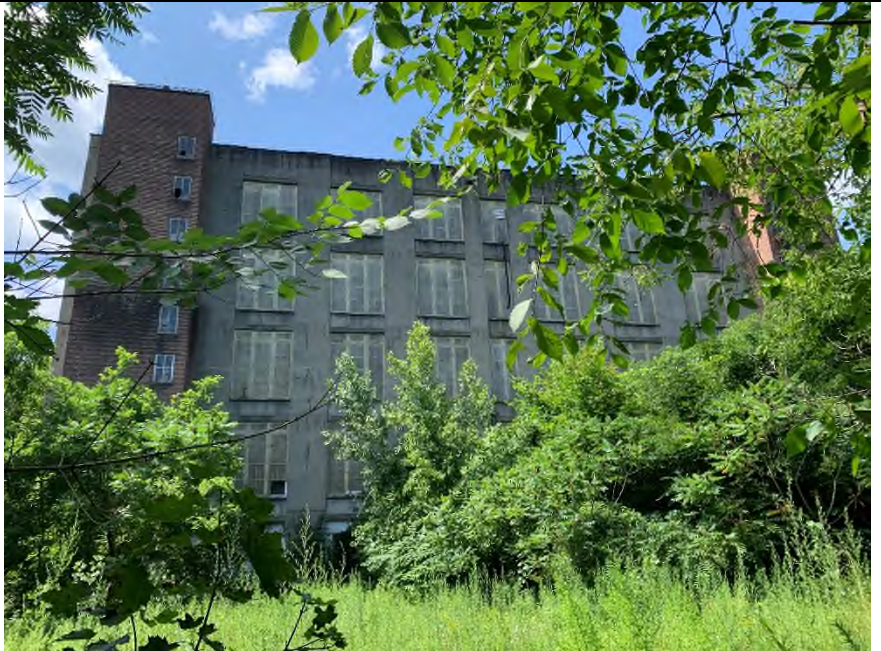
Photo 4 –

View of northern side of main structure.

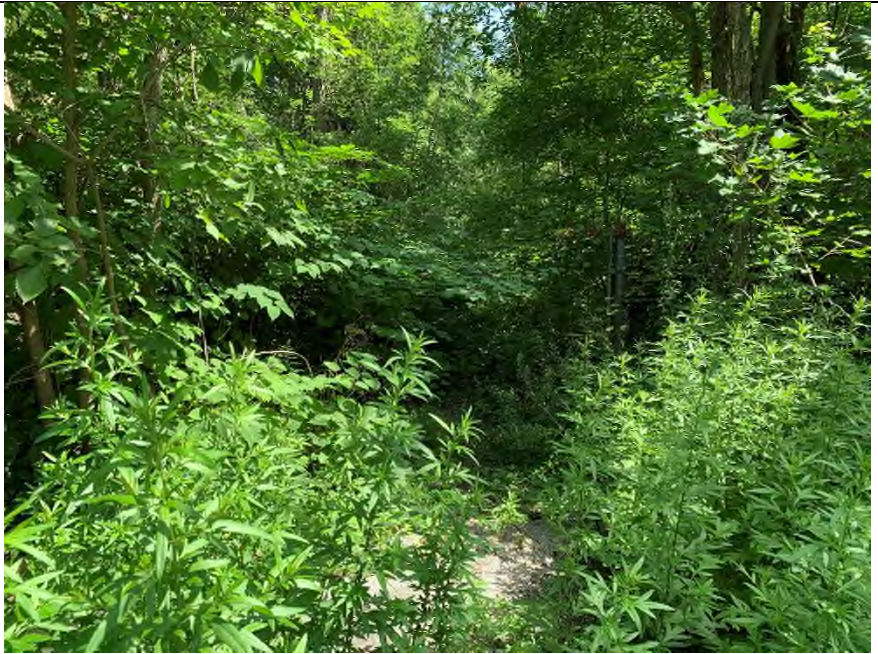
Photo 5 –

View of northern wooded area.

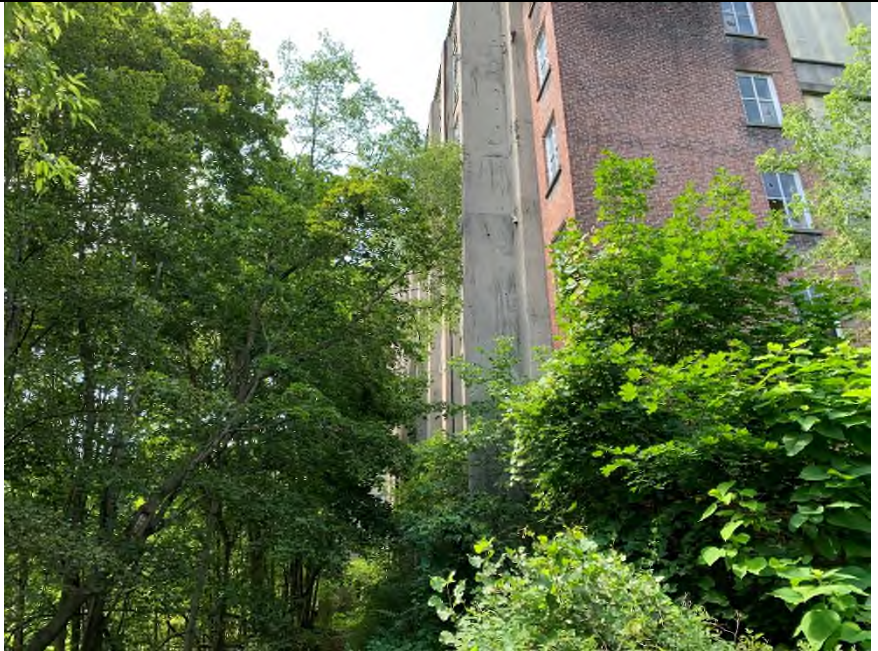
Photo 6 –

View of eastern side of main structure.

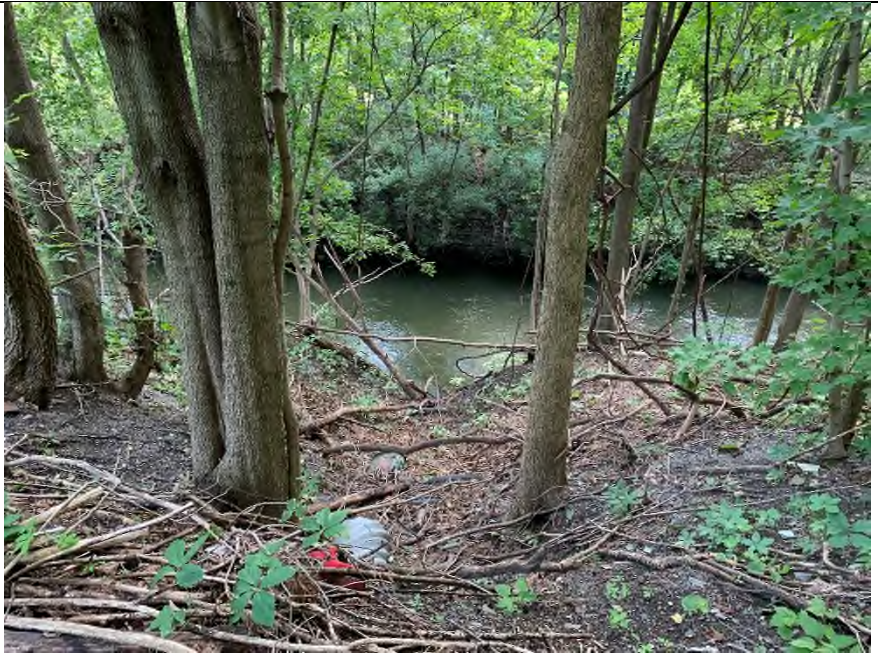
Photo 7 –

Typical view of adjoining stream  
along eastern side of BCP Area.

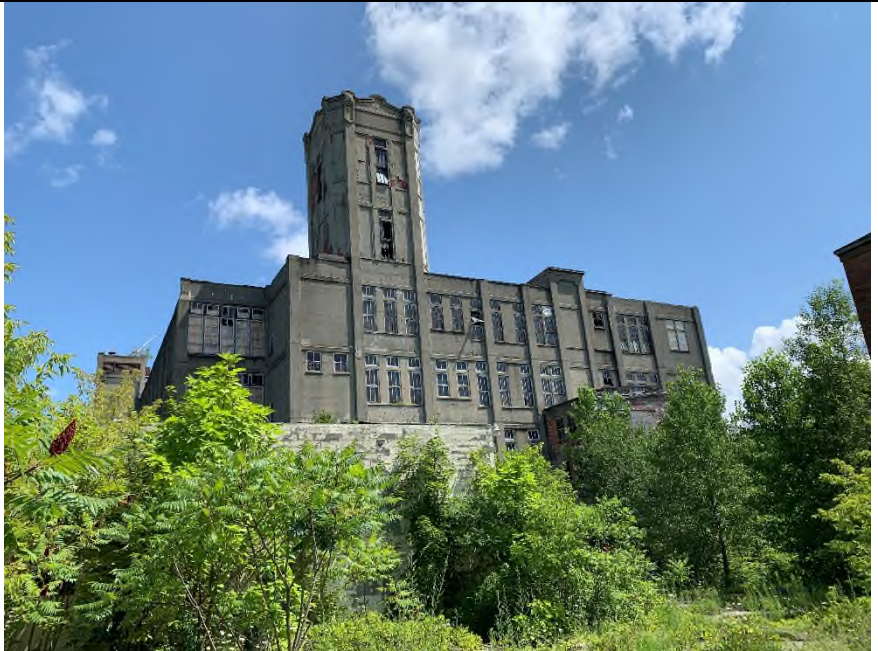
Photo 8 –

View of southern side of main  
structure.

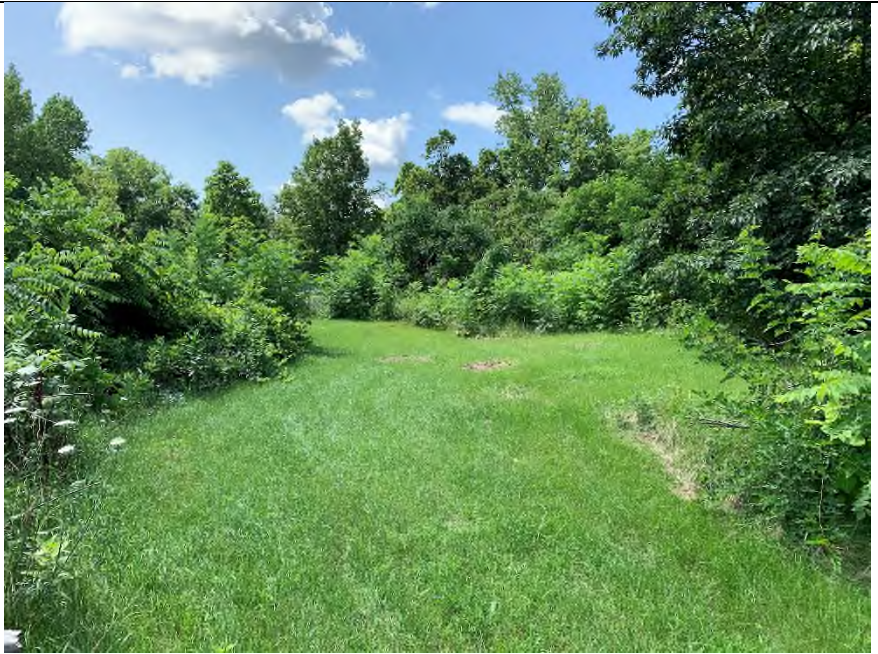
Photo 9 –

Typical view of southern grassed area.

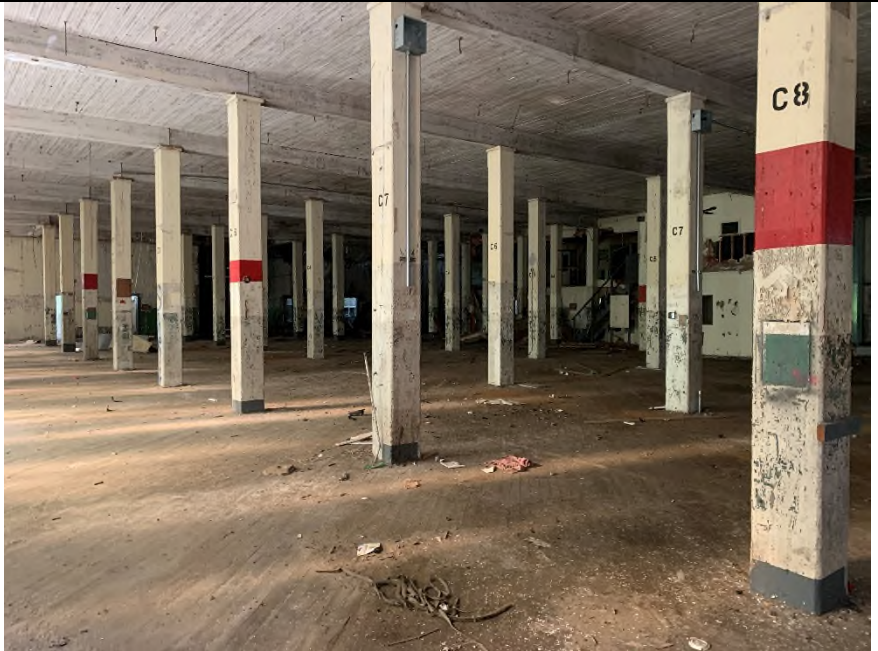
Photo 10 –

Typical interior view of main structure.

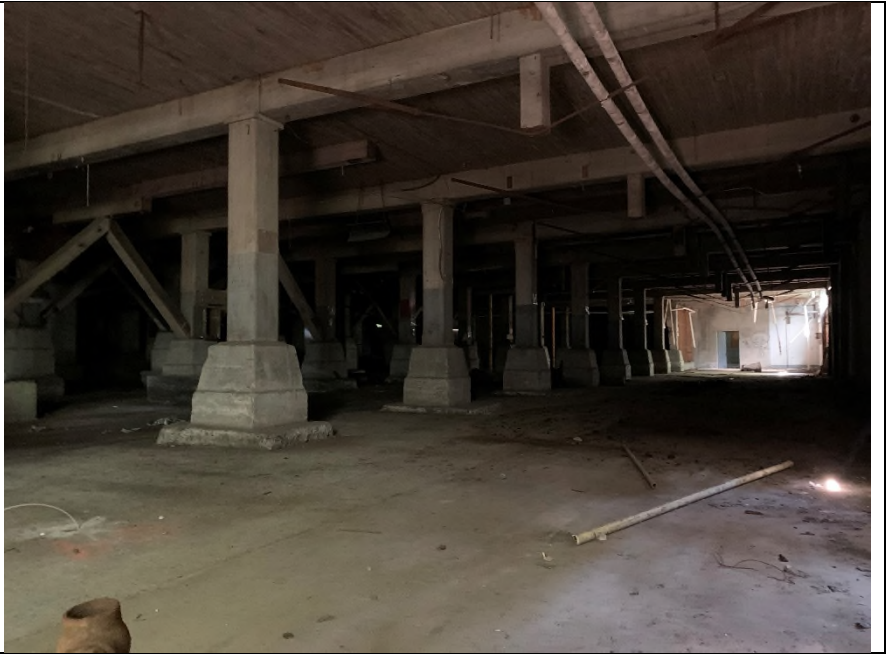
Photo 11 –

Typical basement view of main structure.
