MONTHLY STATUS REPORT

BCP No.:	C546047	PVE Project No.:	561231	Date:	9/27/2021
Project Name:	42 Gates Avenue, Village of Victory, Saratoga County, NY

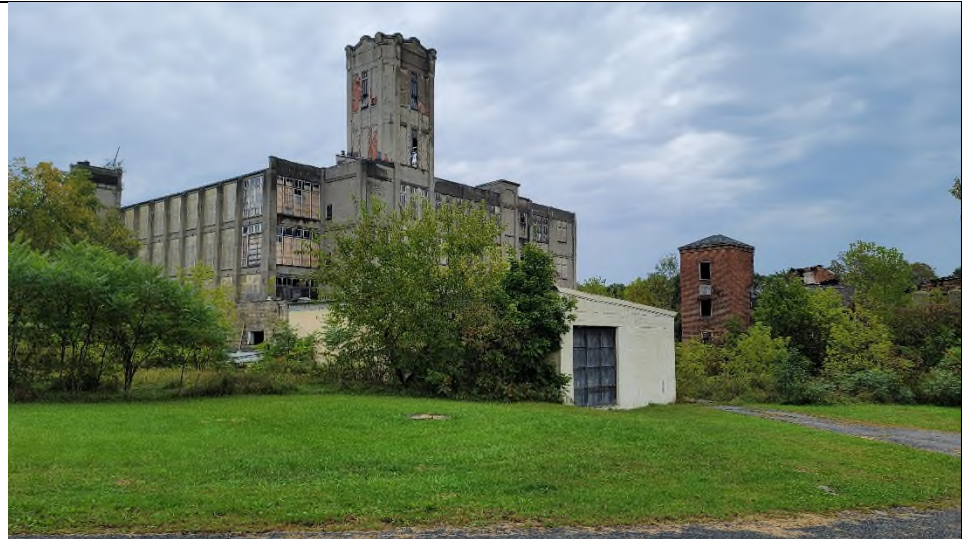
Photo 1 –

Overview of BCP Site from
the west/southwest.

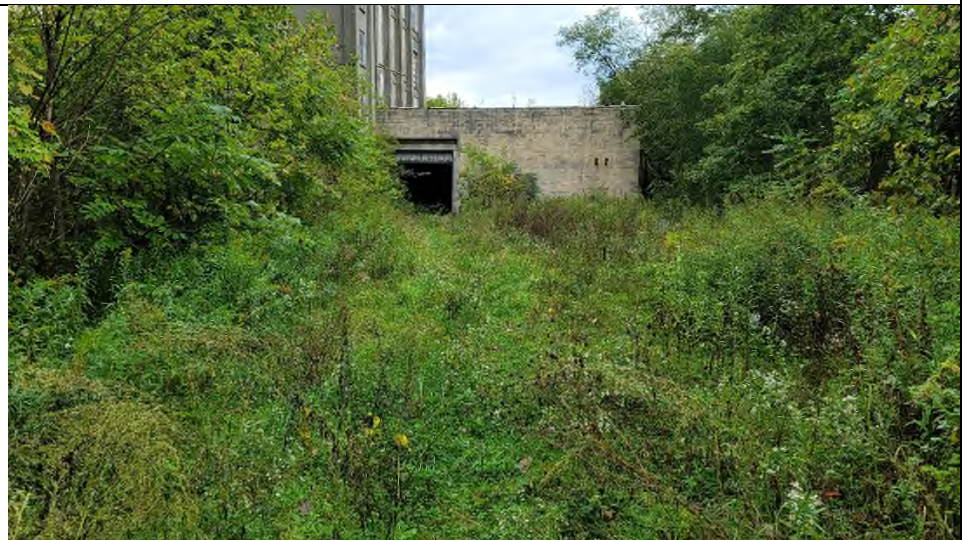
Photo 2 –

View of northwestern side of
main structure.

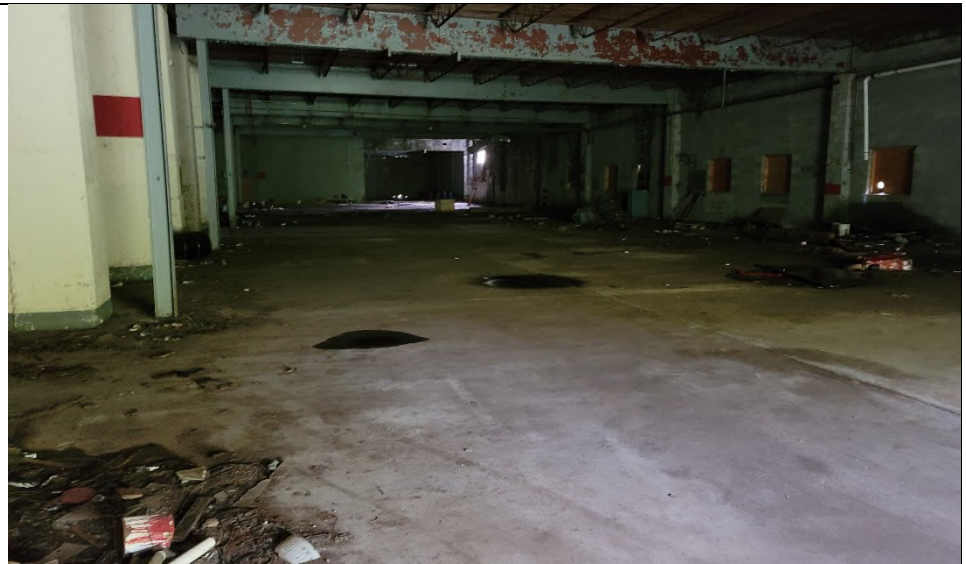
Photo 3 –

Interior of main/garage structure.

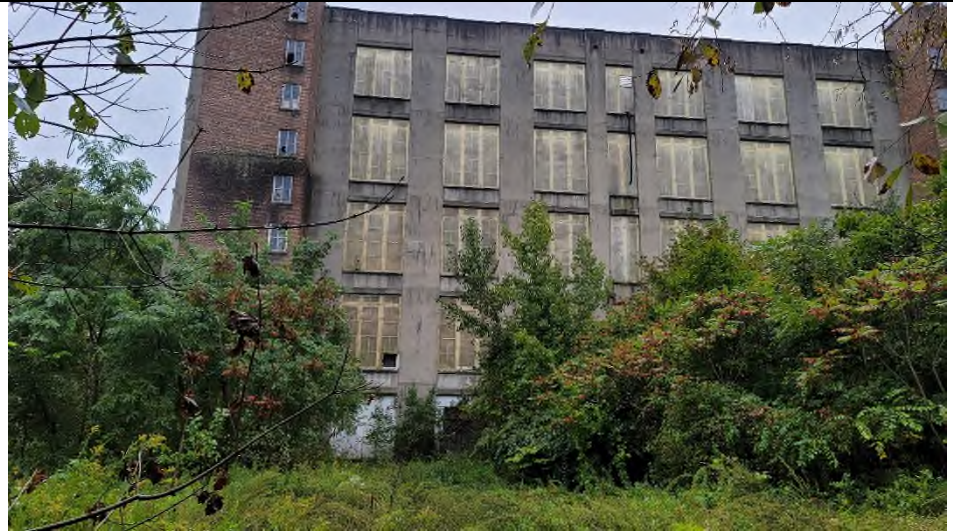
Photo 4 –

View of northern side of main structure.

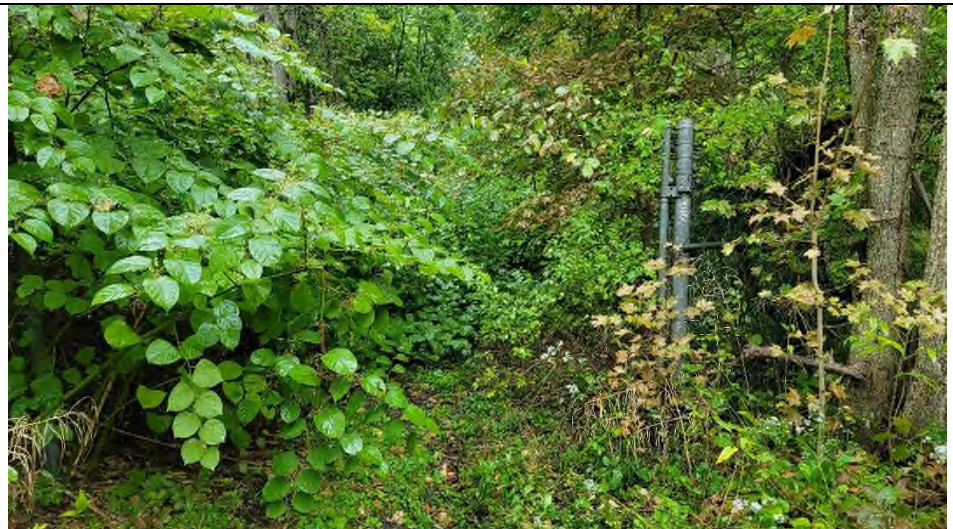
Photo 5 –

View of the entrance to the northern wooded area.

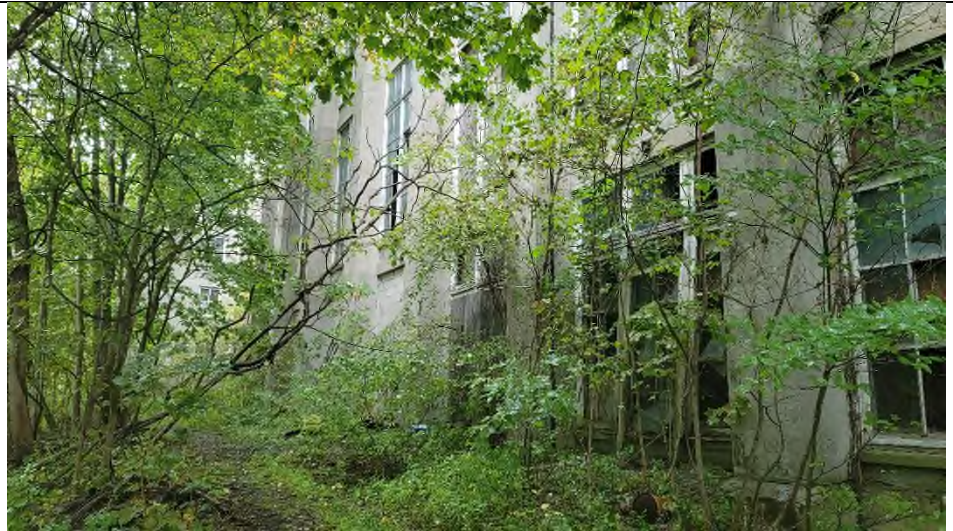
Photo 6 –

View of eastern side of main structure.

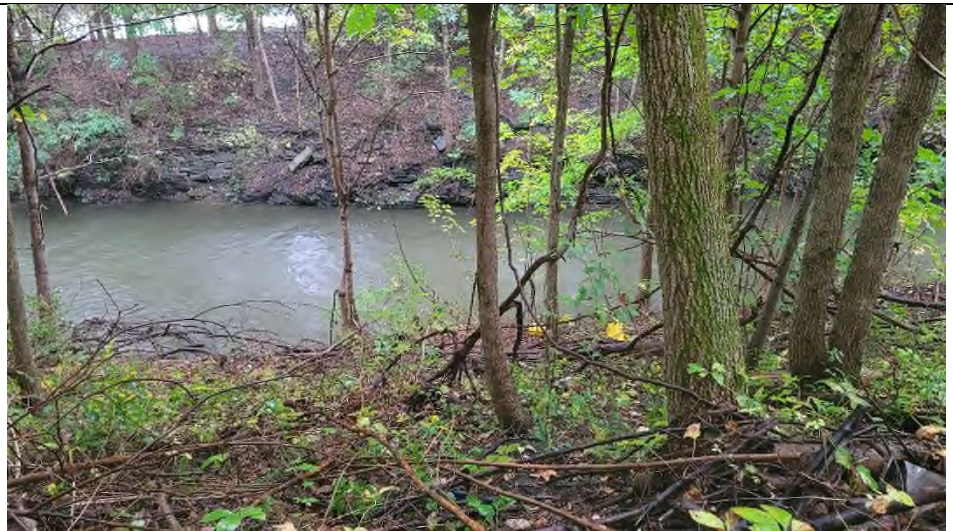
Photo 7 –

Typical view of adjoining stream along eastern side of BCP Area.

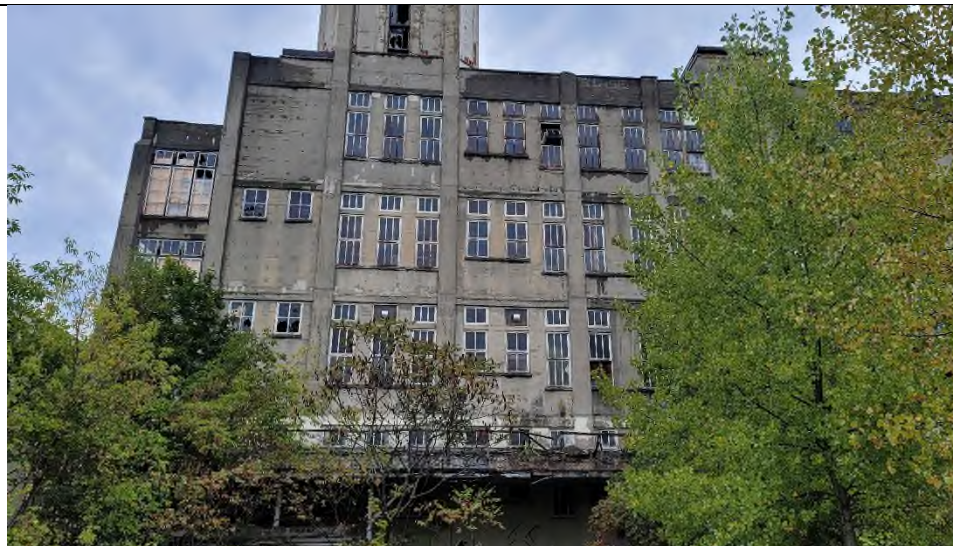
Photo 8 –

View of southern side of main structure.

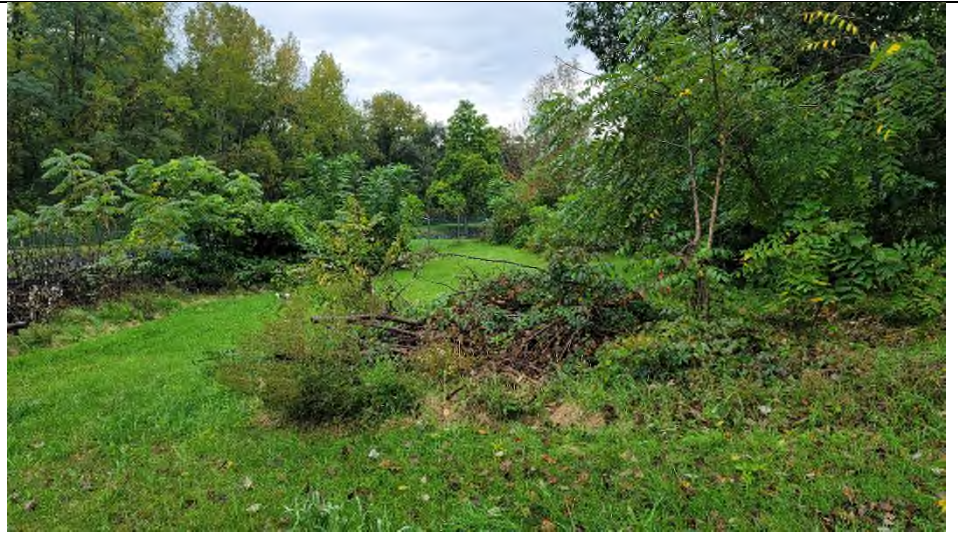
Photo 9 –

Typical view of southern grassed area.

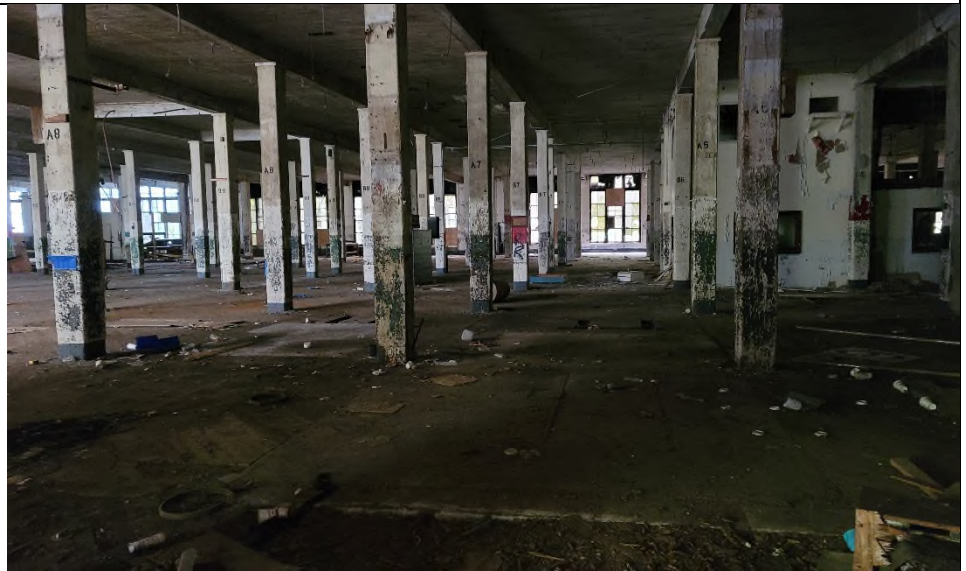
Photo 10 –

Typical interior view of main structure.

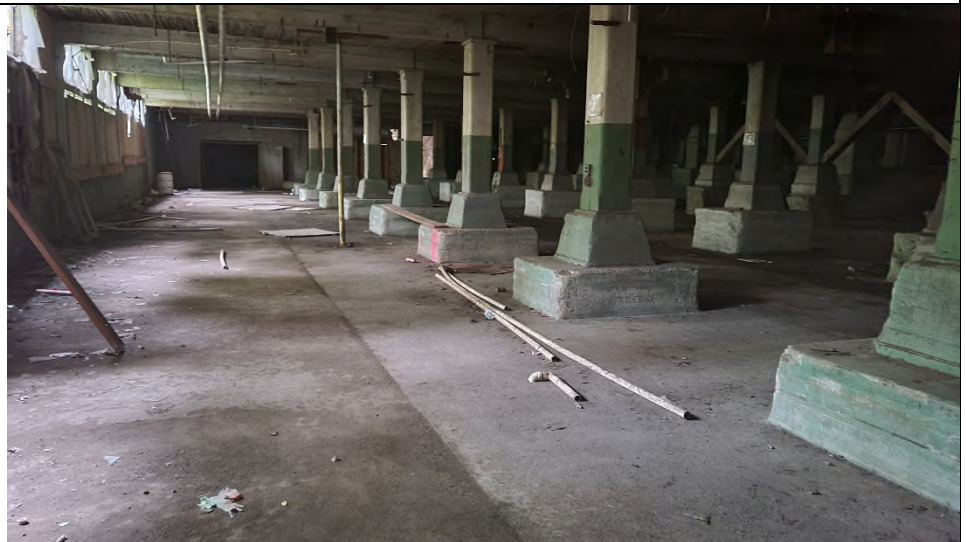
Photo 11 –

Typical basement view of main structure.
