MONTHLY STATUS REPORT

BCP No.:	C546047	PVE Project No.:	561231	Date:	11/24/2021
Project Name:	42 Gates Avenue, Village of Victory, Saratoga County, NY

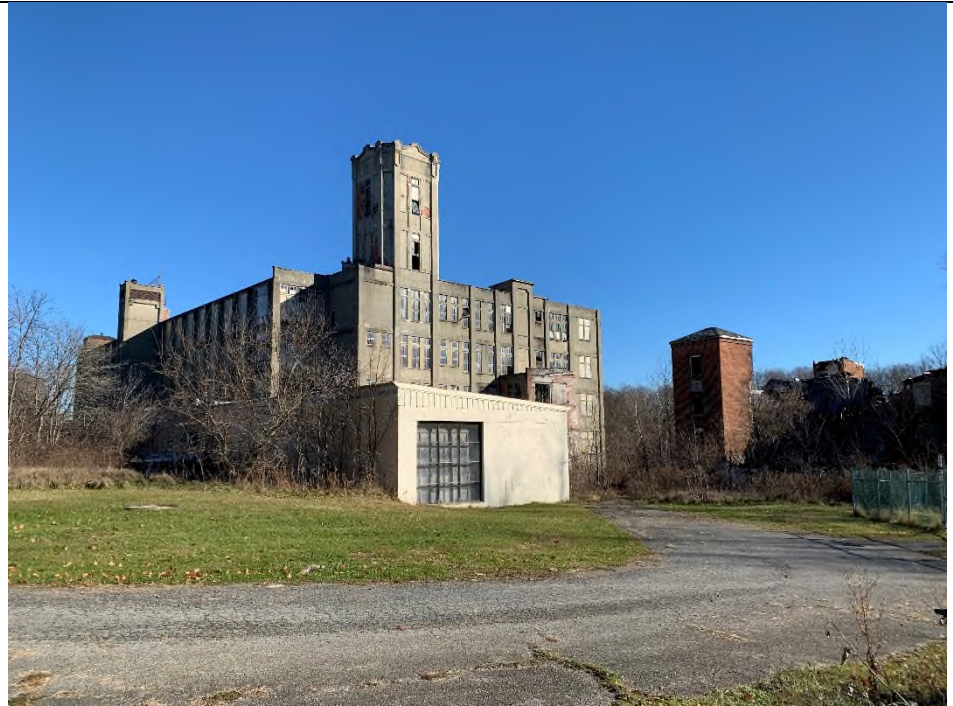
Photo 1 –

Overview of BCP Site from
the west/southwest.

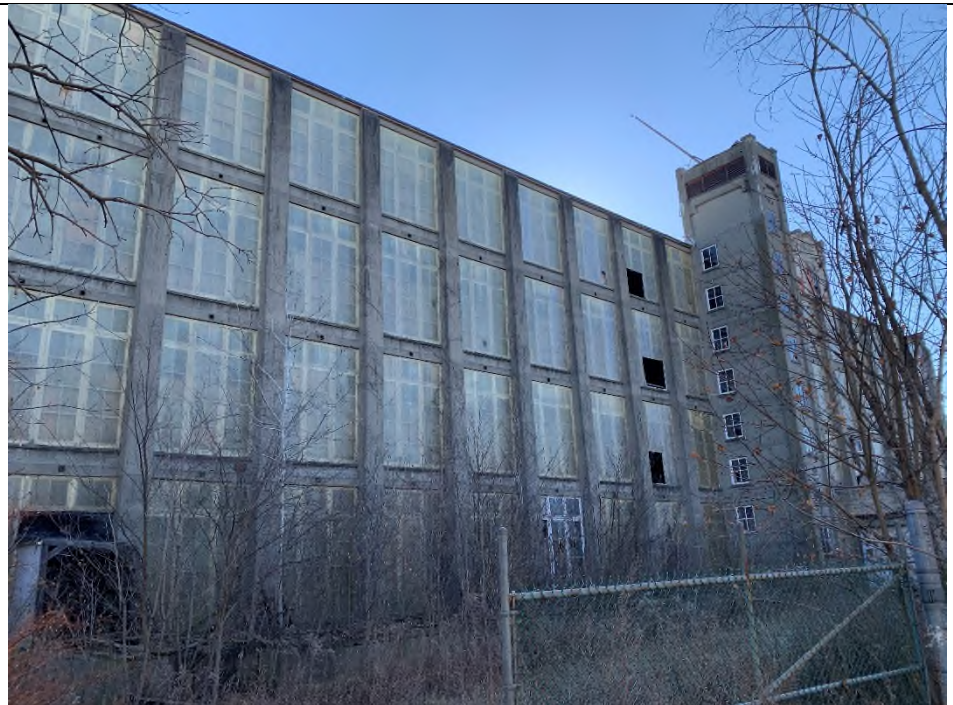
Photo 2 –

View of northwestern side of
main structure.

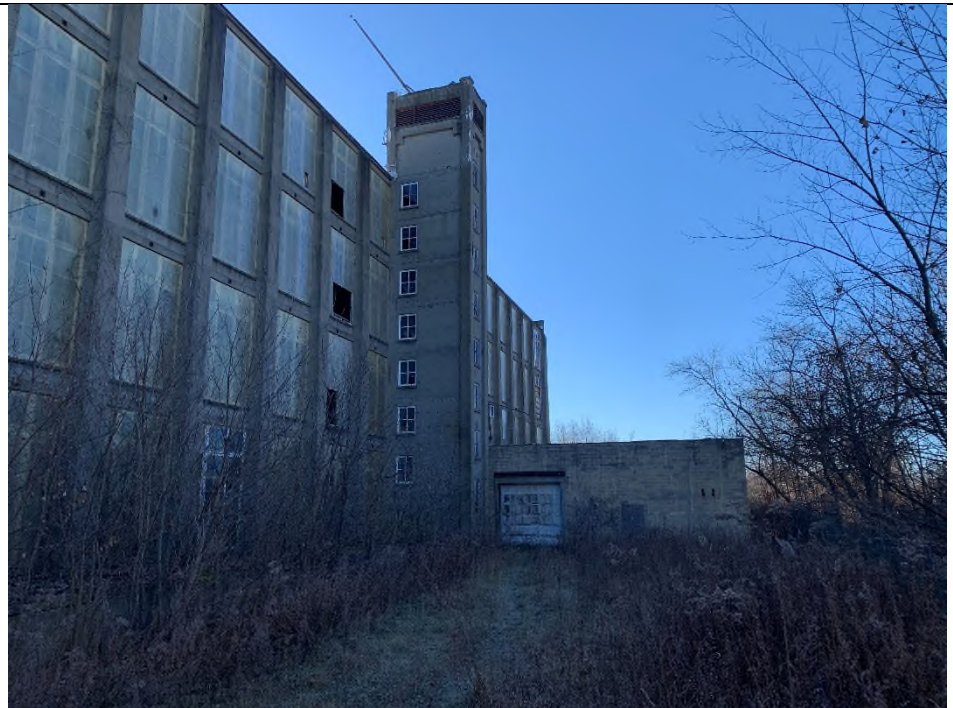
Photo 3 –

Main garage structure has been locked and secured.

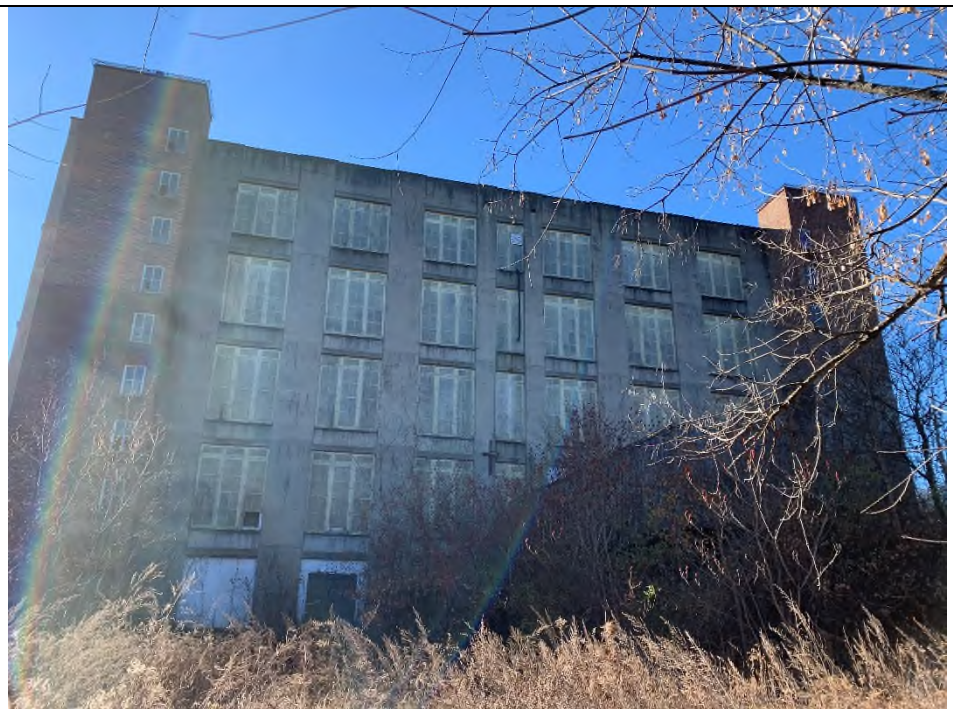
Photo 4 –

View of northern side of main structure.

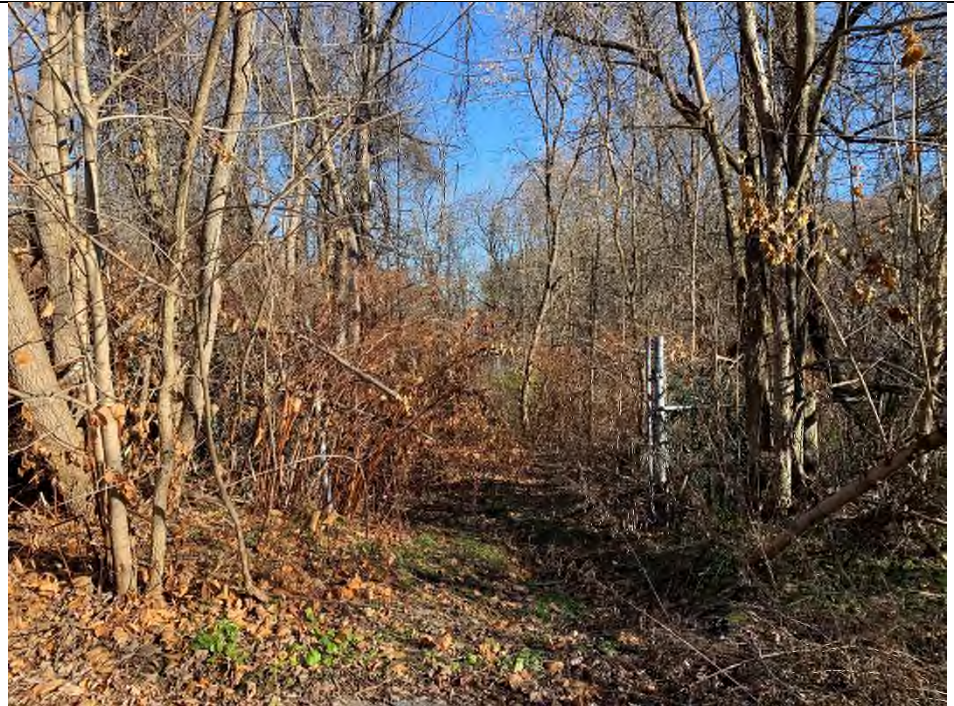
Photo 5 –

View of the entrance to the northern wooded area.

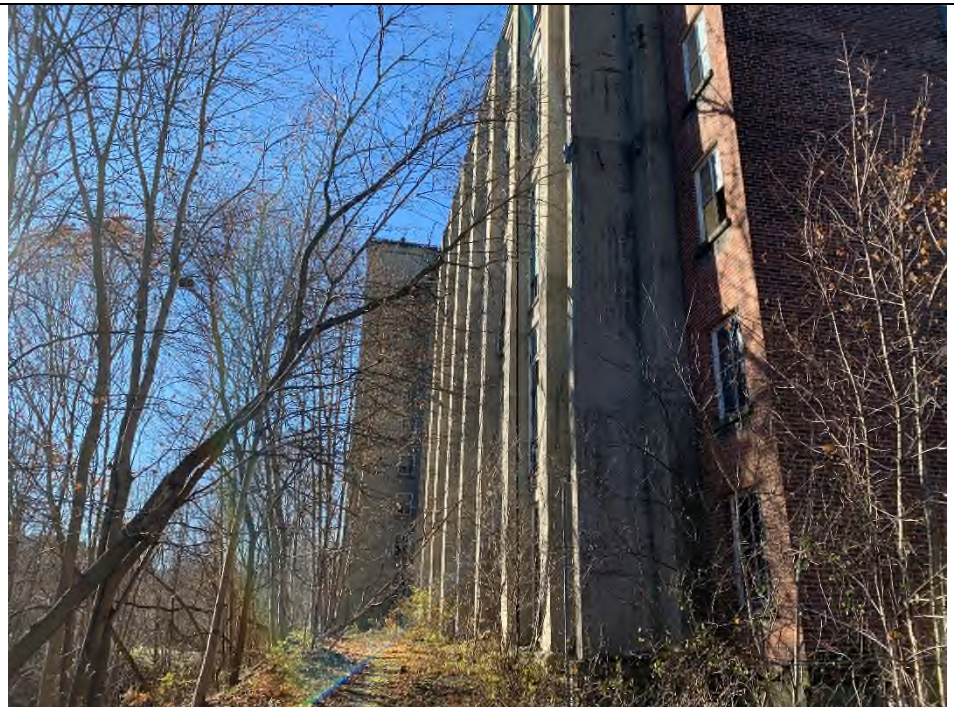
Photo 6 –

View of eastern side of main structure.

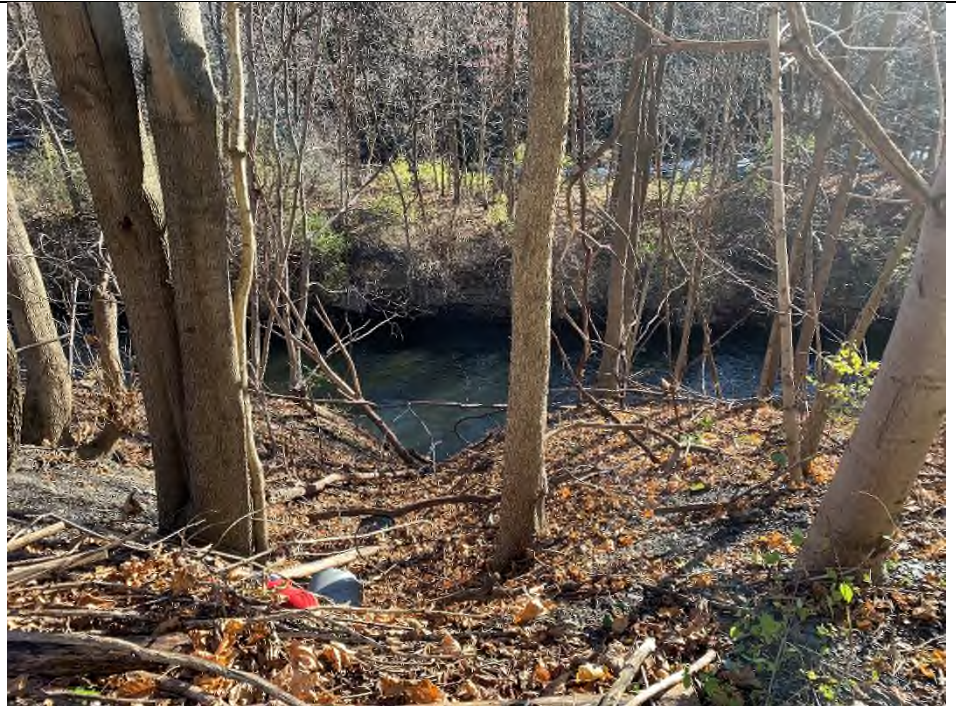
Photo 7 –

Typical view of adjoining stream along eastern side of BCP Area.

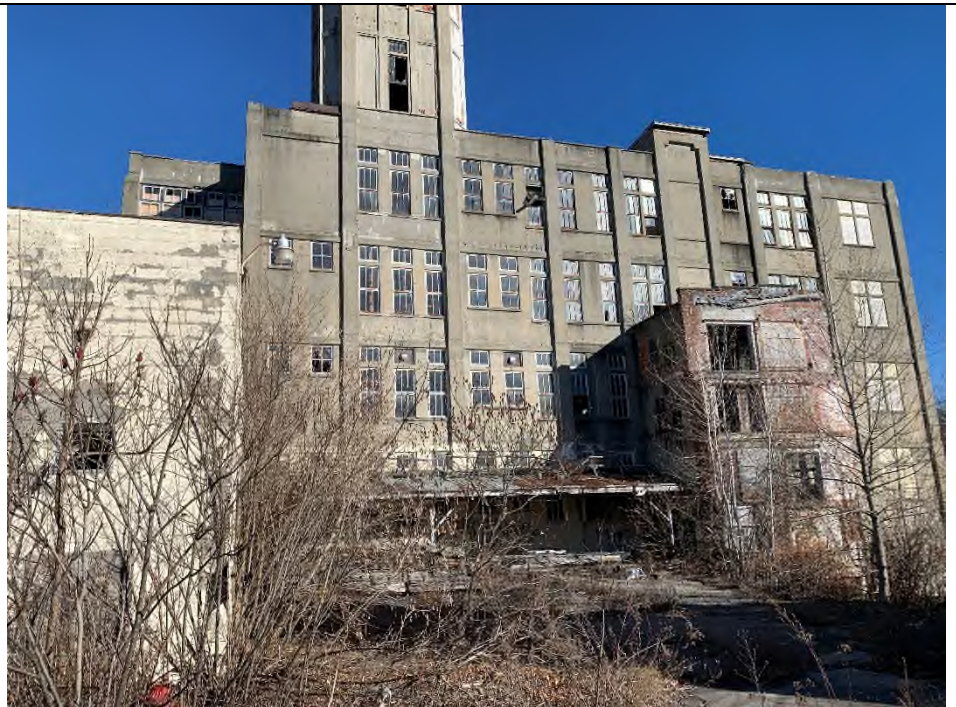
Photo 8 –

View of southern side of main structure.

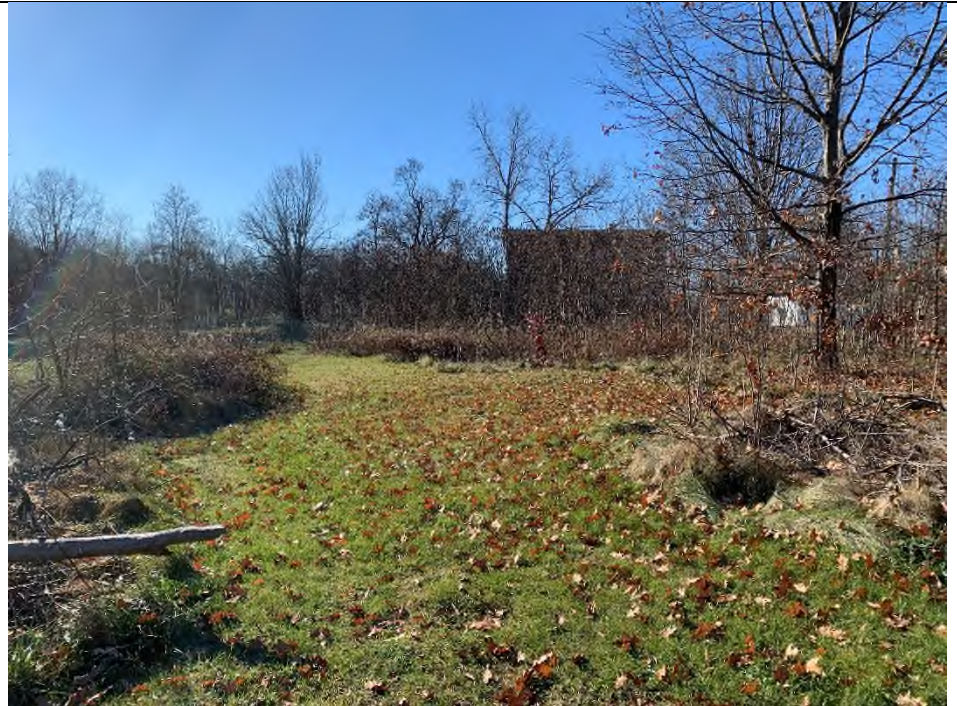
Photo 9 –

Typical view of southern grassed area.

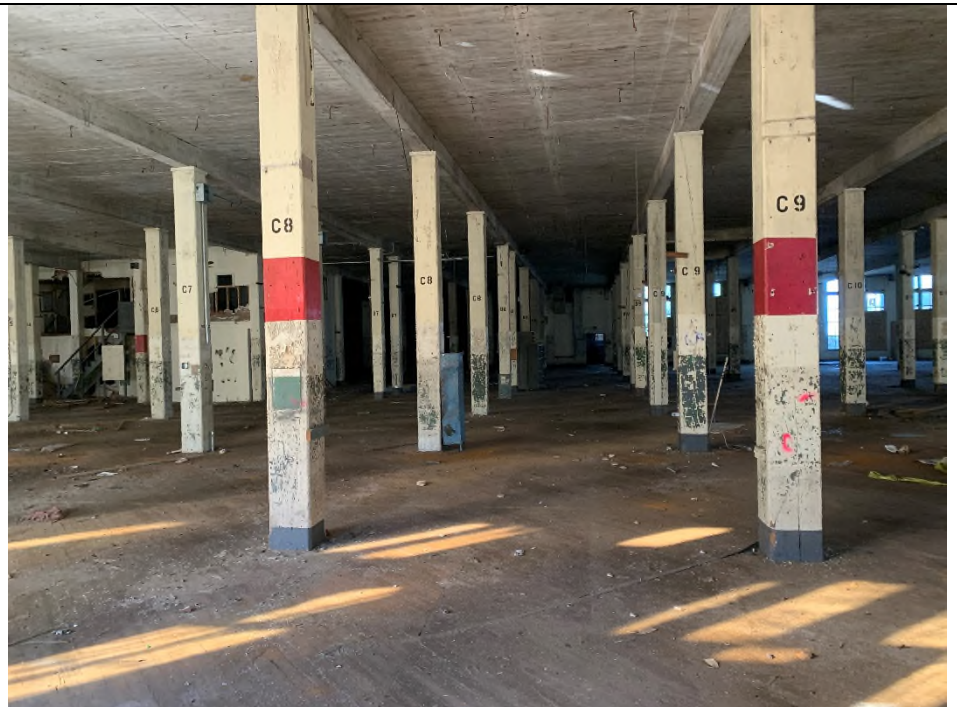
Photo 10 –

Typical interior view of main structure.

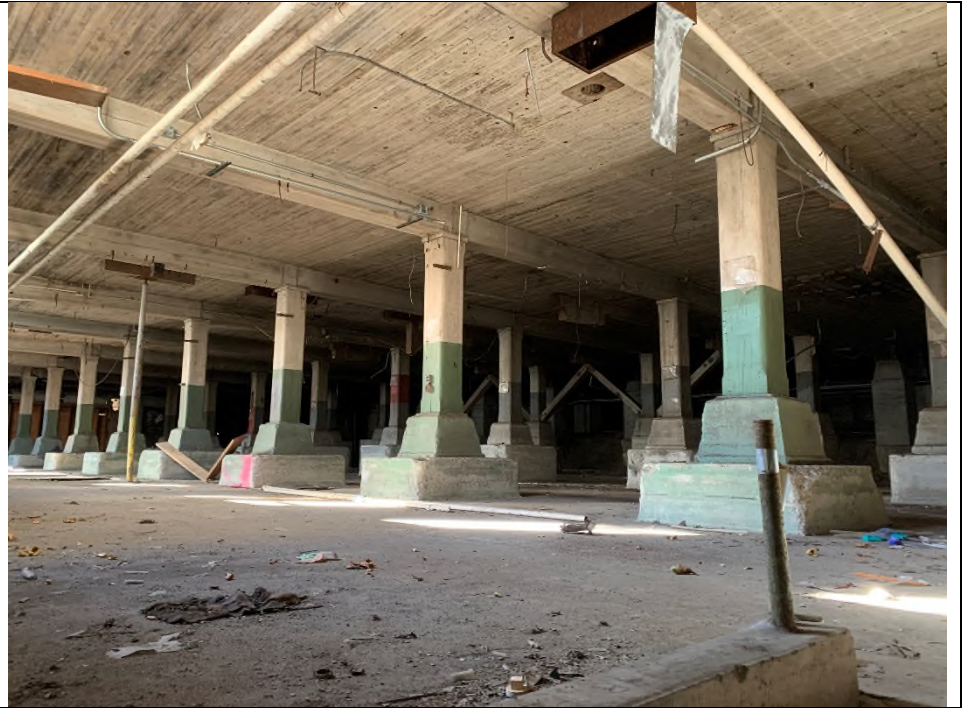
Photo 11 –

Typical basement view of
main structure.
