MONTHLY STATUS REPORT

| BCP No.: | C546047 | PVE Project No.: | 561231 | Date: | 5/5/2022 |
| Project Name: | 42 Gates Avenue, Village of Victory, Saratoga County, NY | | | | |

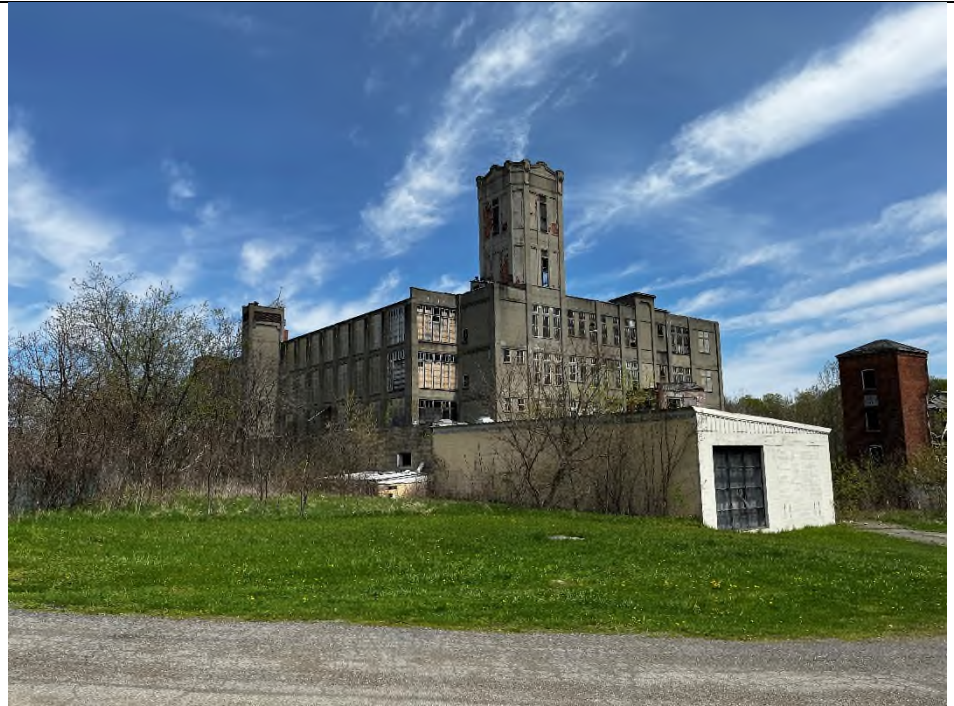
Photo 1 –

Overview of BCP Site from the west/southwest.

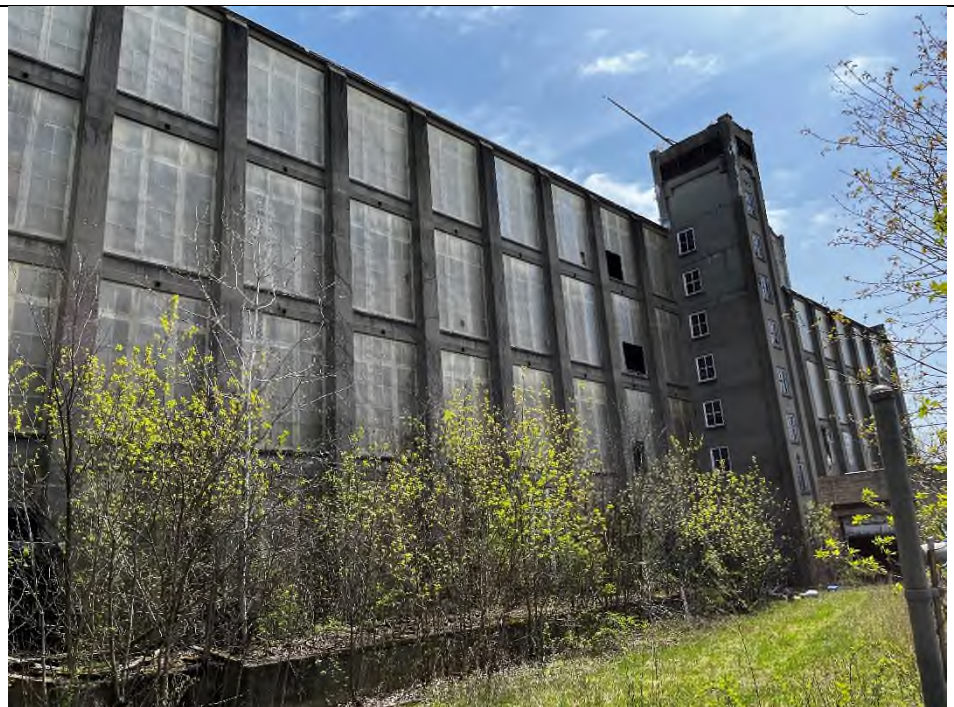
Photo 2 –

View of northwestern side of main structure. Main garage structure.

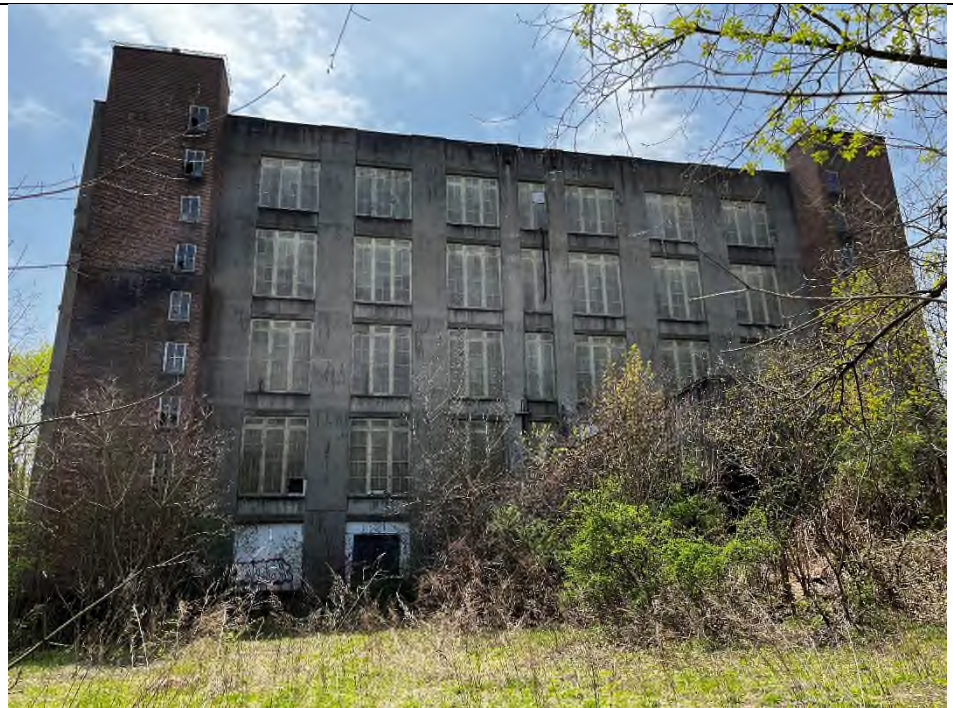
Photo 3 –

View of northern side of main structure.

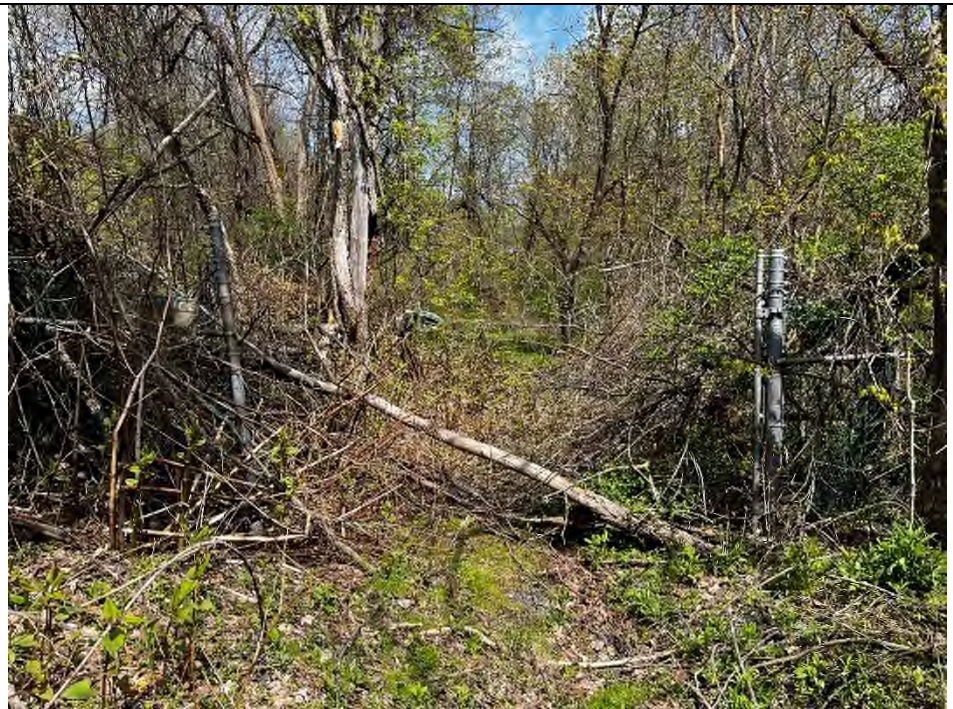
Photo 4 –

View of the entrance to the northern wooded area.

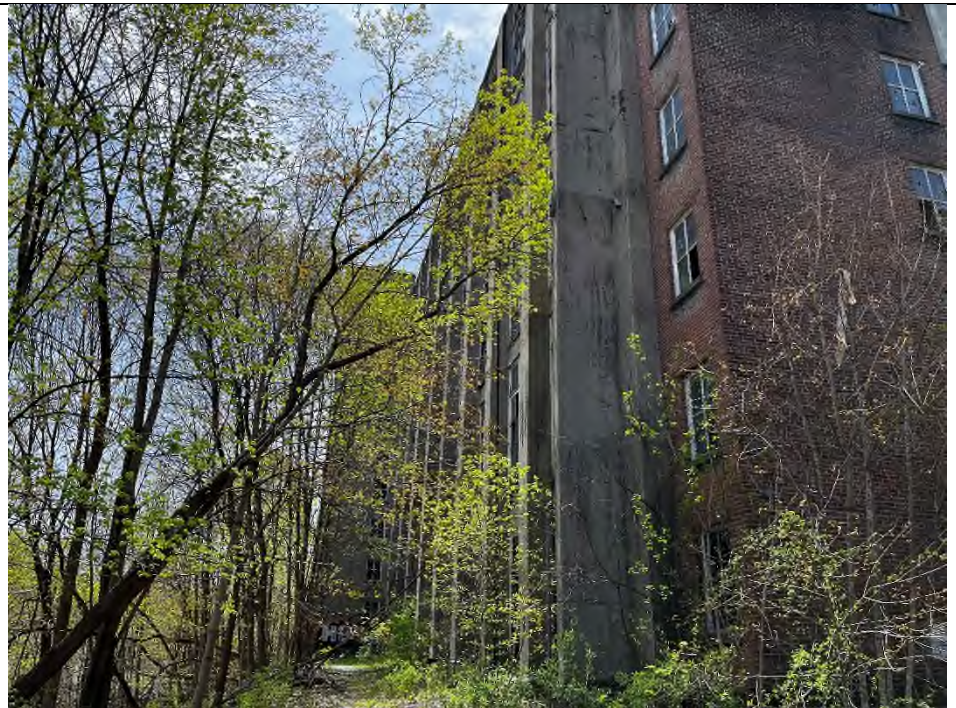
Photo 5 –

View of eastern side of main structure.

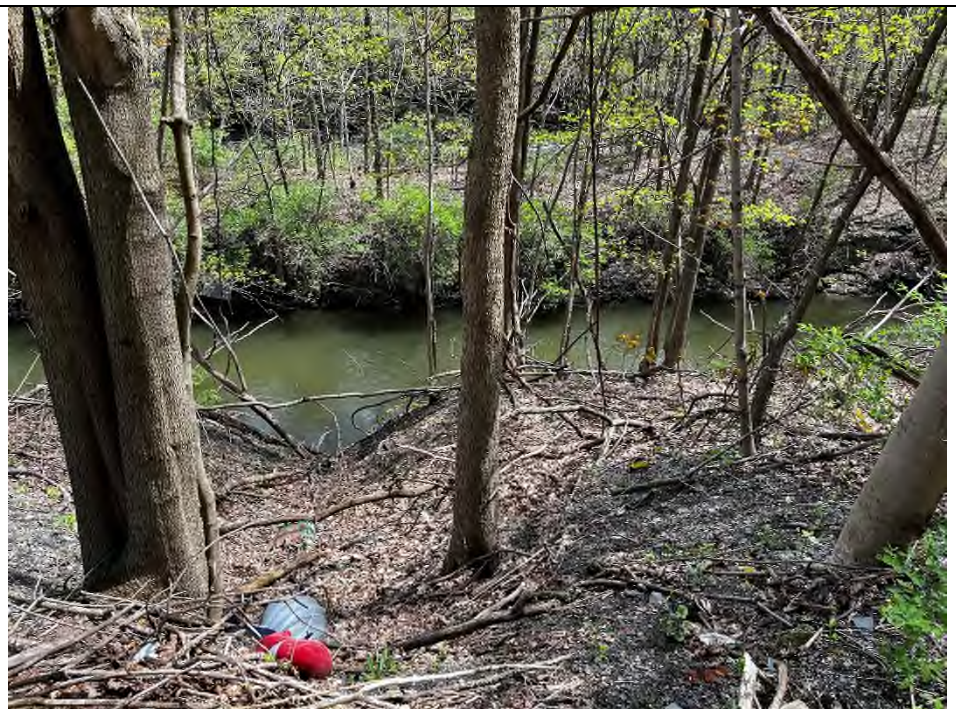
Photo 6 –

View of eastern adjoining stream.

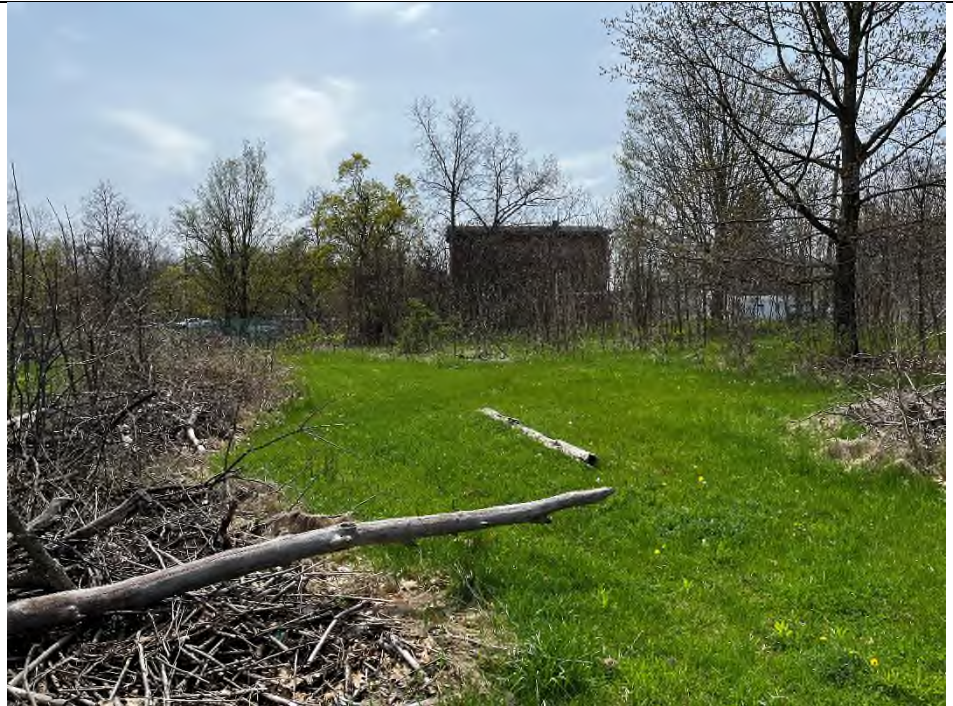
Photo 7 –

Typical view of southern grassed area.

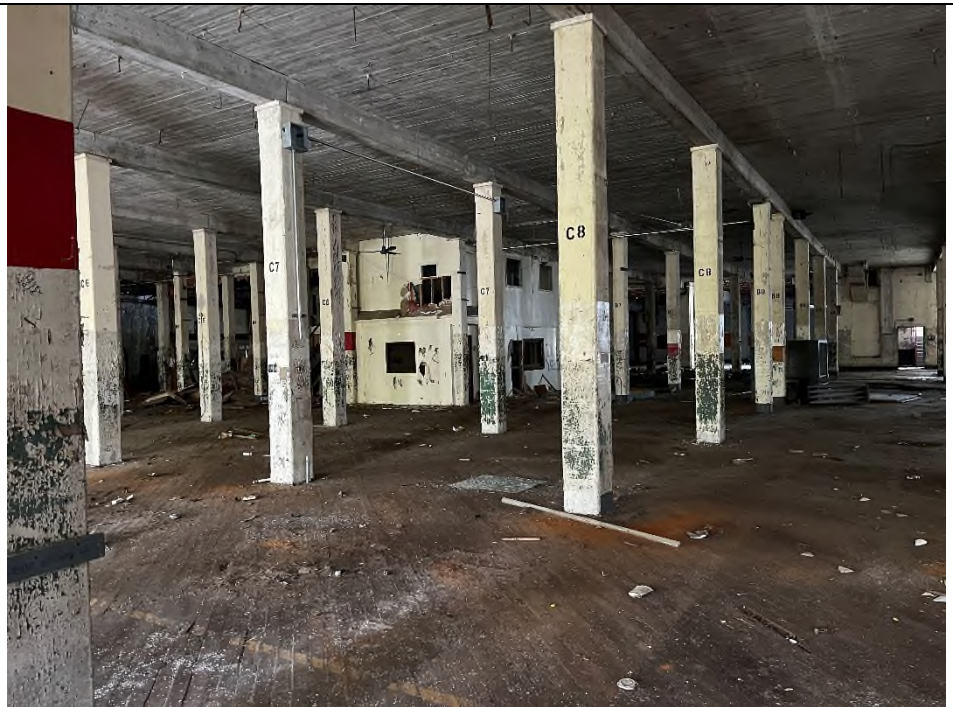
Photo 8 –

Typical interior view of main structure.

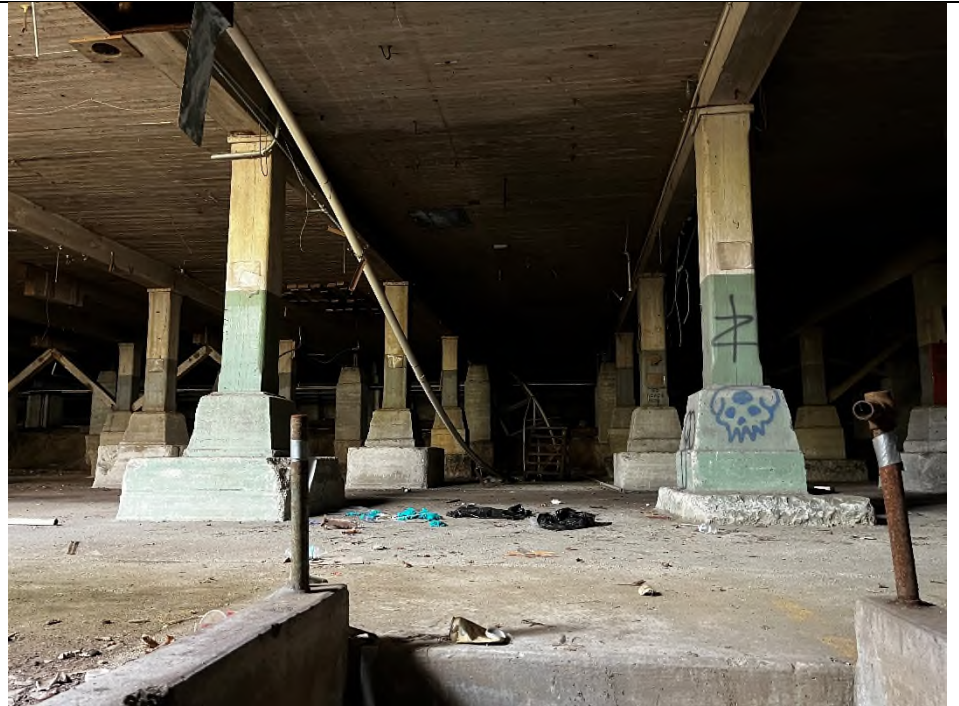
Photo 9 –

Typical interior view of
basement.
