**REMEDIAL INVESTIGATION REPORT
TRIPLE CITIES METAL FINISHING CORPORATION
4 NOWLAN ROAD
HILLCREST, NEW YORK
NYSDEC BCP ID. C-704045**

**BINGHAMTON REALTY, INC.
AND
NEW YORK STATE DEPARTMENT OF ENVIRONMENTAL CONSERVATION**

**November 2009
PROJECT NO. 99011A**

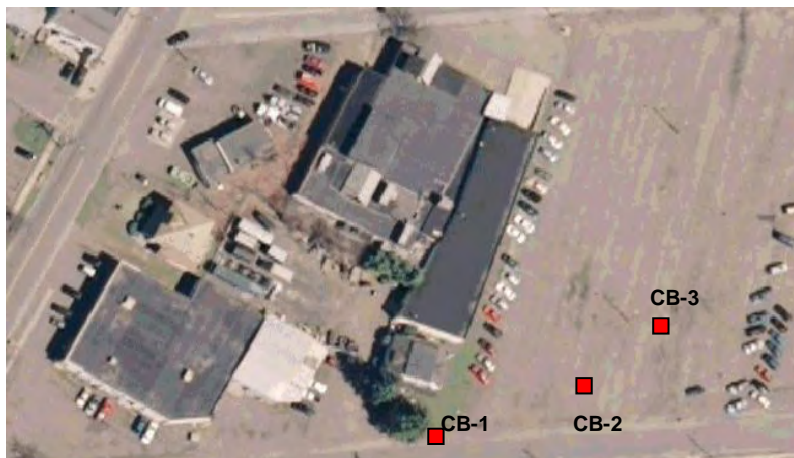
**REMEDIAL INVESTIGATION
SURFACE SOIL AND CATCHBASIN SAMPLE LOCATION PLAN
TRIPLE CITIES METAL FINISHING CORPORATION
BINGHAMTON, NEW YORK
Drawing No. 2**

TAGM-4046 provides guidance values for contaminants in soils. The metal concentrations reported in the sediment samples were similar to the range of concentrations observed in the surface soil samples. The volatile organic analyses for the three sediment samples reported either no contaminant concentrations above the detection limits or were below TAGM 4046 Soil Cleanup Objectives.

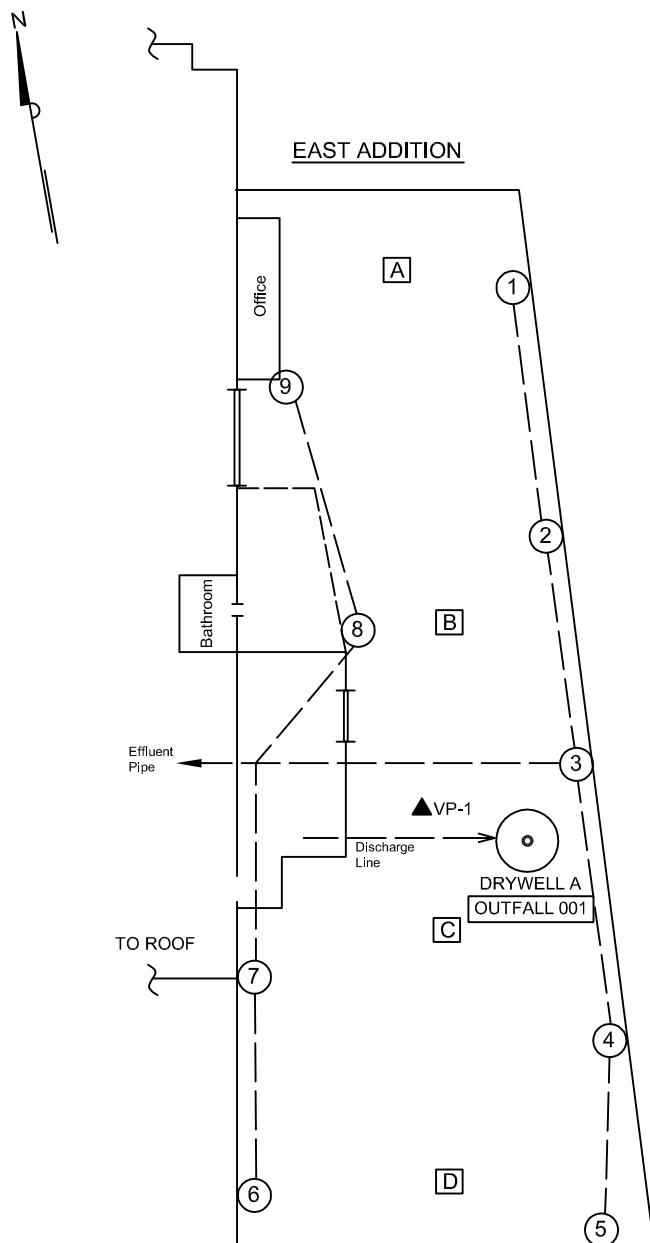
REMEDIAL INVESTIGATION
VAPOR MITIGATION SYSTEM
TRIPLE CITIES METAL FINISHING
BINGHAMTON, NEW YORK

Outfalls 001 and 002 depicted on Drawing No. 7 (Appendix B) were evaluated to identify whether they are sources of volatile organic contamination that is present in groundwater in the vicinity of TCMF, observed in soil vapor samples collected as part of NYSDEC Hillcrest Site Investigations and observed in soil vapor samples collected at TCMF. Outfalls 001 and 002 were also evaluated to determine whether waste sediments are present within the Outfall drywell structures, and the concentrations of the contaminant of concern within sediment and underlying soils.

At Outfall 001 there was no definitive demarcation between backfill material and waste sediments as observed at Outfall 002. The zones of waste sediments appeared to be dispersed within the backfill material. The TCE concentration within these waste sediment zones was 260 ug/kg decreasing to 10 ug/kg in the soils underlying the backfill material, all below the SCO for TCE. No Freon 113 was detected in any of the soil or water samples analyzed at this outfall. The concentration of cadmium and chromium within these waste sediment zones are above the SCO's.

The results observed at the overflow structure for Outfall 001 do not suggest that this catch basin received discharges from TCMF that impacted soil quality, or is the source of elevated soil vapors that have been observed at nearby sampling points (URS 2005). No volatile compounds were detected in the soils above the method detection limits, and cadmium and chromium concentrations are well below the SCO's.

Similar waste sediments were observed in the two drywell structures for Outfall 002. No TCE was detected in the backfill material, the waste sediments or underlying soils. The concentration of cadmium and chromium within these waste sediments are above the SCO's. The concentrations of Freon 113 detected in samples collected adjacent to these two structures were trace (<2 ppb) to non-detect.
