LYONS ENGINEERING, DPC.

2022-2024 PERIODIC REVIEW REPORT

NYSDEC Site Number: C704060

The EJ Victory Building
59 Lester Avenue
Johnson City, New York

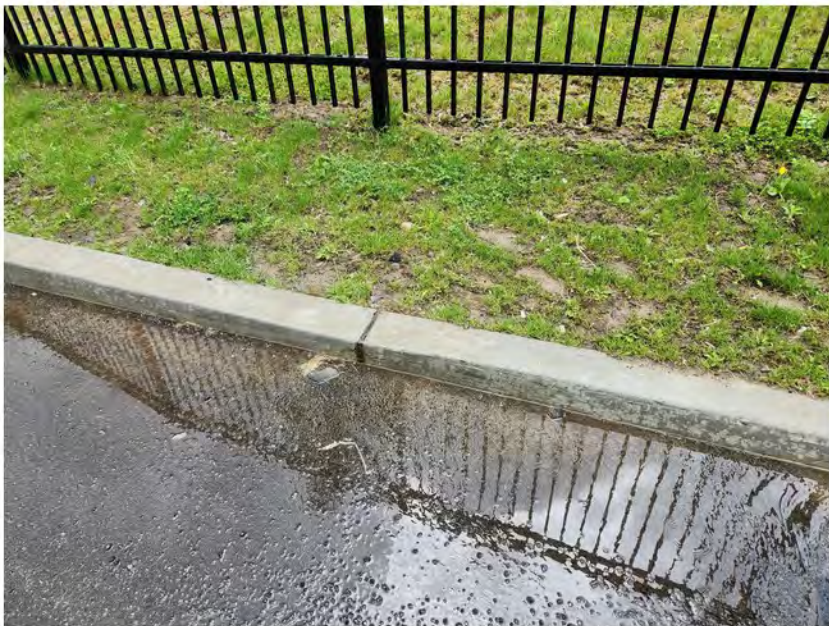
*Note: Although thin lawn cover was noted in areas throughout the Site, no erosion of the cover topsoil was observed. In fact, during the inspection, a heavy downpour occurred. Immediately after the downpour, LYONS personnel inspected thinly-vegetated areas on steep slopes and did not observe any indications of erosion.

Area of thin lawn area on steep grade, immediately after a downpour. No erosion observed.

At the current time, no changes to the SMP are necessary. However, as a Best Management Practice, it is recommended that lawn areas with thin cover be overseeded.

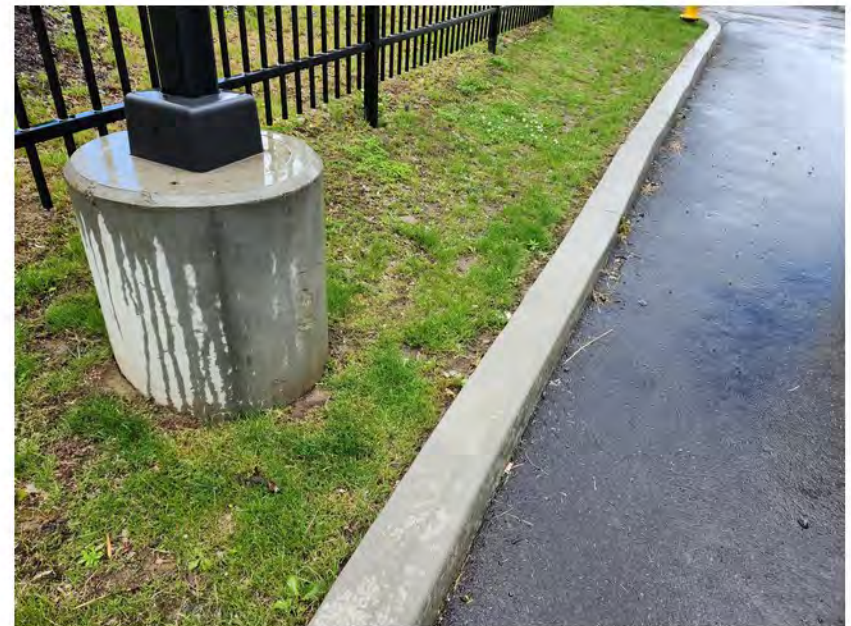
Area of thin lawn area on steep grade, immediately after a downpour. No erosion observed.

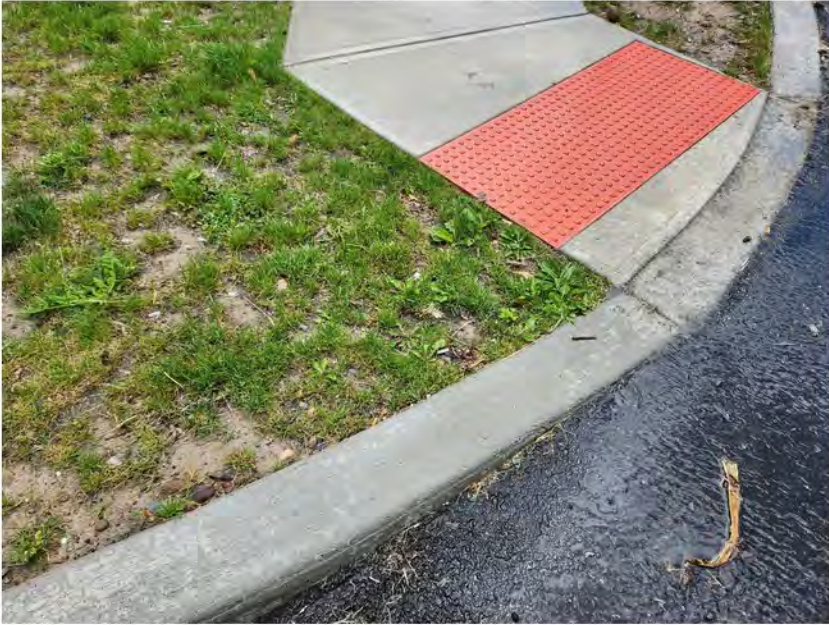
Area of thin lawn area on steep grade, immediately after a downpour. No erosion observed.

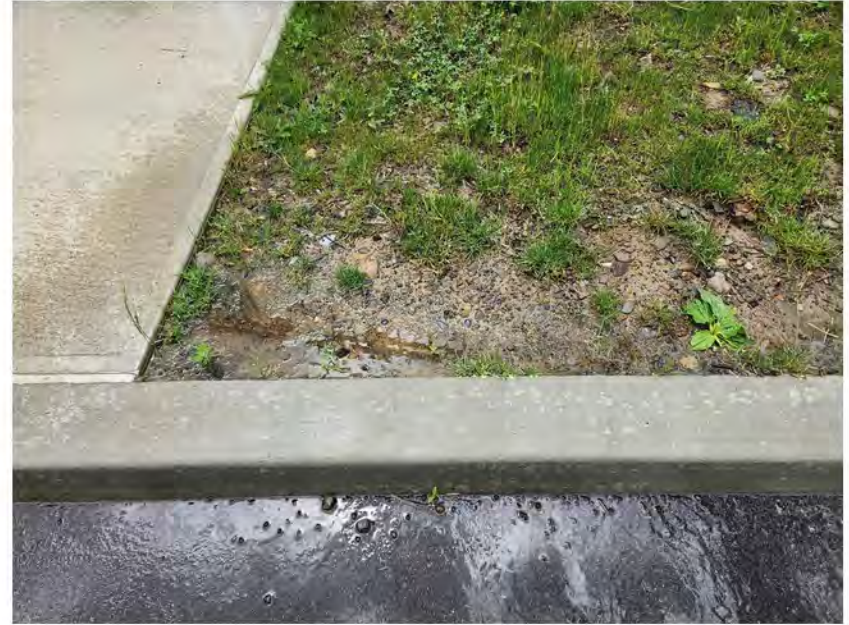
Area of thin lawn area on steep grade, immediately after a downpour. No erosion observed.
