LYONS ENGINEERING, DPC.

2024-2025 PERIODIC REVIEW REPORT

NYSDEC Site Number: C704060

The EJ Victory Building
59 Lester Avenue
Johnson City, New York

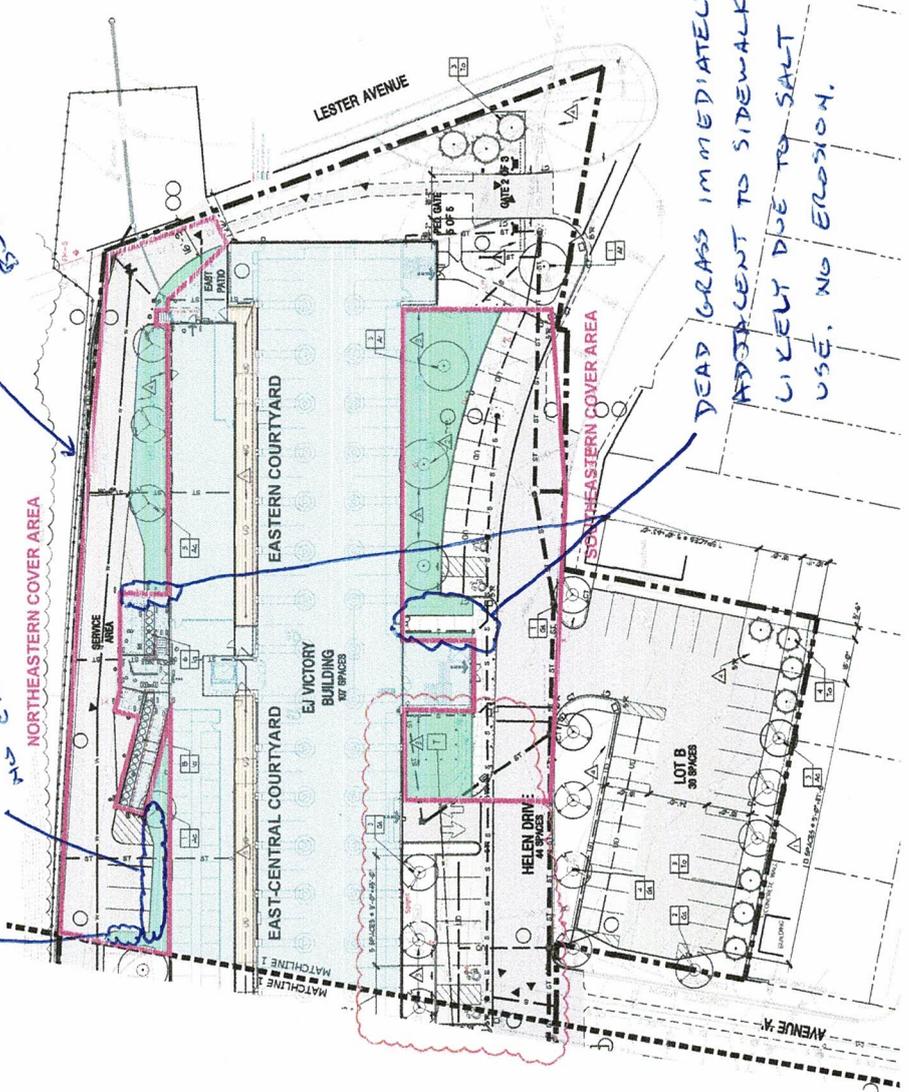
GRASS IS "SPRATCHY" - MONITOR. NO EROSION.

GRASS A WHOLE BORDER BETTER. NO EROSION.
