ENVIRONMENTAL GROUP, INC.  
ENGINEERING, ARCHITECTURE & SURVEYING, PC

February 16, 2016

Subject: Roth Steel – Interim Remedial Measures Report (Revised)

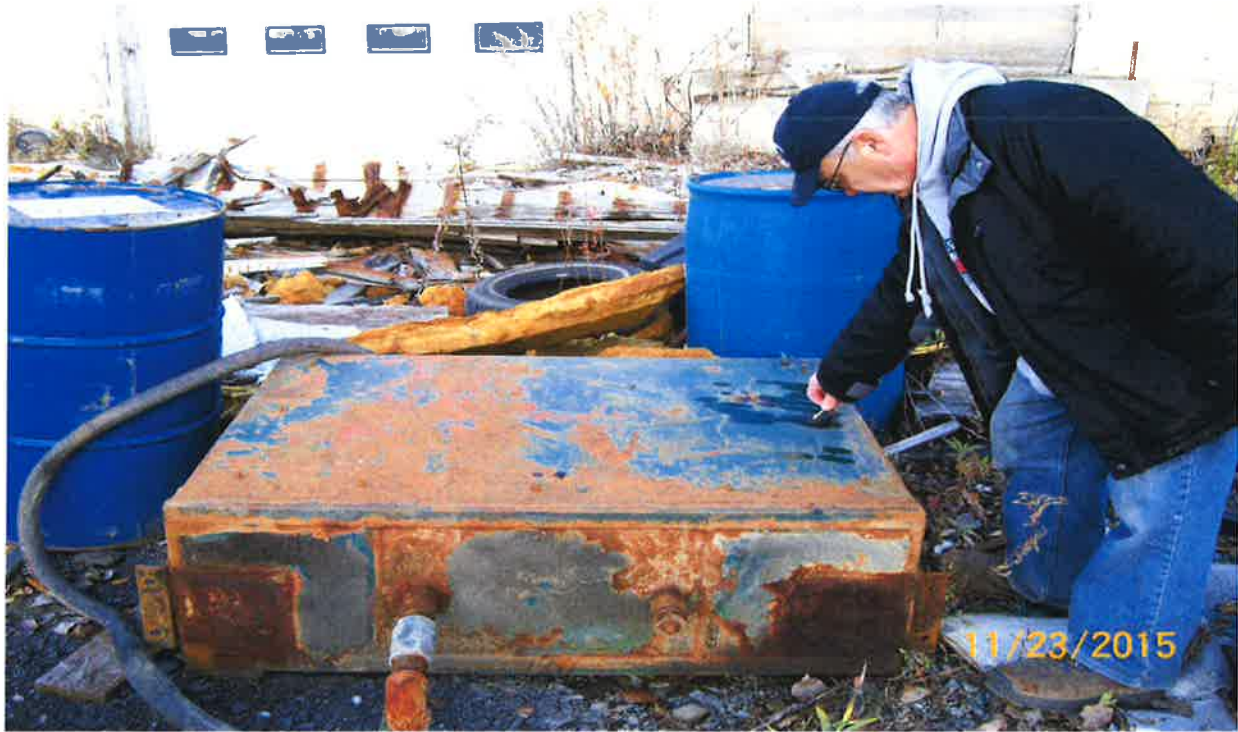
On November 18, 2015 Spectra accompanied the NYSDEC regional project manager, Karen Cahill and two representatives from EPA, on an inspection of the site. During the inspection, Ms. Cahill noticed several leaking drums, abandoned automotive fuel tanks and miscellaneous debris outside of Building 6 (see **Photo 1**, **Photo 2**, and **Photo 3**). At that time Ms. Cahill requested an immediate 24 hour emergency response to mitigate the problem. Spectra immediately contacted three area waste contractors to meet on the site the following day.

Photo 1 – Yard area around building 6 – Abandoned automotive fuel tank, discarded drums and miscellaneous debris

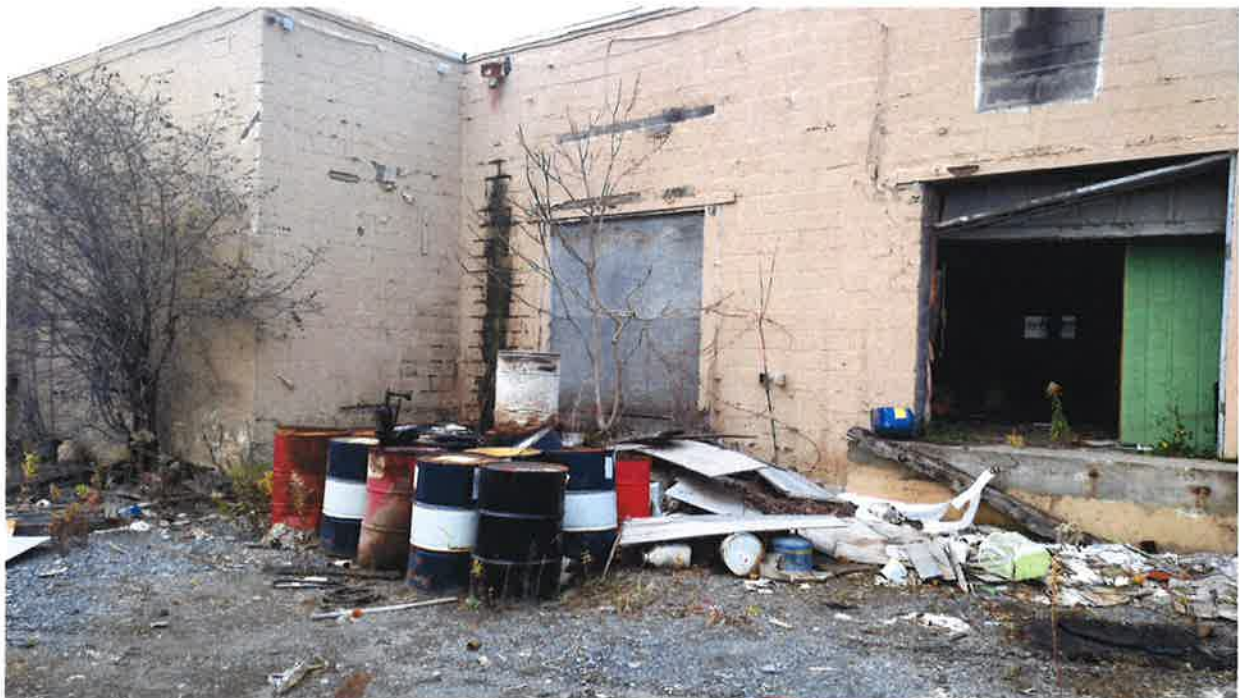
Photo 2 – Yard area near building 6 – Numerous abandoned 55 gallon drums and various debris

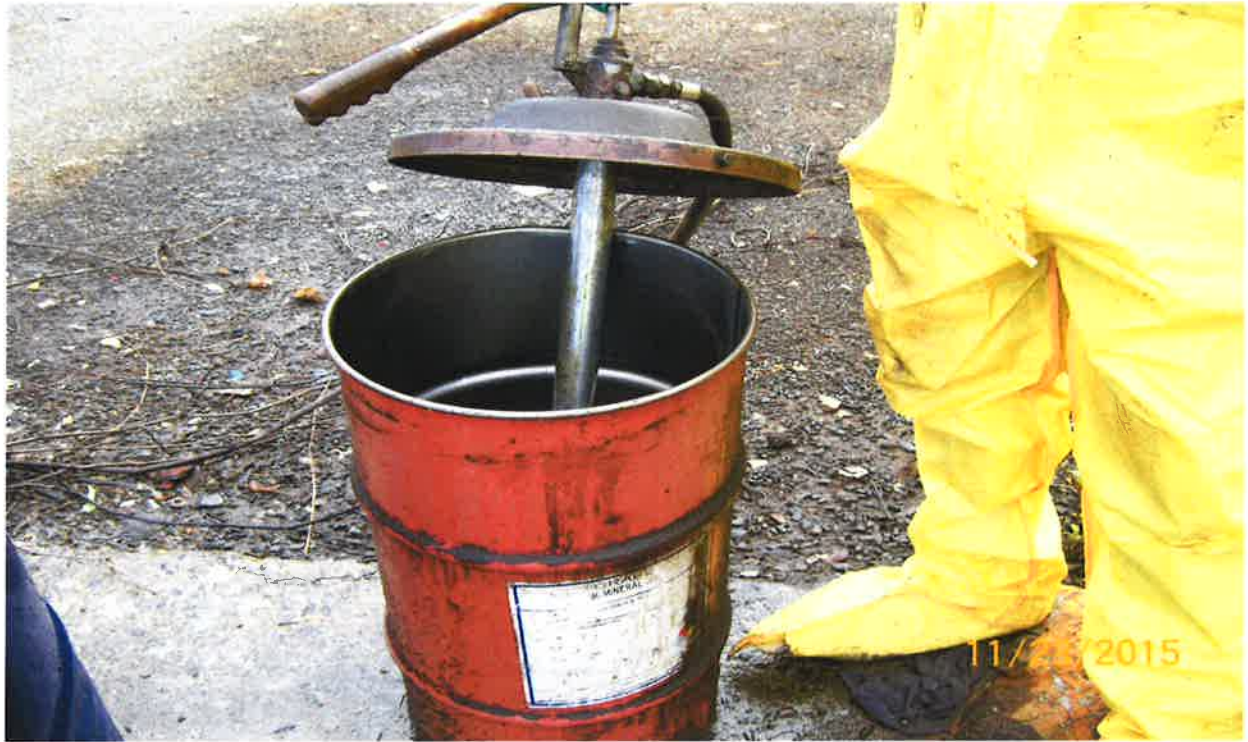
Photo 3 – Yard area near building 6 – Drum containing mineral spirits

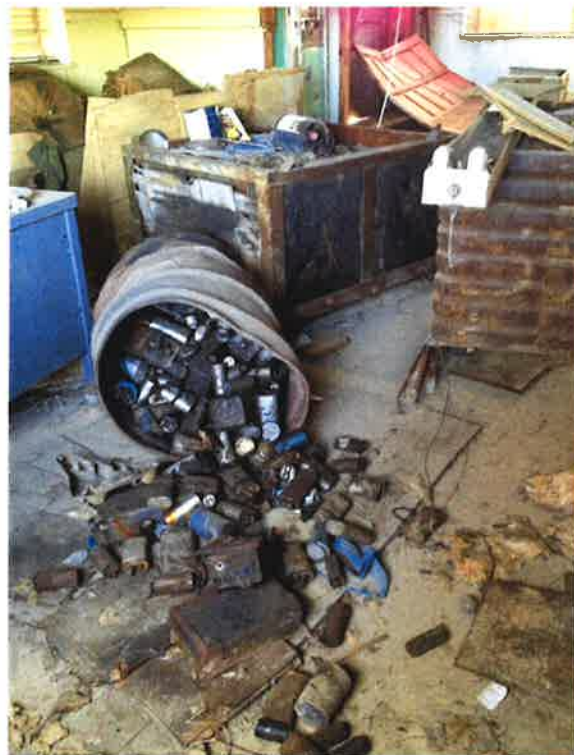
The walk through on November 18 also identified a 55 gallon drum inside Building 4 filled with capacitors which may contain PCBs (see **Photo 4**). The area also contained possible asbestos insulation spread around the room (see **Photo 5** and **Photo 6**). The contractors all acknowledged that these could not be removed until an asbestos assessment was conducted. An assessment of this type would take several weeks at best to complete. Given that the material in question was not exposed to the environment, and confined within the building, Ms. Cahill determined that, since there was minimal exposure risk, not to include the capacitors in this emergency action at this time.

Photo 4 – Building 4 – potential PCB containing capacitors within building 4

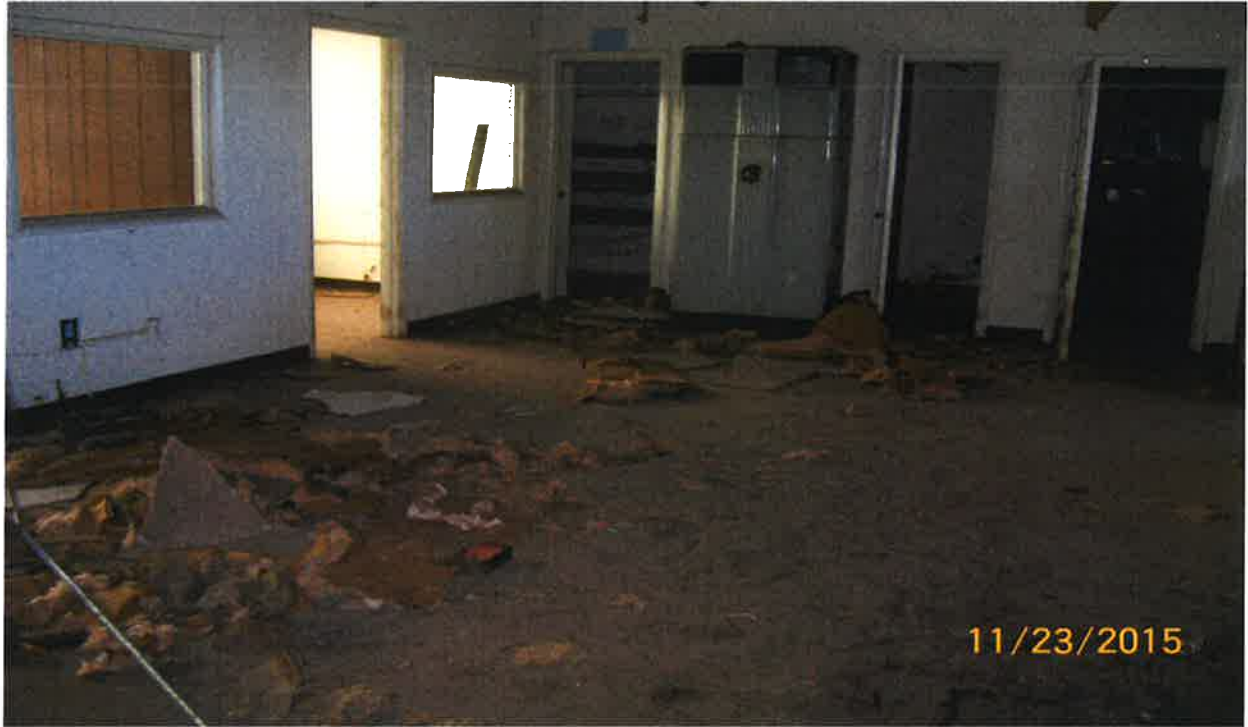
Photo 5 – Building 4 – Potential asbestos containing materials within building 4

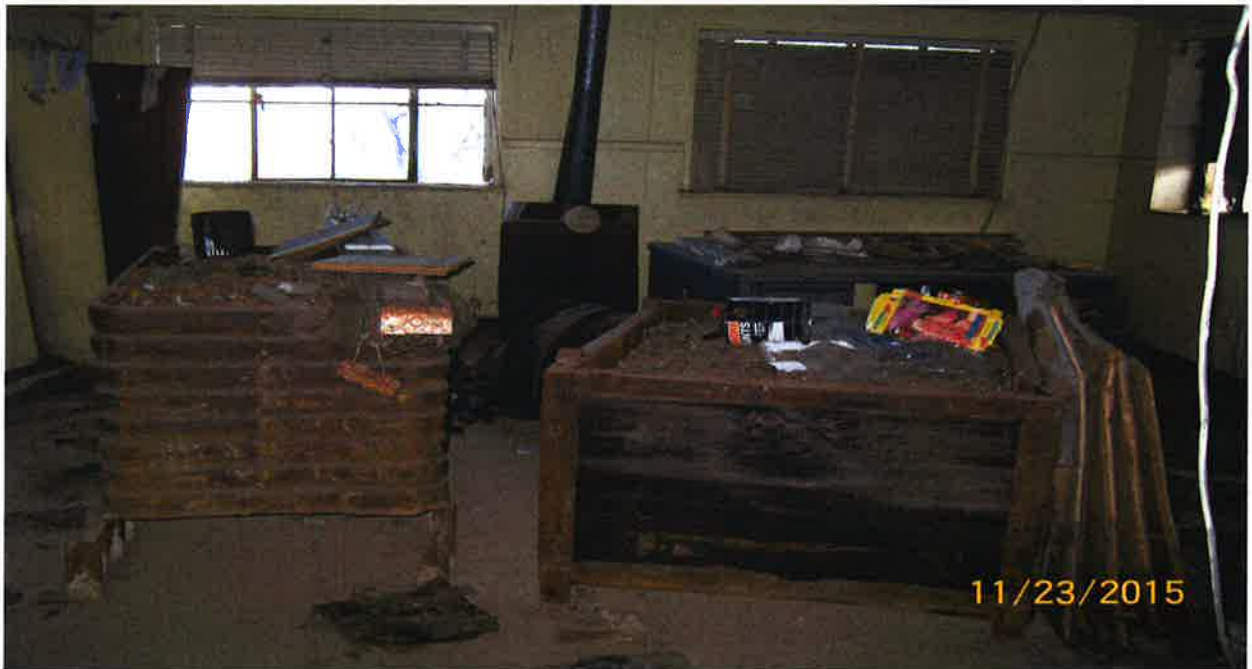
Photo 6 – Building 4 – Potential asbestos containing materials within building 4

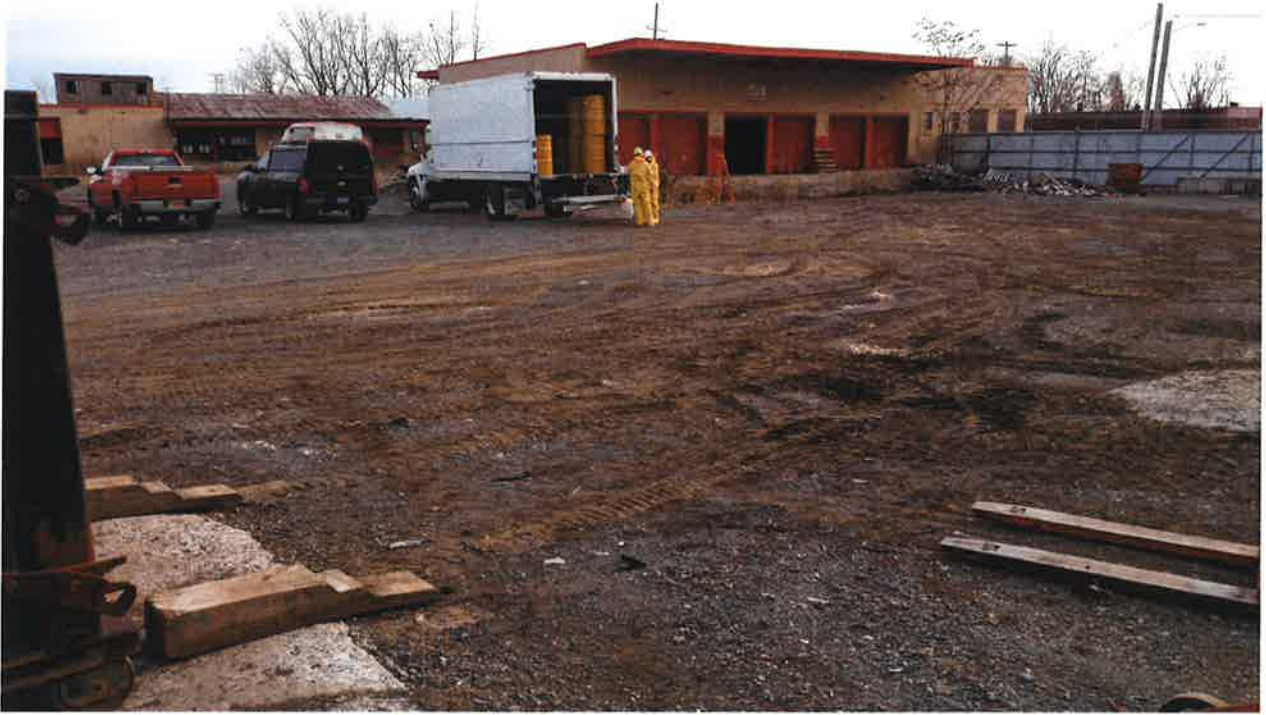
Photo 7 – Building 5 (foreground) & Building 4 (background) – facing North

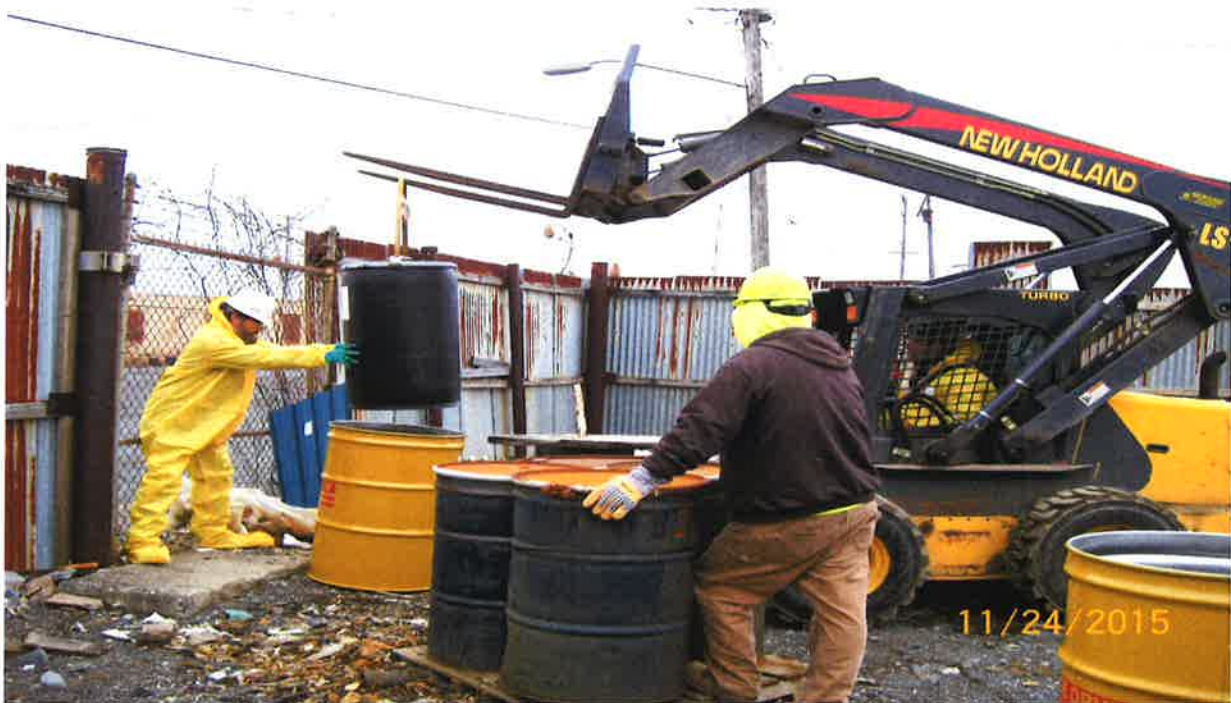
On November 23<sup>rd</sup> and 24<sup>th</sup>, Action Technical Services mobilized to the site to conduct the IRM activities under Spectra oversight. An assessment of the area around Building 6 identified that a number of 55-gallon drums were filled or partially filled with what appeared to be lubricants and oils, 2 fuel tanks, aerosol cans, paint cans and assorted plastic containers. All items were inspected for competency, quantified, categorized, and staged within Building 5 (see **Photo 7**). Two additional leaking drums were identified outside of Building 1 and were incorporated into the interim remedial measure plan (see **Photo 8**).

Photo 8 – Yard near building 1 – Over-packing of 55 gallon drum into 85 gallon drum

Any 55 gallon drum that was found to be incompetent was over-packed within a steel 85 gallon drum (photo 8). A total of nineteen (19) 55 gallon drums were over-packed and staged together within Building 5 (see **Photo 9**). A number of the abandoned 55 gallon drums around Building 6 along with various containers were observed to be open and to contain collected rainwater. The collected rainwater was transferred into reconditioned 55 gallon drums. A total of seven (7) reconditioned drums were used to containerize all observed collected rainwater. These drums were staged together within Building 5 (Photo 9).

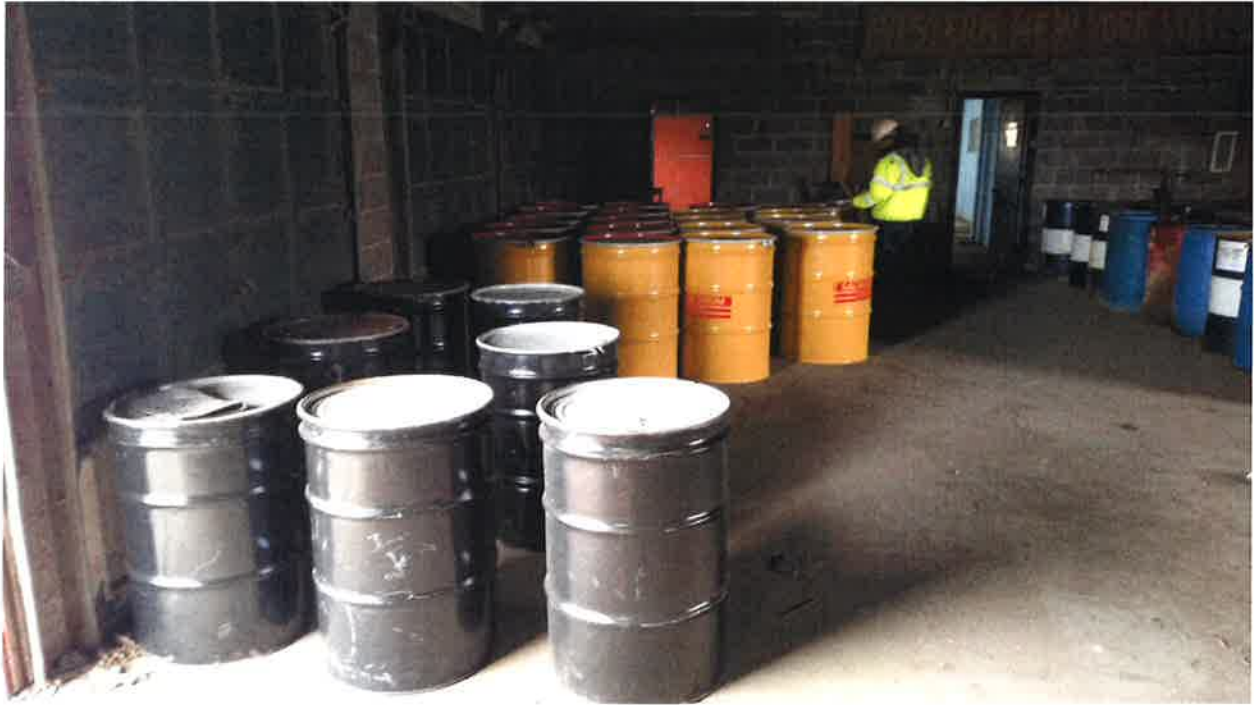
Photo 9 – Building 5 – Nineteen over packed 85 gallon drums (background) and seven 55 gallon water drums (foreground) condensed and housed within building 5

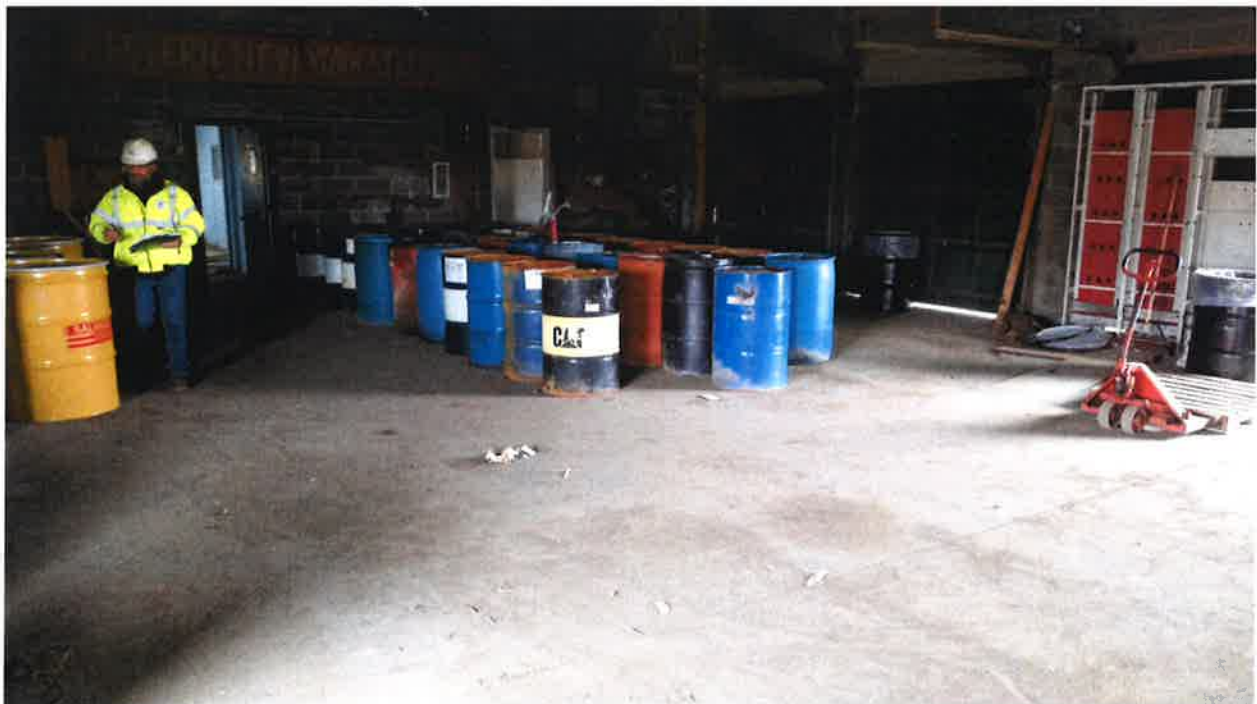
Photo 10 – Building 5 – 31 partially full 55 gallon drums (center) and a single drum of aerosol containers (right) condensed and housed within building 5

Thirty-one (31) other sealed 55 gallon drums that were found to be competent were staged “as-is” along with other competent drums within Building 5 (see **Photo 10**). A competent drum is one that, based on the contractor’s experience, is not sufficiently dented or rusted, or otherwise leaking so as to compromise the drums structural integrity. Ultimately, the final decision on the competency of a drum lies with the transporter.

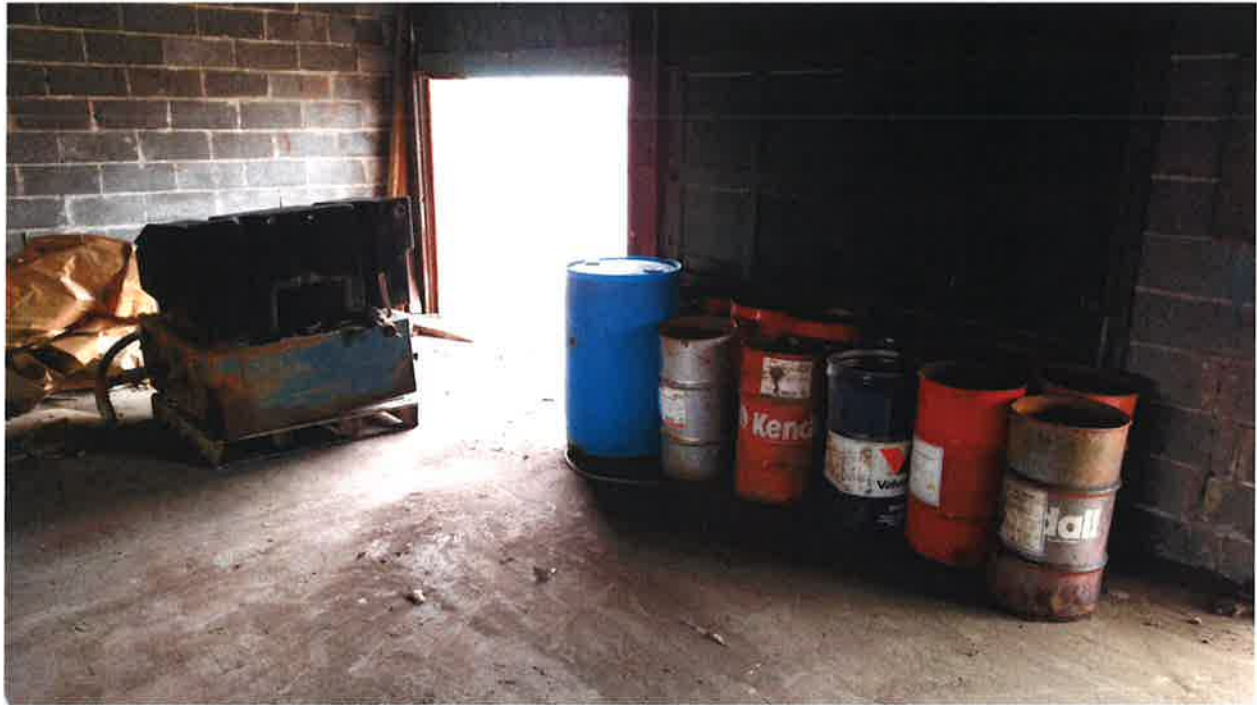
Photo 11 – Building 5 – 13 empty containers (right) and 2 horizontal fuel tanks (left) condensed and housed within building 5

Numerous small containers were observed on site. The containers varied greatly from small quantity oil storage, propane tanks, paint cans to medium sized horizontal fuel tanks. These containers were identified, transported to Building 5, categorized with like products and staged on polyethylene sheeting within the building. Approximately 100 containers (plastic oil containers, 5 gallon buckets, paint cans, automotive tanks, propane tanks etc.) were identified and staged within Building 5. Aerosol cans were collected and placed into a reconditioned 55 gallon drum with other like material (See **Photo 11** and **Photo 12**).

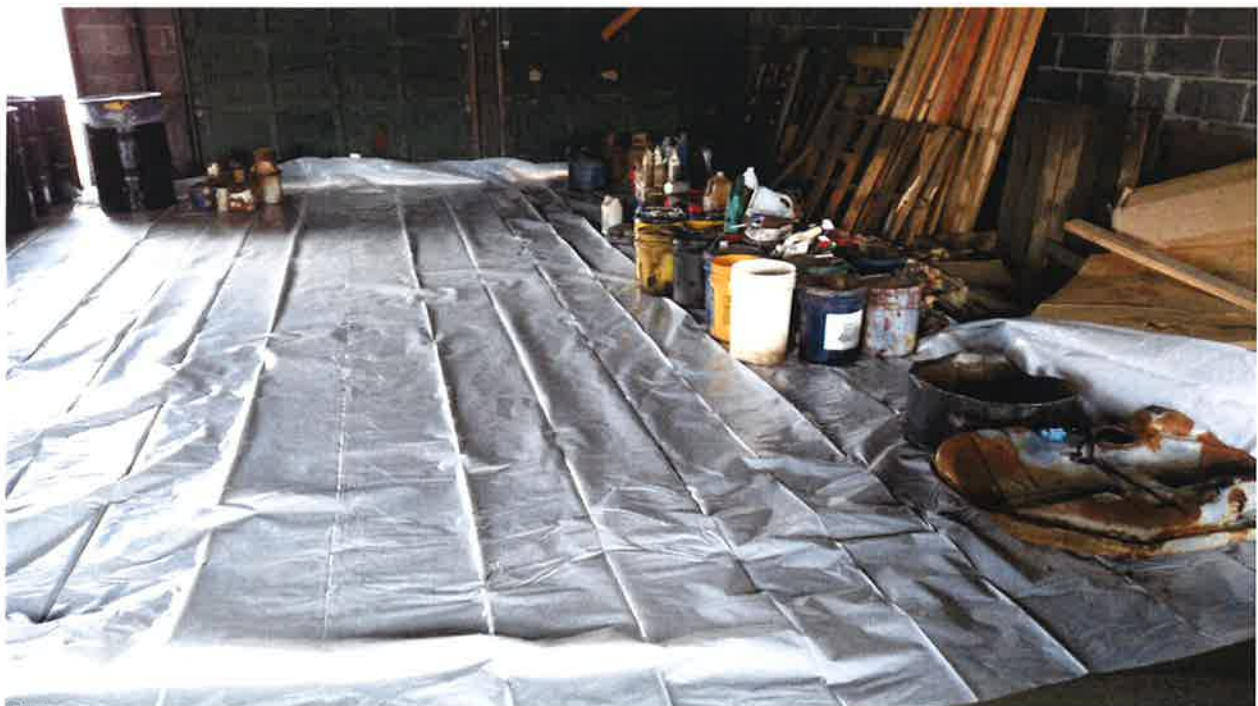
Photo 12 – Building 5 – Assorted plastic containers, propane tanks, paint cans and automotive fuel tank condensed and housed within building 5
