BROWNFIELD CLEANUP PROGRAM FINAL ENGINEERING REPORT For 432 NORTH FRANKLIN STREET SYRACUSE, NEW YORK

BCP AGREEMENT NO: B7-0615-02-06 SITE NO. C734089

FINAL ENGINEERING REPORT

432 NORTH FRANKLIN STREET, SYRACUSE, NEW YORK

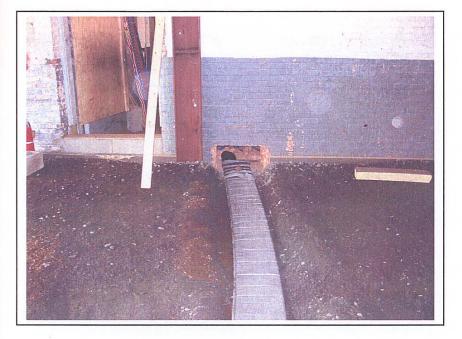
NOTES View looking North where main section enters the Three Story Building

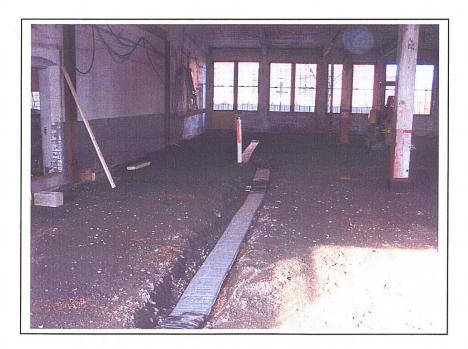
View looking west along of two laterals at south end of the Main Building

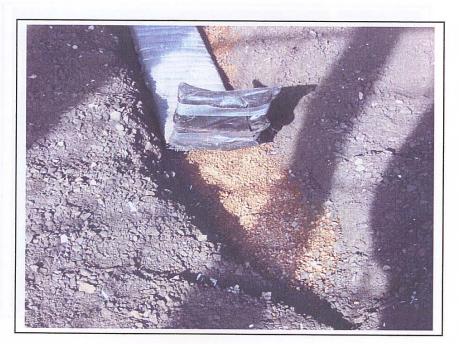
view 0.	t pea-gra	vel bene	ath vent

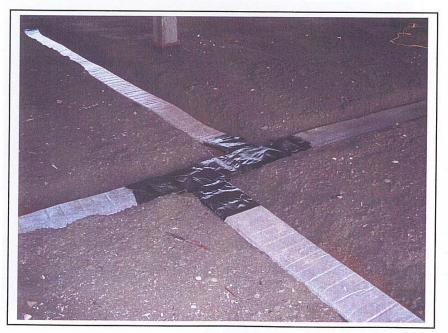
Typical joint	 	
I ypical joint

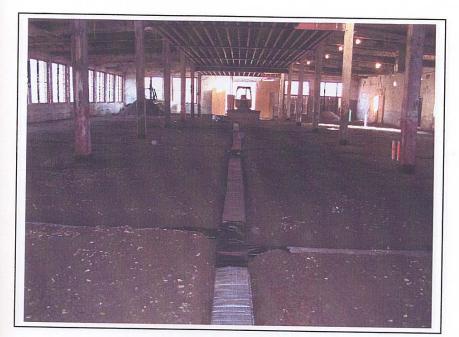
View looking north along the axis of h Main Building; Main section and	e
laterals in view

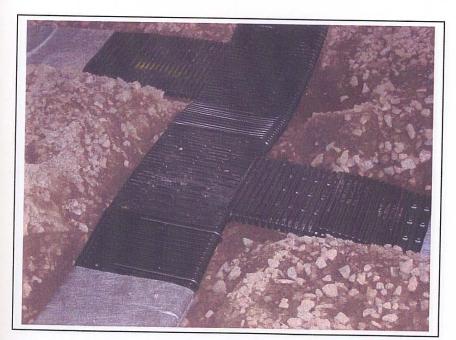
Close	up of joint	 	*********
	up of joint

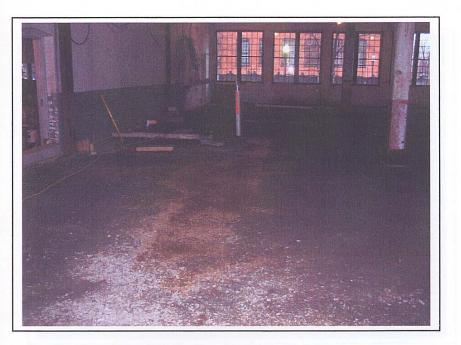
View looking west at south end of Main Building. Photo shows that the backfilling with pea-gravel is complete.

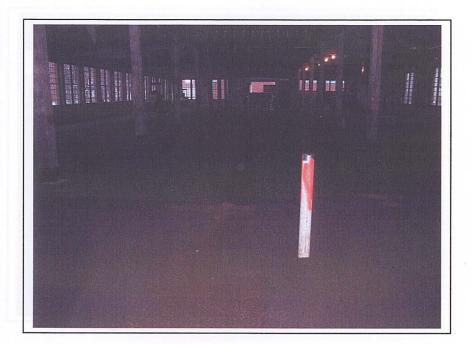
View looking north along long axis of Main Building showing the backfill with pea-gravel.

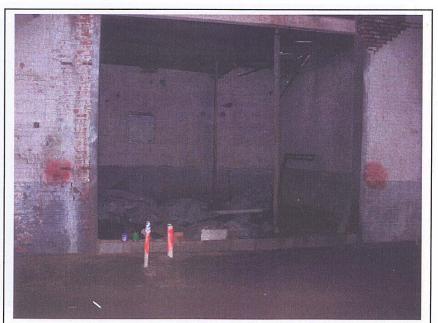
NOTES Typical floor penetration prior to emplacement of vapor barrier

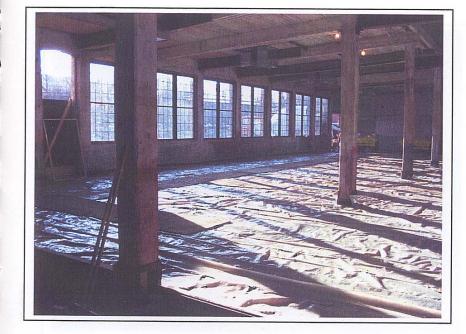
View looking southwest; vapor barrier complete with adequate overlap at penetrations

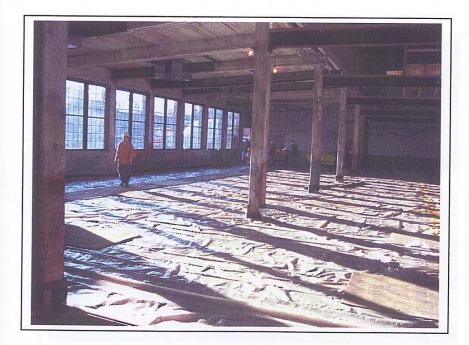
Vapor barrier complete and ready for installation of concrete; plywood decking was placed on top of vapor barrier to protect it from traffic during work.
