S&W Redevelopment

Re: Well Decommissioning Summary
Pass & Seymour (P&S) Boyd Ave Brownfield Cleanup Program
(BCP) Site No. C734102

Inventory of Old Monitoring Wells, Pass & Seymour
 16 October, 2007
 S&W Redevelopment of North America, LLC

FIGURE 1
PRE-EXISTING GROUNDWATER MONITORING
WELLS DECOMMISSIONED IN OCT 2007

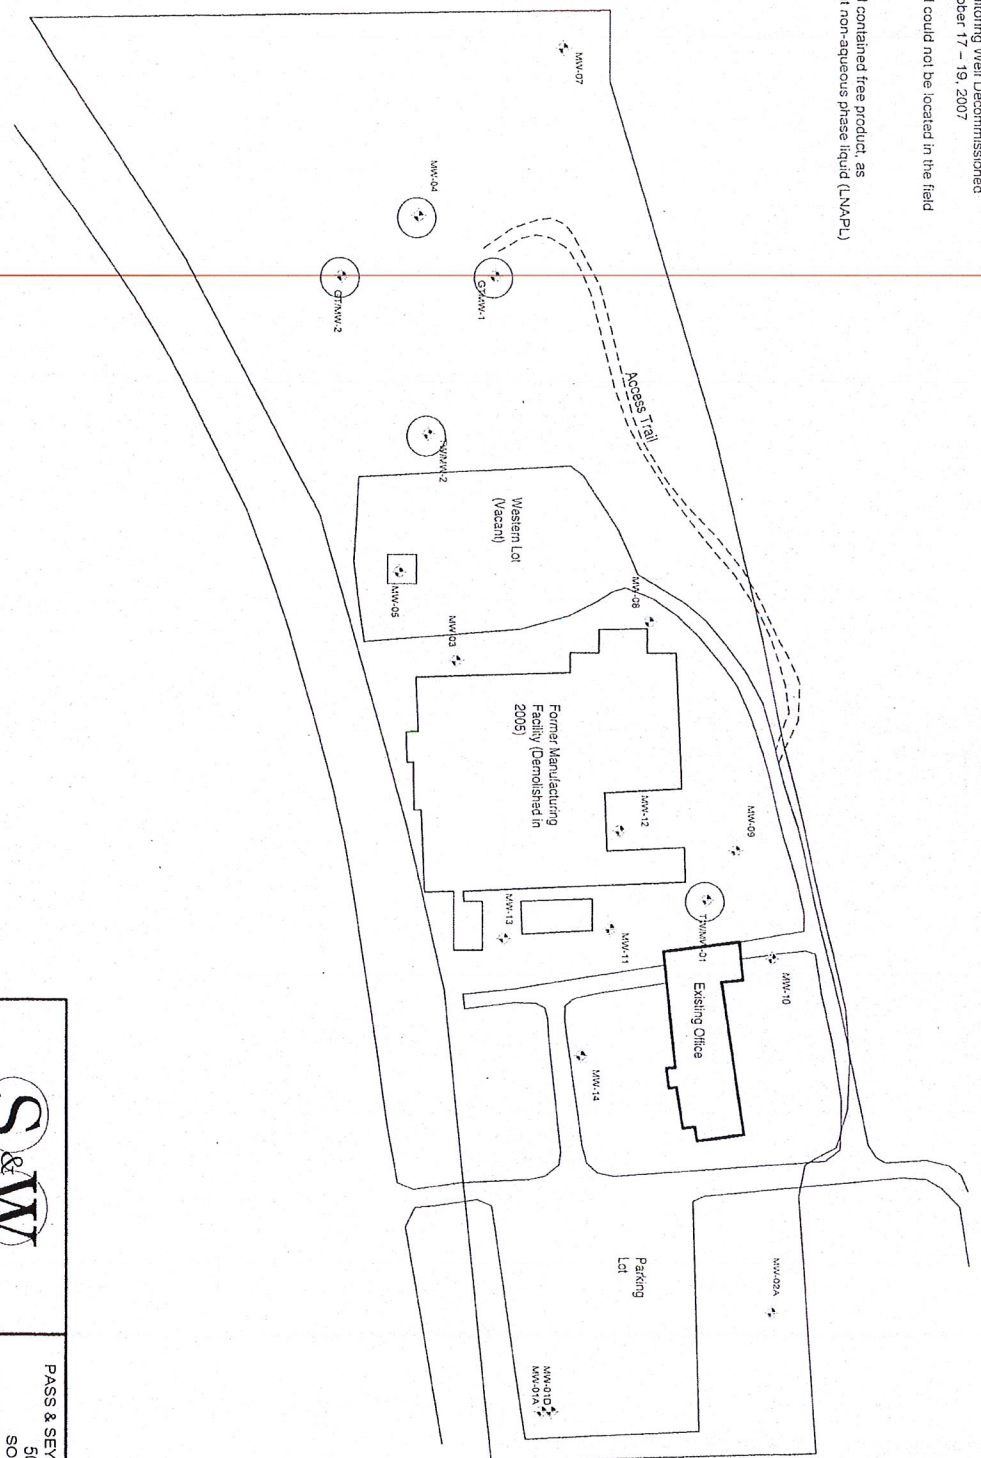
The attached table indicates that thirteen (13) pre-existing monitoring wells were located and decommissioned. Five (5) monitoring wells could not be found because they had apparently been overgrown by thick brush, or they had evidently been paved over.

Figure 1 shows the approximate locations of the decommissioned wells, as well as those that could not be located.

A dedicated bailer was lowered into each of the wells to visually examine the groundwater prior to decommissioning. There was generally no indication of subsurface contamination based on visual examination of groundwater, or direct field observation as the wells were removed, except for well MW-05. Well MW-05, in the southern portion of the western lot area, contained several inches of dark light non-aqueous phase liquid (LNAPL). The New York State Spills Hotline was called upon discovery of the LNAPL, and Spill No. 0707863 was assigned to the site. Well MW-05 was not decommissioned to enable the LNAPL to be bailed, so an assessment could be made of the amount and its recoverability. To date, periodic baling into a 55-gallon drum has collected approximately 0.8 gallon of LNAPL, and 24 gallons of groundwater.

Aside from MW-05, there was no evidence of contamination associated with the groundwater monitoring wells that were decommissioned. Groundwater contamination associated with the LNAPL in MW-05 does not appear to extend beyond the immediate vicinity of that well, based on analytical results for groundwater samples collected from neighboring RI monitoring wells in the western lot area in November 2007. RI monitoring well MW05-20, within approximately 20 feet from MW-05, contained only low levels of dissolved VOCs below groundwater standards, and no evidence of free product. RI groundwater samples collected in 2005 and 2006 contained neither VOCs nor SVOCs, which indicates the LNAPL has not caused widespread groundwater contamination. In view of the above findings, it is proposed that an IRM Work Plan be prepared to address the localized LNAPL that exists at MW-05.
