## INCIDENT REPORT

**700 Out Parcel, LLC**  
**NYSDEC Site No. C734111**  
**701-709 East Water Street**

Syracuse, New York 13202  
PSG Project Number: 21-340263  
November 21, 2022

Subject: **Incident Report**  
700 Out Parcel, LLC  
701-709 East Water Street  
Syracuse, New York 13202  
PSG Project Number: 21-340263  
NYSDEC Site Number: C734111

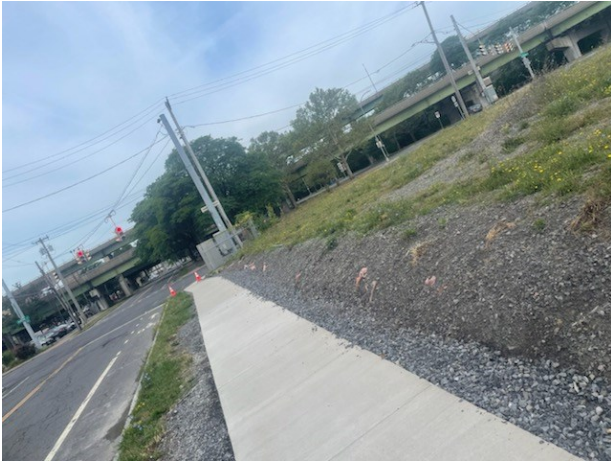
On August 18, 2022 it was brought to PSG's attention that the City of Syracuse had installed a sidewalk along the Water Street side of the site, which apparently disturbed the EC, engineered cap. The site cover (gravel cap) and demarcation layer (orange warning barrier) were damaged during sidewalk installation activities. Based on the Final Engineering report, it does not appear that shallow soil exceedances were identified in that area of the site.

**Image of the engineered cap disturbance during sidewalk installation activities.**

The City of Syracuse took responsibility for this incident. On November 2, 2022, the City of Syracuse repaired the gravel cover system, which was placed over the demarcation layer (US Fabric 65HVO ORANGE Warning Barrier). The cover material was comprised of a minimum of 12 inches of clean crusher run gravel meeting the requirements of DER-10 Section 5.5. Refer to **Appendix A** for a photo log documenting the EC disturbance and repairs.

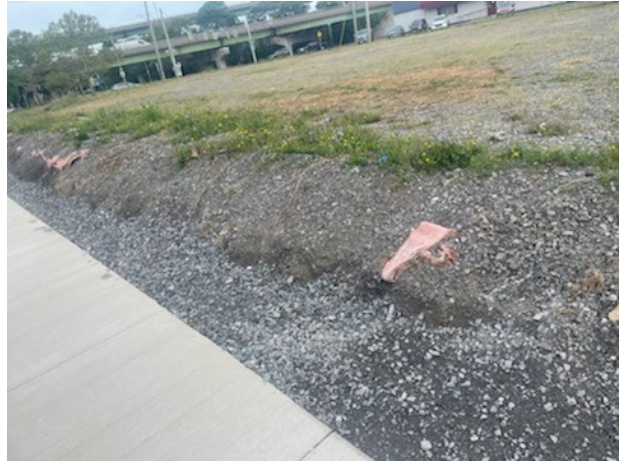
**Image of the engineered cap disturbance during sidewalk installation activities.**

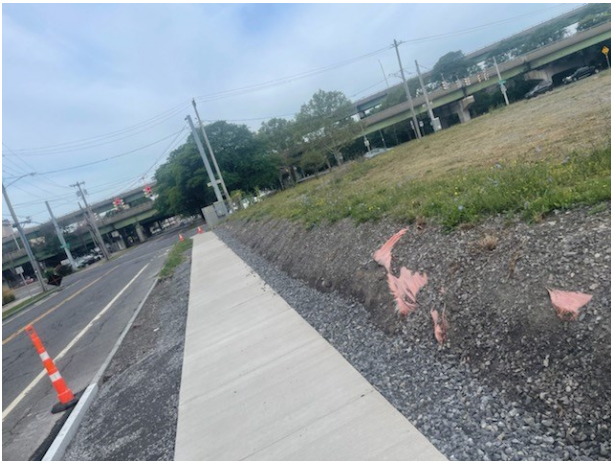
**Image of the engineered cap disturbance during sidewalk installation activities.**

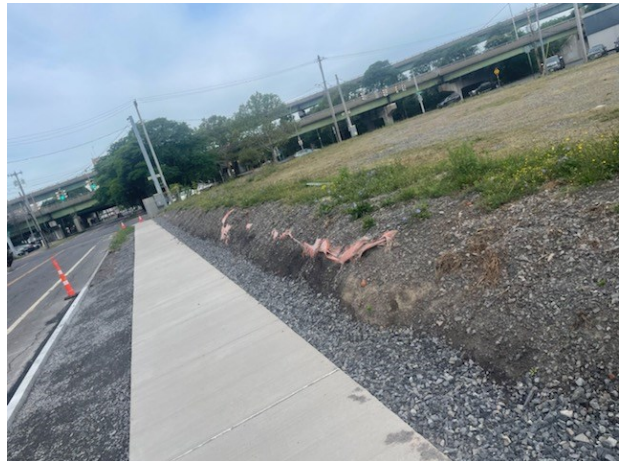
**Image of the engineered cap disturbance during sidewalk installation activities.**

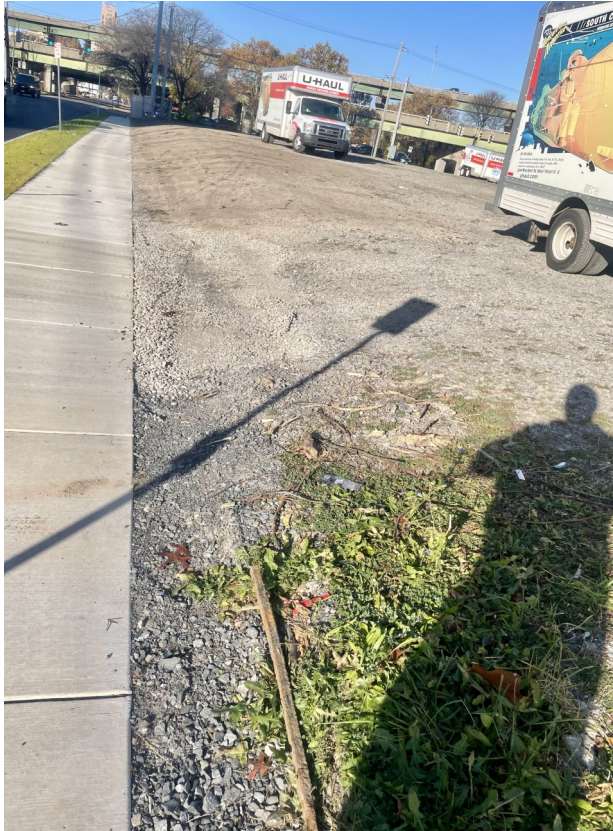
PSG reviewed the photos provided by the City of Syracuse and determined that the site cover system and demarcation layer have been repaired and remains as an effective engineering control (protective of human health and the environment).

**Image of the restored engineered cap.**

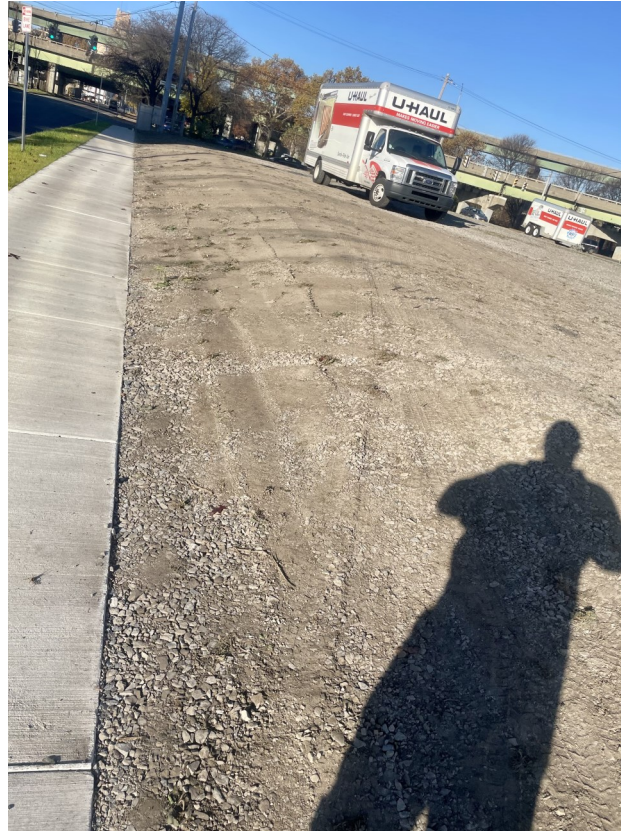
**Image of the restored engineered cap.**

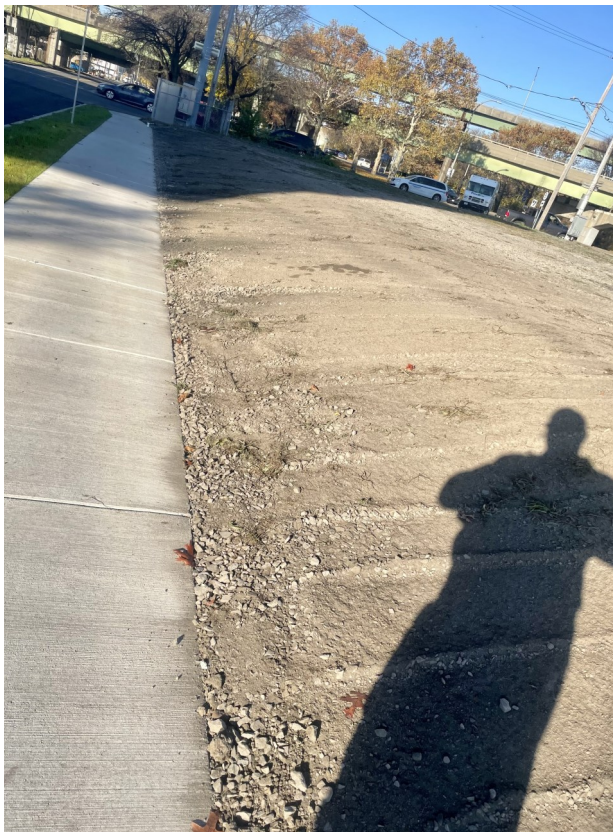
**Image of the restored engineered cap.**

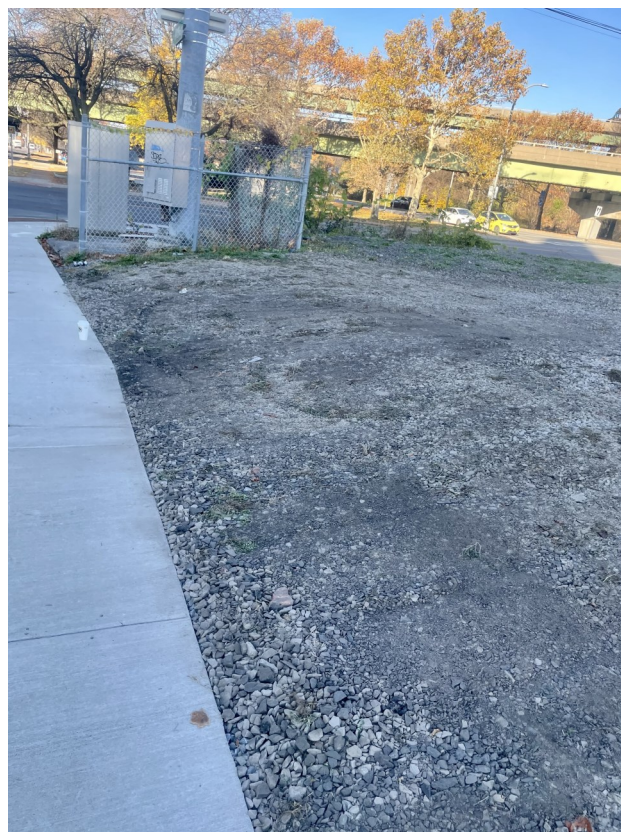
**Image of the restored engineered cap.**
