Periodic Review Report

110 Luther Avenue BCP Site (BCP Site #C734118)
March 17, 2017 to March 17, 2018 Reporting Period

Syracuse Label Company, Inc.

GHD | 1 Remington Park Drive Cazenovia New York 13035 USA
8614941 | 183 | March 30, 2018

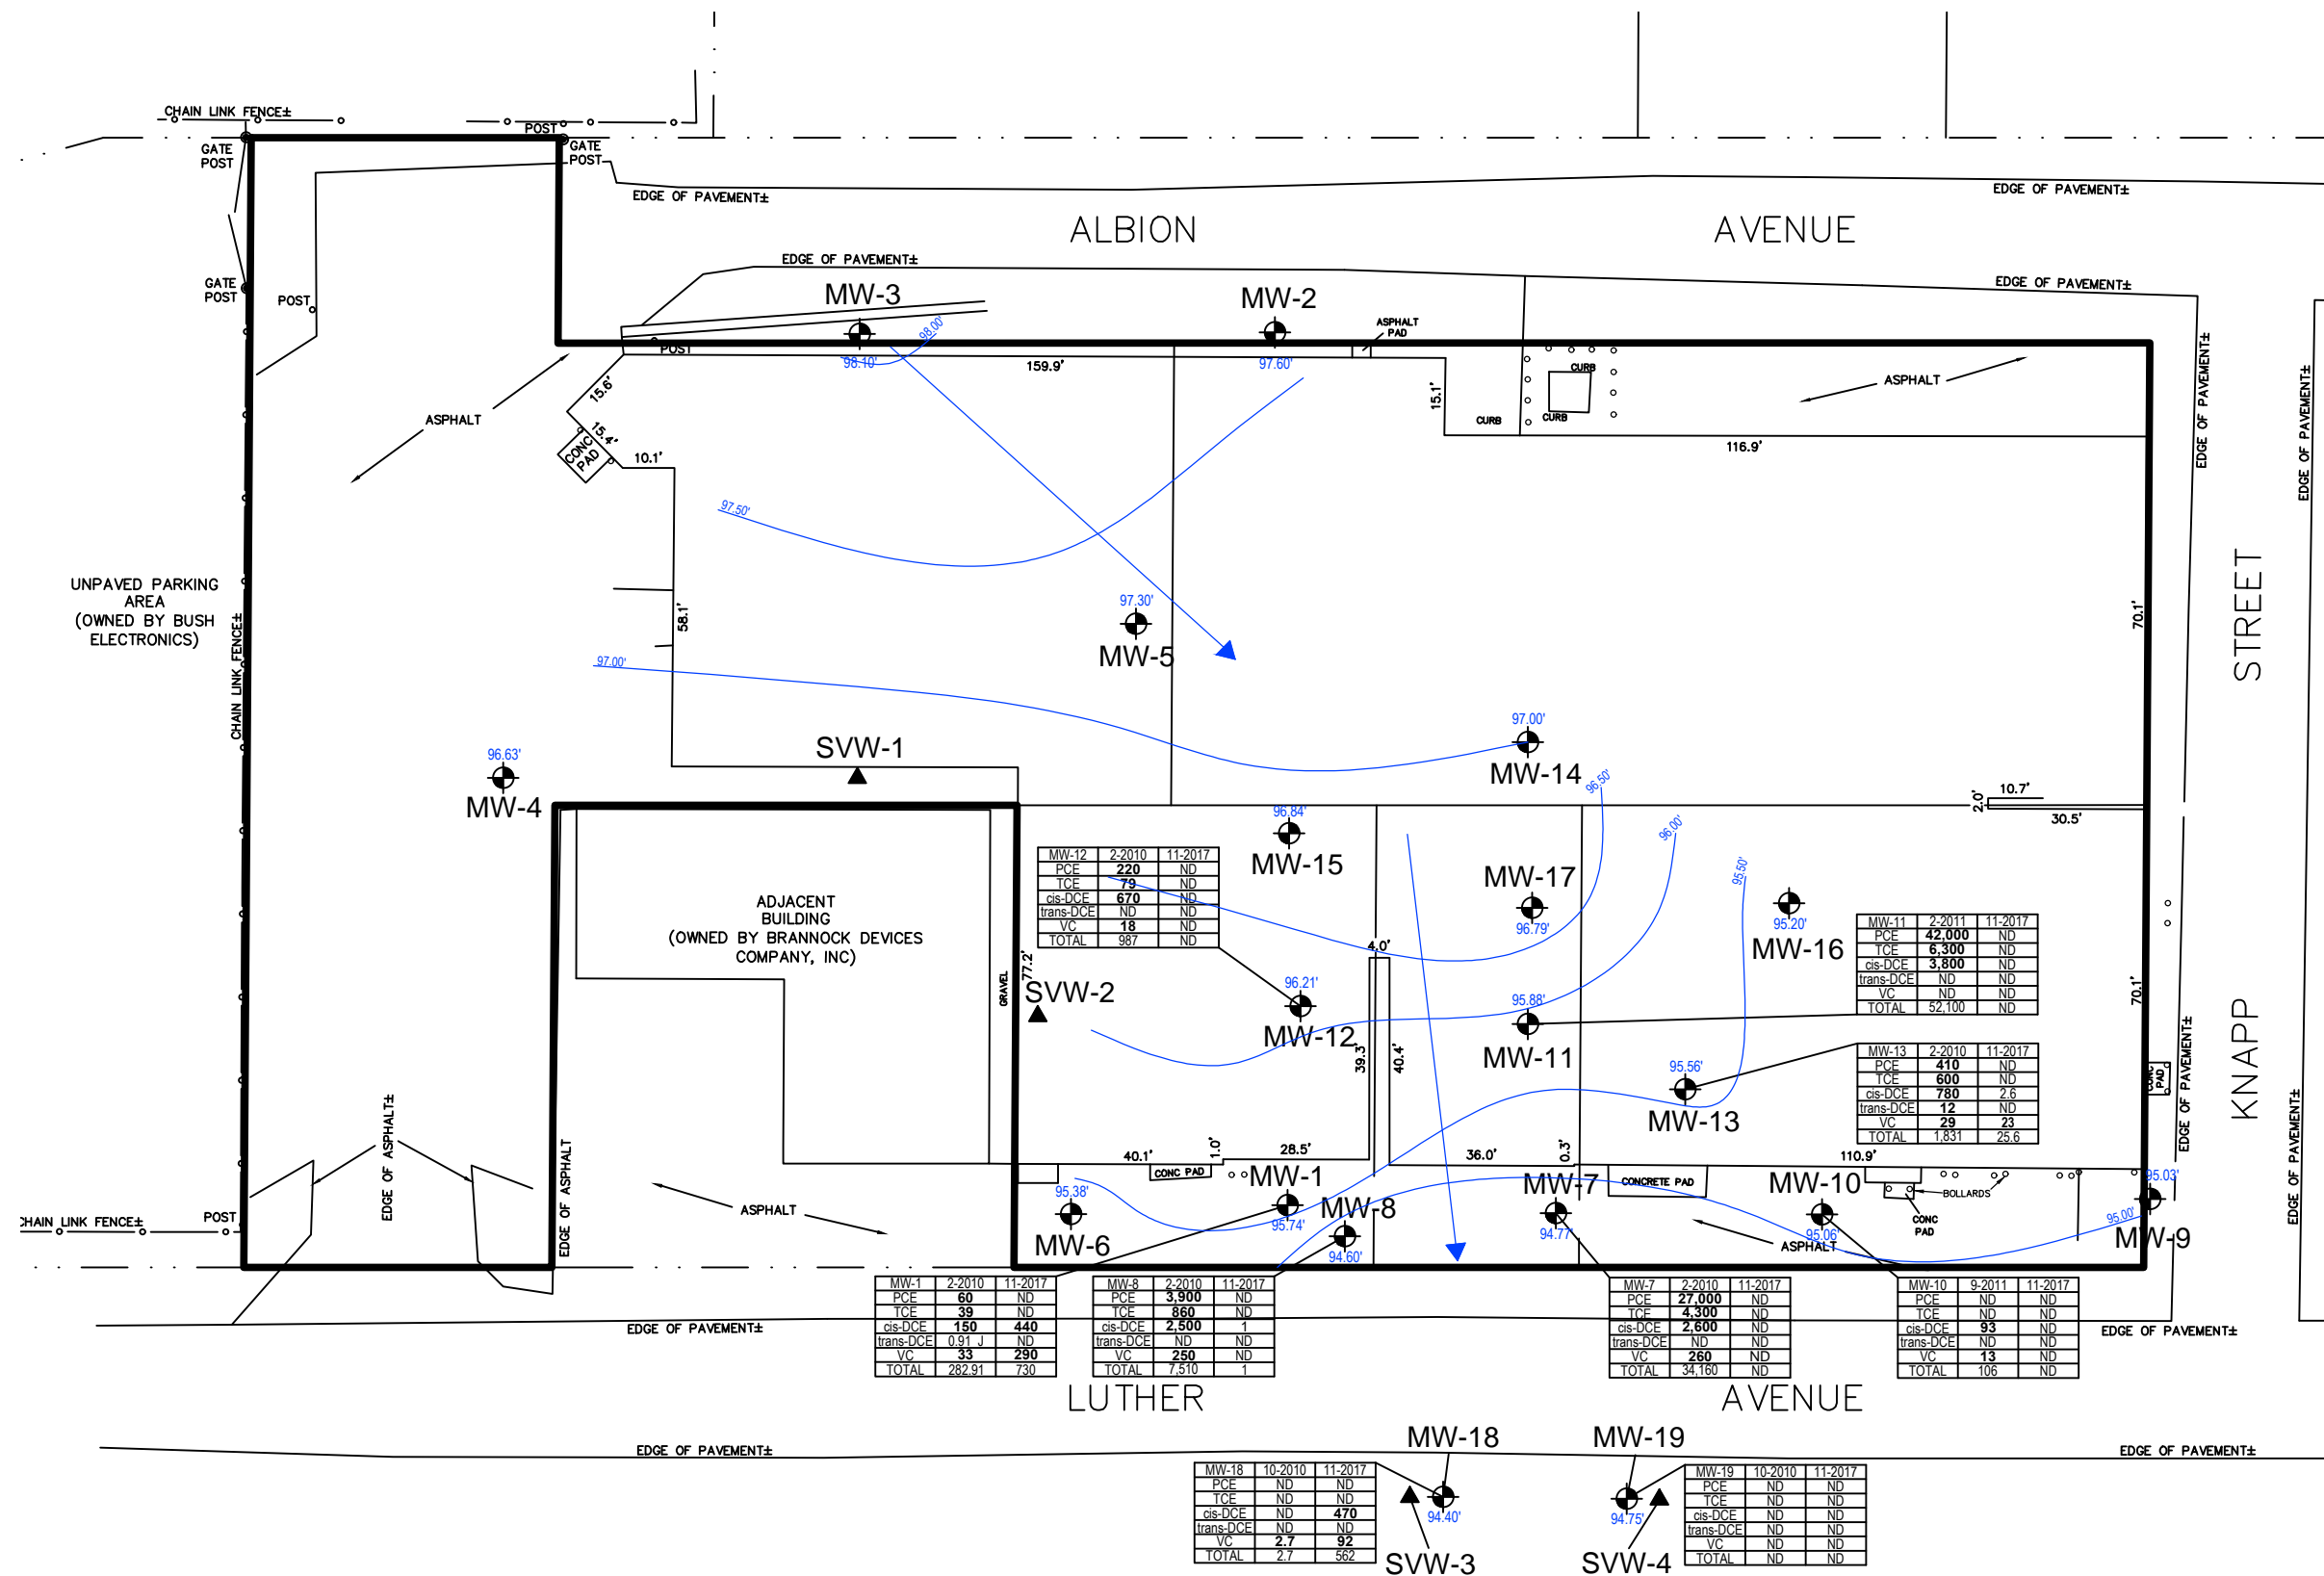
Job Number 86-14941
Revision A
Date 03.14.2018
Figure 3

The Remedial Investigation (RI), which was conducted under Brownfield Cleanup Agreement (BCA) Index #B7-0811-09-08 between December 2009 and November 2010, characterized the nature and extent of contamination at the Site. The results of the RI, as reported in the RI Report (S&W Redevelopment of North America, LLC [SWRNA], January 2011, Revised: June 2011) determined that groundwater contamination, consisting of chlorinated volatile organic solvents (tetrachloroethene, trichloroethene, and their degradation products), existed in a discrete area located in the eastern/central portion of the Site (Figure 3).

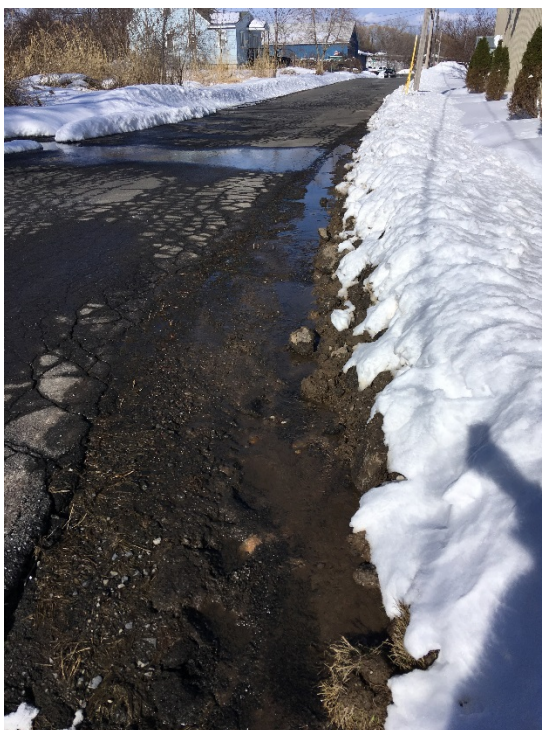
During the Site visit on March 15, 2018, snow cover limited direct observation of the ground surface across portions of the Site, however, there was no reported removal or breach of the soil cover system during this certification period. An isolated area near the southwestern corner of the building was observed to have some rutting due to snow removal. This area will need to be

Photo 1 - View of isolated soil cover system damage near southwestern corner of building.

regraded and reseed in the spring, when conditions are favorable. Documentation of the repairs will be included in the next PRR.

The isolated area of rutting observed near the southwestern corner of the building should be regraded and reseeded in the spring, when weather conditions are favorable. Periodic (i.e., monthly) Site inspections should be continued to assess the proper functioning of the SSDS and that the soil cover engineering controls are in place and functioning as intended. The ICs should be evaluated in accordance with the revised-SMP, at a minimum annually at the time the next PRR is completed in 2019.

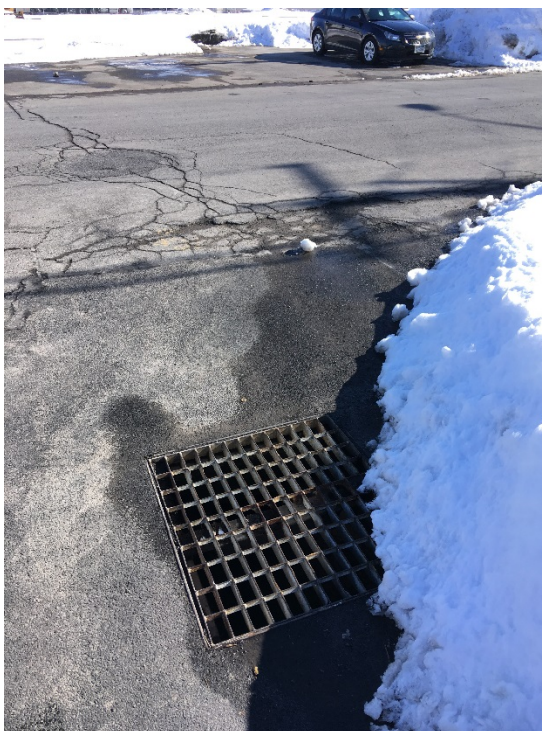
During the Site visit on March 24, 2017, for the prior year's certification period, an area adjacent to the stormwater catch basin at the corner of Luther Avenue and Knapp Street was found to have some localized subsidence. Based on the current Site visit on March 15, 2018 the catch basin was replaced and the surrounding area repaired with new asphalt paving. The work was performed adjacent to the Site by others, but the work did not appear to extend on-Site and therefore does not constitute a breach of the soil cover system.

Photo 2 - View of apparently replaced catch basin near corner of Luther Avenue and Knapp Street (adjacent to, but off, the BCP Site).

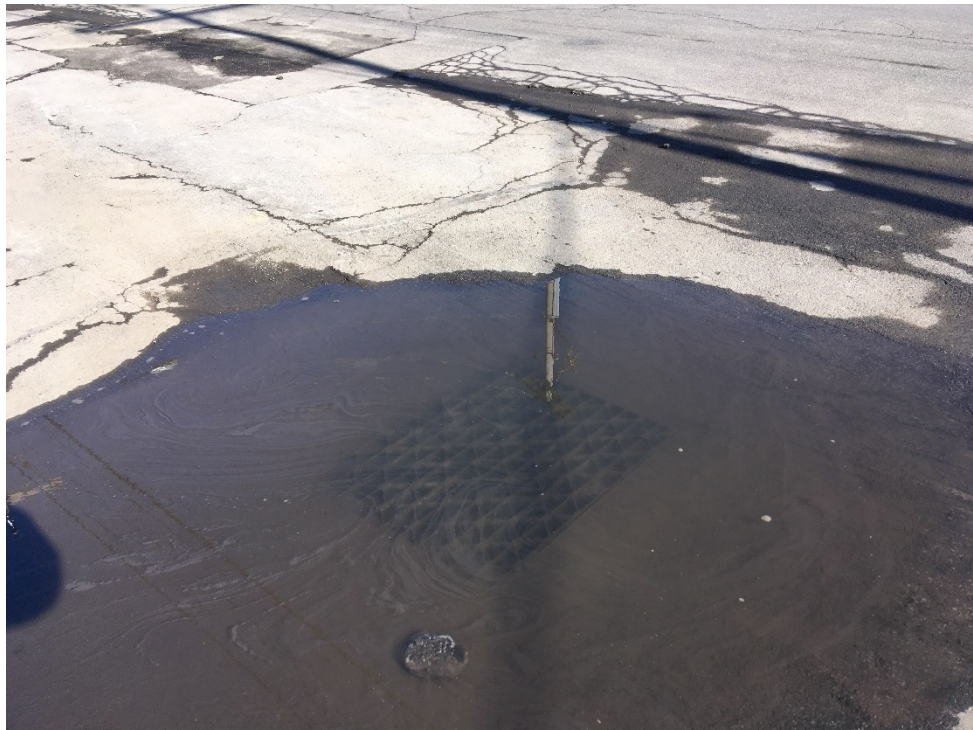
During the March 15, 2018 Site visit the stormwater catch basin adjacent to Luther Avenue, approximately midpoint of the paved parking area along the buildings, was observed to have ponding water and no apparent appreciable flow. It is presumed the catch basin is filled with sediment and not draining properly.

Photo 3 - View of ponded water at catch basin along Luther Avenue.

Finally, it is recommended that the Town of Salina be contacted to clean the stormwater catch basin adjacent to the Luther Avenue right-of-way to remedy the localized ponding of stormwater.
