# **Periodic Review Report**

**110 Luther Avenue BCP Site (#C734118)  
March 17, 2020 to March 17, 2021  
Reporting Period**

Syracuse Label Company Inc.

April 15, 2021

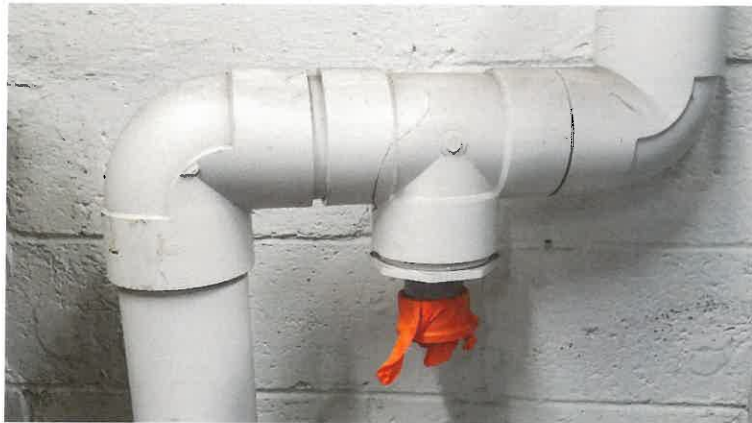
While checking gauges this month it was observed that the drain valve was not connected to the PVC pipe. As a quick fix to get the system back up and running I used a rubber glove and part of the original valve. This entire section will have to be replaced in the near future due to a crack as seen in the picture.

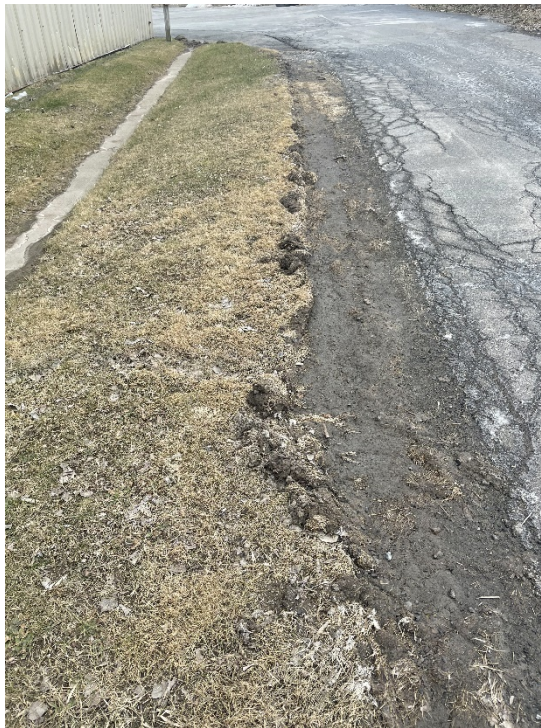
Photo 1 - View of minor soil rutting near western corner of building along Albion Avenue (not on the BCP Site). Recommended to be repaired when weather conditions allow.

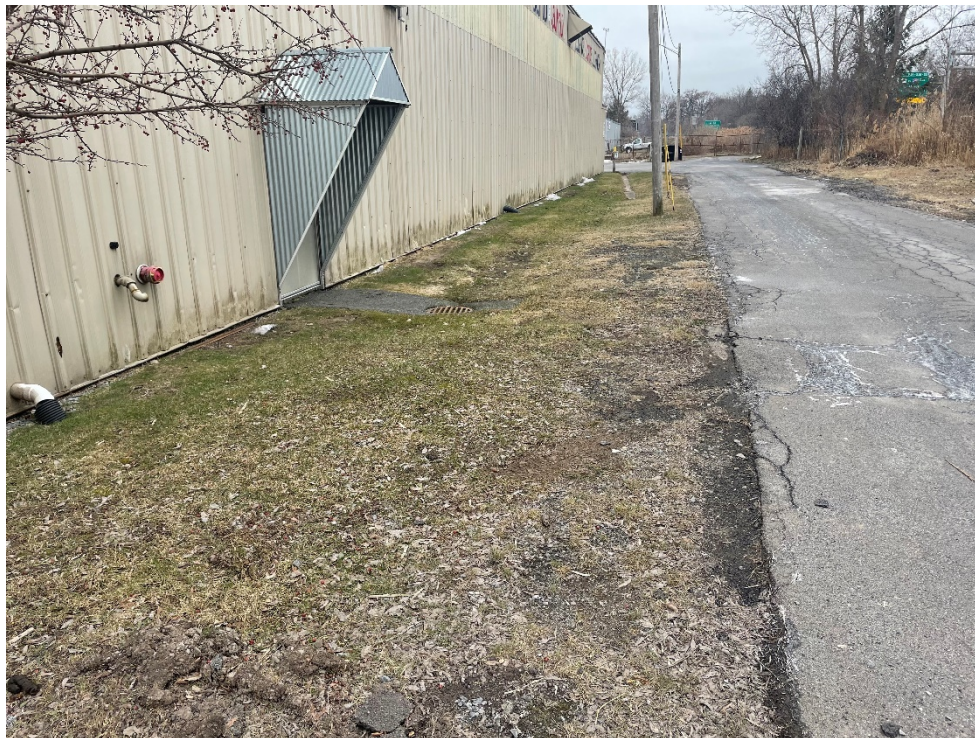
Photo 2 - View of minor soil rutting along Albion Avenue (not on the BCP Site). Recommended to be repaired when weather conditions allow.

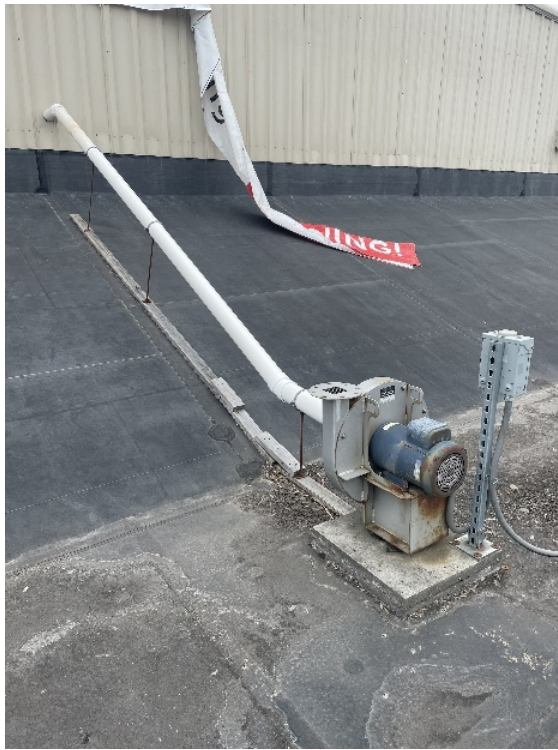
Photo 9 - View of Fan 1 and pipe supports. Recommended repairs were made by Box Capital in April 2020.

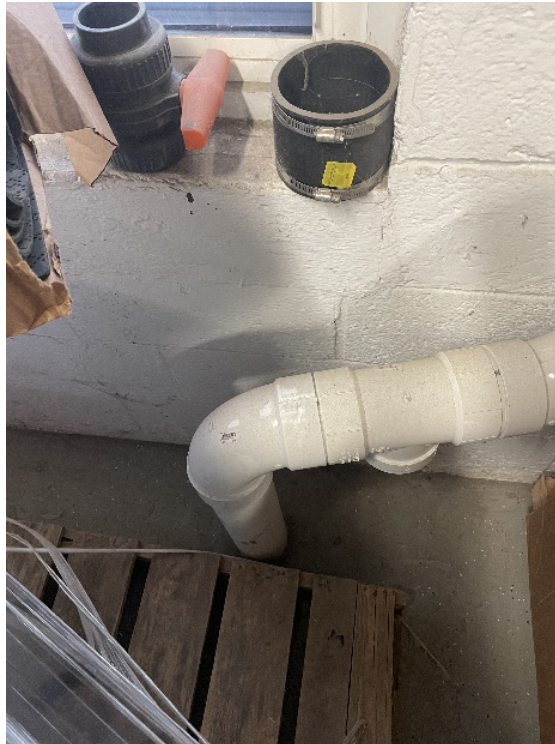
Photo 10 - View of repaired "T" fitting on SSDS suction riser S-14, leading to Fan 2. Recommended repairs were completed by Box Capital in April 2020.

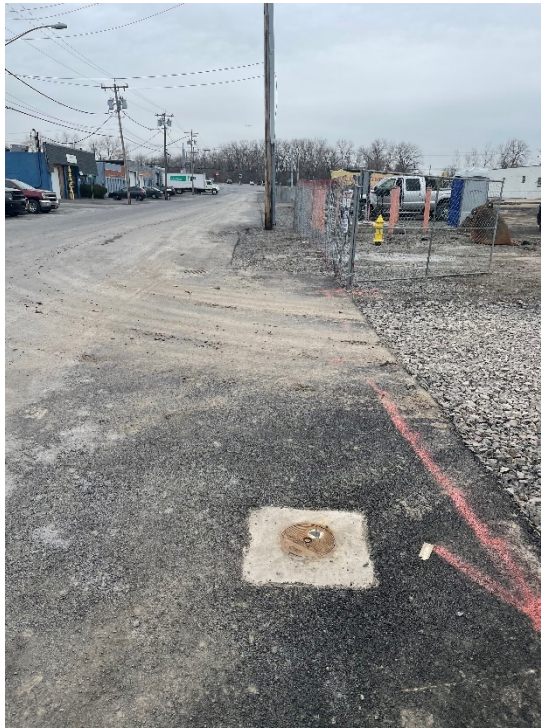
Photo 15 - View of repaired MW-18, off-site in the Luther Avenue right-of-way.

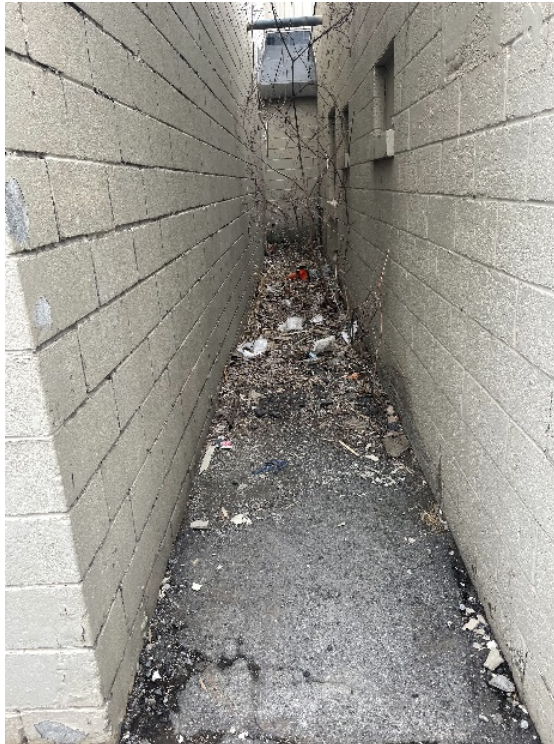
Photo 16 - View of trees in alleyway between building sections along Luther Avenue.  
Recommend trees be removed for integrity of soil cover engineering control.

1. Protection (i.e., bollards or cones) should be added around SSDS suction risers S-14 and S-11 to provide a level of protection against material storage and moving equipment.
2. The trees in the alleyway between building sections along Luther Avenue should be removed to ensure long-term integrity of the soil cover system in that portion of the Site.
3. The surface cracks in the concrete slab located in the main warehouse portion of the building should be repaired and/or sealed to ensure long-term effectiveness of the engineering control and to prevent potential short-circuiting of the SSDS installed in this portion of the building.

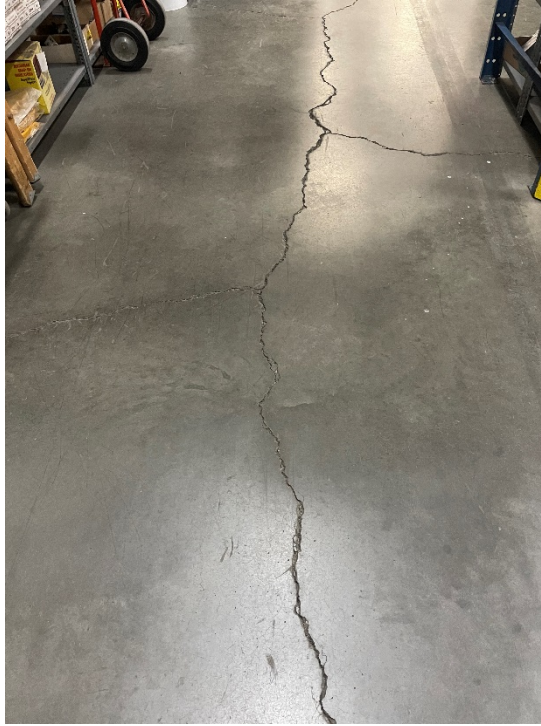
Photo 17 - View of surface cracks in interior concrete floor slab located in main warehouse portion of building. Recommended to be repaired or sealed for integrity of soil cover engineering control and/or to prevent potential short-circuiting of the SSDS in this portion of the building.
