Periodic Review Report

**110 Luther Avenue BCP Site (#C734118)
March 17, 2021 to March 17, 2022
Reporting Period**

Syracuse Label Company Inc.

April 29, 2022

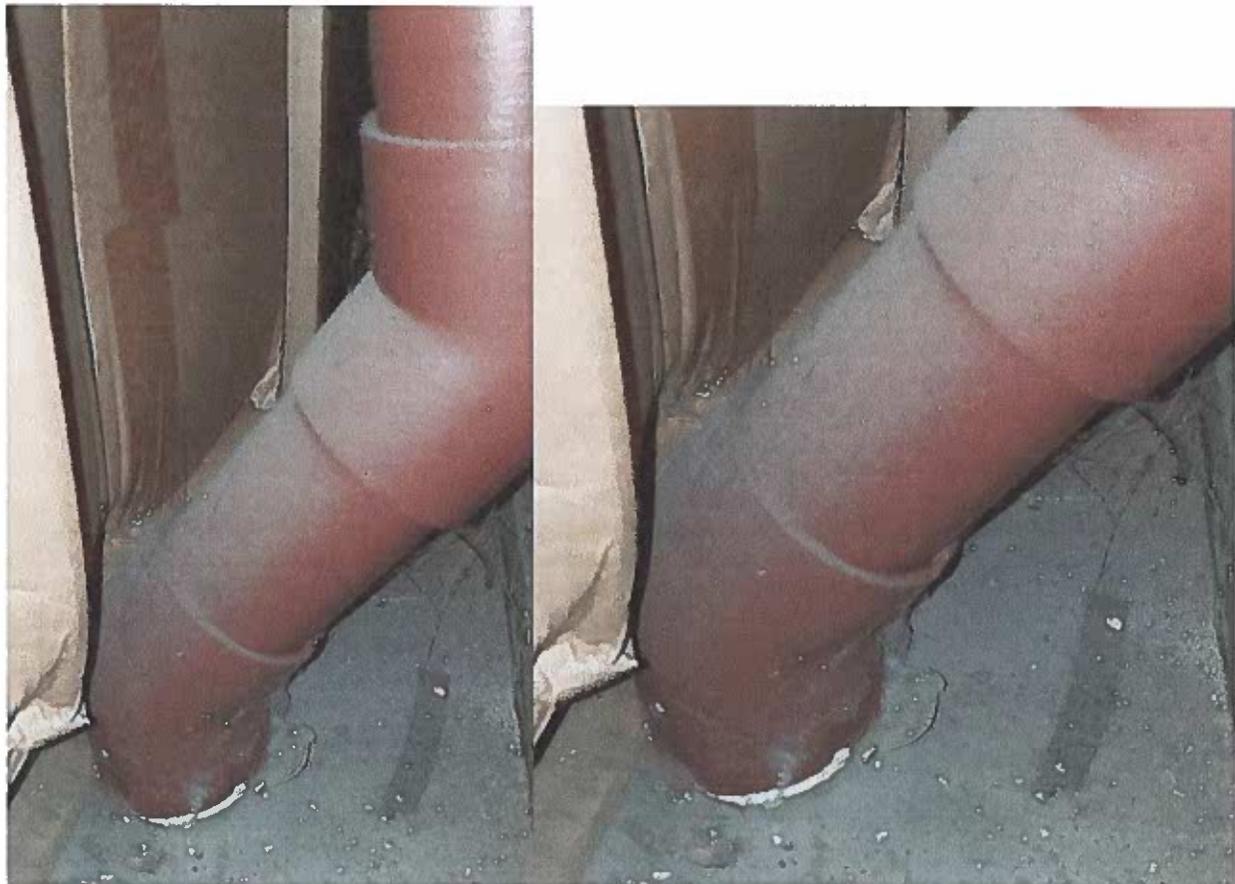
While checking pressure readings for the month of September it was observed that the floor penetration S-11 was sheared off from a pallet running into it. See images below. The opening in the floor is covered by the pallet and you can see the white ring of broken PVC at the bottom of the pipe.

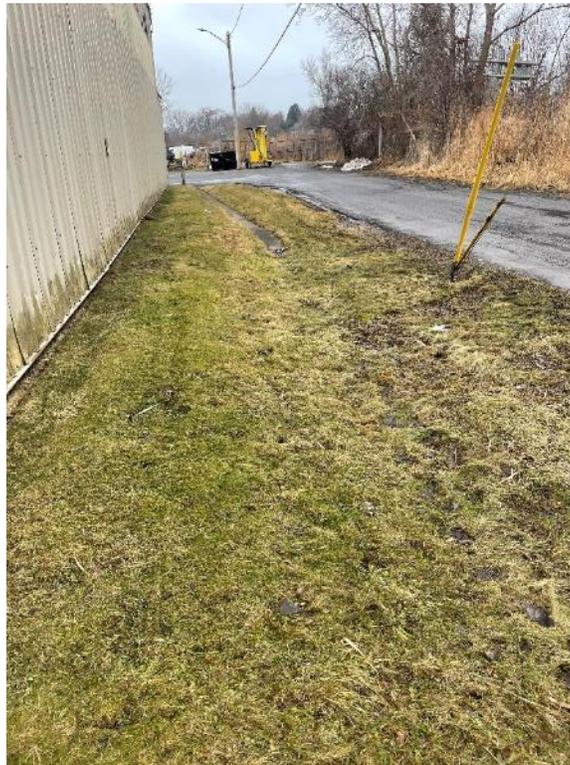
Photo 01 - View of minor soil rutting near western corner of building along Albion Avenue (not on the BCP Site). Recommended to be repaired when weather conditions allow.

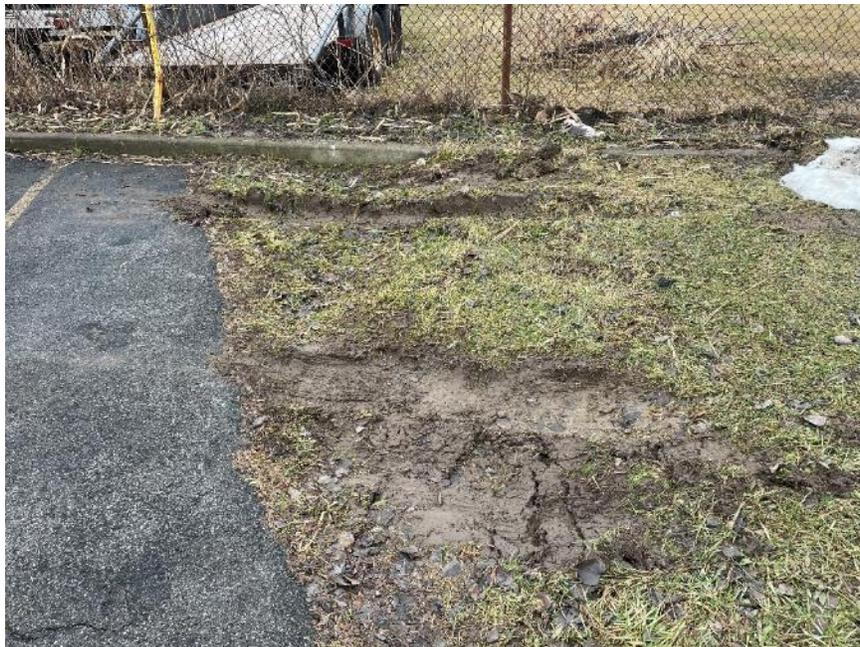
Photo 02 - View of minor soil rutting on the southwest side of the Site near end of Albion Avenue. Recommended to be repaired when weather conditions allow.

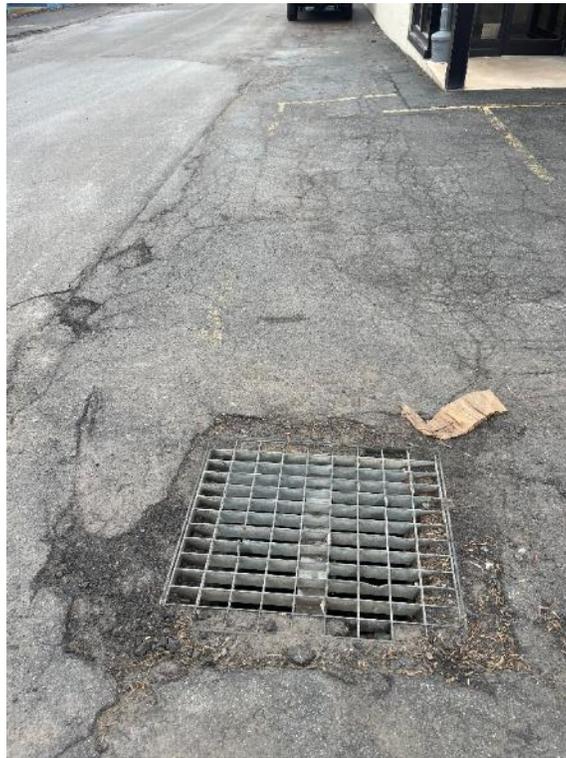
Photo 07 – View of cracked and deteriorated asphalt pavement around stormwater catch basin near Knapp Street and Albion Avenue intersection.

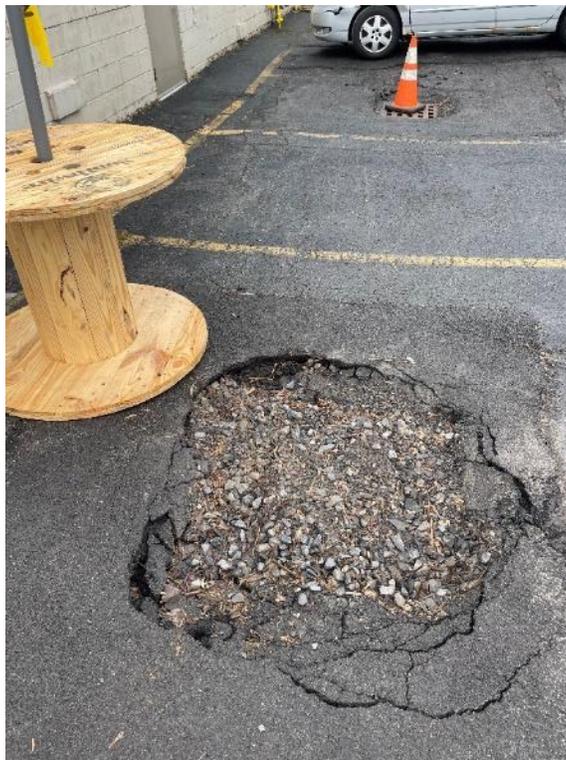
Photo 08 – View of area of subsidence in asphalt pavement on northern side of Site building.

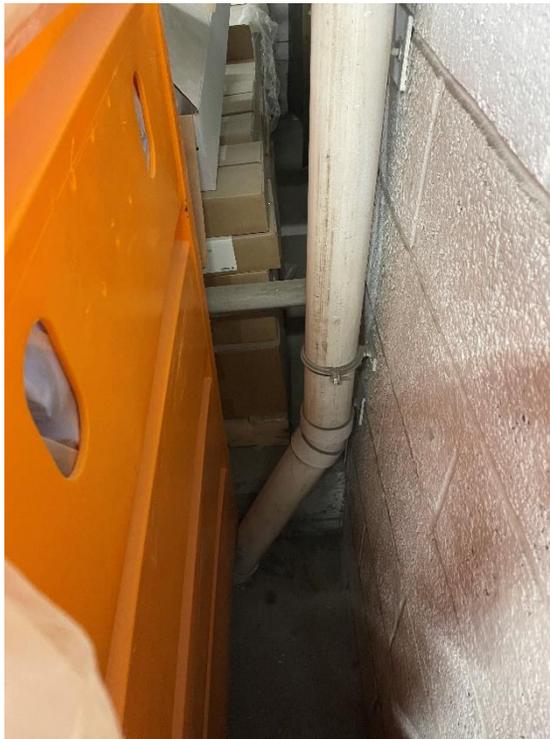
Photo 13 – View of SSDS riser at suction point #8, bollard installation recommended for protection.

GHD's recommendation for the 2020/2021 reporting period to protect SSDS suction riser S-14 via bollard installation was not executed; this recommendation was restated in the March 16, 2022 Site inspection report. In addition, the inspection report noted that riser S-8 should also have bollards installed for protection from potential damage.

S-14 Recommend bollards to protect riser.
S-8 Recommend bollards to protect riser

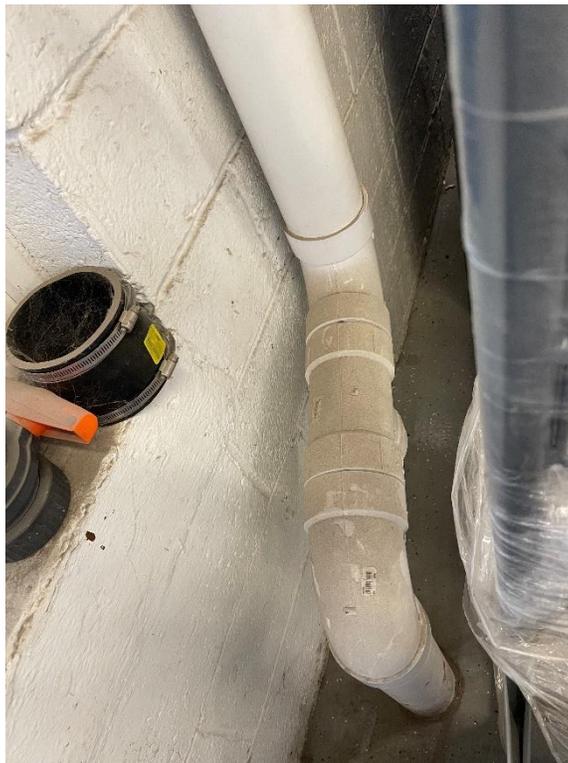
Photo 14 – View of SSDS riser at suction point #14, bollard installation recommended for protection.

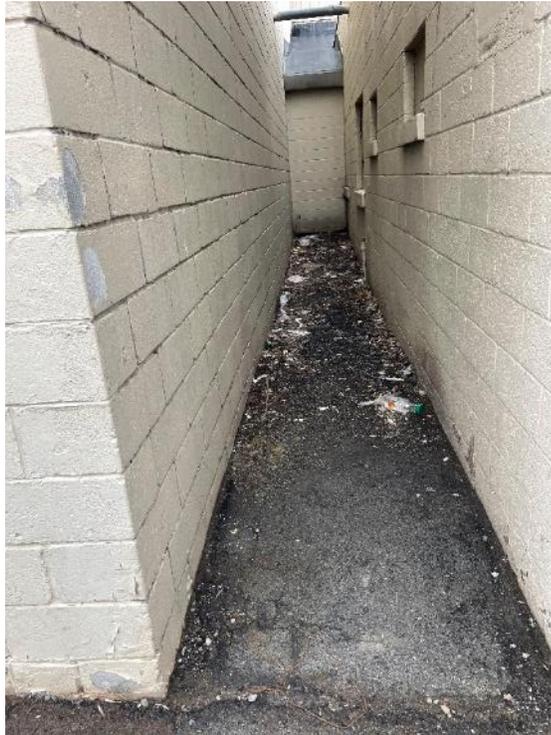
Photo 16 – View of alleyway between building sections along Luther Avenue with previous vegetation removed.

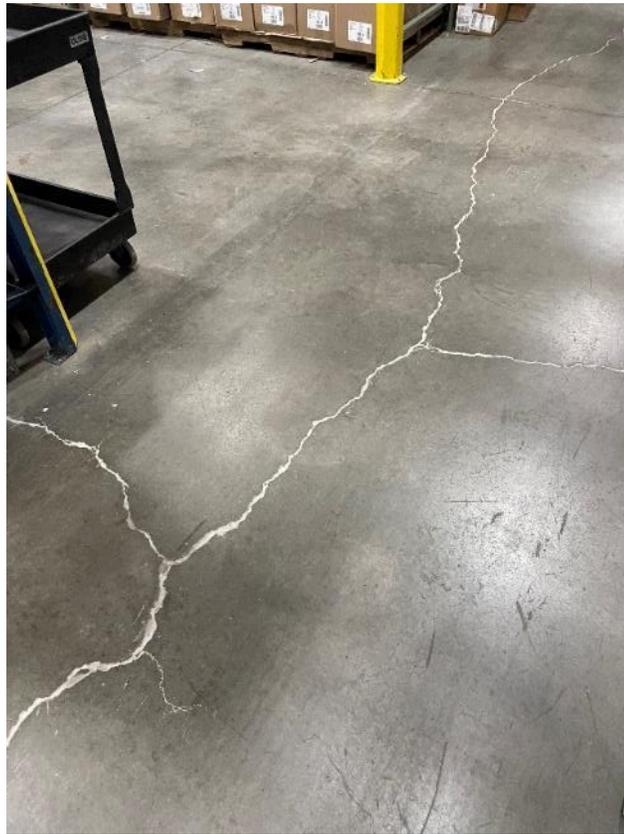
Photo 17 – View of sealed surface cracks in interior concrete floor slab located in main warehouse portion of building.

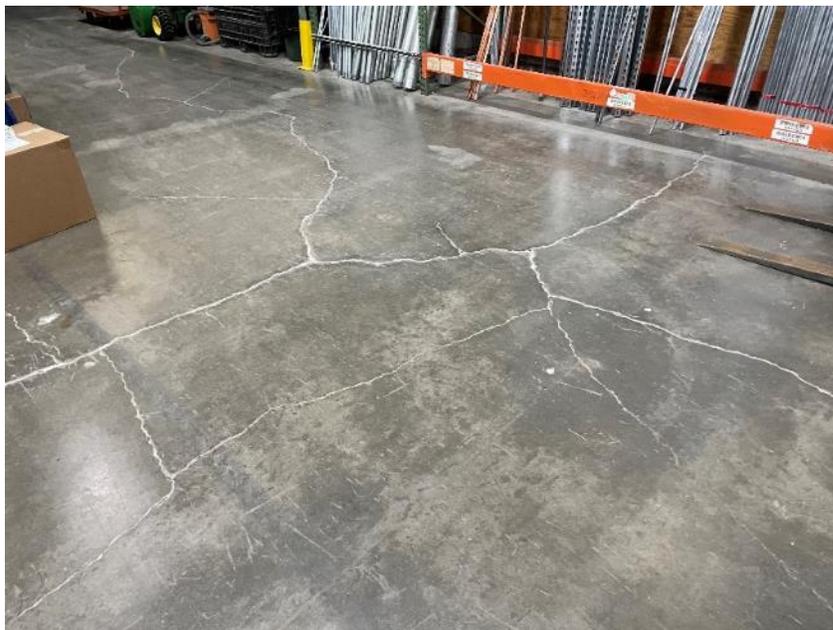
Photo 18 – View of sealed surface cracks in interior concrete floor slab located in main warehouse portion of building.

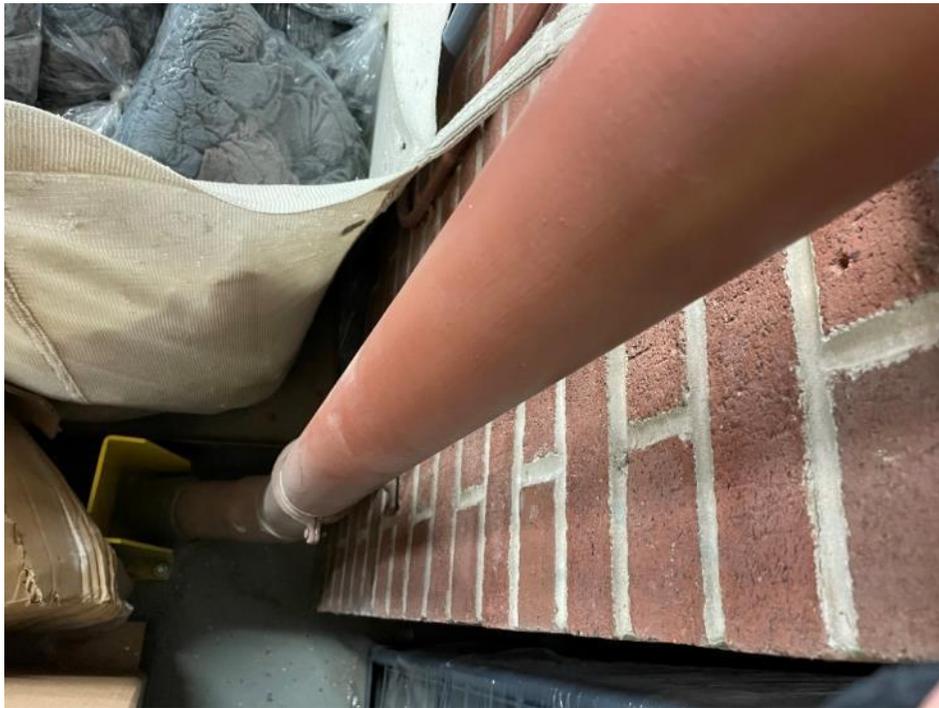
Photo 19 – View of bollard installed at S-11 to protect the suction riser from impact damage.

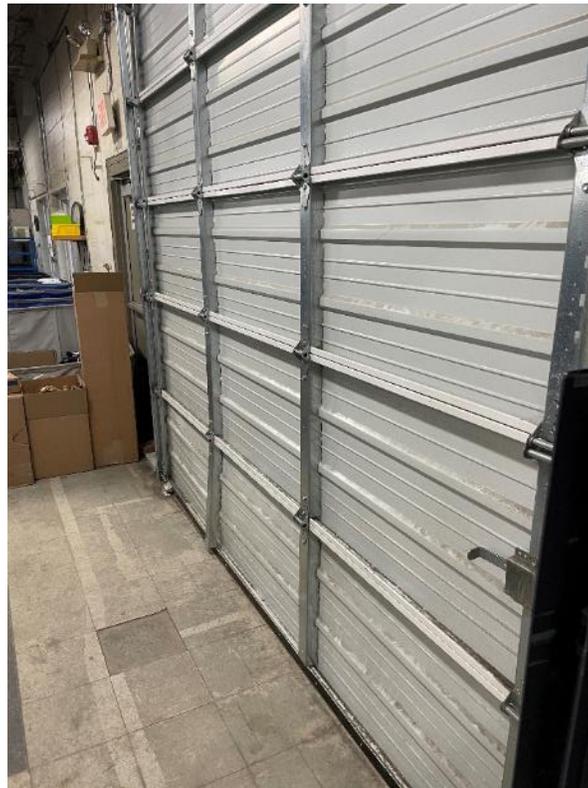
Photo 20 – View of new overhead door on Luther Ave side of the building which provides improved seal.
