# **Periodic Review Report**

**110 Luther Avenue BCP Site (#C734118)  
March 17, 2023 to March 17, 2024  
Reporting Period**

Syracuse Label Company Inc.

July 22, 2024

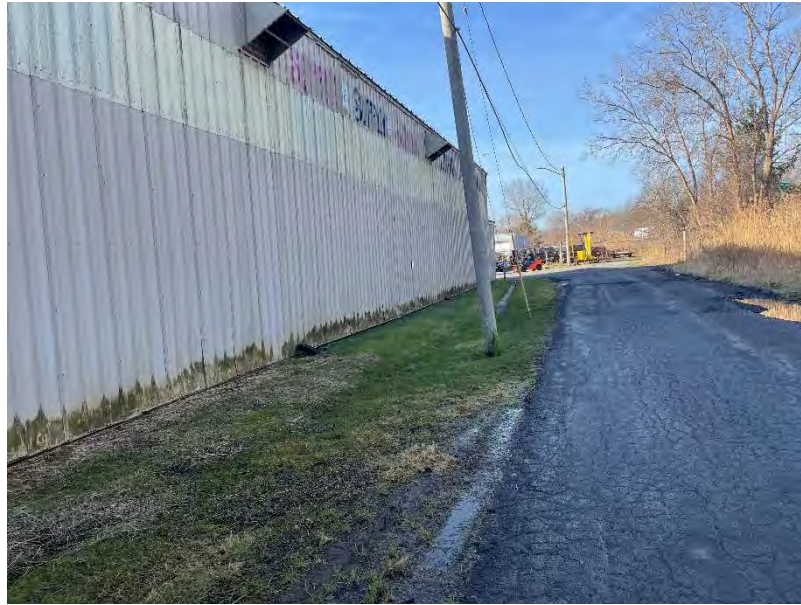
*Photo 1 View looking southwest of grass and pavement areas located at northwest side of building.*

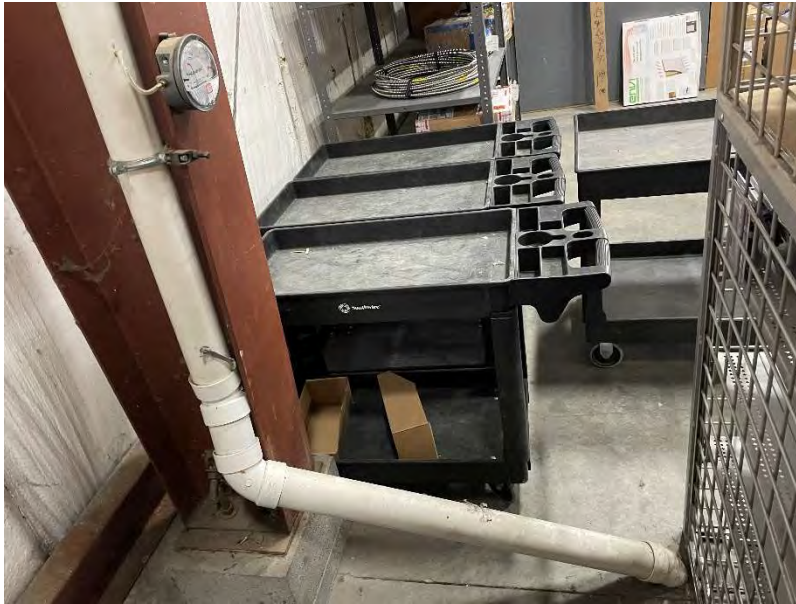
**Photo 3** Typical view of riser with magnehelic gauge in warehouse area.

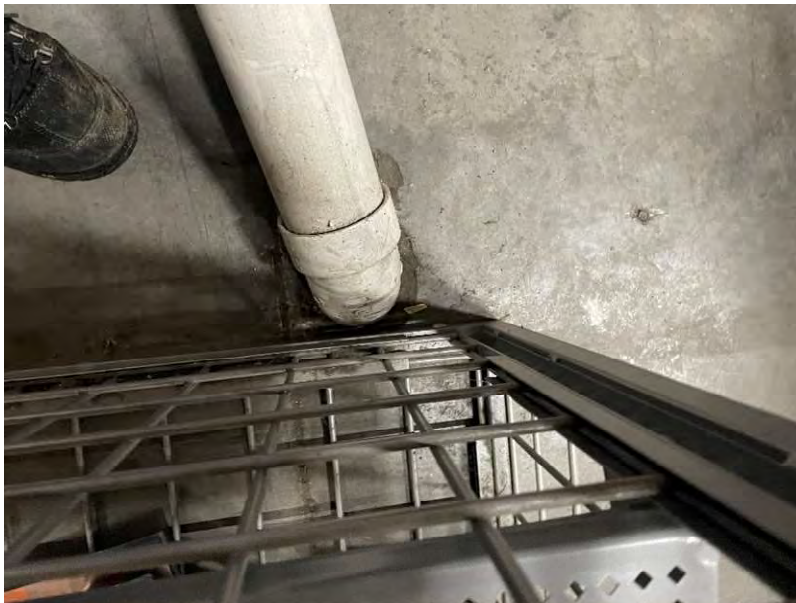
**Photo 4** Typical view of riser connection with floor slab.

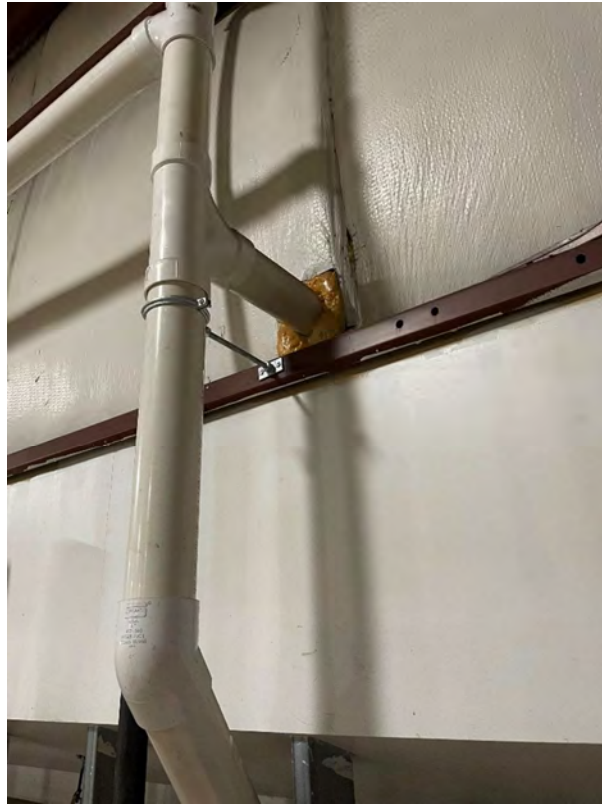
**Photo 5** Typical view of riser wall penetration to exterior roof mounted fan.

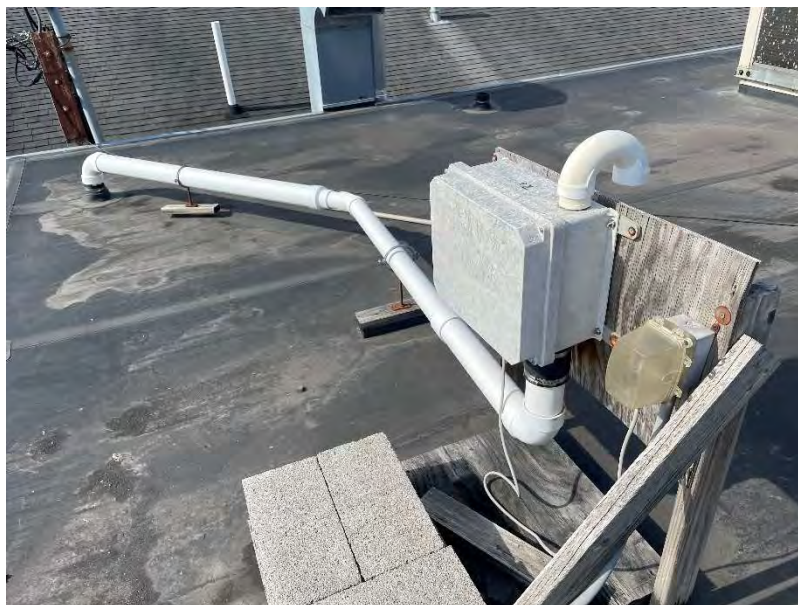
**Photo 6** Typical view of header pipe and exhaust fan located on the roof.

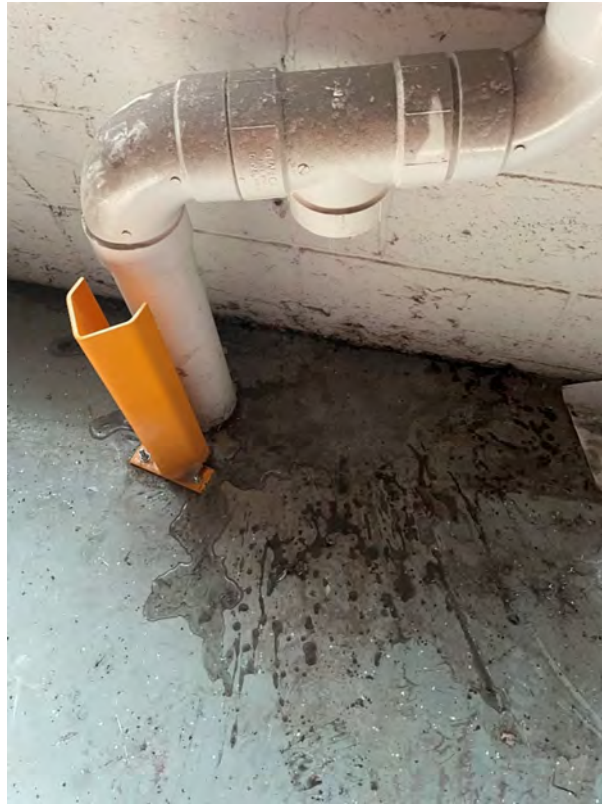
**Photo 7** *View of riser piping showing bollard and potential leak at knockout from condensation or water intrusion into exhaust fan.*

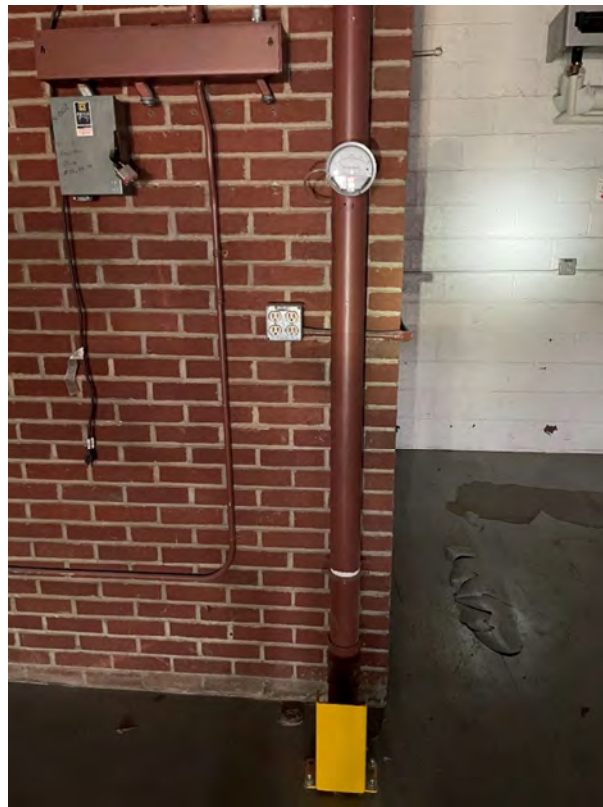
*Photo 9 Typical view of riser piping with bollard and magnehelic gauge.*
