Our ref: 12670317

August 06, 2025

**Re: 110 Luther Avenue BCP Site (Site #C734118), 2024 – 2025 Annual Groundwater Monitoring, SSDS Inspection, and Site Inspection Report**

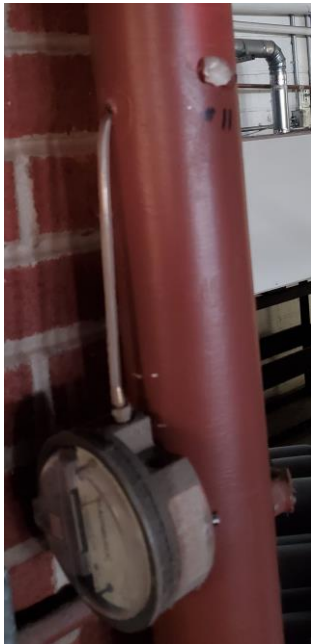
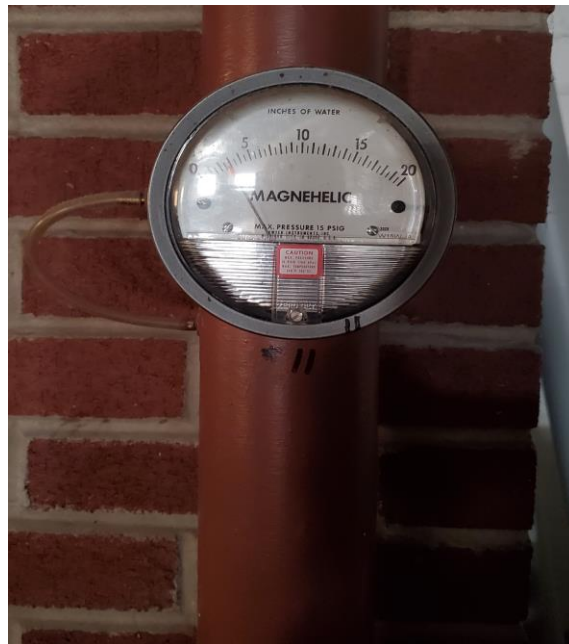
**Remount manometer on S-11 riser.**

# 11 IS FUNCTIONAL, BUT THE MOUNTING TAB IS BROKEN & THE GAGE IS HANGING. WILL RETURN SHORTLY TO FIX.

While checking pressure readings for the third quarter of 2024 it was observed that the gage at S-11 was hanging from its connection tube. See images below. The mounting tab had broken and needed replacement.

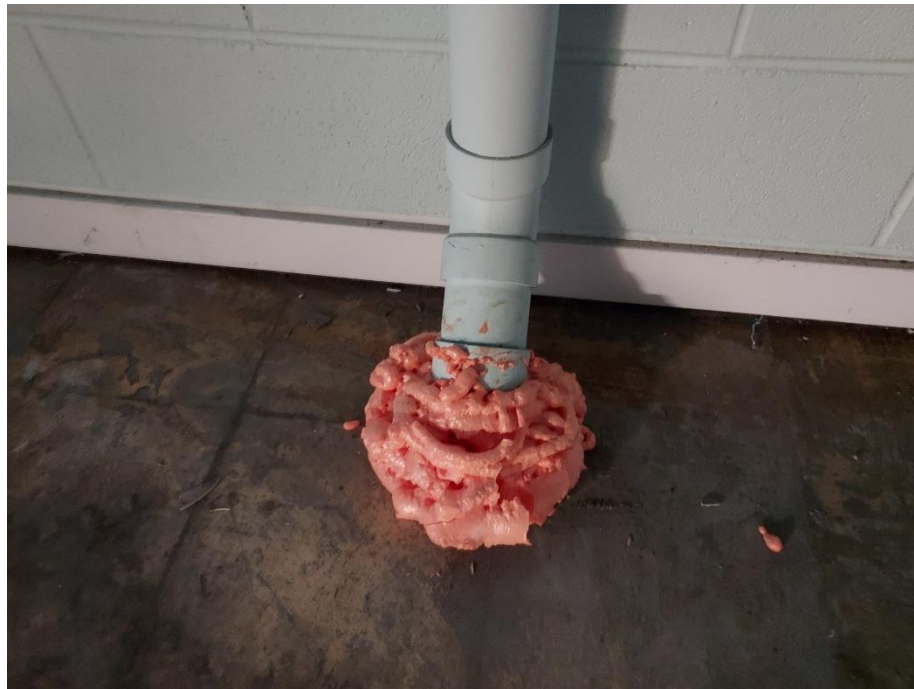
**Lots of spray foam around floor penetration at location S-6, but no air leaks noted.**

*Photo 2 View of spray foam around floor penetration of suction riser S-6, no air leak noted.*

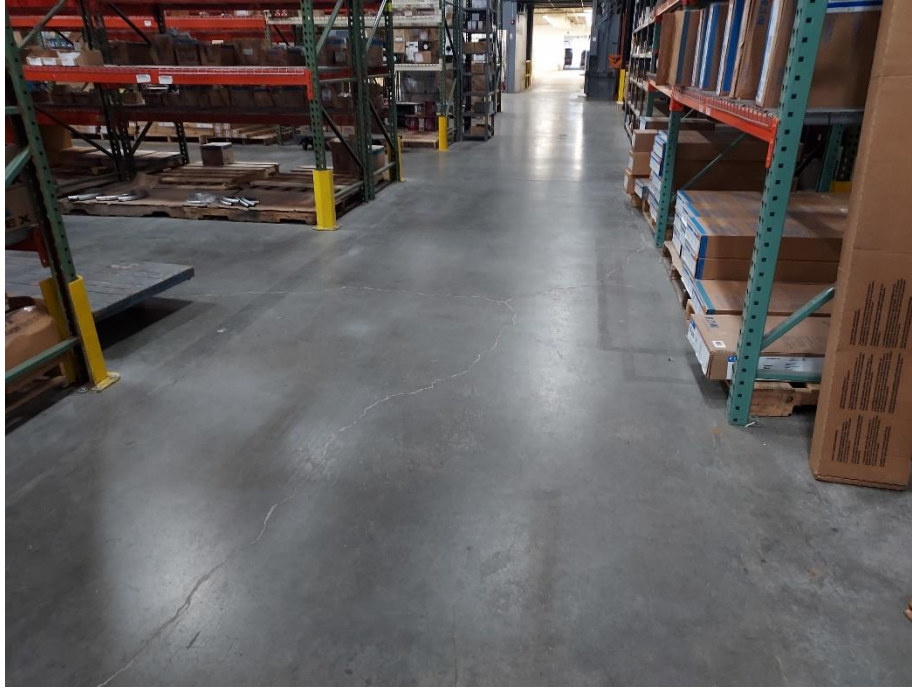
*Photo 5 View of warehouse space showing previously sealed cracks still in good condition.*

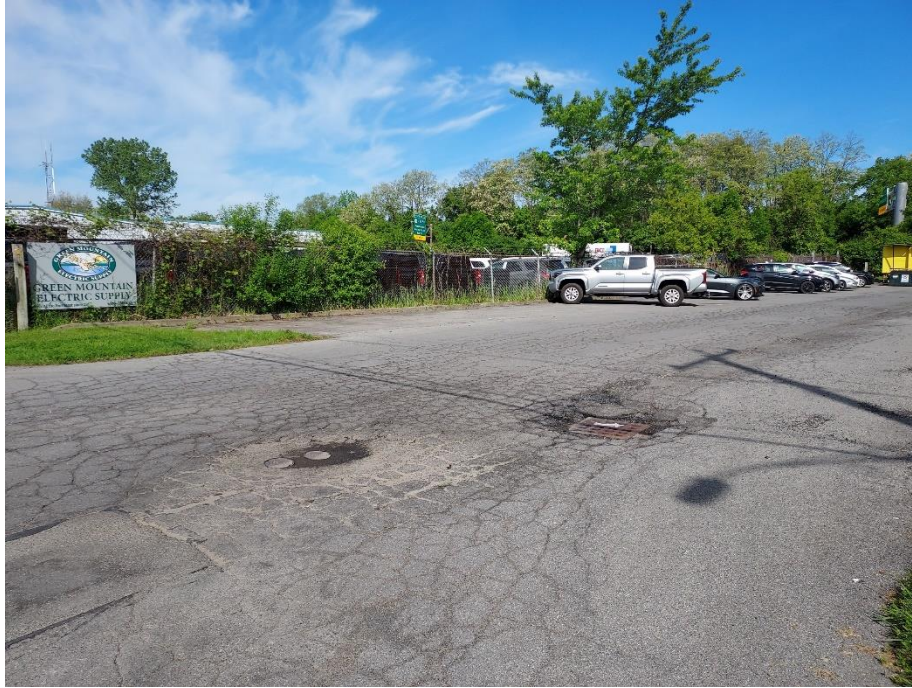
An annual Site inspection was conducted on May 28, 2025 by GHD. The 2025 Site Inspection Form is included as Attachment 3. The Site Inspection indicated that some larger cracks were developing in the southwestern paved areas, and the observation was communicated to the Site owner for further investigation. Cracks in the concrete slab within the warehouse that were previously sealed were in good condition, and the rest of the slab of the Site building was also in good condition. No other issues were observed, with the exception of a non-operating SSDS fan, which is discussed in the following section. No other maintenance issues were identified during the May 28, 2025 Site inspection.

*Photo 9 View of asphalt pavement deterioration along western side of Site.*

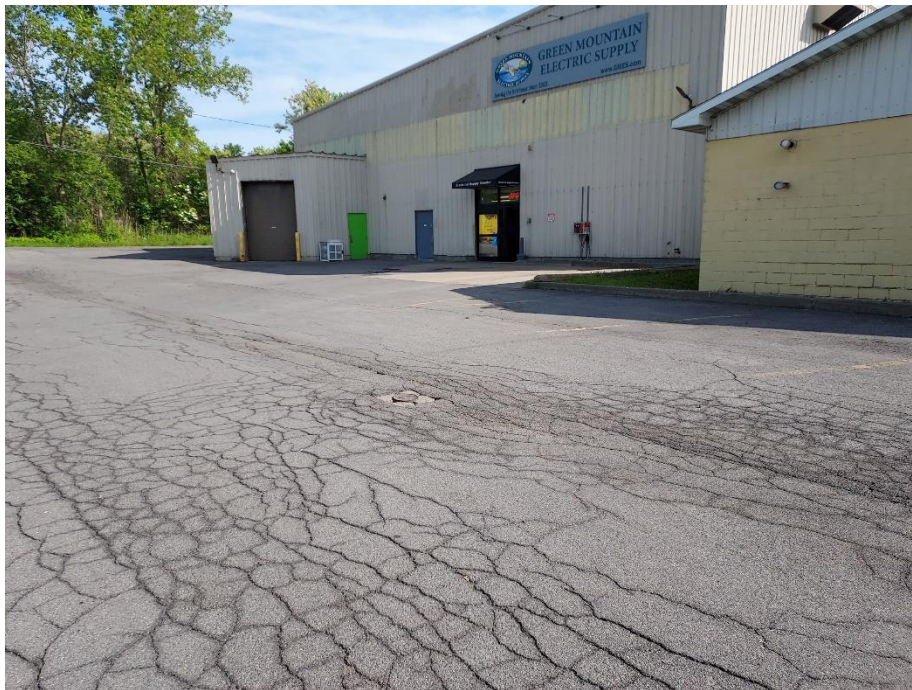
*Photo 10 Another view of asphalt pavement deterioration along western side of Site.*

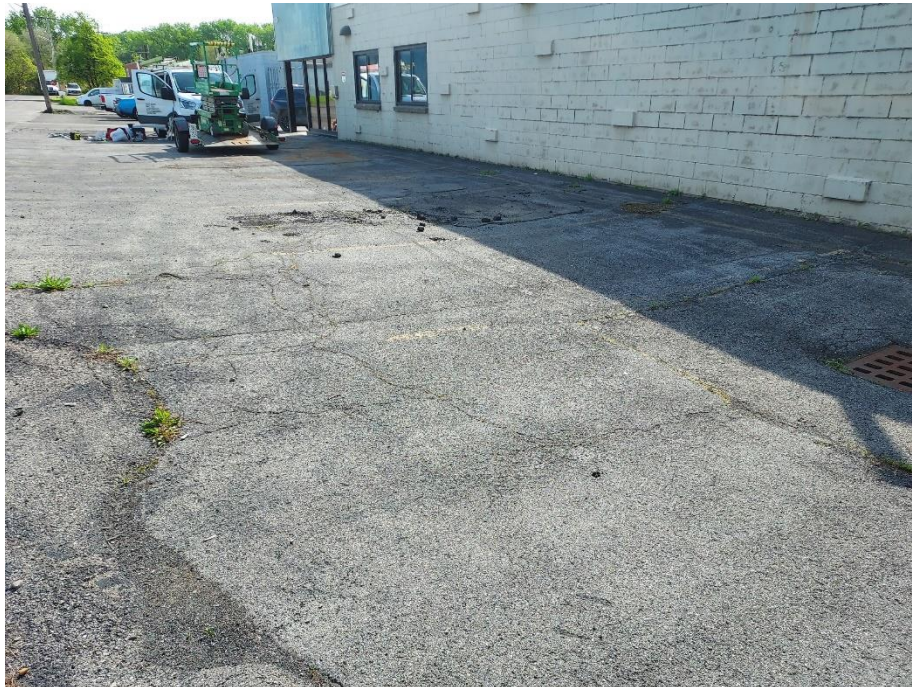
*Photo 12 View of northern asphalt pavement area in generally good condition.*

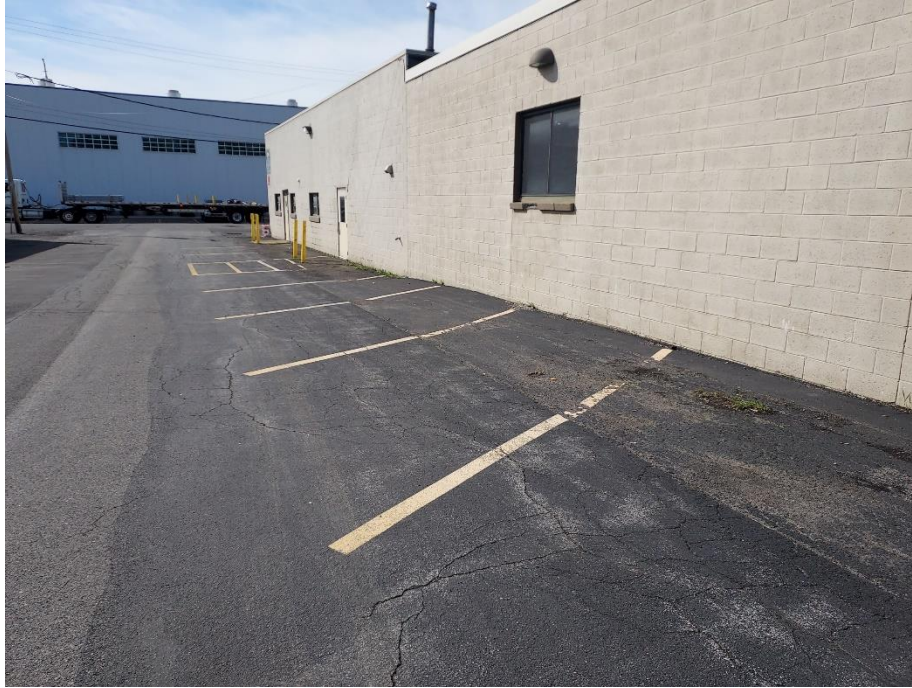
**Photo 13** View of eastern asphalt pavement area in generally good condition.

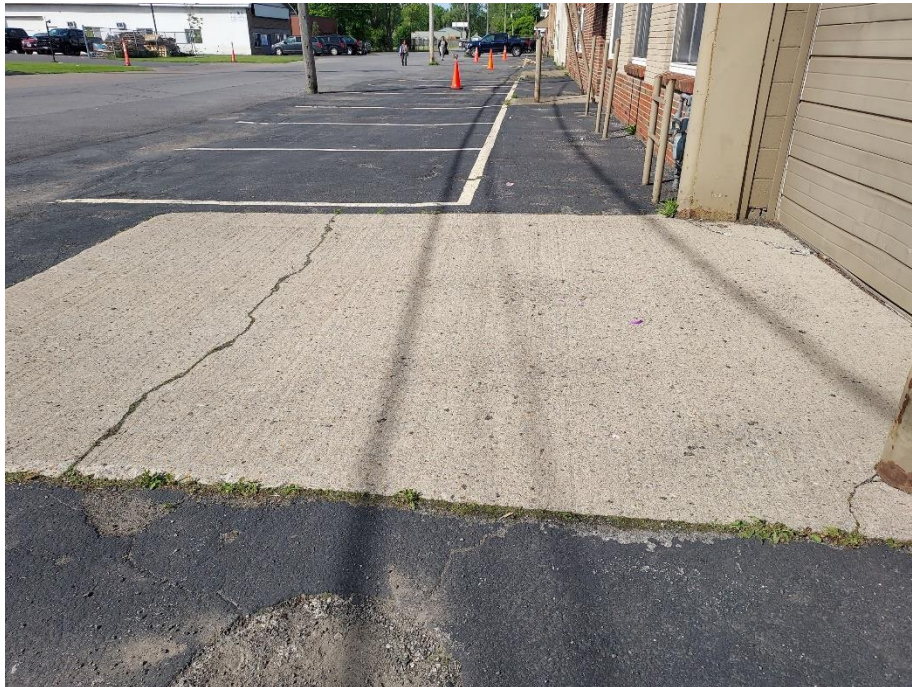
**Photo 14** View of southern asphalt pavement area in generally good condition.

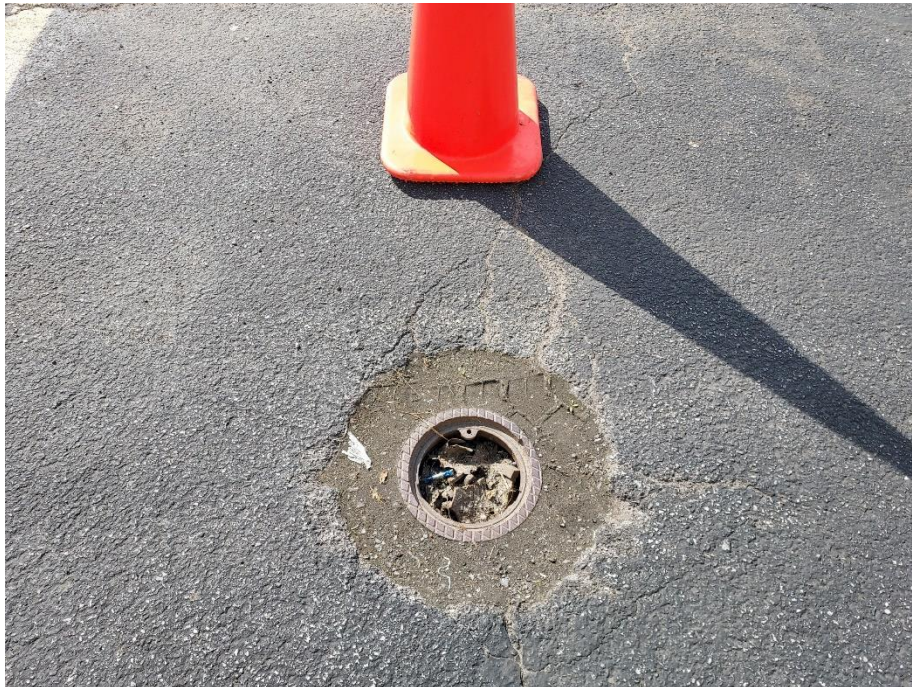
**Photo 16** View of groundwater monitoring well MW-8 that was found to be missing its cover. The cover was replaced following the May 2025 groundwater monitoring event.
