Site Investigation  
Salvation Army Site  
Syracuse, New York

**SITE INVESTIGATION  
SALVATION ARMY SITE  
BURT STREET  
SYRACUSE, NEW YORK**

Prepared for  
SYRACUSE HOUSING AUTHORITY  
516 Burt Street  
Syracuse, New York 13202

Project No. N2014.0

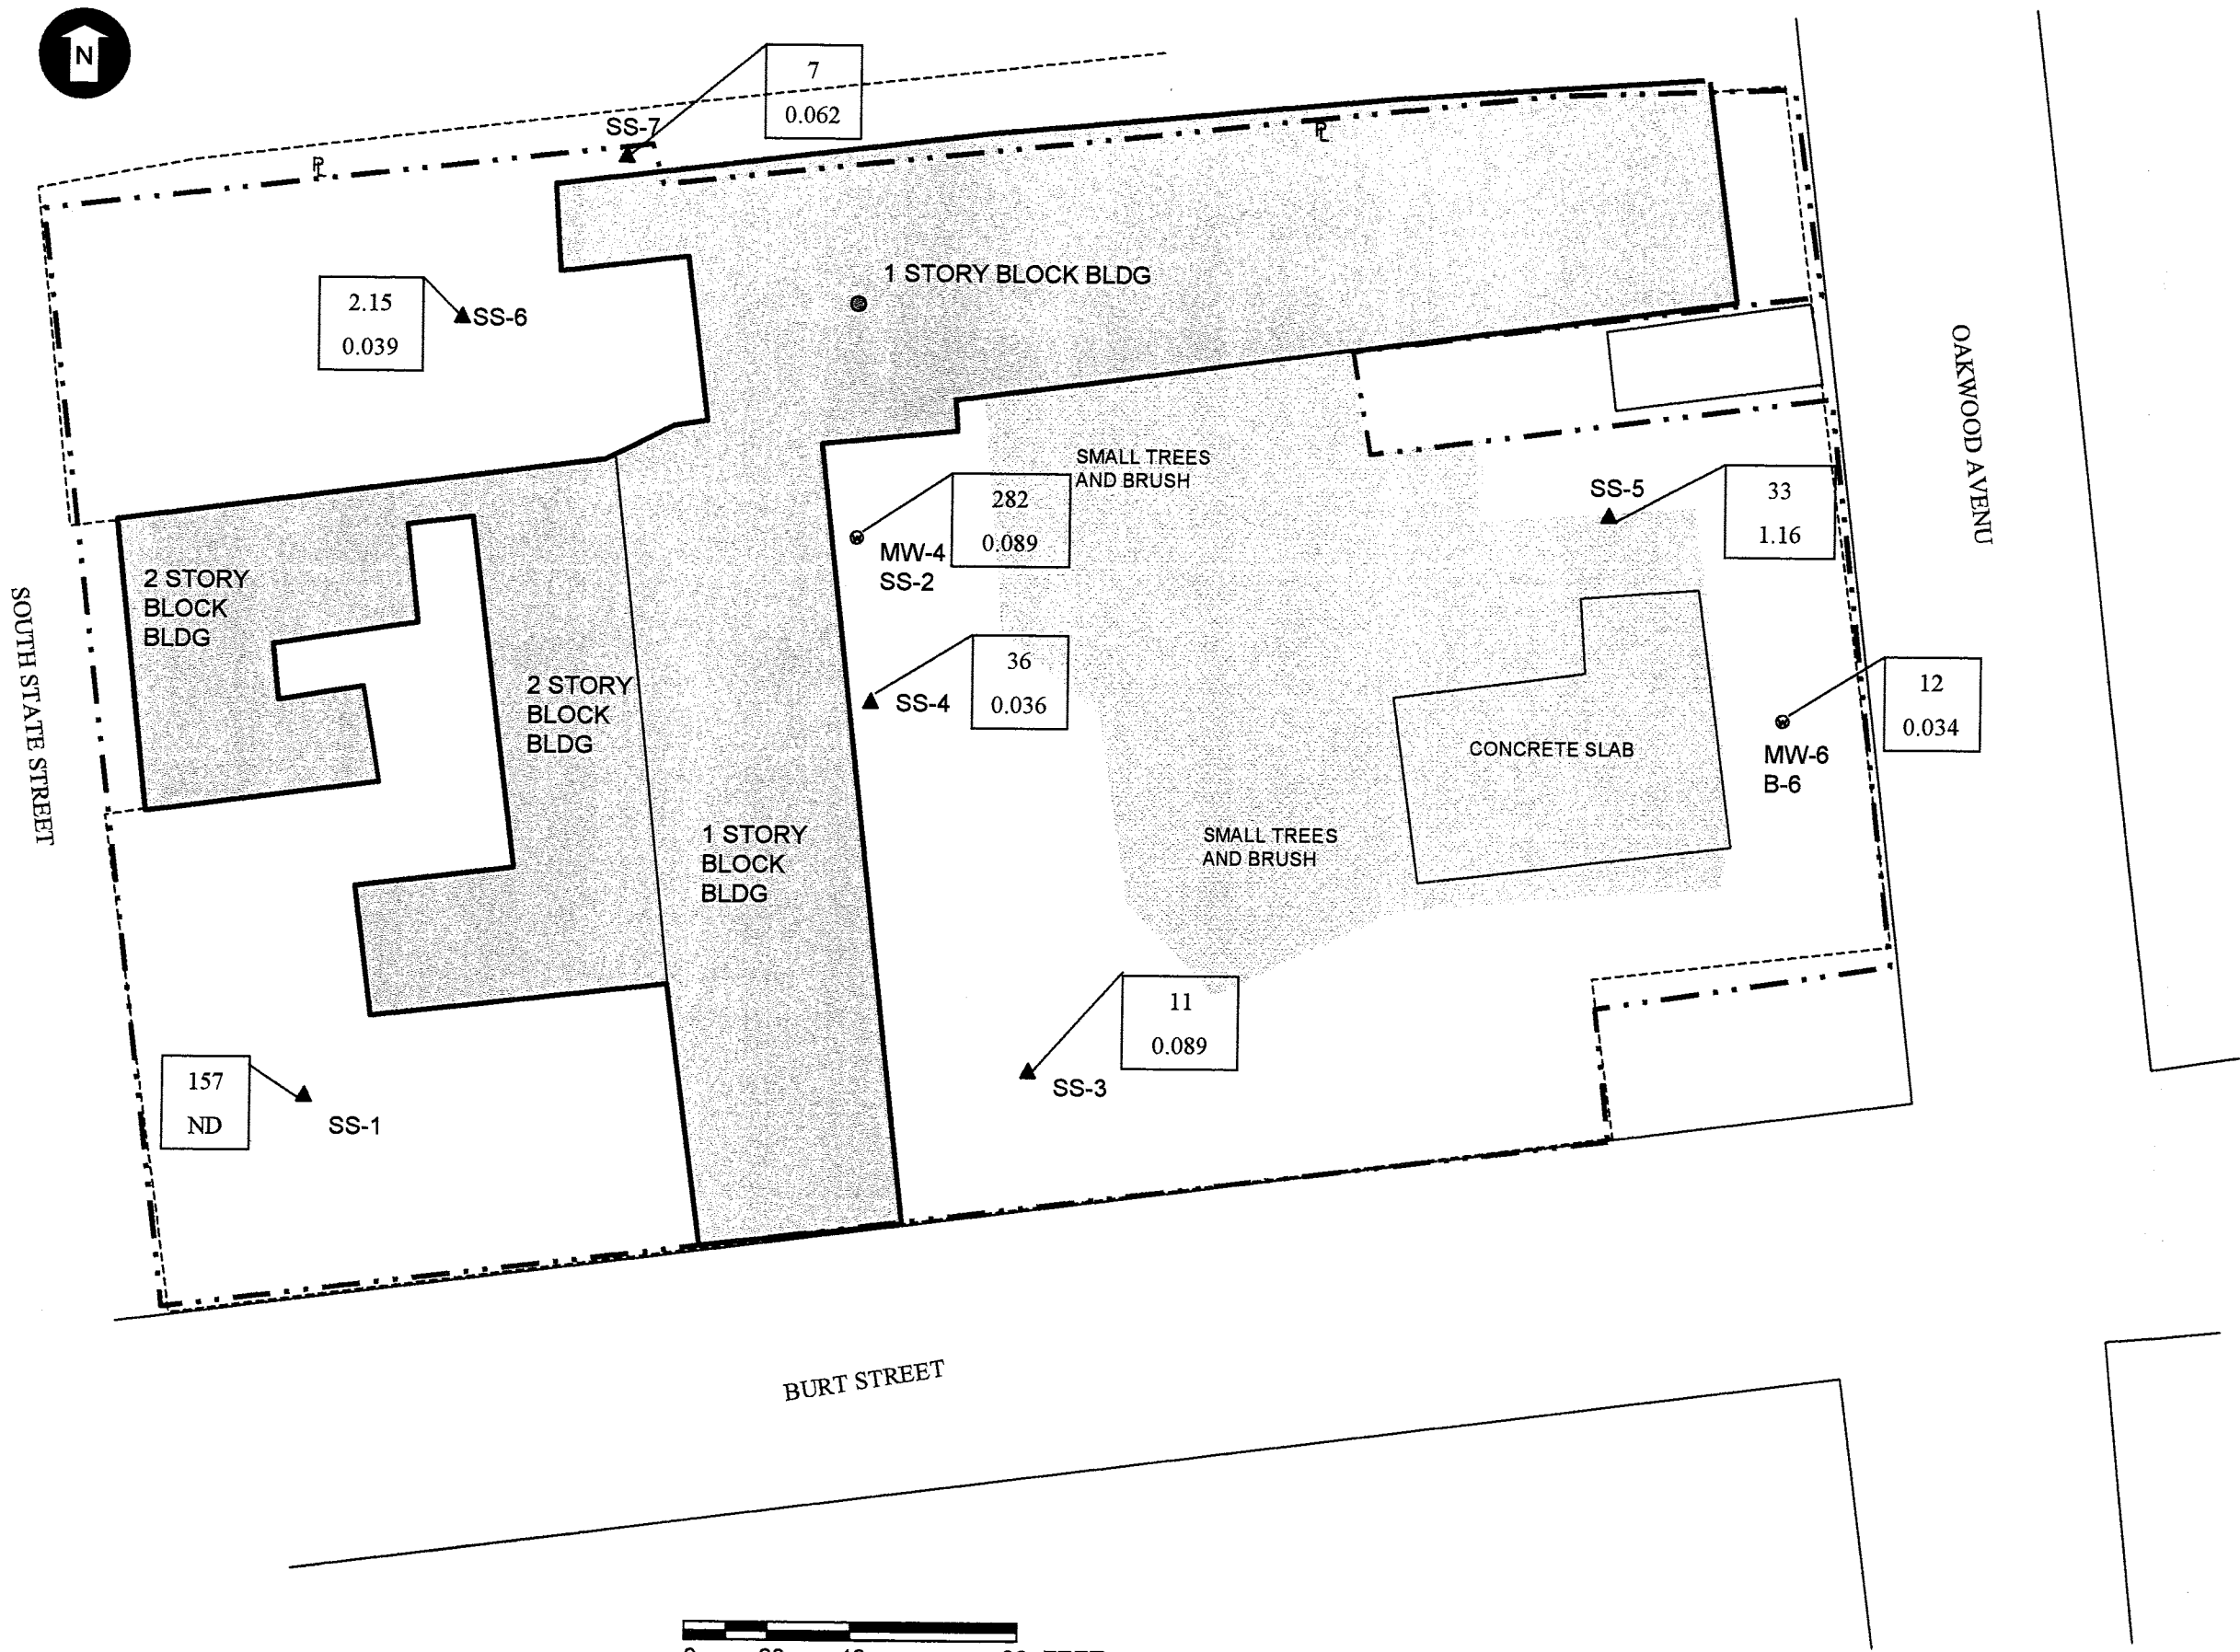
**A. SVOCs.** The majority of the SVOCs detected in surface soils are polycyclic aromatic hydrocarbons (PAHs), which are a subclass of SVOCs found in a variety of common sources including petroleum distillates (fuel oil, diesel fuel), vehicular exhaust, coal, and coal by-products. As such, PAHs are common contaminants in urban and industrial areas.

Overall, only minor impacts were observed in samples collected at the site, and these impacts were in surface soil samples. In particular sample SS-5 appears to have the greatest number of analytes that exceed applicable SCGs. Sub-surface soils and groundwater contained noticeably fewer analytes above SCGs, and on that basis appear to be less impacted than surface soils.

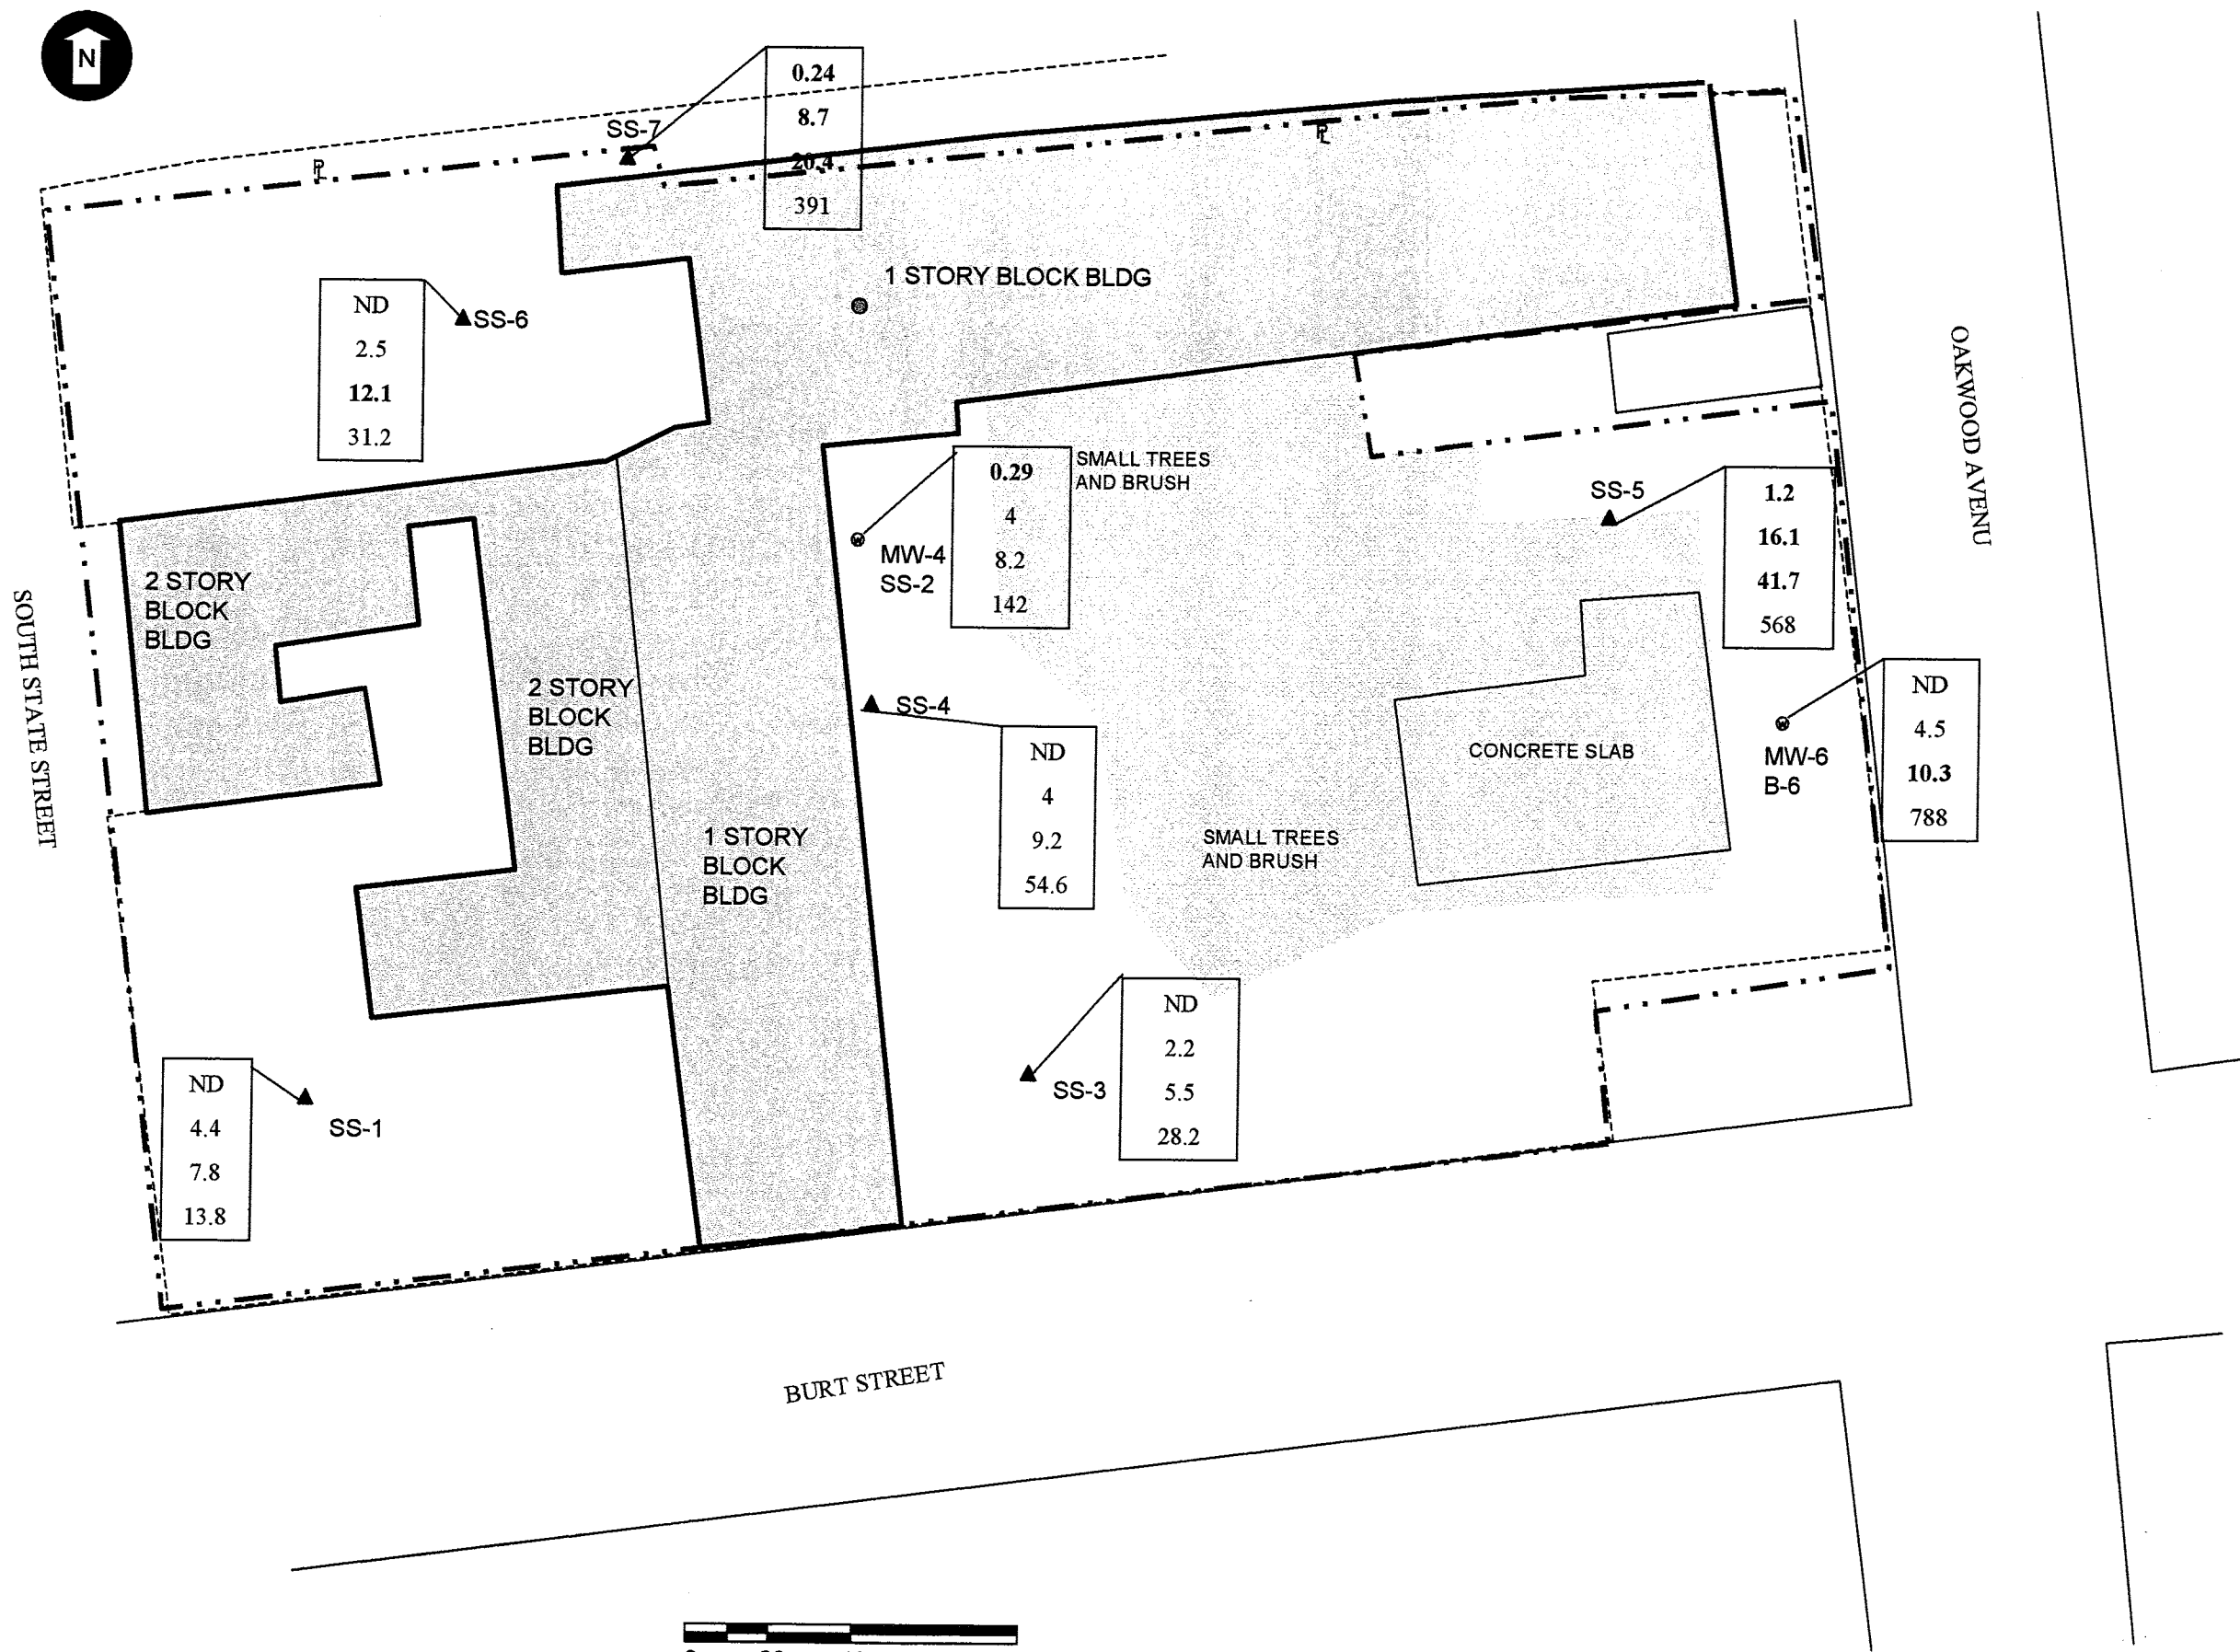
Although several metals were detected in surface soil samples collected at the site, only six (6) metals were detected at levels that exceed TAGM cleanup objectives. Samples SS-2 and SS-5, on the southeast side of the site building, contained slightly elevated concentrations of mercury relative to the recommended soil cleanup objective of 0.1 mg/kg with 0.29 mg/kg and 1.16 mg/kg of mercury, respectively. Sample SS-5 also contained levels of several other metals that were elevated with respect to other surface soil samples taken at the site.

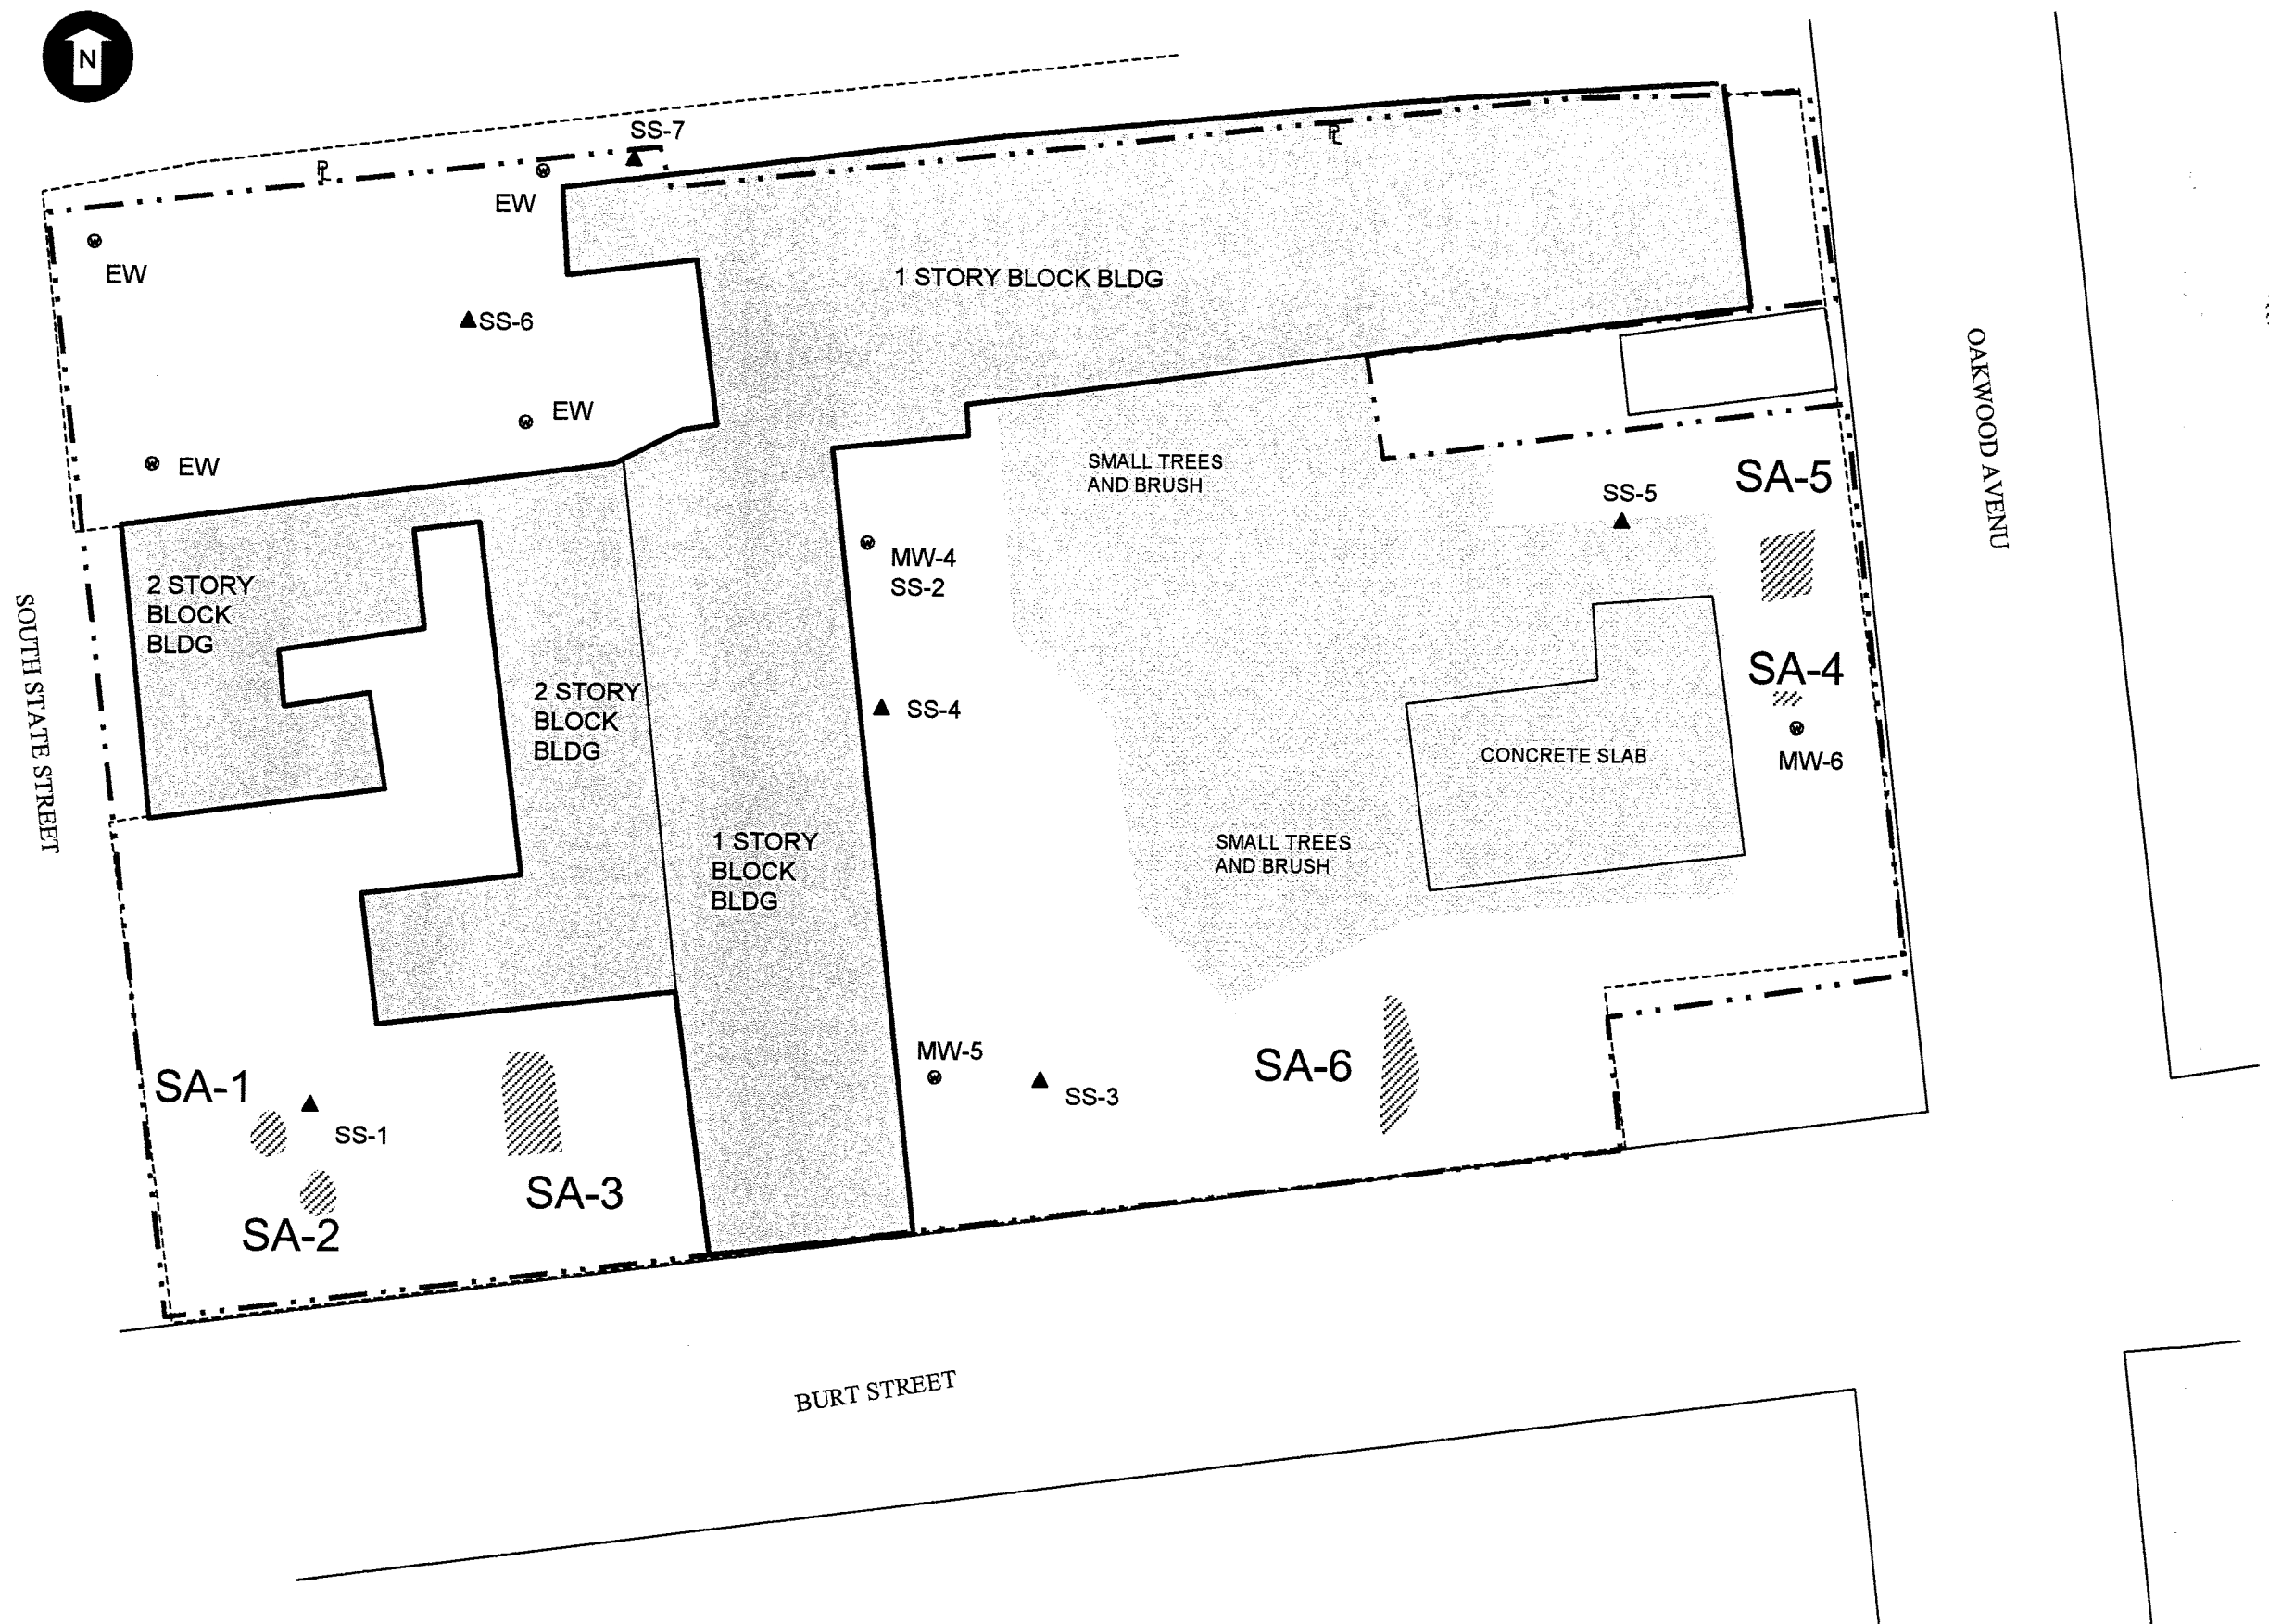
Six metallic anomalies were observed at the site (Figure 3-4). Four of the anomalies had characteristics that indicate numerous small buried objects and debris. Two of the anomalies (SA4 and SA5) had characteristics that suggest the possibility of a buried drum (SA4) and an underground tank (SA5). However, these anomalies may also represent debris oriented in similar dimensions as a drum or tank.

The results of the geophysical survey indicate the possible presence of drums and a UST on the eastern side of the parcel. Although groundwater data do not suggest the presence of USTs or drums, it is recommended that prior to, or immediately following building demolition, this area be investigated to confirm or refute the source of the anomalies. If a UST or drums are identified the materials they contain should be sampled and disposed of in accordance with applicable regulations.

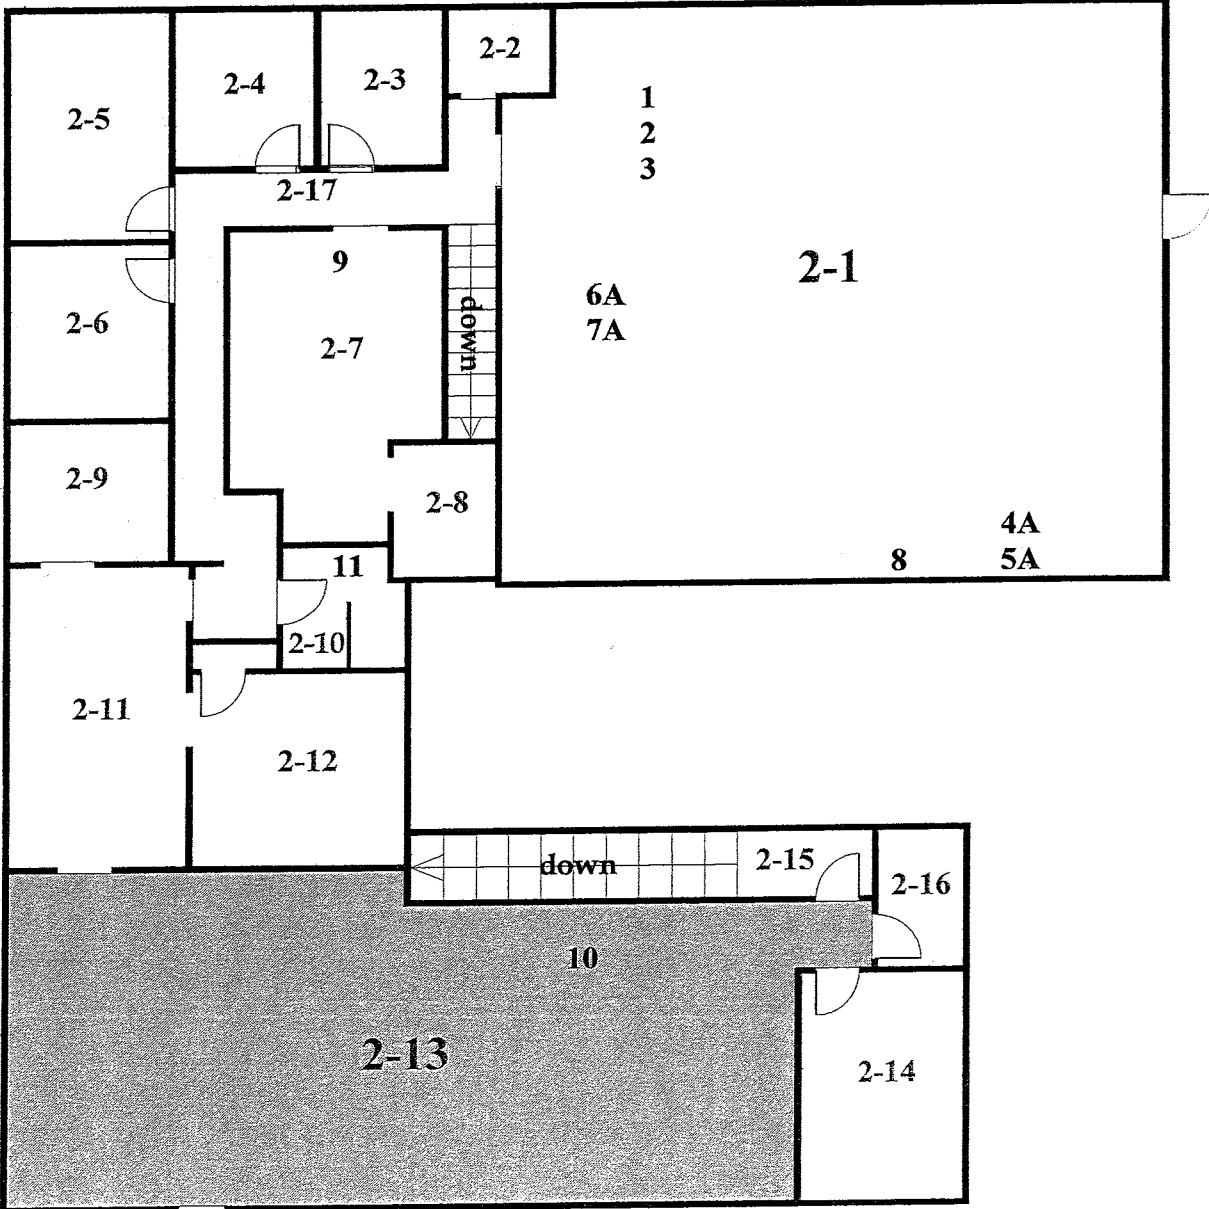
## SECTION A - 2ND FLOOR

- asbestos containing floor tiles & mastic
- asbestos containing floor tiles & mastic  
asbestos containing ceiling material

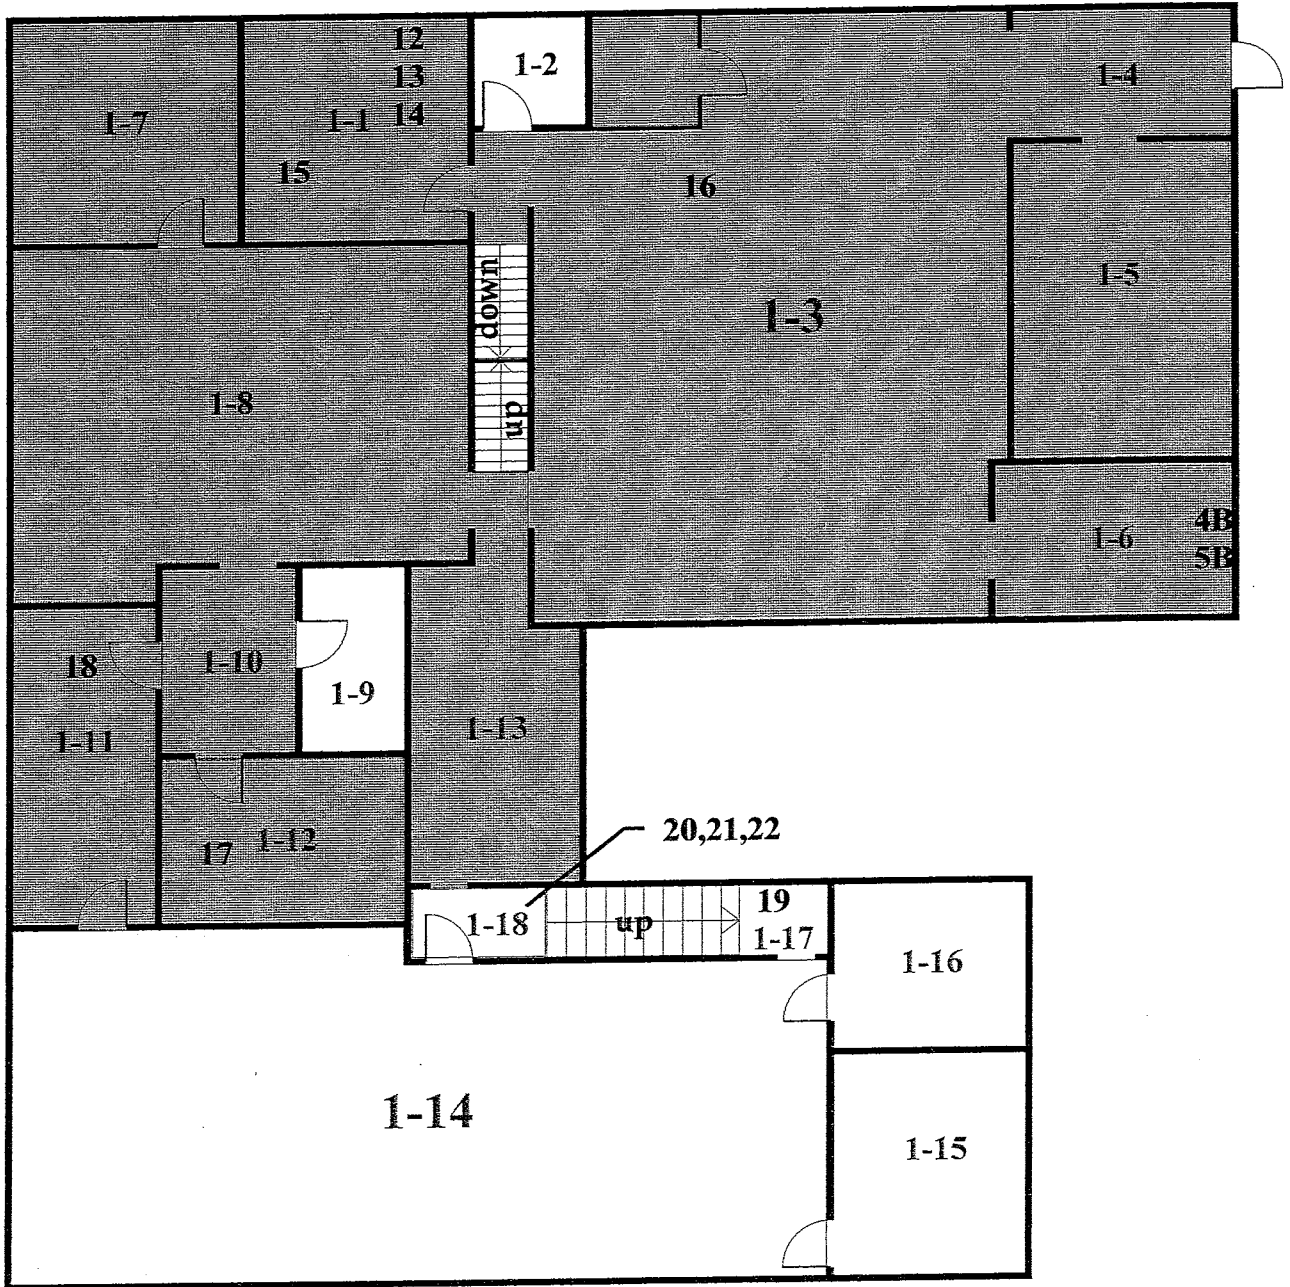
## 1ST FLOOR-NW OFFICES (SECTION A)

□ asbestos containing floor tiles & mastic

▒ asbestos containing floor tiles only

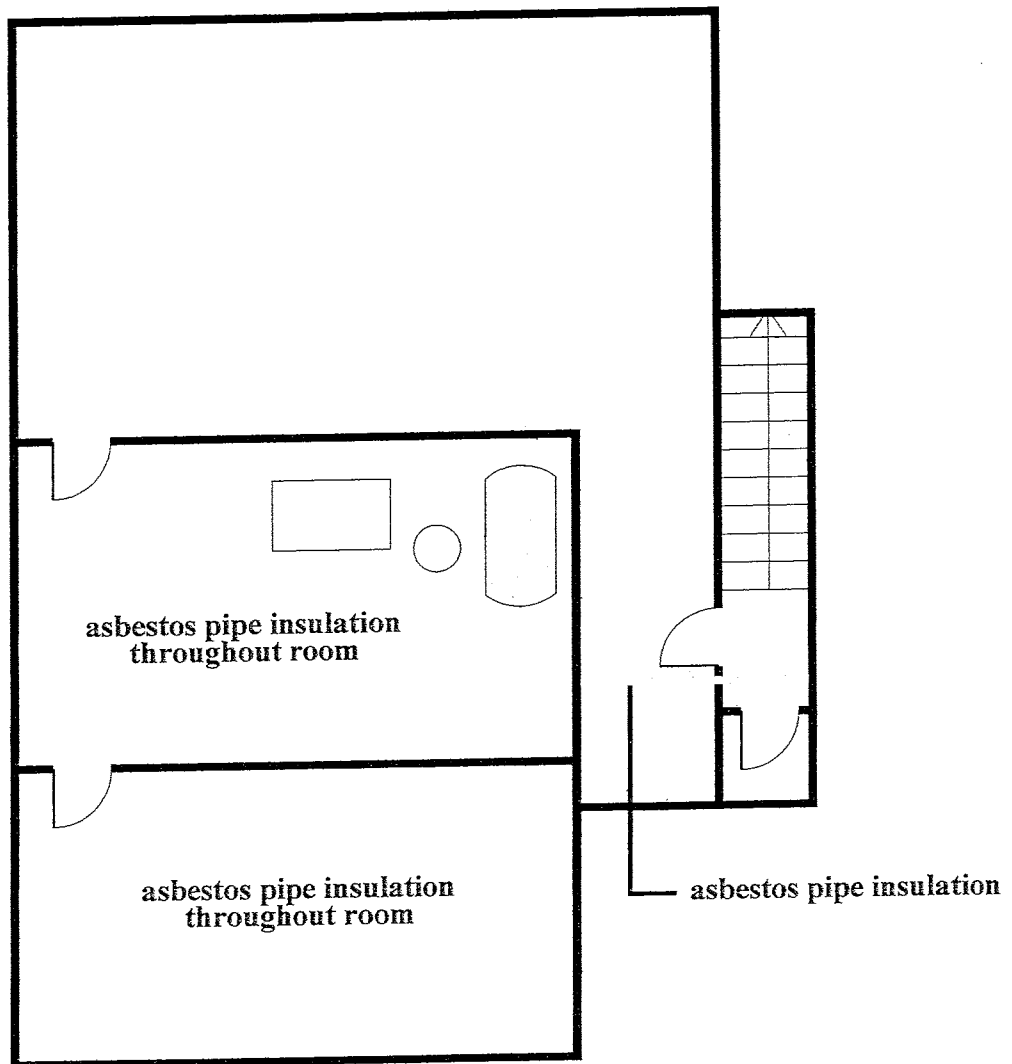
## BASEMENT-NW OFFICES (SECTION A)

The pipe insulation and associated fitting insulation were in poor condition at the time of the inspection. Primarily, this material was found in the basement of Section A, but a small piece was located on the first floor in space ID# 1-17. Additional insulation may be present in the walls or floors of the structure that was not accessed during the survey. The insulation was not sampled as part of this inspection, because it was previously sampled and found to be asbestos containing. Asbestos containing felt paper was found under the wood floor throughout the second floor of Section B. This material was not found in the stairwell or in the elevator area. The 9" x 9" dark brown & light brown checkered pattern floor tiles found in Section G are situated on black mastic which is in turn on a layer of wood. Under this layer of wood is an additional layer of the same floor tile and non-asbestos containing felt paper under that.

asbestos tank insulation

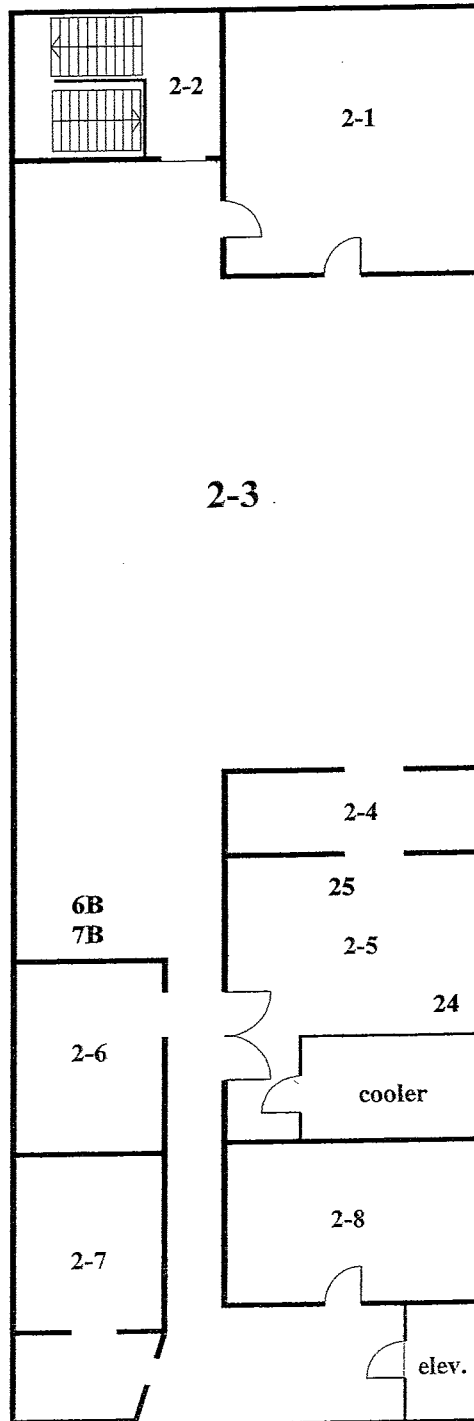
**2ND FLOOR-CENTER SECTION (SECTION B)**

asbestos felt paper under wood floor

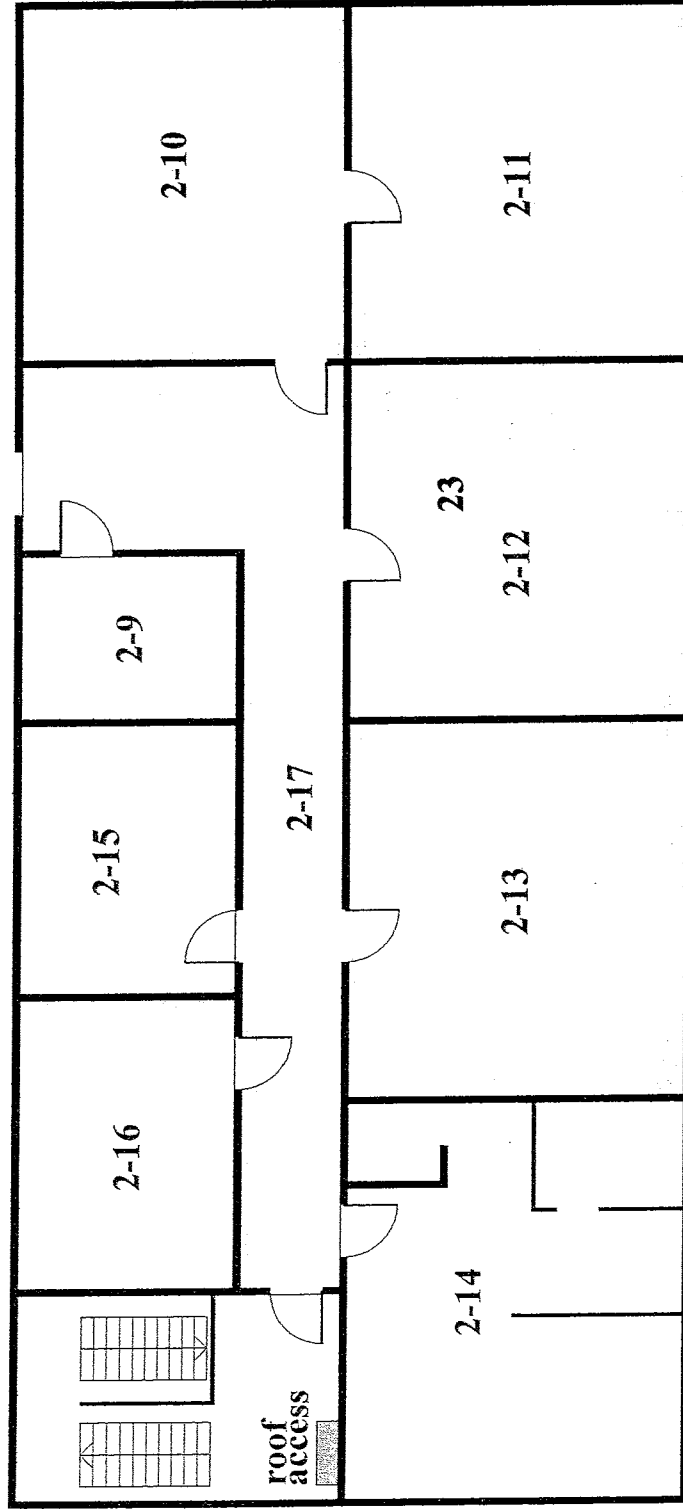
**2ND FLOOR-SOUTH SECTION (SECTION C)**

□ asbestos linoleum
