**SITE INVESTIGATION
SALVATION ARMY SITE
BURT STREET
SYRACUSE, NEW YORK**

Prepared for
SYRACUSE HOUSING AUTHORITY
516 Burt Street
Syracuse, New York 13202

Prepared by
S&W Redevelopment
of North America, LLC
430 East Genesee Street
Syracuse, New York 13202

January 2004

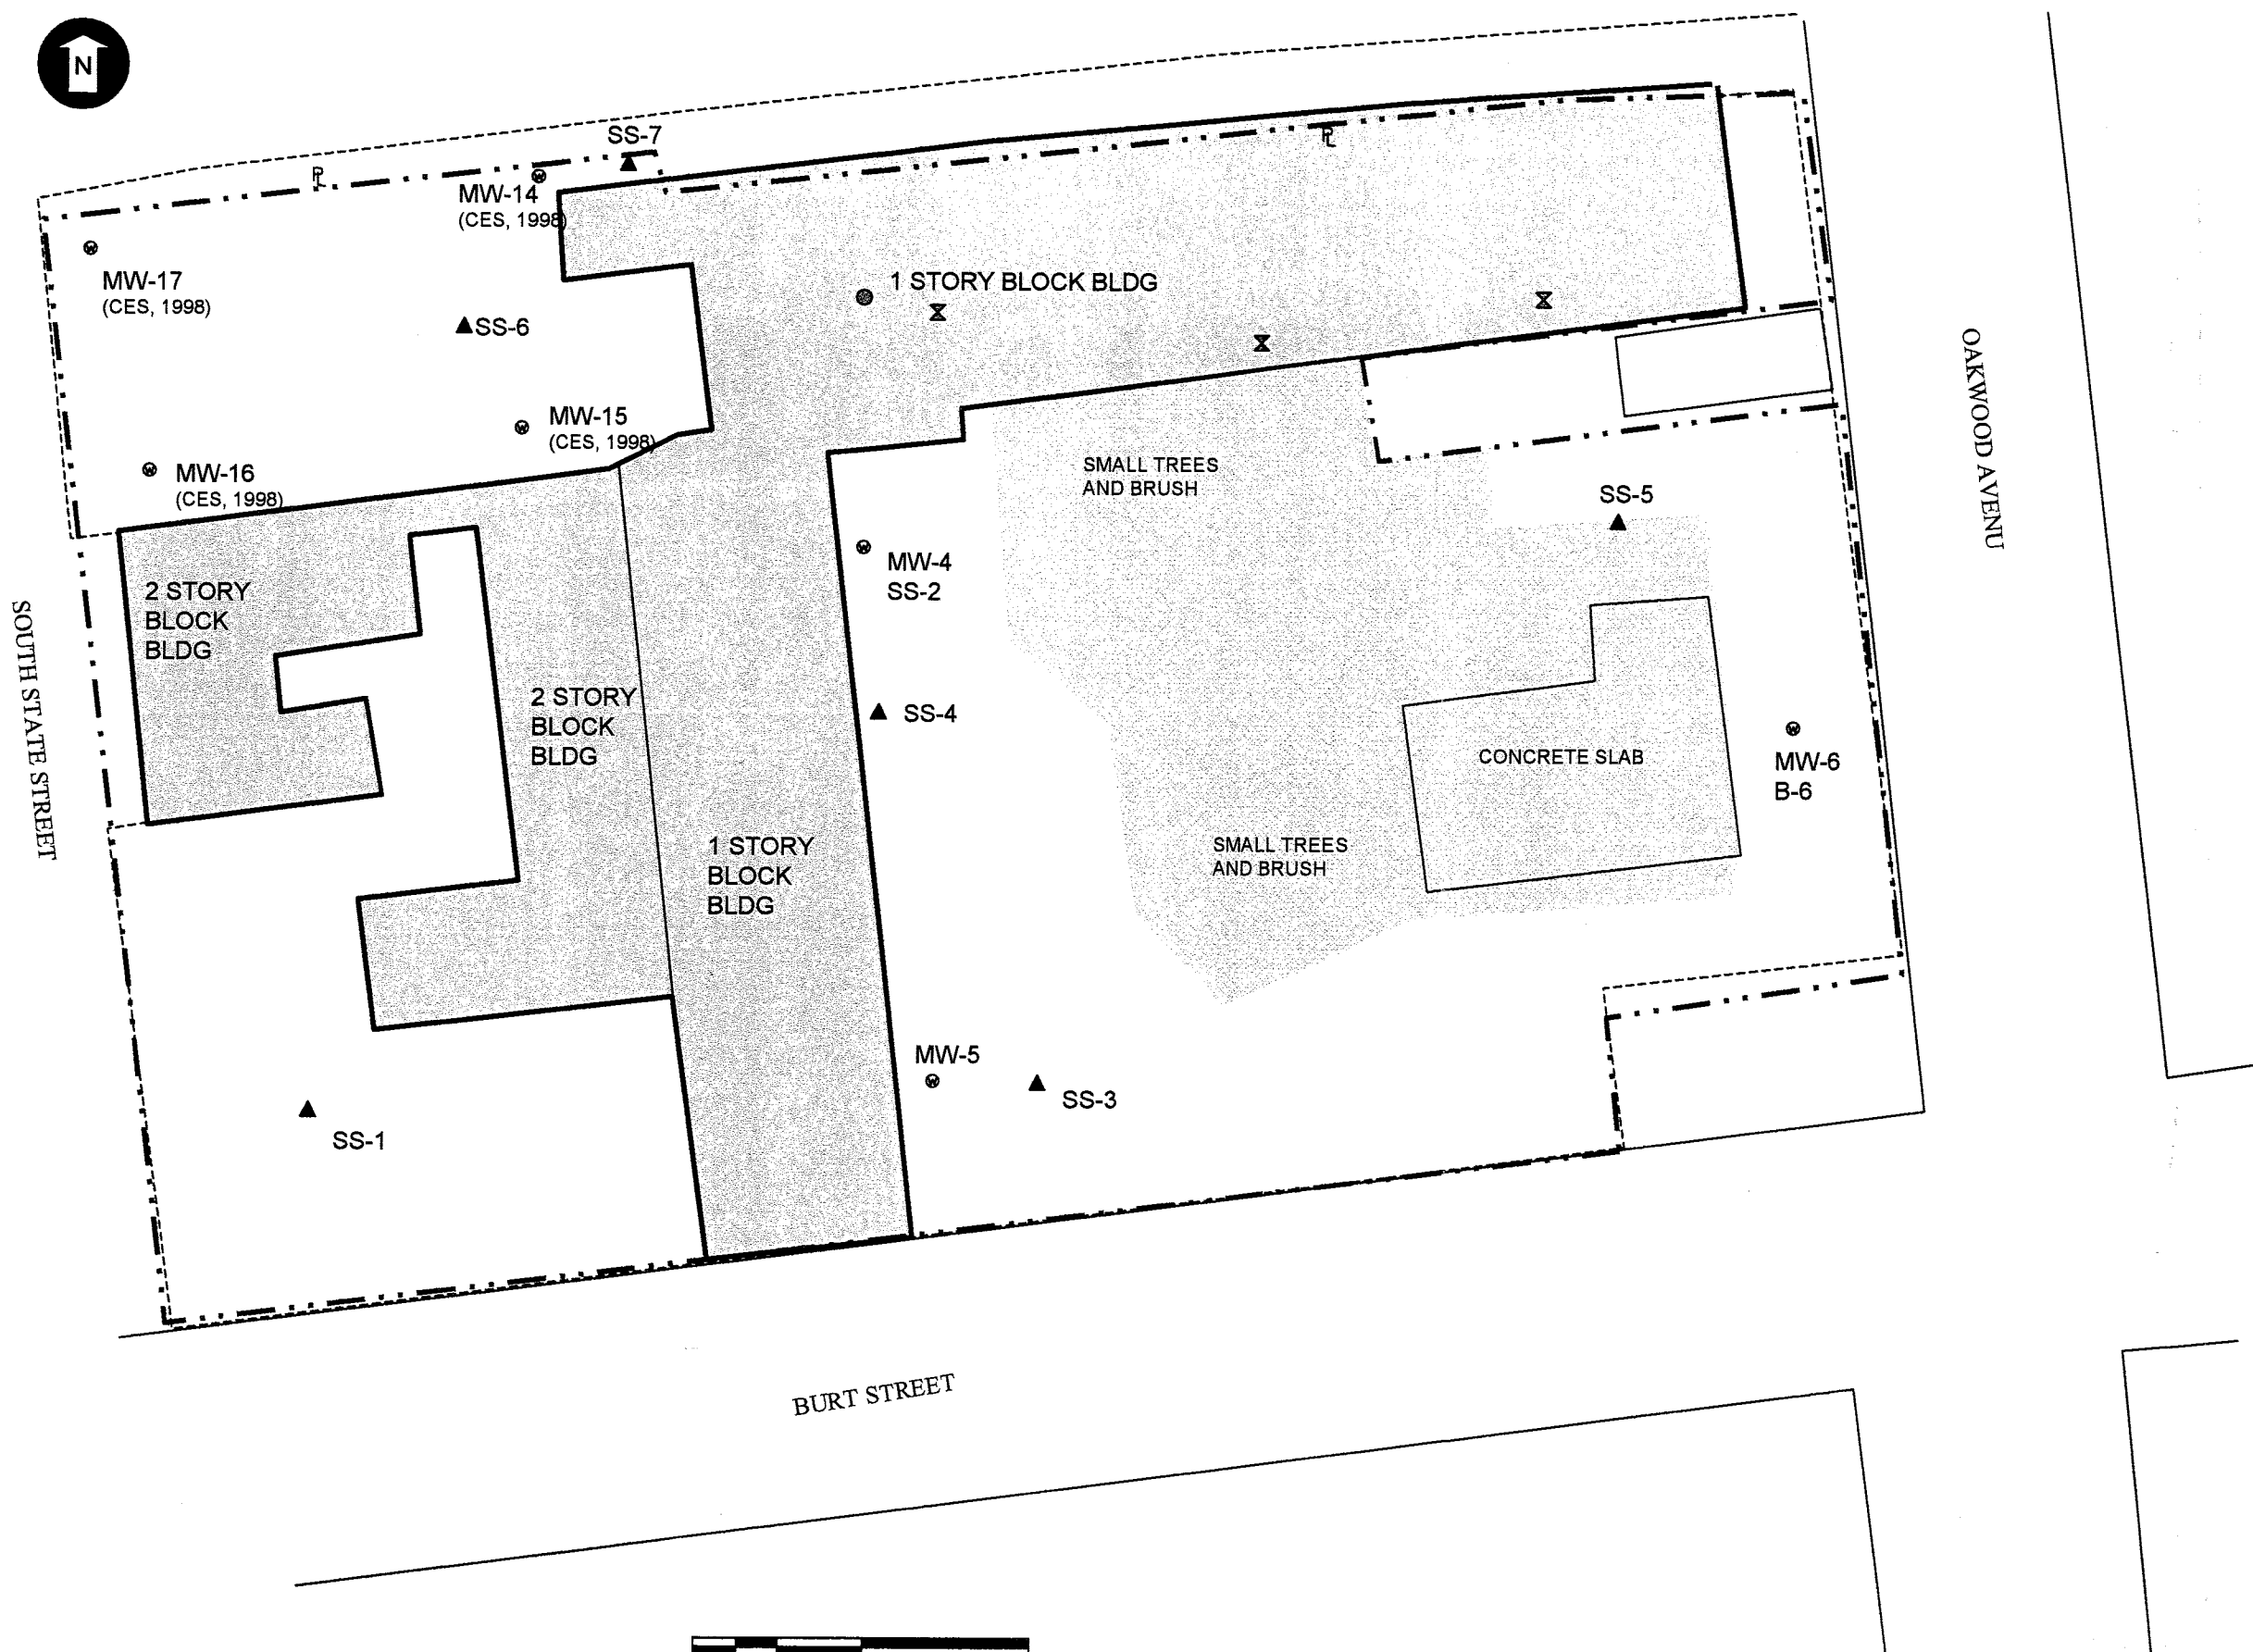
Three soil borings were advanced into the subsurface on April 7 and 9, 2003 (B-4, -5, -6, Figure 2-1). Drilling was completed by advancing hollow stem augers to depths ranging from 14- to 16-feet below ground surface (bgs). In addition, soil samples were collected continuously using a 2-inch stainless steel split spoon soil sampler. Soil samples were field screened with a photoionization detector (PID), visually examined, and described by a SWRNA hydrogeologist. Soil observations and PID readings were recorded in subsurface boring logs (Appendix A).

Eight surface soil samples (SS-1 through SS-7 and B-6) were collected between April 7 - 9, 2003. Soil samples SS-1 and SS-6 were collected from soil beneath asphalt material. SS-1 was collected in an area where a sink hole caused paving to cave in. All of the surface soil samples were collected from the upper six (6) inches using either collected in an isolated area using dedicated stainless steel trowel (“SS” samples), or at boring locations using split spoon samplers (“B” samples, as discussed in Section 2.1). All eight surface soil samples were analyzed for target compound list (TCL) semi-volatile organic compounds (SVOCs) by USEPA Method 8270C, PCBs by USEPA Method 8082, and target analyte list (TAL) metals by USEPA Methods 6010B/7471A.

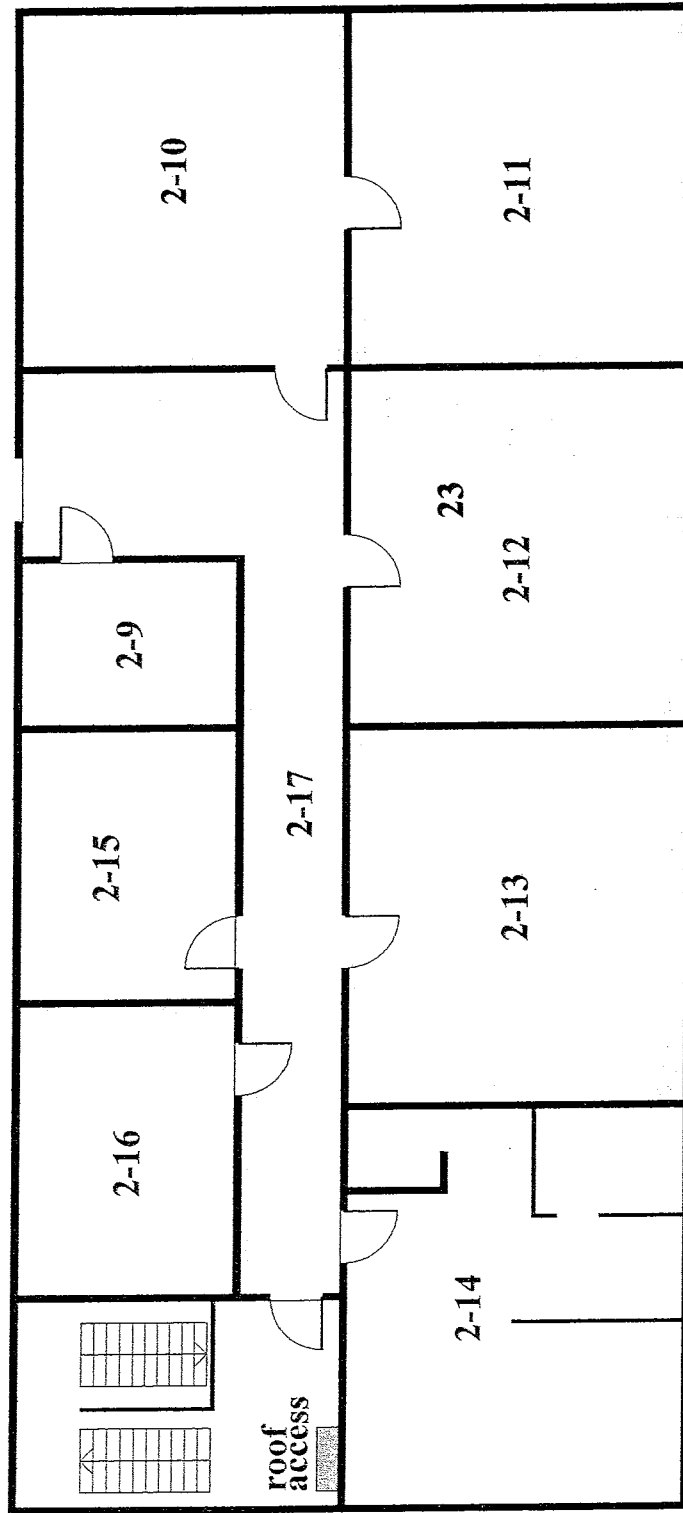
2ND FLOOR-SOUTH SECTION (SECTION C)

□ asbestos linoleum

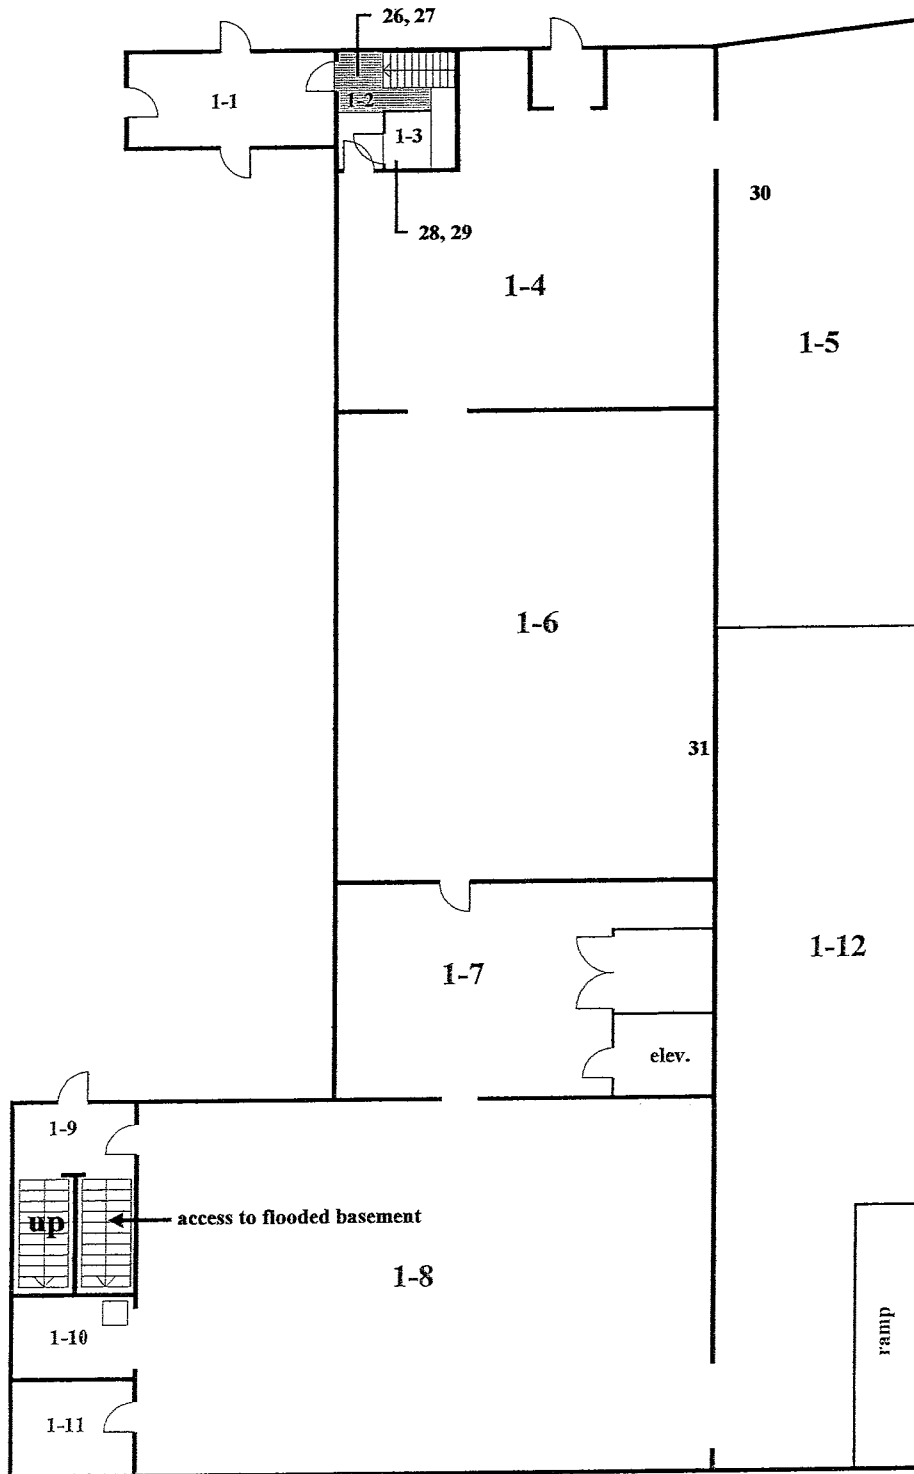
1ST FLOOR-CENTER SECTIONS (SECTIONS B, C & E)

- asbestos floor tiles & mastic
- ▨ asbestos mastic (under floor tiles)
