14 May 2015

**Subject: Short Term Response Action Report
Former Sperry Remington Site – North Portion (#808022)
777 South Main Street, City of Elmira, Chemung County, NY**

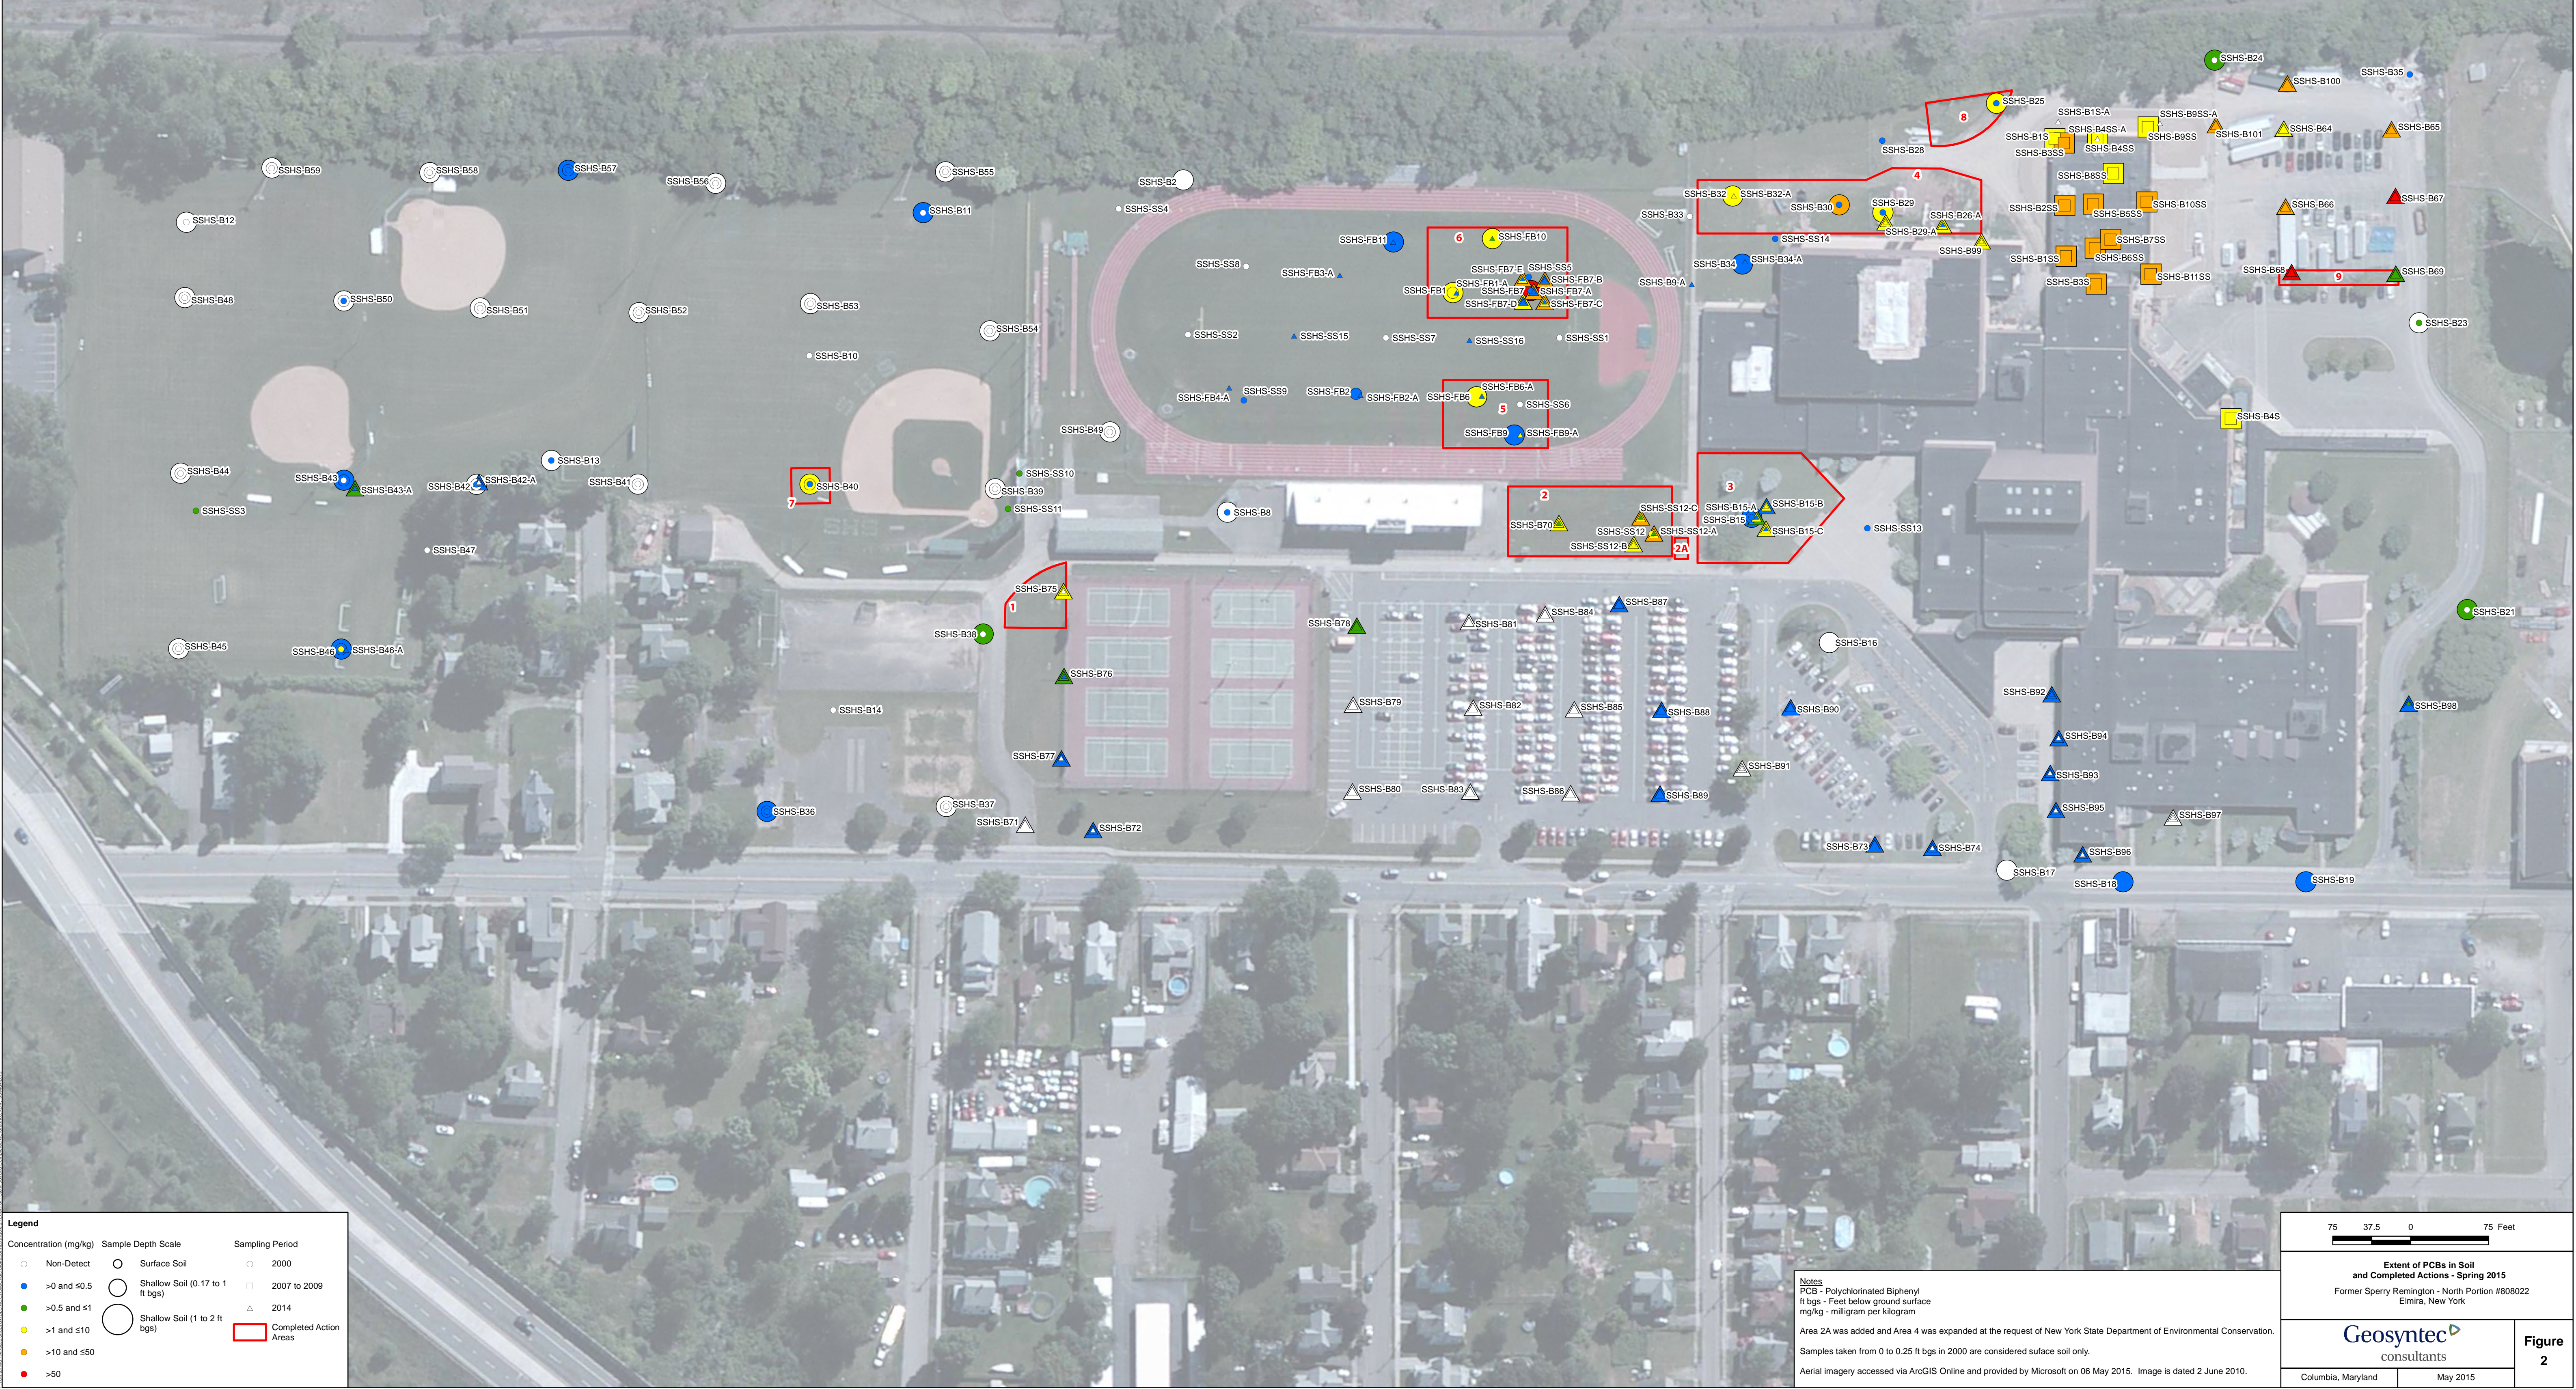
As shown on **Figure 2**, PCBs have been detected in shallow soil samples (0 to 2 feet bgs) at concentration greater than the Restricted Residential Soil Cleanup Objective (SCO)² of one (1) milligram per kilogram (mg/kg) at select sample locations at the Site. Some of those locations are located under paved areas (e.g. the rear parking lot) or under buildings (e.g. the Science Addition). Other locations are in certain portions of unpaved areas including the football field, the athletic field and landscaped areas near the tennis courts, the rear parking lot, and adjacent to the athletic wing at the north end of the EHS building.

On 30 March 2015, Geosyntec and NYSDEC inspected Areas 1, 2, 5, 6, and 7 for well-established vegetation (see **Figure 2**). NYSDEC determined that existing cover was sufficiently established in those areas to minimize human exposure and that over-seeding was not required. Photographs of existing conditions are presented in Attachment 2. NYSDEC requested the following areas not included in the STRA Work Plan be addressed: (a) a muddy area on the edge of Area 4; (b) potholes in the rear parking lot south of Area 8; (c) bare areas immediately adjacent to the track; and (d) the unfenced area to the south of Area 2. Unisys agreed to expand the temporary cover installation in Area 4 and install temporary cover to the south of Area 2 (Area 2A as shown on **Figure 2**). Bare areas adjacent to the track and potholes in the rear parking lot would be addressed by ECSD by over-seeding and repaving, respectively.

Unisys installed temporary cover in Areas 2A, 3, 4, 8 and 9 as shown on **Figure 2**. Temporary cover consisted of non-woven geotextile and approximately twelve (12) inches of hardwood mulch. Mulch was kept in place by wood frames secured by rebar. Ground surface in each area was prepared by removal of angular or sharp objects. After surface preparation, geotextile was used to cover existing ground surface and held in place with landscaping staples. An approximate twelve-inch (12-in) high border was prepared for each area using landscaping timbers, anchored in place using rebar as ground-spikes. Each area was completed by adding an approximate twelve-inch (12-in) hardwood mulch layer. After completion, the surrounding area was broom swept /raked to remove mulch from outside the completed area. Details specific to cover installation at each area are provided below.

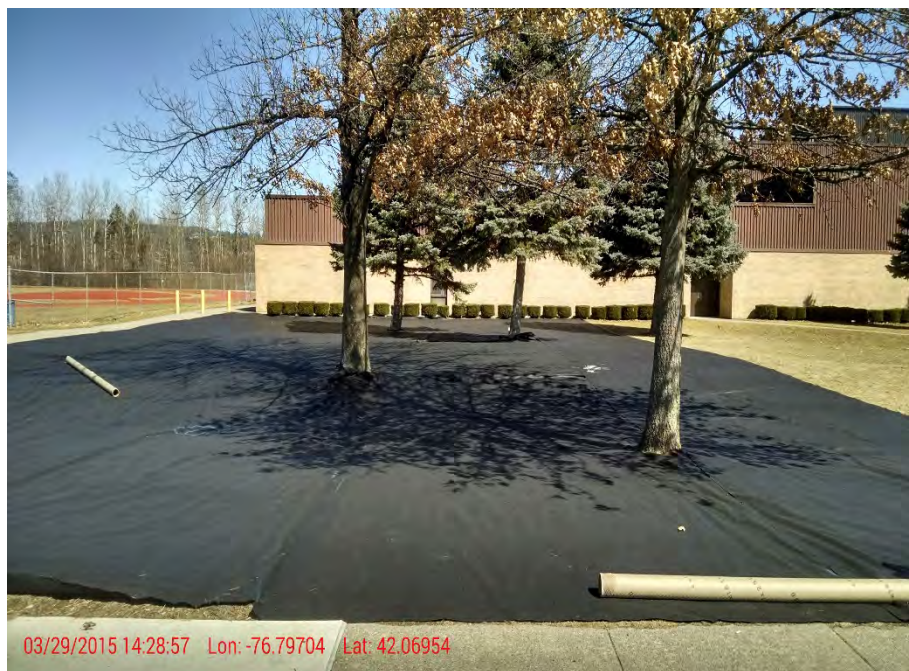
**Comments: Installing
geotextile over Area 3**

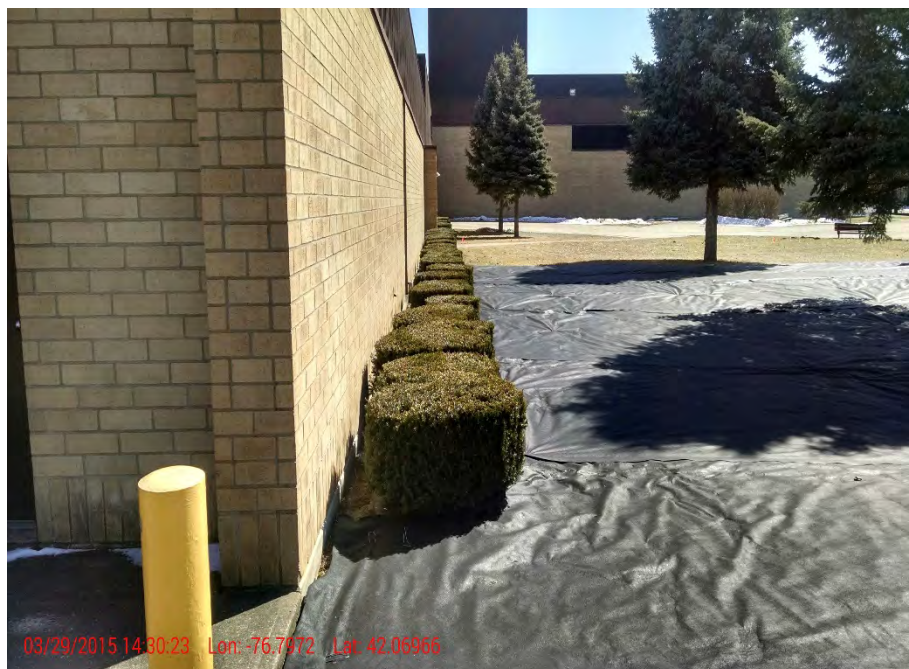
Photograph 2

**Comments: Hedge
along west side of the
gym. Fabric cut at the
edge of the bushes**

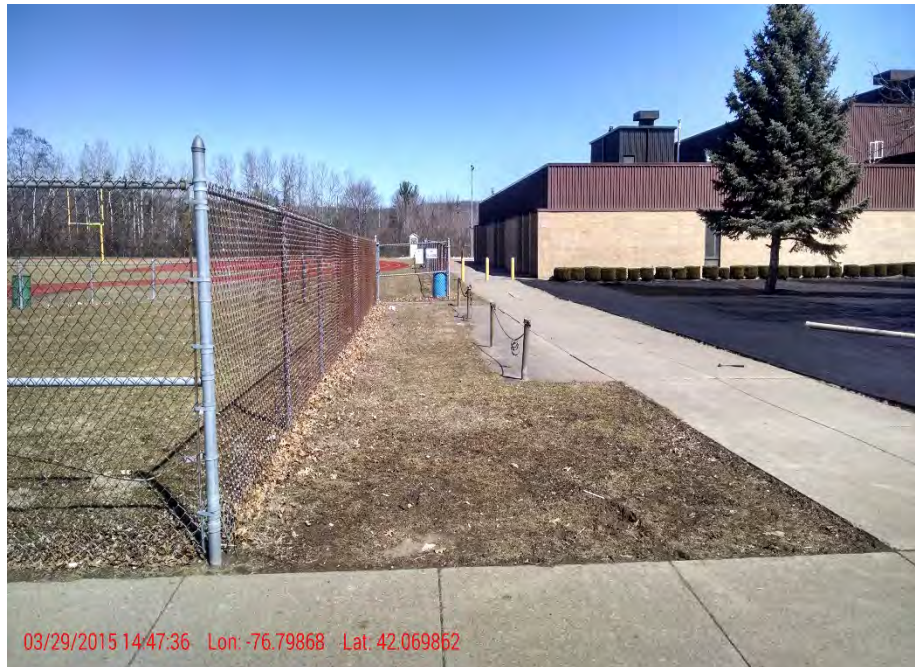
Comments: Areas 2 and 3 – pre-installation.

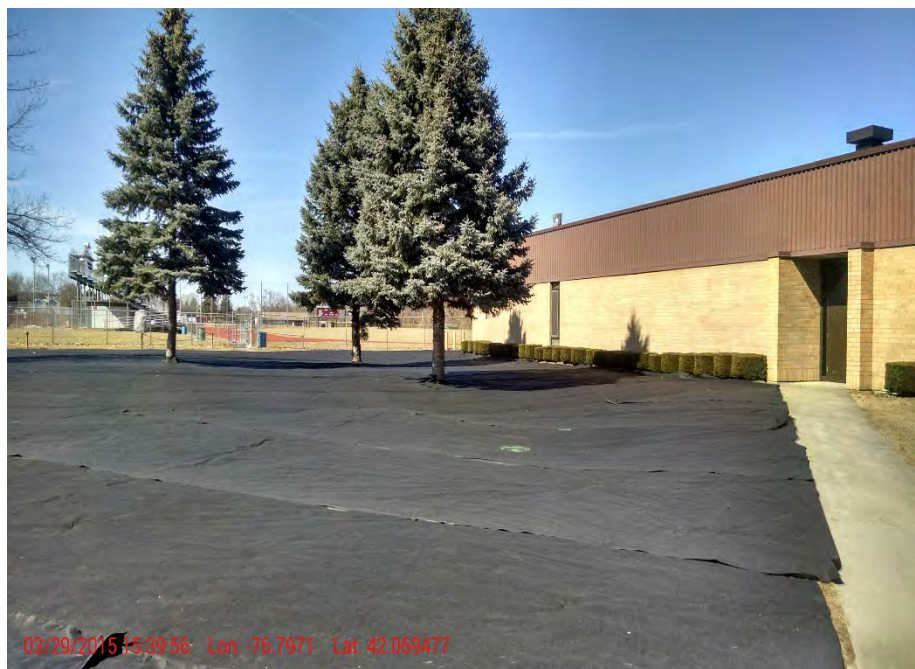
Photograph 4

Comments: Area 3 completely covered in geotextile

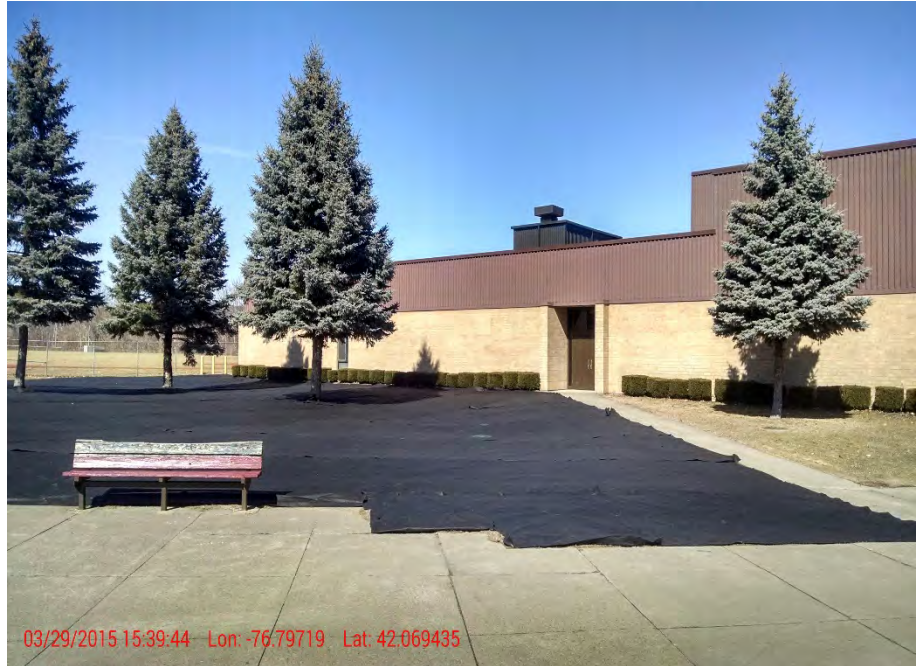
Comments: Area 3 completely covered in geotextile

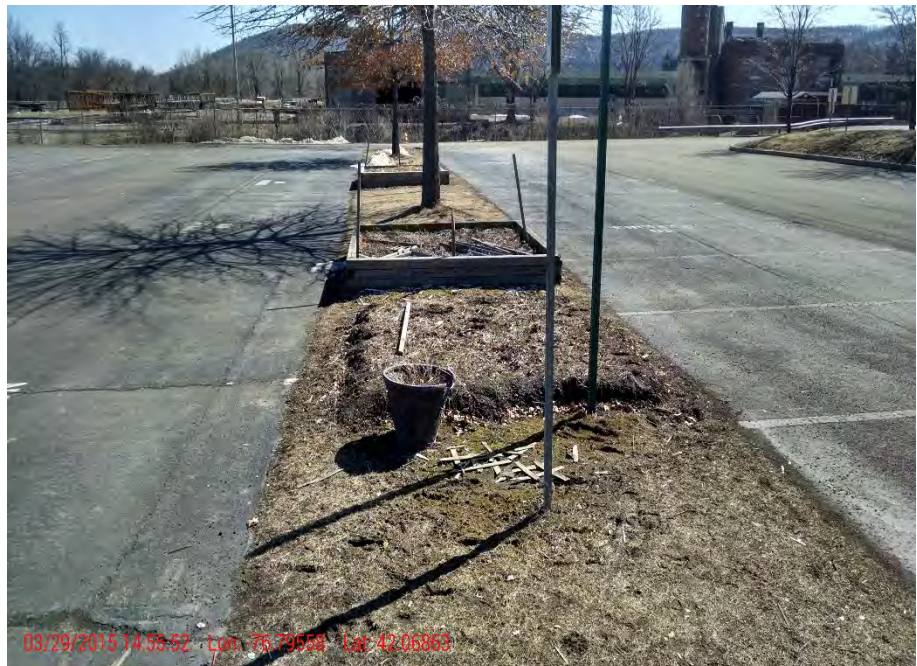
Photograph 6

Comments: Pre-STRA condition of Area 9

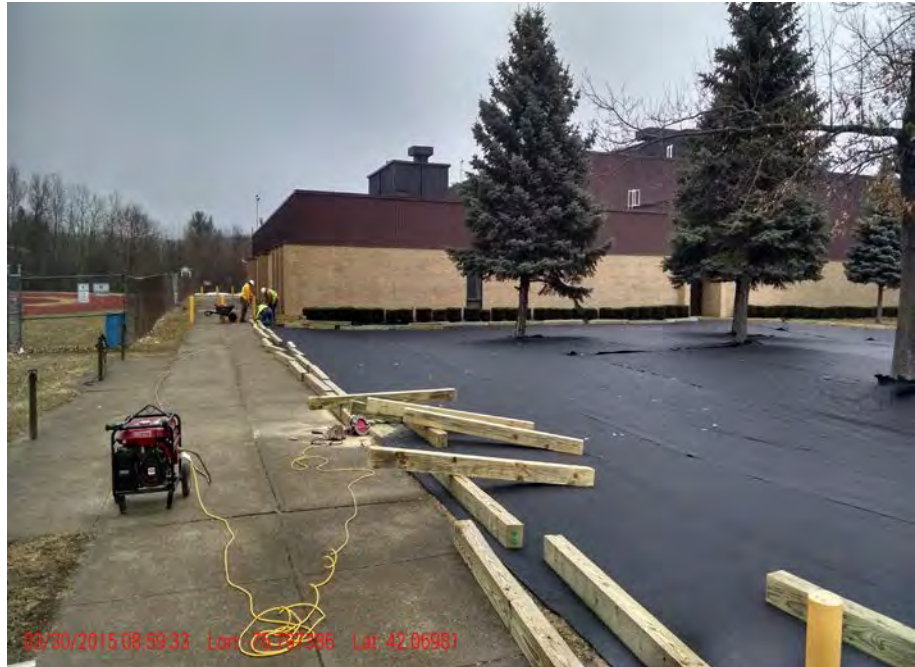
Comments: Laying out border around Area 3

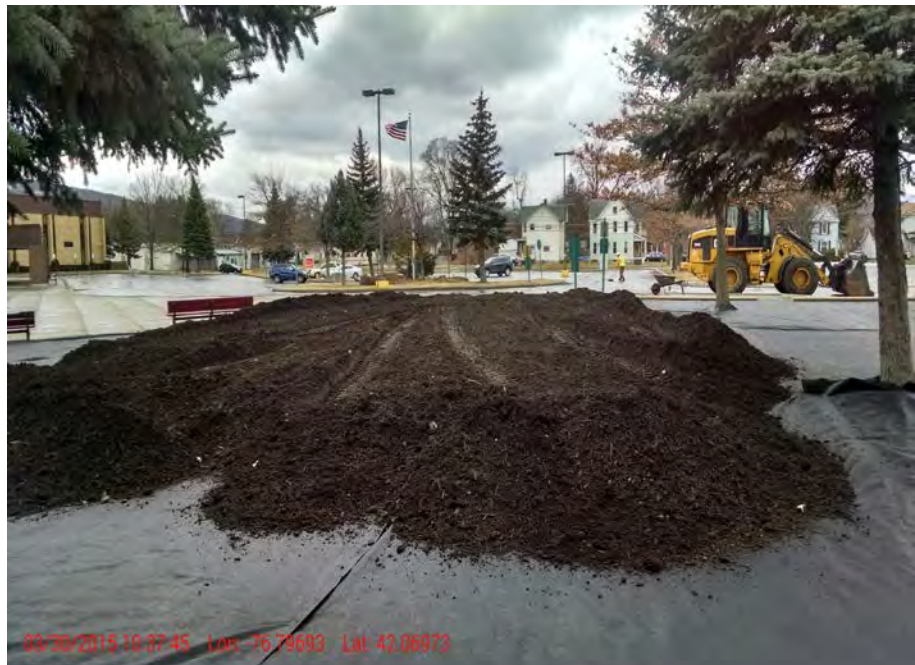
Photograph 8

Comments: Mulch installation - Area 3

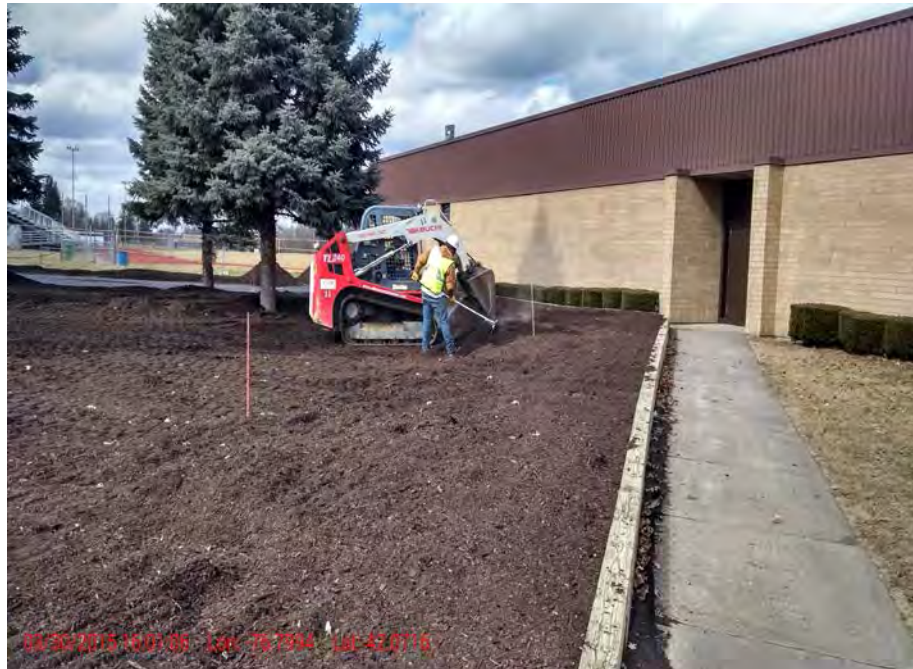
Comments: Area 3 – mulch installation

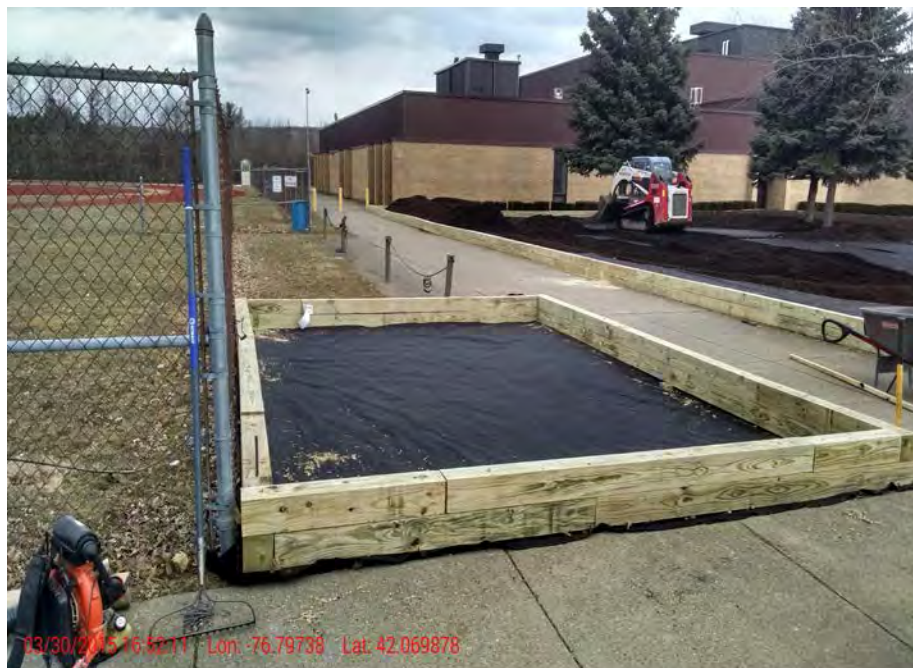
Photograph 10

Comments: Area between Area 2 and Area 3 framed and ready for mulch installation.

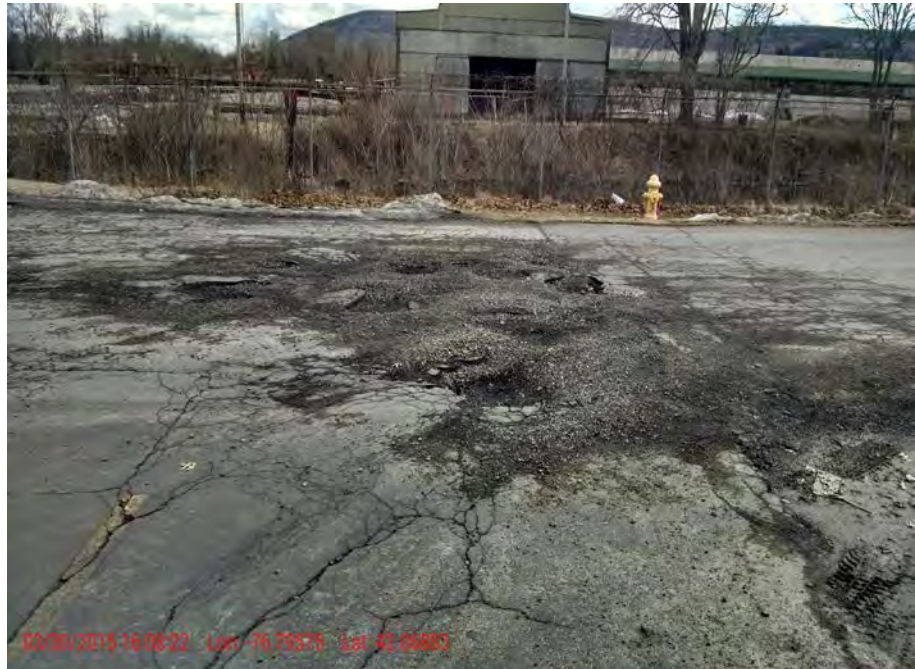
Comments: Pot holes on the south side of the parking. Area added to STRA Area 4 after consultation with NYSDEC.

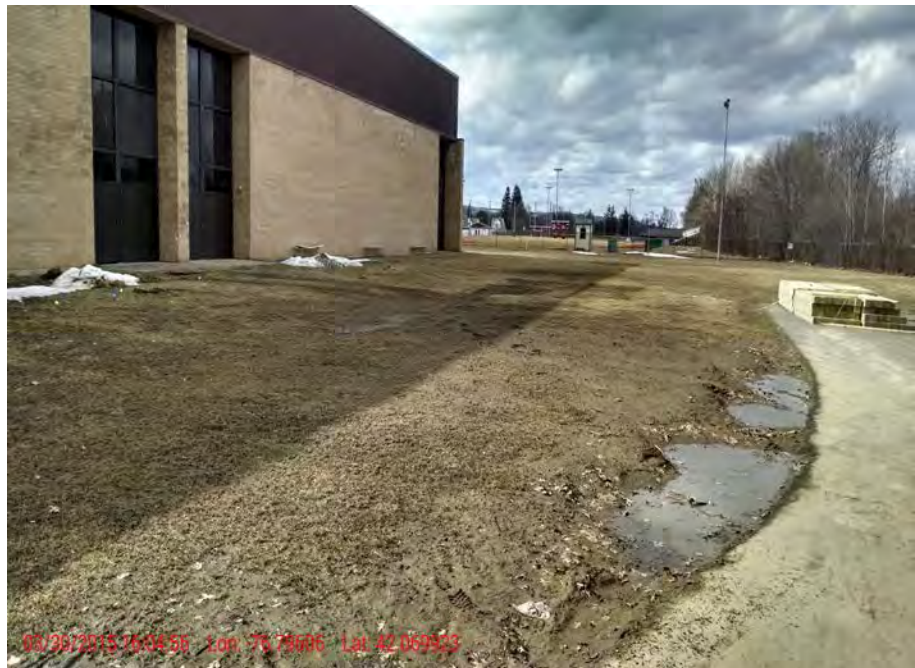
Photograph 12

Comments: Pre-STRA conditions adjacent to Area 4. After consultation with NYSDEC this area was added to Area 4.

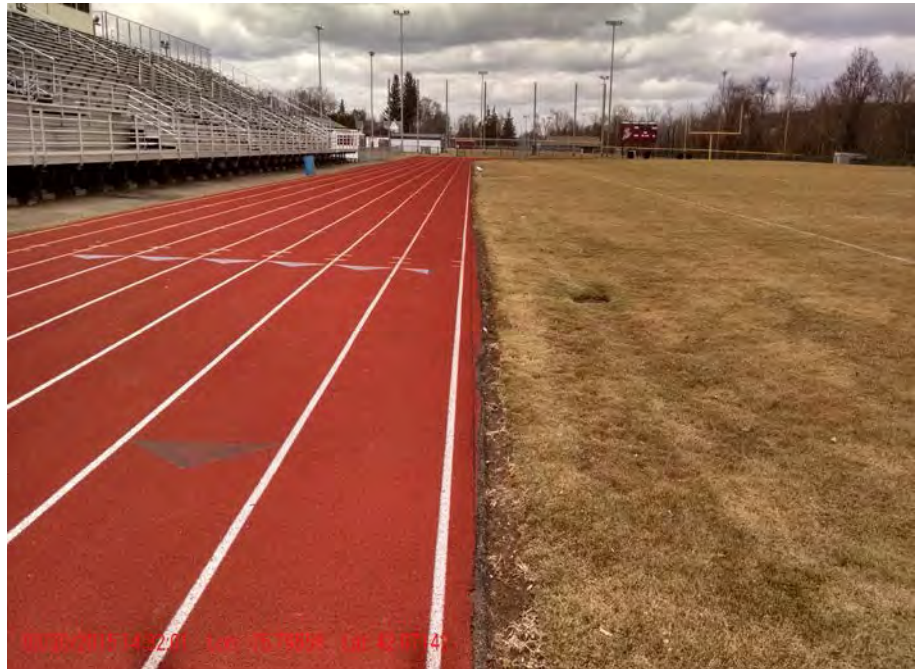
Comments: Football field turf conditions.

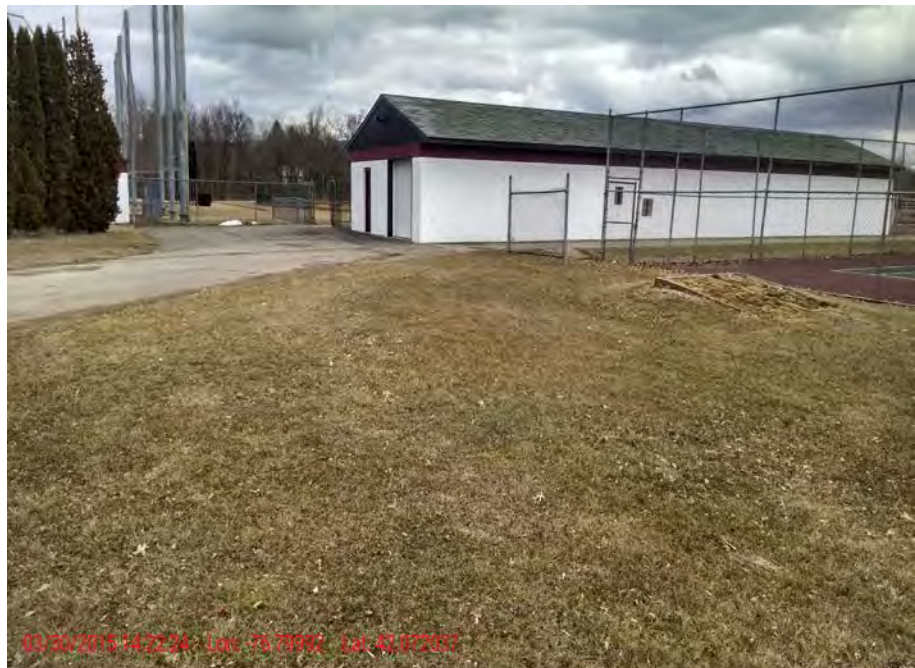
Photograph 14

Comments: Current condition of the grass cover adjacent to the tennis court.

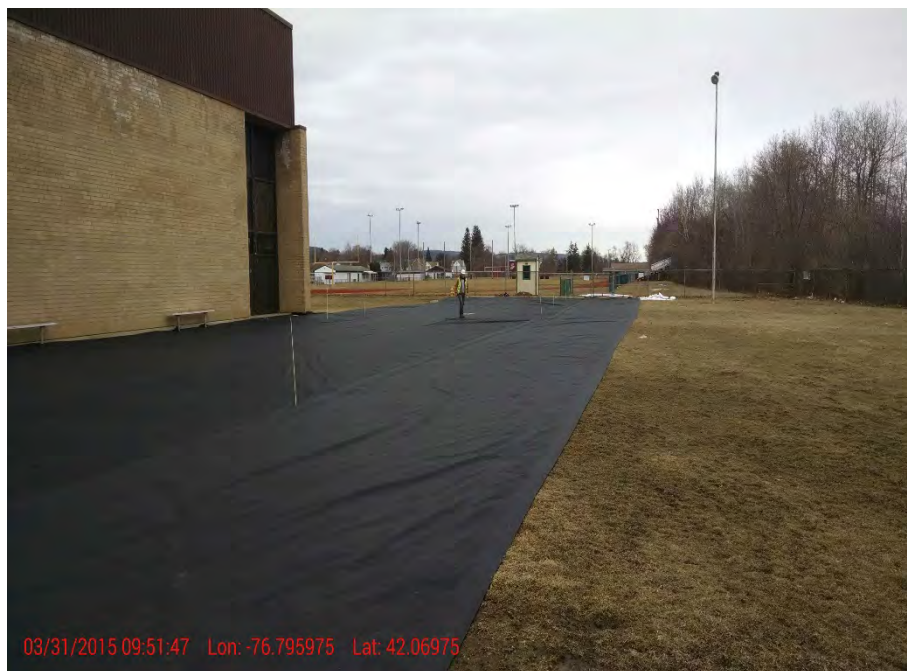
Comments: Laying geotextile in Area 4.

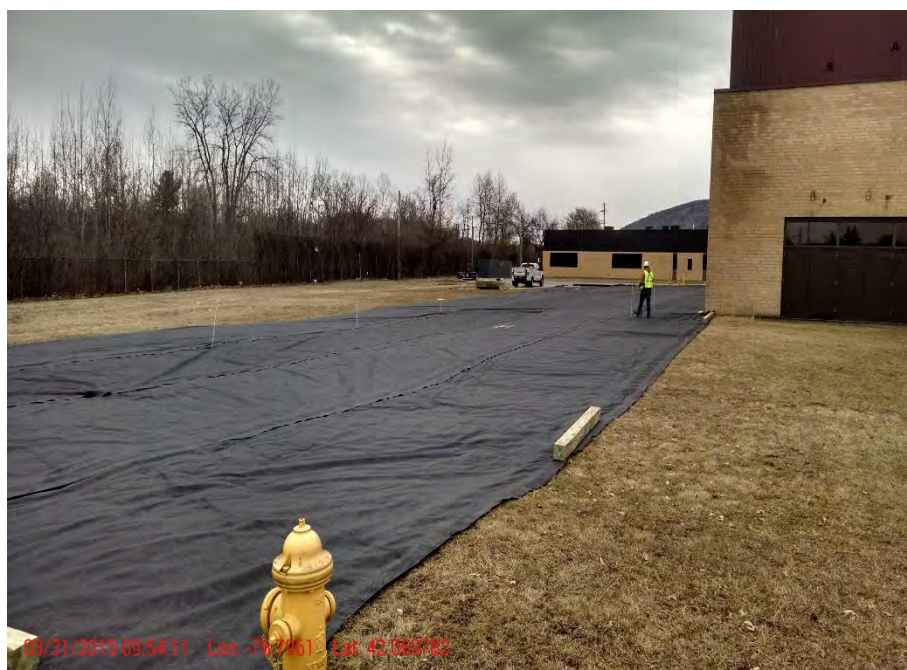
Photograph 16

Comments: Geotextile installed in Area 4

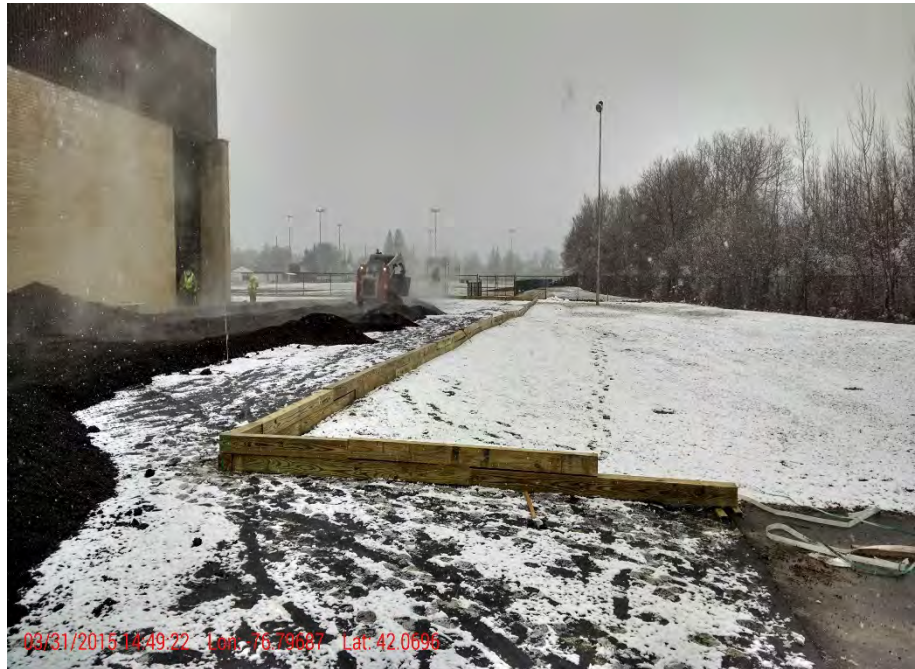
Comments: Framing in Area 4

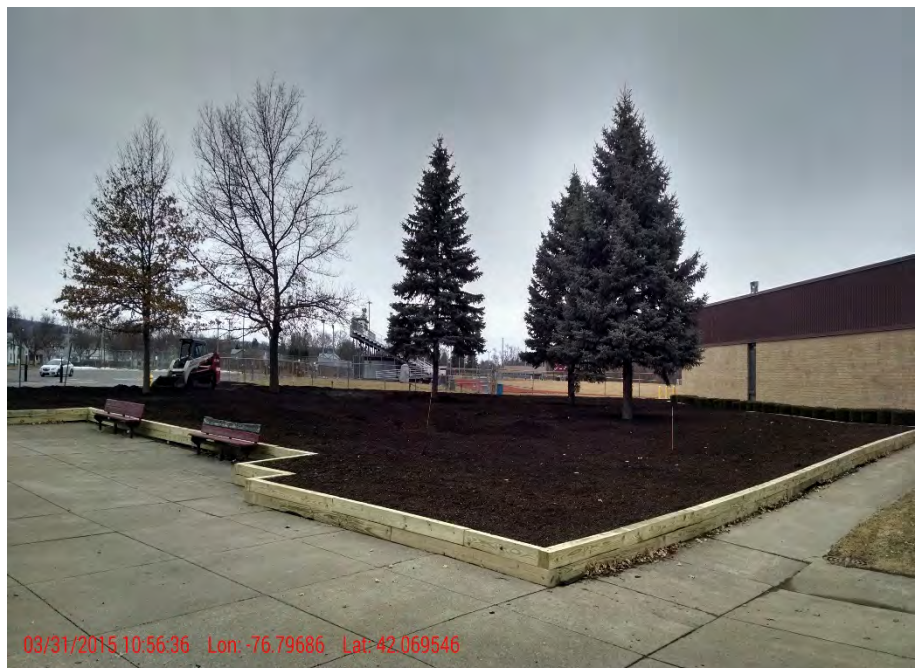
Photograph 18

Comments: Area 3 mulching completed

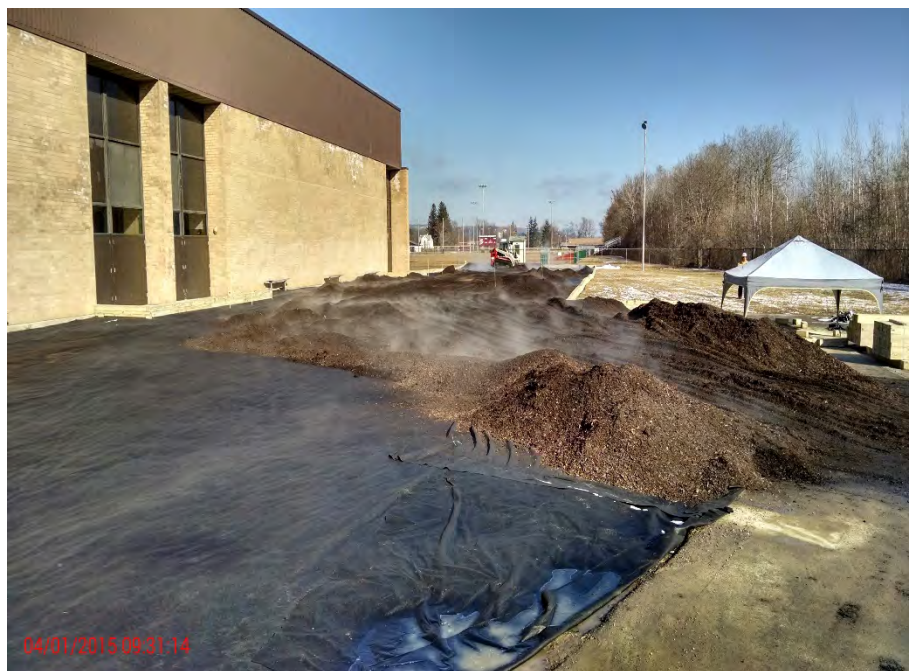
Comments: Placing mulch in Area 4

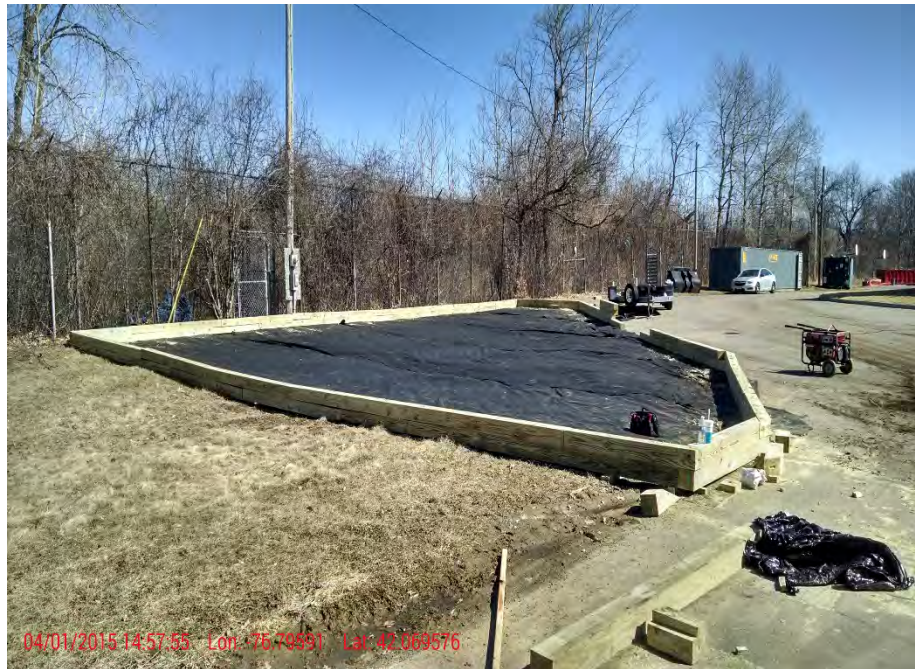
Comments: Area 8 with geotextile and framing.

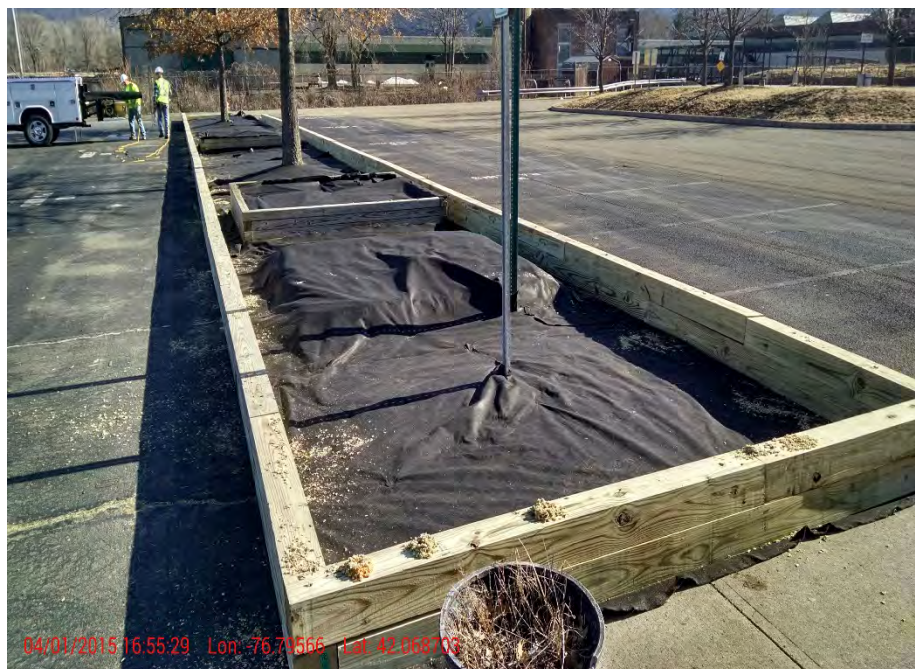
Photograph 21

Comments: Area 9 with fabric and framed.

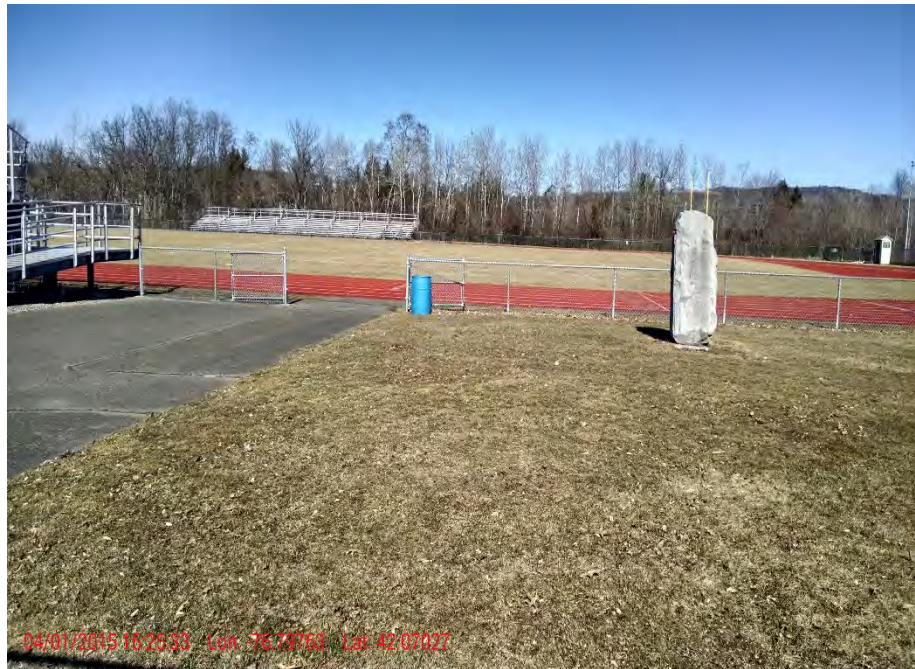
Comments: Waist high fence between the outer fence and Area 2

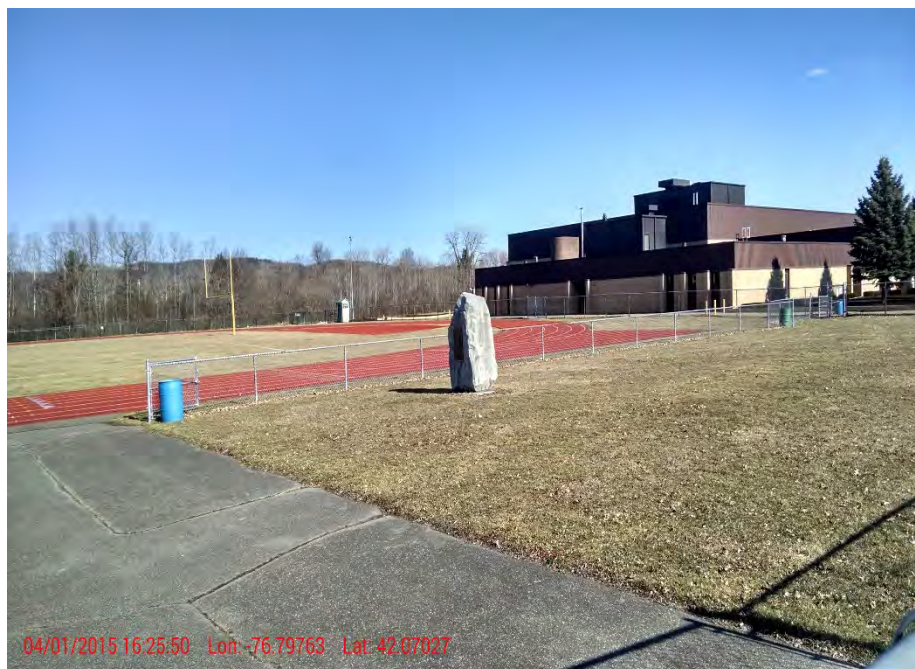
Photograph 23

Comments: Turf conditions, south end of Area 2.

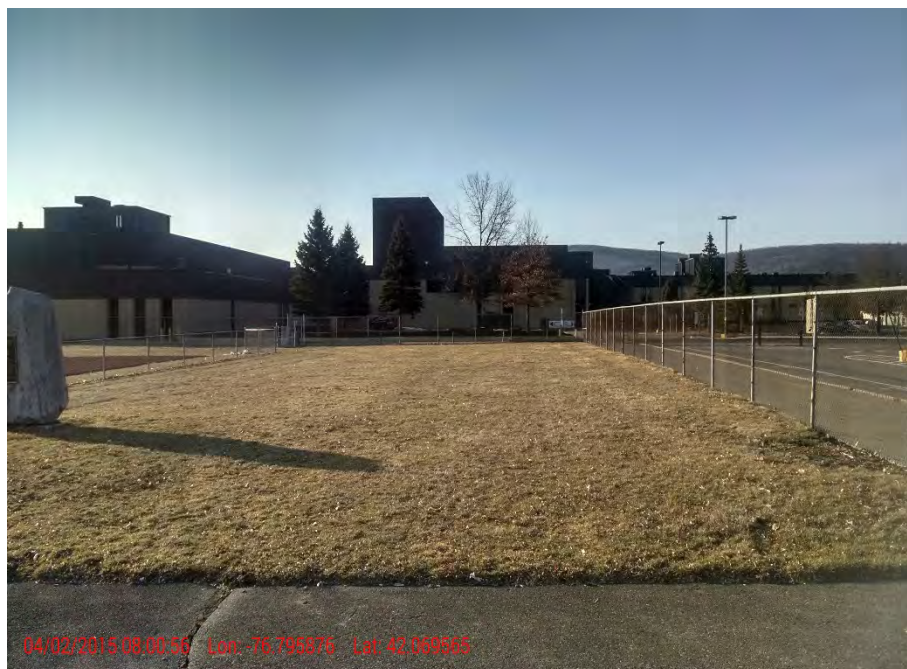
Comments: Area 2 turf conditions.

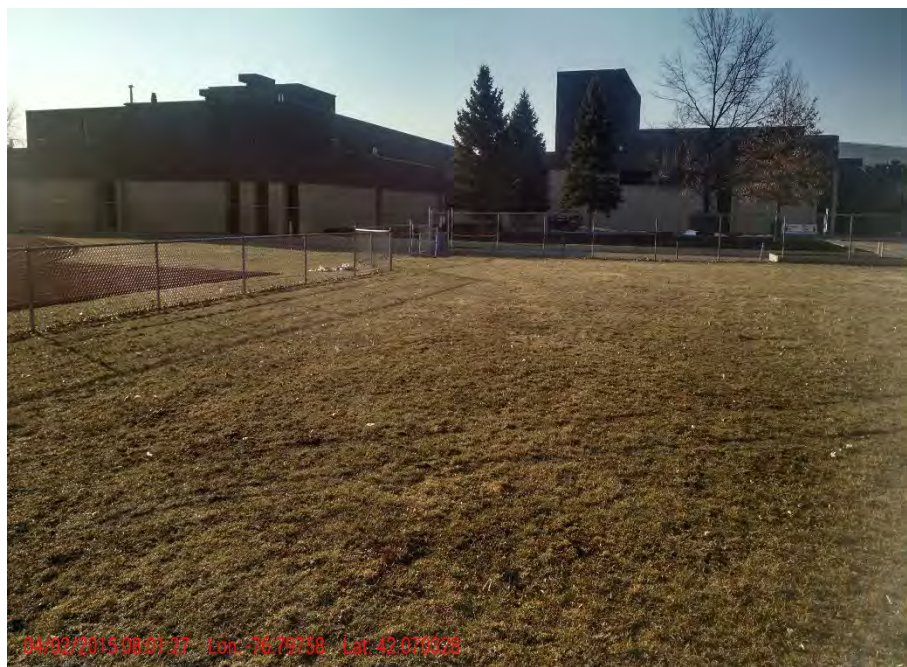
Photograph 25

Comments: Area 2 turf conditions.

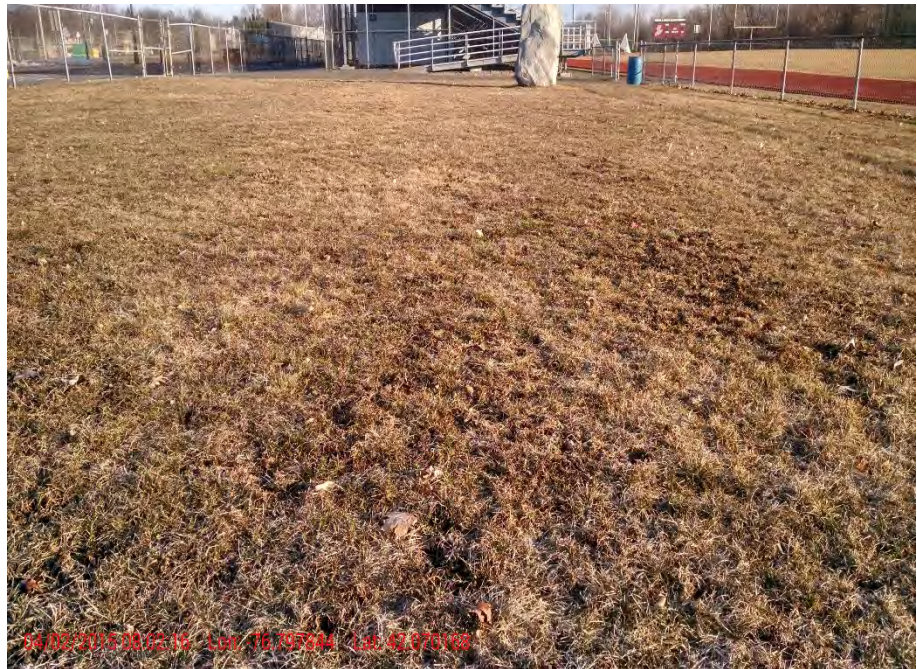
Comments: Condition of the grass cover in Area 2

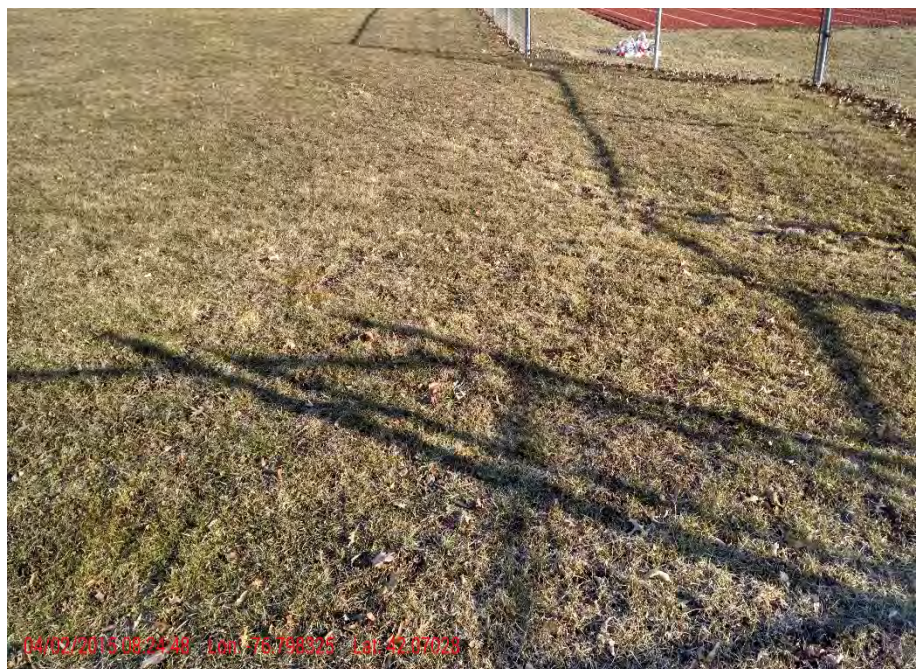
Photograph 27

Comments: Condition of the grass cover in Area 2

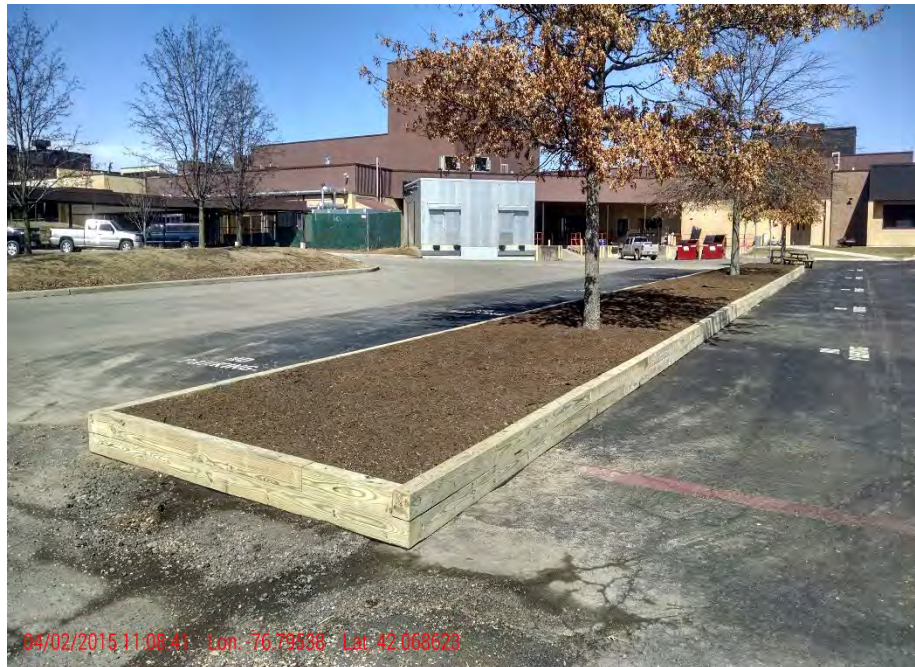
**Comments: Area 9
completed**

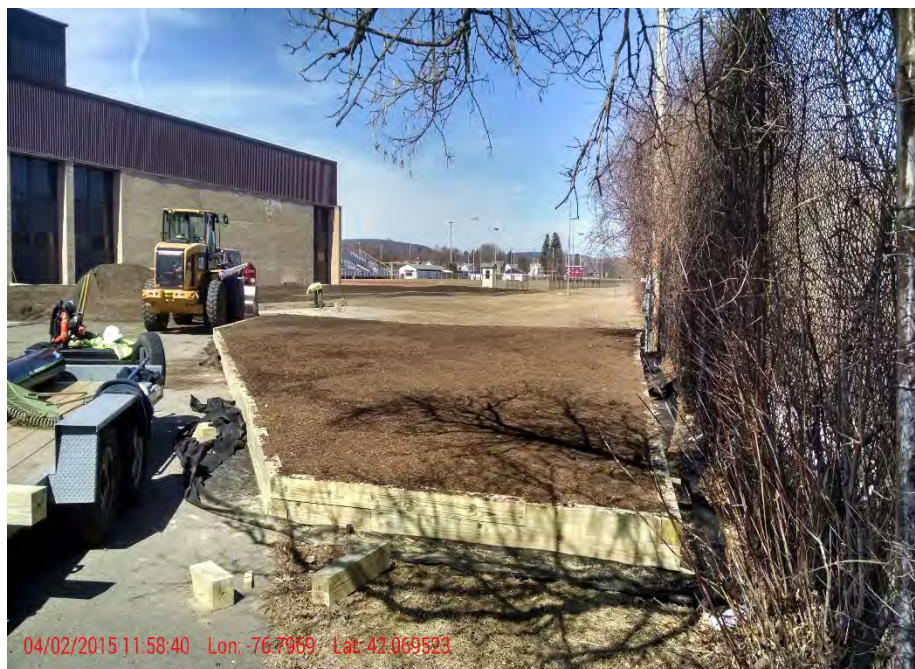
Photograph 29

**Comments: Area 8
completed**

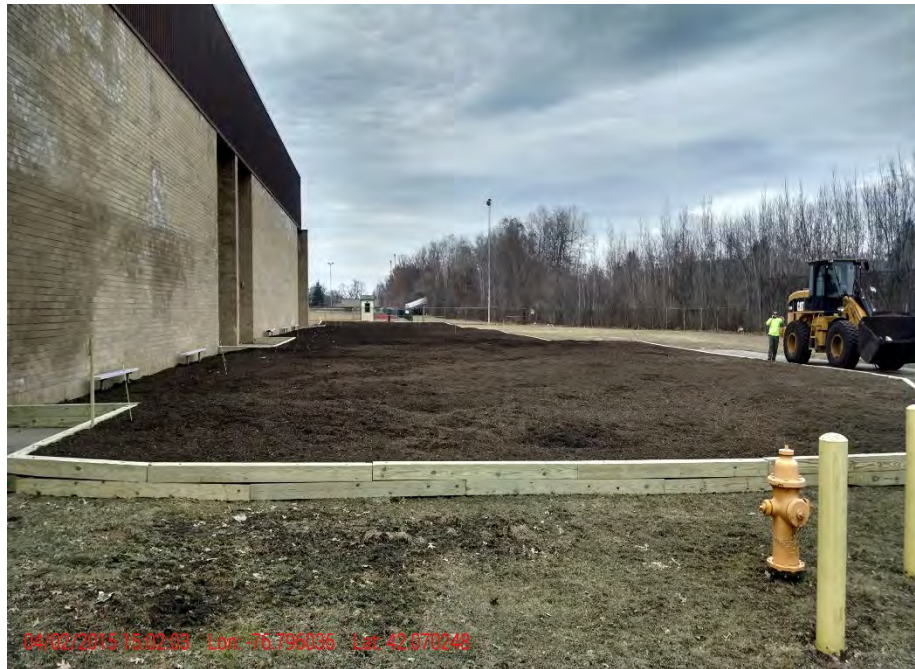
Comments: Area 4 completed
