14 May 2015

**Subject: Short Term Response Action Report
Former Sperry Remington Site – North Portion (#808022)
777 South Main Street, City of Elmira, Chemung County, NY**

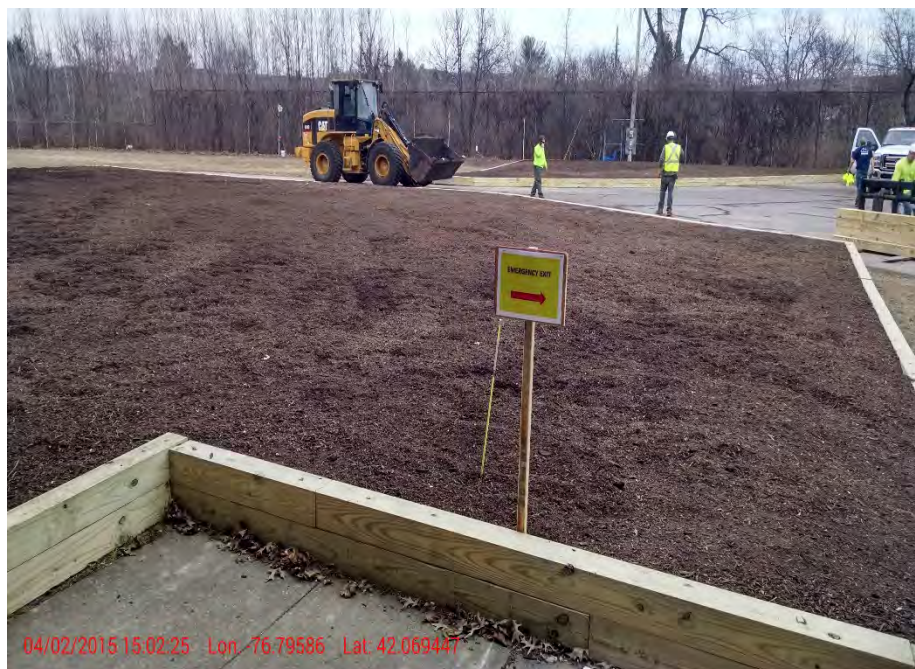
Photograph 31

Comments: Emergency exit signs outside gym and pool.

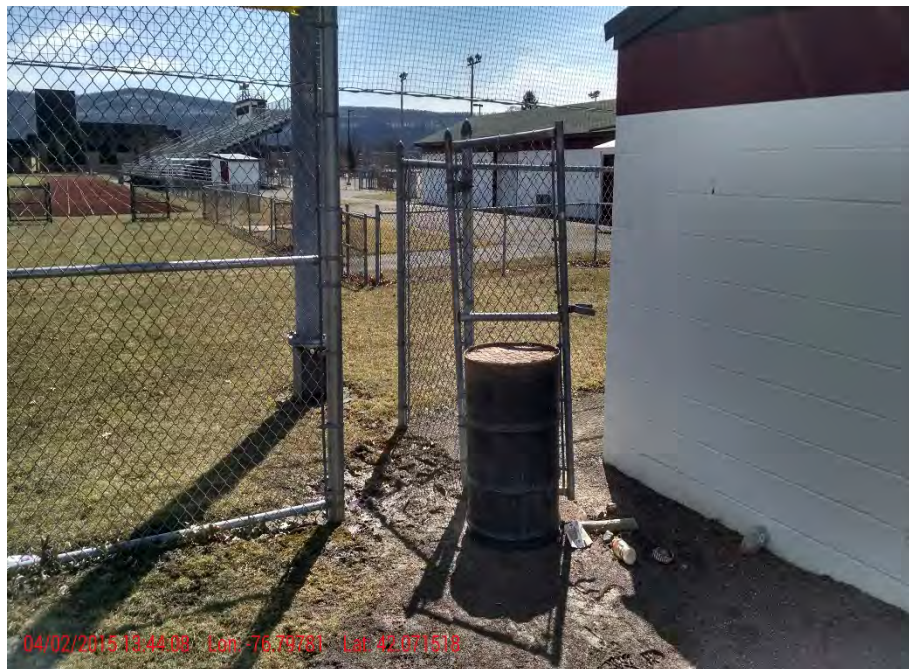
Comments: Man gate at the end of the field

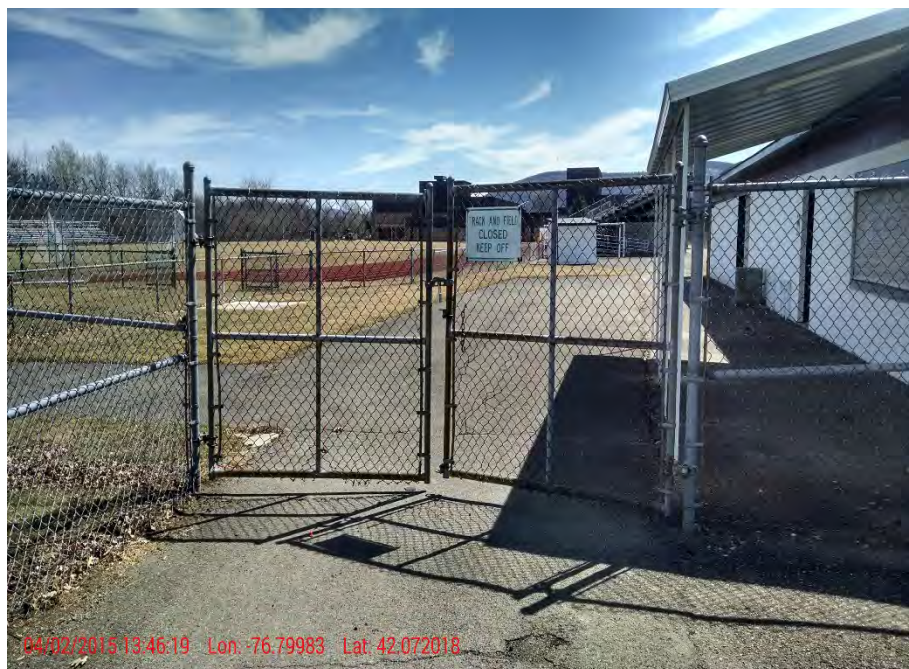
Photograph 33

Comments: Vehicle entry gate on the north side of the field

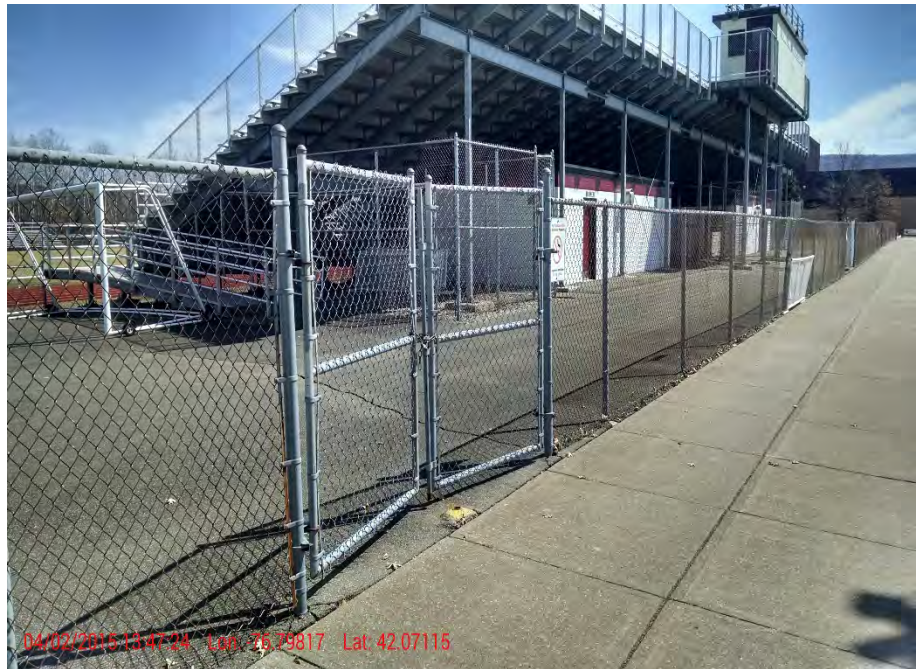
**Comments: Gates on
the north west side of
the site**

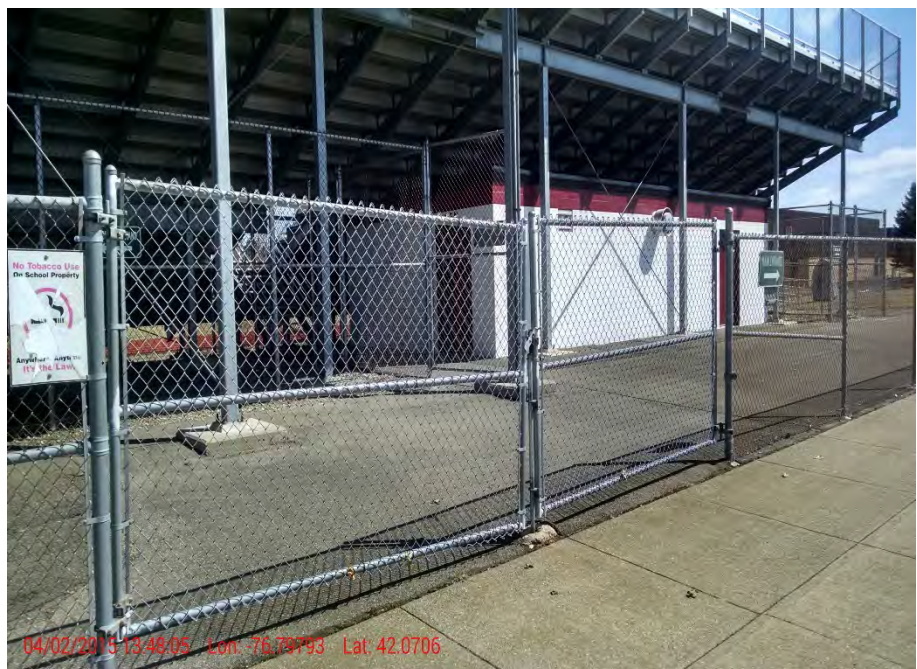
Photograph 35

**Comments: Gate
behind the grandstand
on the west side of the
site.**

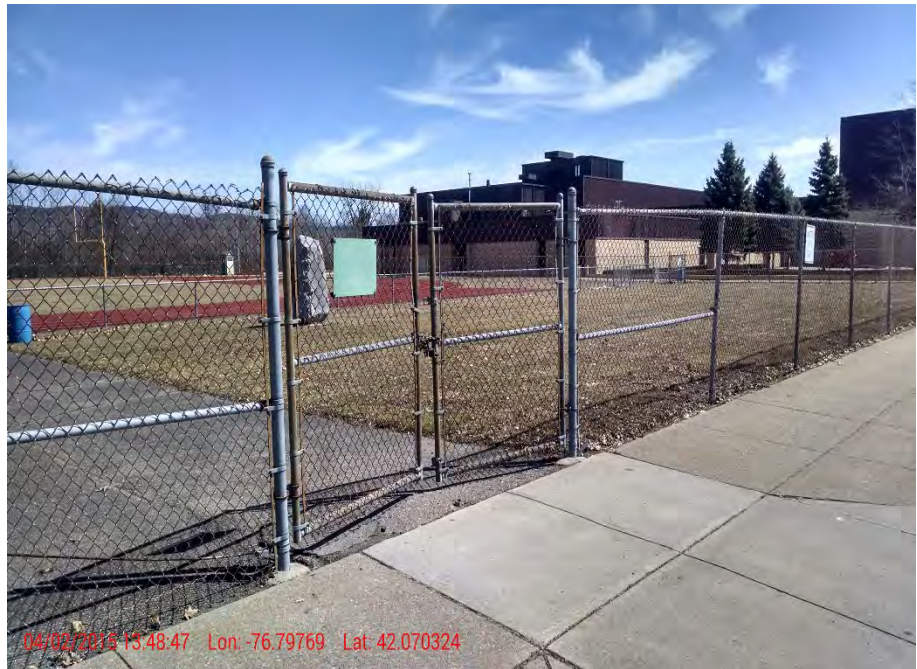
**Comments: Gate
adjacent to Area 2**

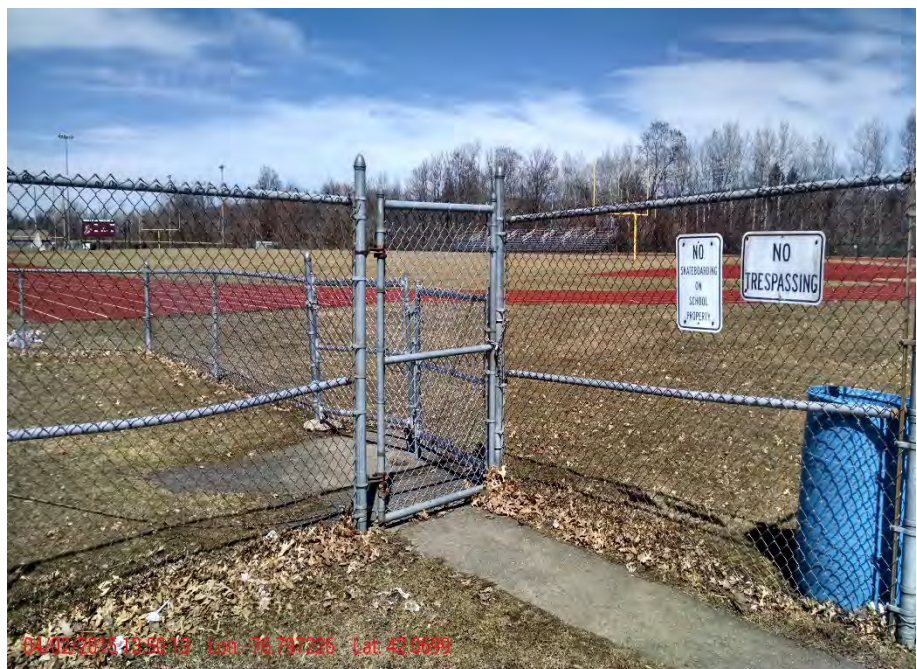
Photograph 37

**Comments: Gate on
the south side of Area
2.**

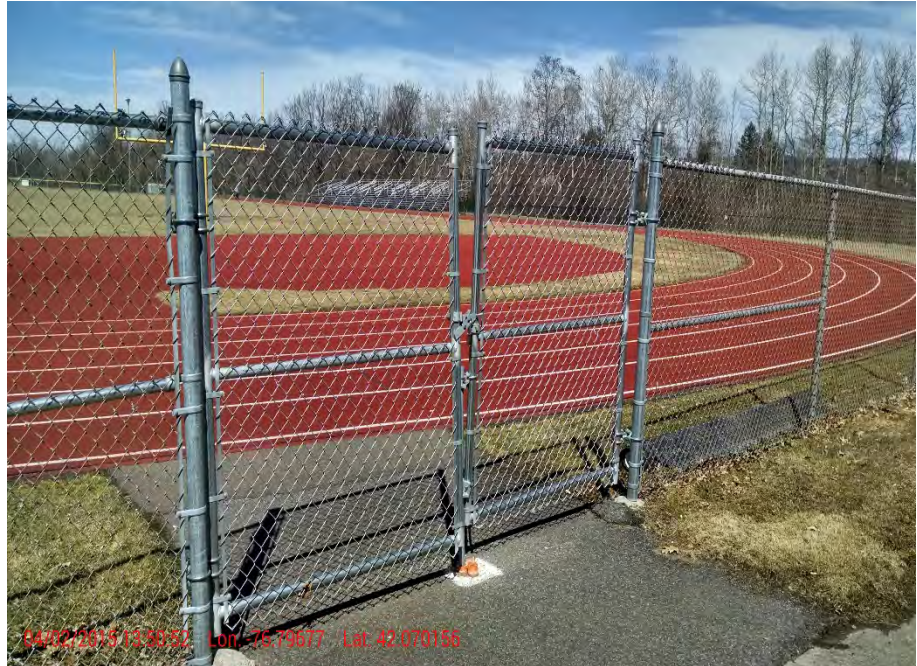
Comments: Gate on the south side of the football field.

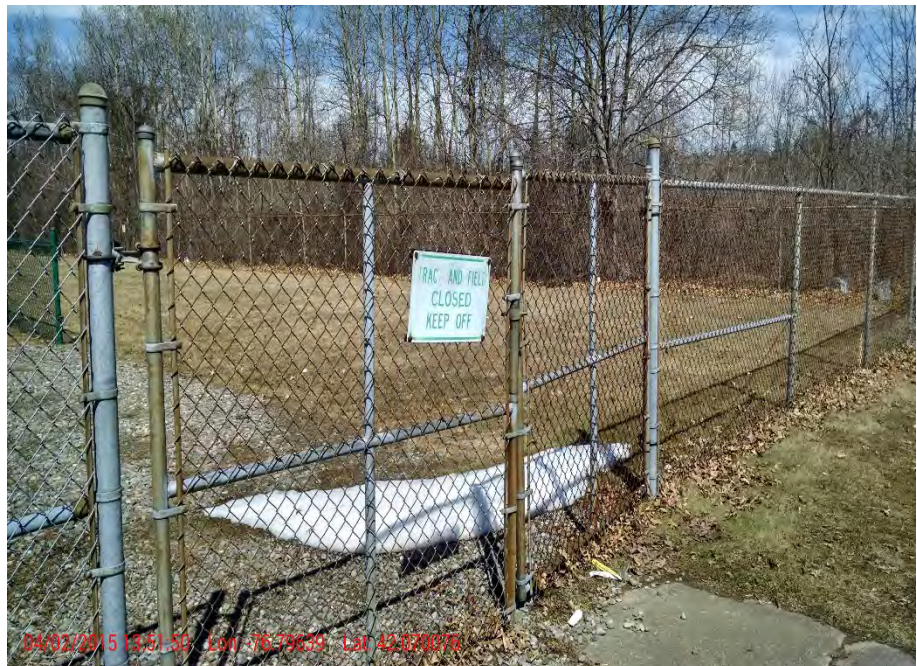
Photograph 39

Comments: Gate on the southwest corner of the football field.
