### Inline Camera Sewer Inspections

# SUBSURFACE UTILITY ENGINEERING PROJECT COMPLETION REPORT

DATE: 1/24/2020, **Revised 1/31/2020**

PROJECT NAME: Football Field Complex, Elmira, NY

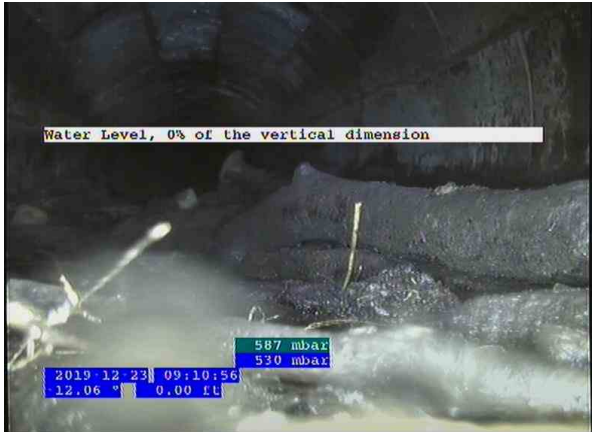
CB-15 to  
Unkonwn\_5d9536ee-0086-4a96-8d9d-b047ccc76eb3\_201912  
23\_092042\_185.jpg, 00:00:00, 0.00ft  
Water Level, 0% of the vertical dimension

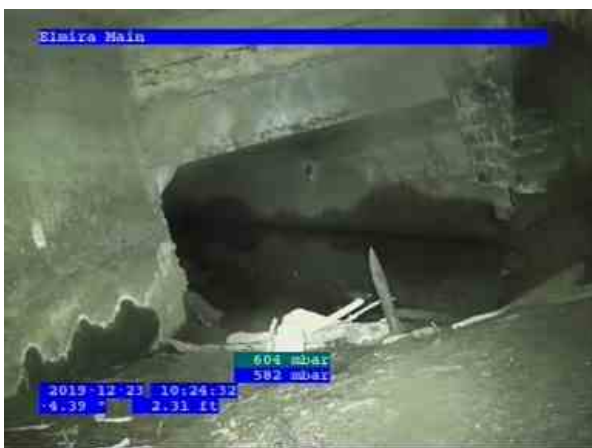
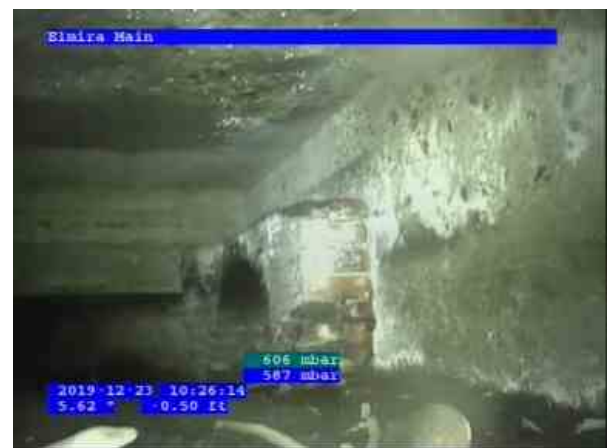
CB-15 to  
Unkonwn\_8b18f192-5f82-4cb8-abec-494fe7f9c17e\_20200116  
\_202616\_483.jpg, 00:00:59, 0.00ft  
General Observation / Pipe to the west from CB15 main line in  
the large vault like manhole

CB-15 to  
Unkonwn\_66e81865-30aa-450d-9b37-f8c4fd69e433\_2020011  
6\_202753\_009.jpg, 00:00:59, 0.00ft  
General Observation / Pipe to the west from CB15 main line in  
the large vault like manhole

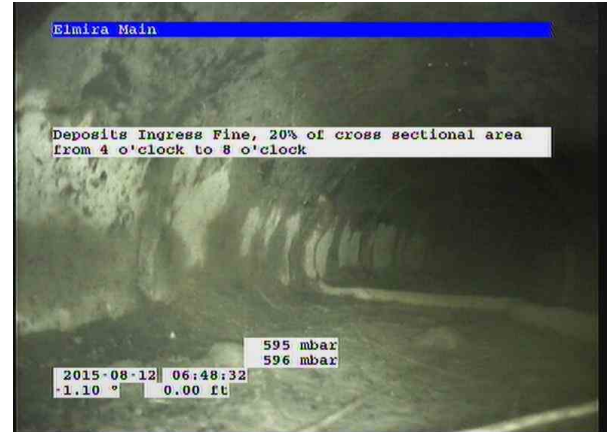
100 ft N  
CB24\_fd7bd9d1-089b-447f-b169-1101e55f2961\_20191223\_125549\_819.jpg, 00:00:00, 0.00ft  
Deposits Ingress Fine, 20% of cross sectional area from 4 o'clock to 8 o'clock

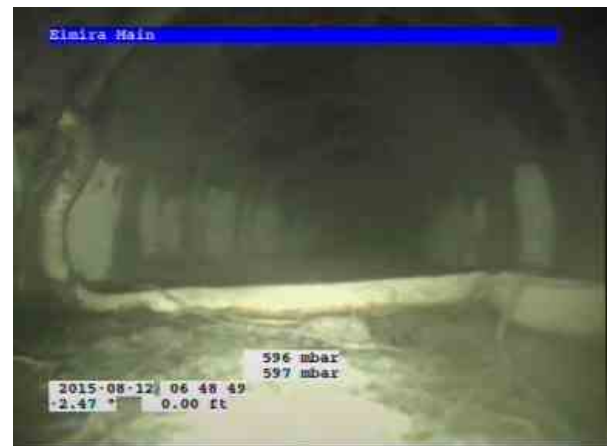
Test Pit 3 to  
CB24\_e0451d6a-9a20-41c9-807d-15aefa77ebb6\_20200116\_203414\_514.jpg, 00:00:08, 0.00ft  
Roots Tap Barrell from 4 o'clock to 8 o'clock, 10% of cross sectional area, within 8 inch, Start / Restricted Robot Movement

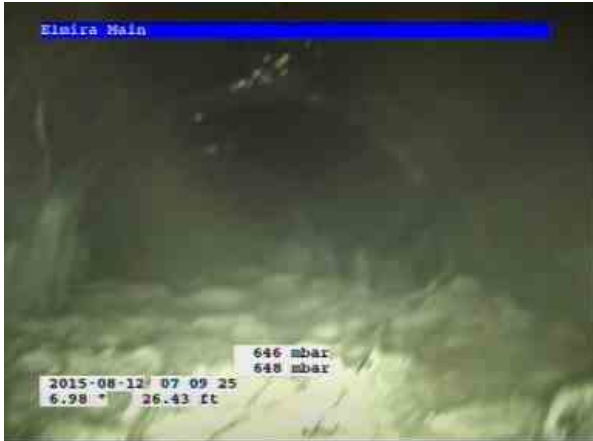
Test Pit 3 to  
CB24\_429c2098-c040-43cc-9dd2-596e8ab088cc\_20200116\_203628\_049.jpg, 00:15:10, 26.00ft  
Deposits Ingress Gravel, 40% of cross sectional area from 3 o'clock to 9 o'clock, within 8 inch, Start

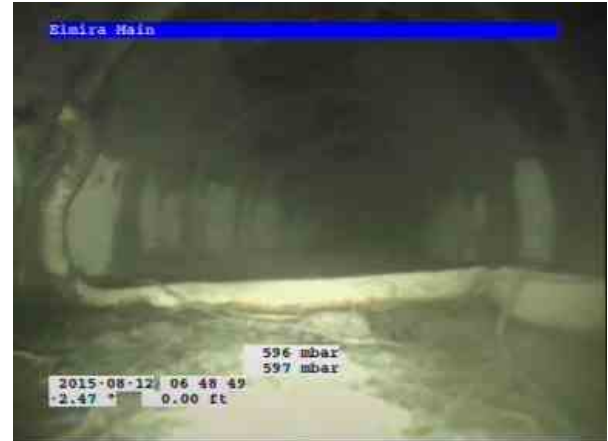
Test Pit 3 to  
CB24\_4385de2d-c372-4285-972d-a1a498ae8a72\_20200116\_203933\_753.jpg, 00:00:08, 30.00ft  
Roots Tap Barrell from 4 o'clock to 8 o'clock, 10% of cross sectional area, within 8 inch, Finish / Restricted Robot Movement

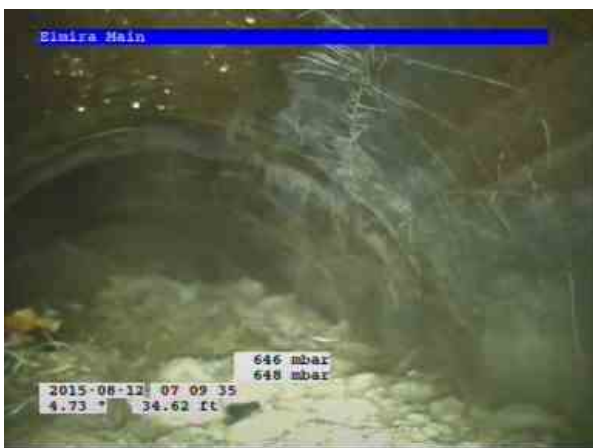
Test Pit 3 to  
CB24\_193ac897-ba82-42a1-8636-2d8ac1facbb\_20200116\_203846\_891.jpg, 00:15:21, 35.00ft  
Deposits Ingress Gravel, 100% of cross sectional area from 12 o'clock to 12 o'clock, within 8 inch

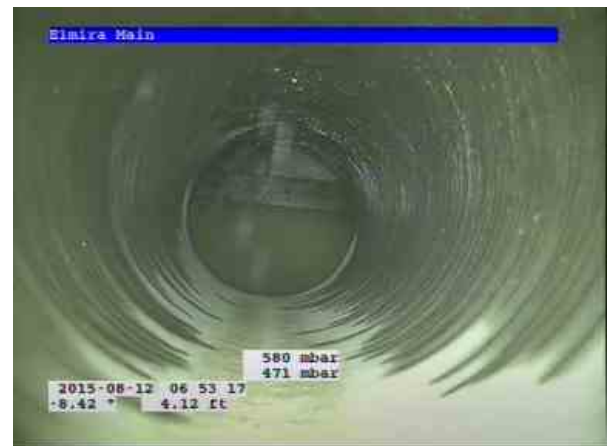
CB-08 to  
CB-05\_7918116b-a89f-4947-a85a-91bfc2f12073\_20200116\_2  
05255\_403.jpg, 00:07:22, 9.03ft  
Tee Connection at 12 o'clock, 12"inch vertical

CB-08 to  
CB-05\_82122a3b-94c4-4f3d-9f4d-24c45f0c4c50\_20200116\_2  
05336\_185.jpg, 00:07:22, 9.03ft  
Tee Connection at 12 o'clock, 12"inch vertical

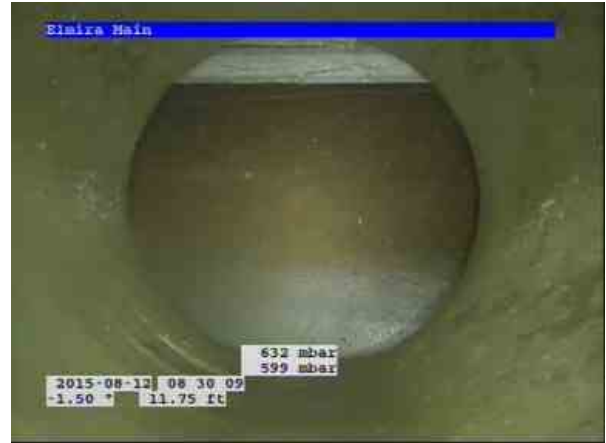
cb02 to  
west\_8bacb4ef-3d2a-4fad-97fb-8a5a6a0566c6\_20200116\_20  
5609\_951.jpg, 00:02:31, 14.20ft  
Tee Connection at 3 o'clock, 36"inch vertical

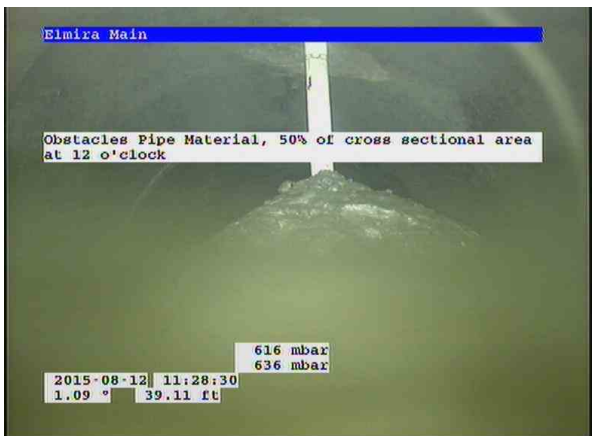
tp-9 to tp  
10\_dc7e1b52-471d-4d07-ae9e-686ce495abdf\_20191227\_142  
541\_658.jpg, 00:18:41, 39.11ft  
Obstacles External Pipe or Cable, 20% of cross sectional area  
at 12 o'clock

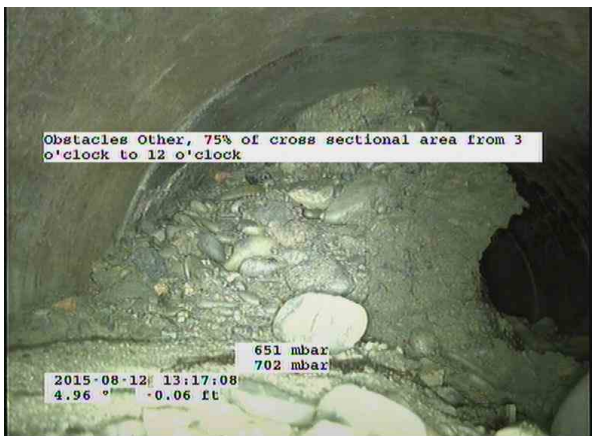
tp7  
cb1\_0b6ffbc7-a5dd-4884-b536-bdfcb22f2ae9\_20191227\_161  
419\_952.jpg, 00:02:19, 4.00ft  
Deposits Settled Gravel, 80% of cross sectional area from 4 o'clock to 12 o'clock, within 8 inch

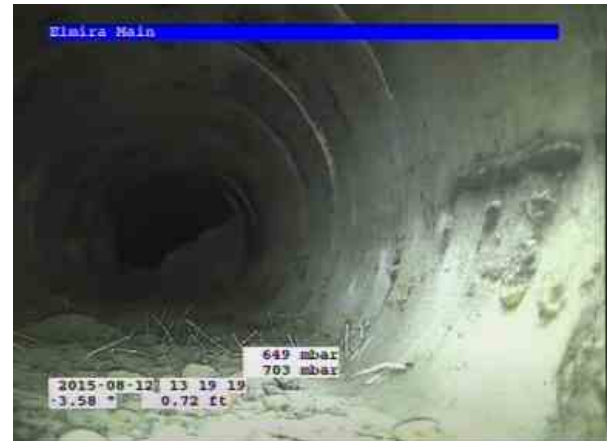
TP-07 to  
CB-24\_272ee1b9-0713-4031-a3c3-a601bffe9576\_20200116\_211526\_222.jpg, 00:00:39, 0.00ft  
Deposits Settled Gravel, 15% of cross sectional area from 4 o'clock to 8 o'clock, Start

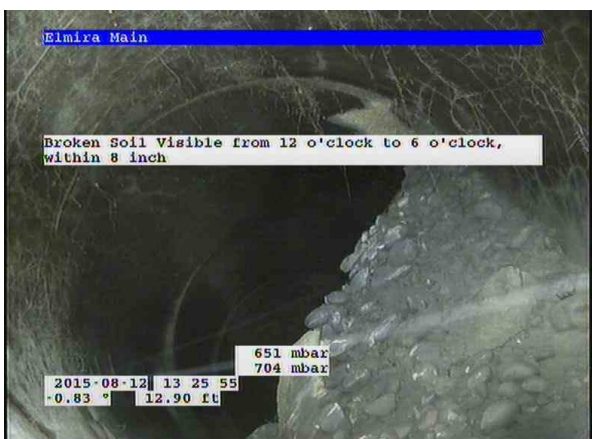
tp7 to  
cb24\_6fc84e18-5cff-42e2-a8e7-d1007cb0572a\_20191227\_16  
2307\_412.jpg, 00:03:05, 12.90ft  
Broken Soil Visible from 12 o'clock to 6 o'clock, within 8 inch

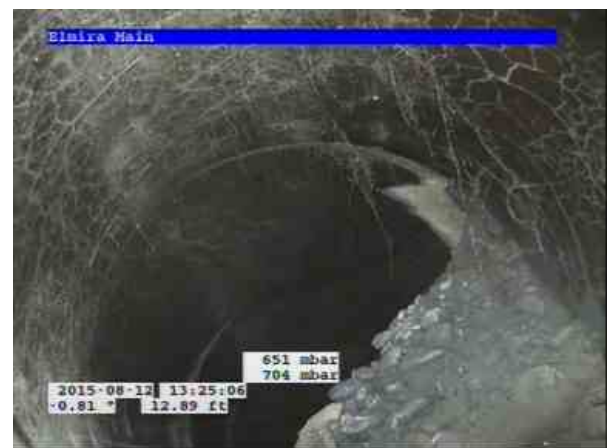
TP-07 to  
CB-24\_6736e719-2d5b-4ac1-88c1-db9eb574c72d\_20200116\_211026\_467.jpg, 00:02:50, 13.00ft  
Deposits Ingress Gravel, 65% of cross sectional area from 1 o'clock to 7 o'clock, within 8 inch

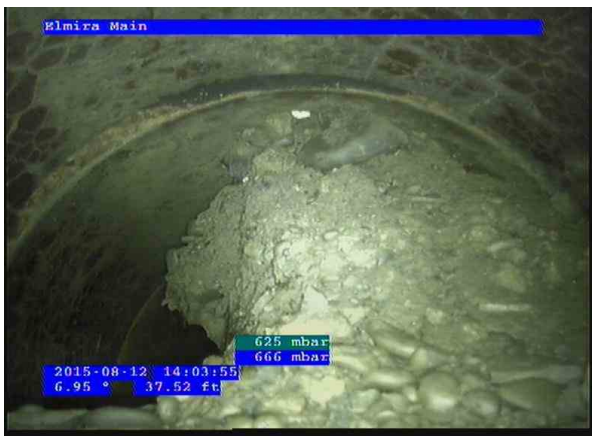
CB1 to  
North\_34b2221a-9bc8-45a6-be9f-adab65d65e17\_20191227\_171006\_857.jpg, 00:01:25, 37.52ft  
Deposits Ingress Gravel, 85% of cross sectional area from 11 o'clock to 7 o'clock, within 8 inch

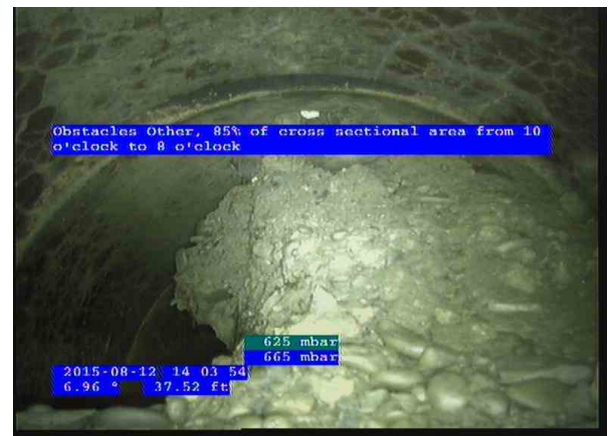
| 1:284 | Distance | Code | Observation | Counter | Photo | Grade | |
|---|---|---|---|---|---|---|---|
| | 37.52 | HSV | Hole Soil Visible at 12 o'clock, within 8 inch, 3inch defective | 00:01:22 | CB1 to North_f745 a7d9-1f96- | S5 | |

CB1 to  
North\_f745a7d9-1f96-485b-b468-2b0fa75d1210\_20191227\_171005\_621.jpg, 00:01:22, 37.52ft  
Hole Soil Visible at 12 o'clock, within 8 inch, 3inch defective

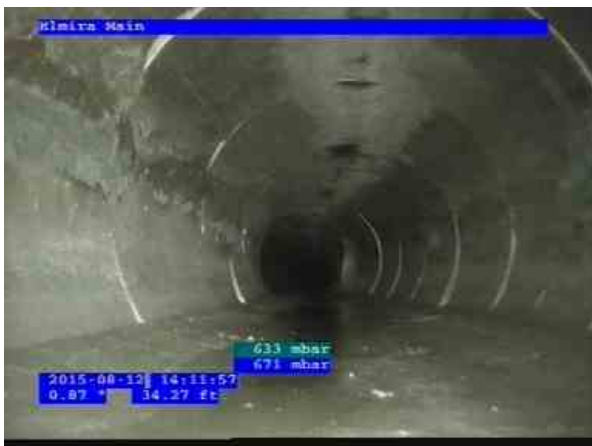
CB-01 to  
TP-09\_e1a0b801-41b1-4691-b8b6-3c378fd5efef\_20200116\_2  
12138\_866.jpg, 00:00:36, 0.00ft  
Deposits Settled Fine, 15% of cross sectional area from 4  
o'clock to 8 o'clock, within 8 inch, Start / MUD

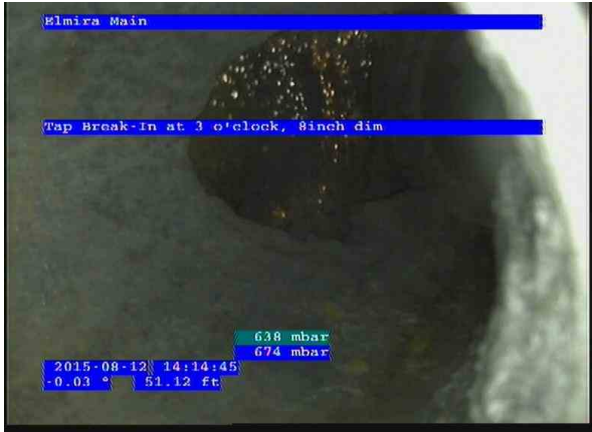
cb1 to  
tp9\_0b14f4d2-d1c7-4454-a854-ed68ed522aaa\_20191227\_17  
2057\_095.jpg, 00:02:56, 51.12ft  
Tap Break-In at 3 o'clock, 8inch dim

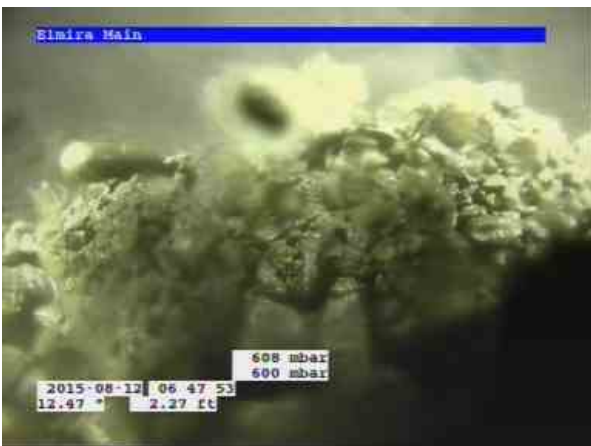
Test Pit 8 to the  
West\_8c26fefb-8314-4832-b1af-1d2df3c1615e\_20200130\_19  
2036\_857.jpg, 00:01:04, 2.27ft  
Obstacles Other, 50% of cross sectional area from 3 o'clock to  
9 o'clock / Mud

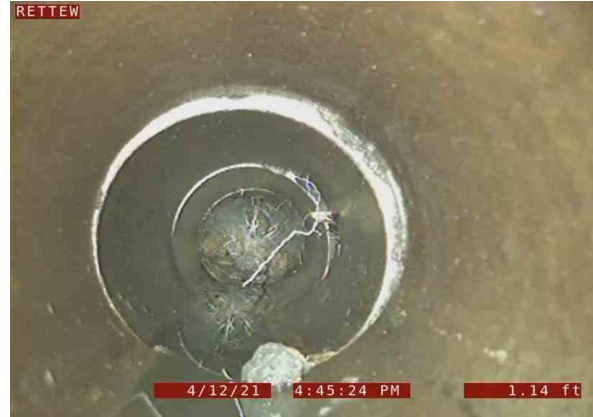
2, 00:00:11, 3.00ft  
Joint Offset Medium

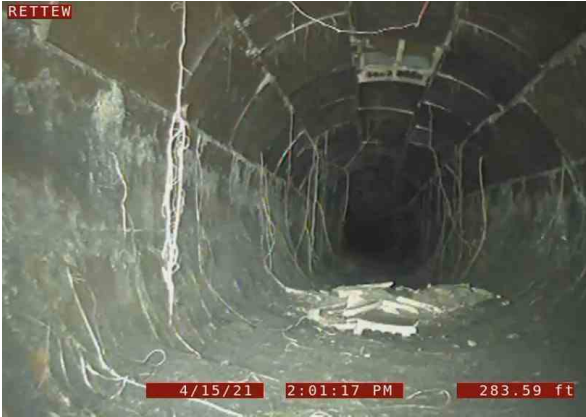
| 1:3926 | Distance | Code | Observation | Grade | | | |
|---|---|---|---|---|---|---|---|
| | 295.00 | B | Broken at 12 o'clock | S3 | | | |

5, 00:08:02, 295.00ft  
Broken at 12 o'clock

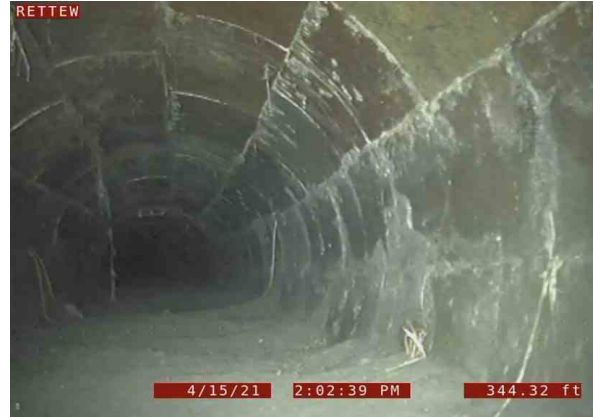
6, 00:09:23, 344.00ft  
Deposits Settled Fine, 25% of cross sectional area from 4 o'clock to 8 o'clock, Start
