### Technical Impracticabilty Structures

# NORTHERN ATHLETIC FIELDS INTERIM REMEDIAL MEASURE

# INTERIM REMEDIATION MEASURE #2

## **Appendix N – Technical Impracticability Structures**

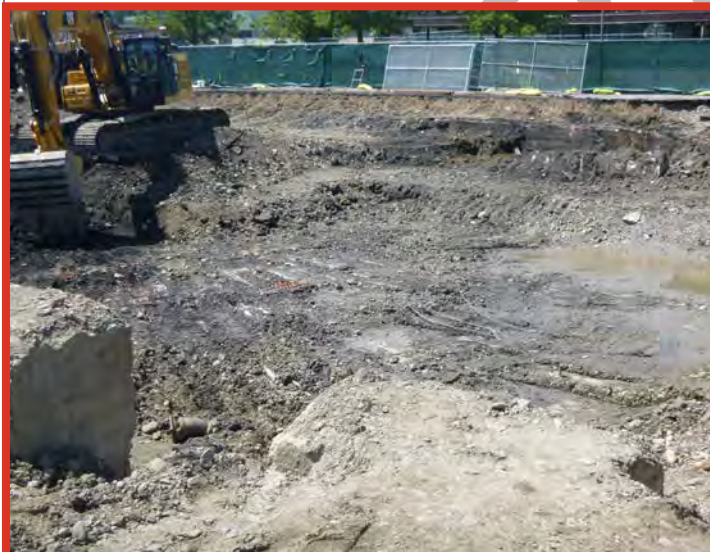
Concrete slab exposed at a depth of ~8.5 ft bgs

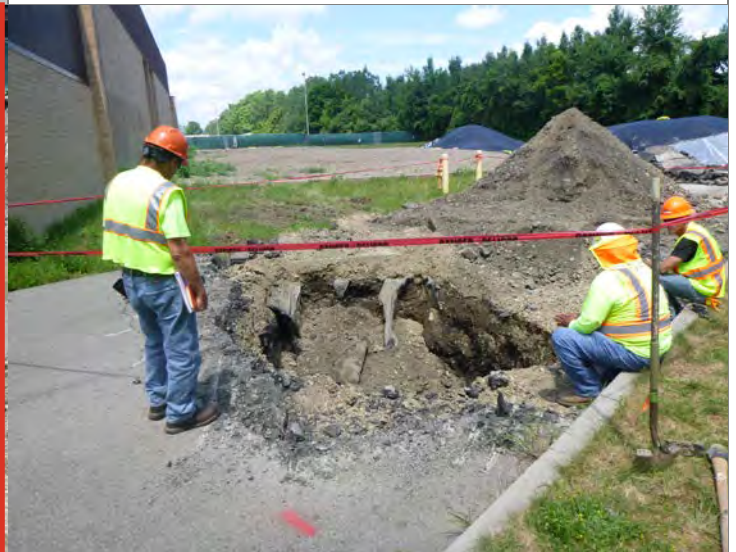
Scott Williams from the DEC and Recon at the water line excavation in the afternoon. Water line found at ~8 ft bgs.

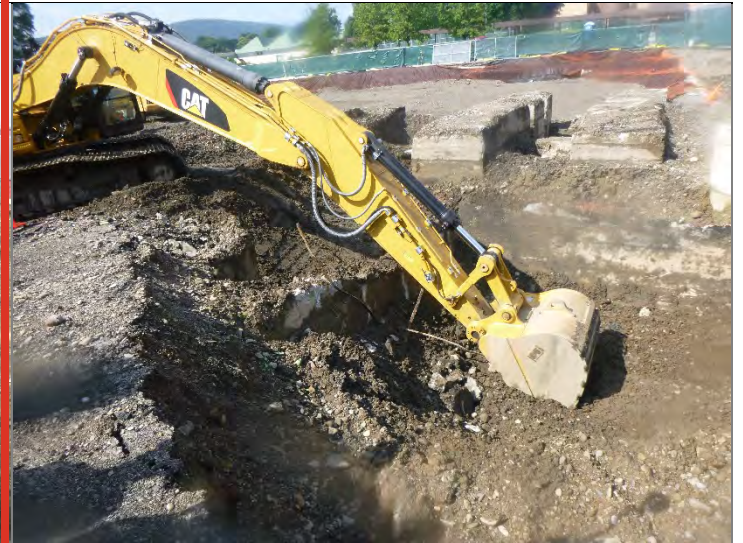
Exposed concrete structure

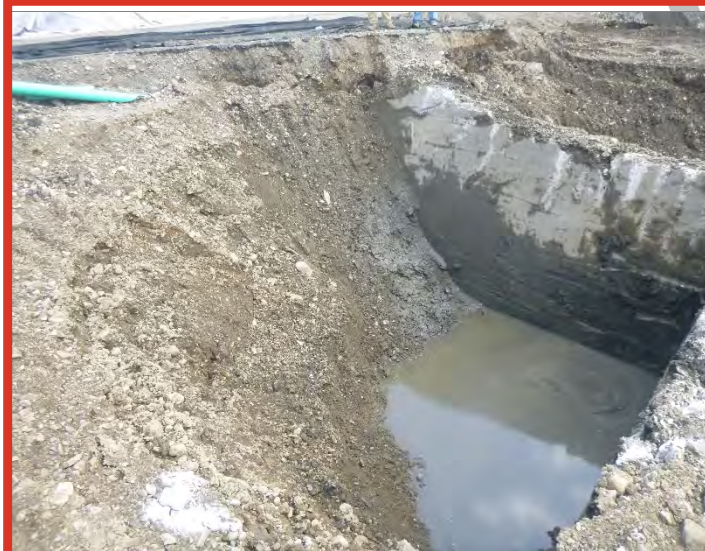
Bottom slab of concrete structure~13.5' + below BGS

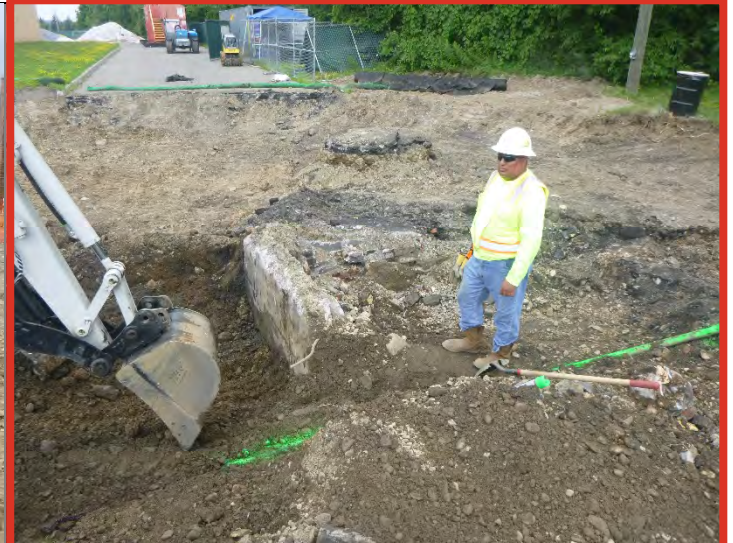
Concrete structure found adjacent to gas line

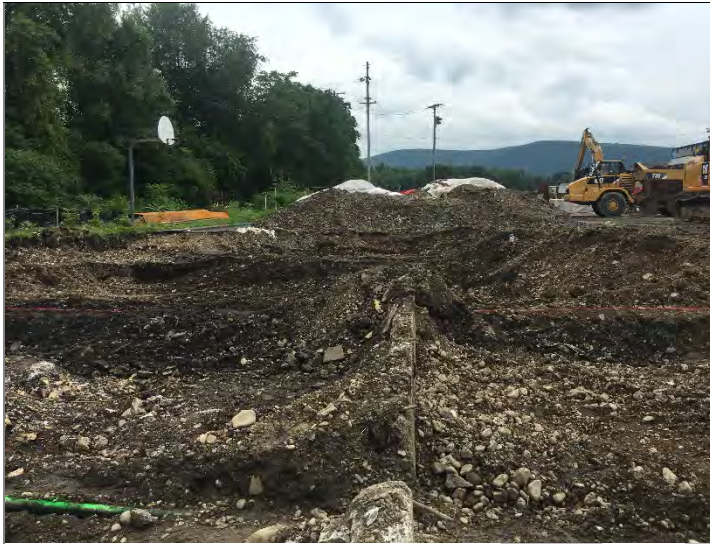
Gas line running through concrete structure

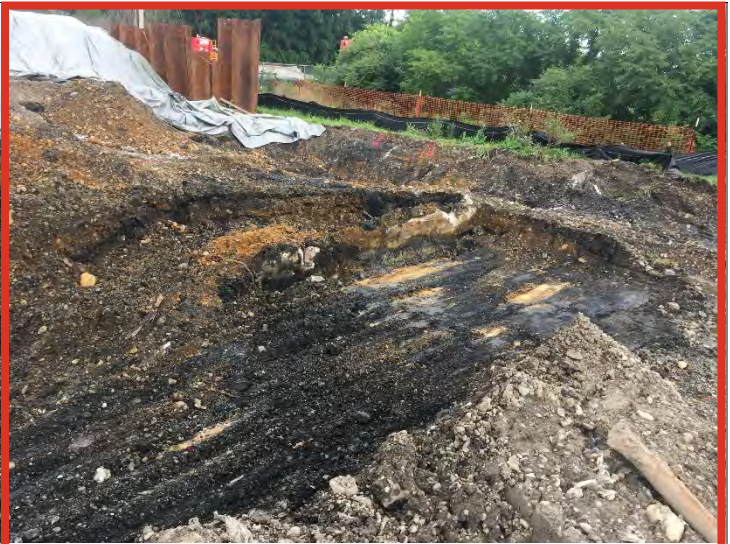
Exposed concrete slab and structure to South west of site.

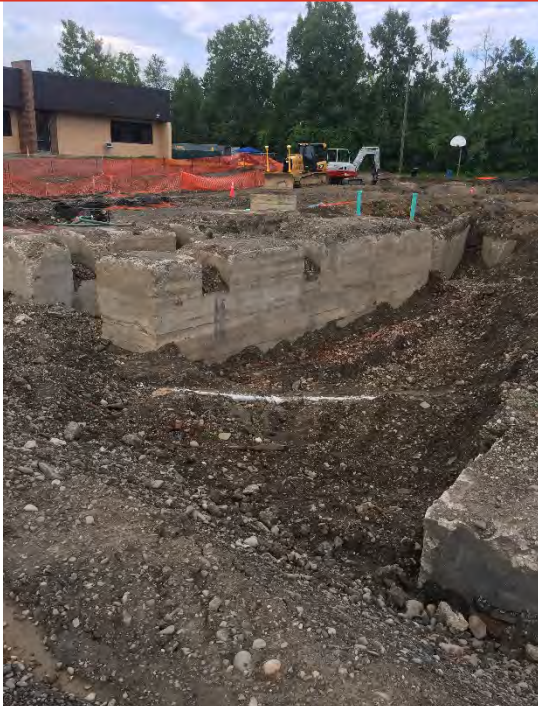
Concrete foundation
