**SUPPLEMENTARY REMEDIAL  
INVESTIGATION/REMEDIAL  
WORK**

**EVANS STREET SITE  
BATAVIA, NEW YORK**

Prepared for:  
City of Batavia  
10 West Main Street  
Batavia, New York 14020  
and  
Graham Manufacturing Company  
20 Florence Avenue  
Batavia, New York 14021  
December 11, 1992

Woodward-Clyde Consultants, Inc.  
363 Seventh Avenue, 11th Floor  
New York, New York 10001  
Project Number 92C4120

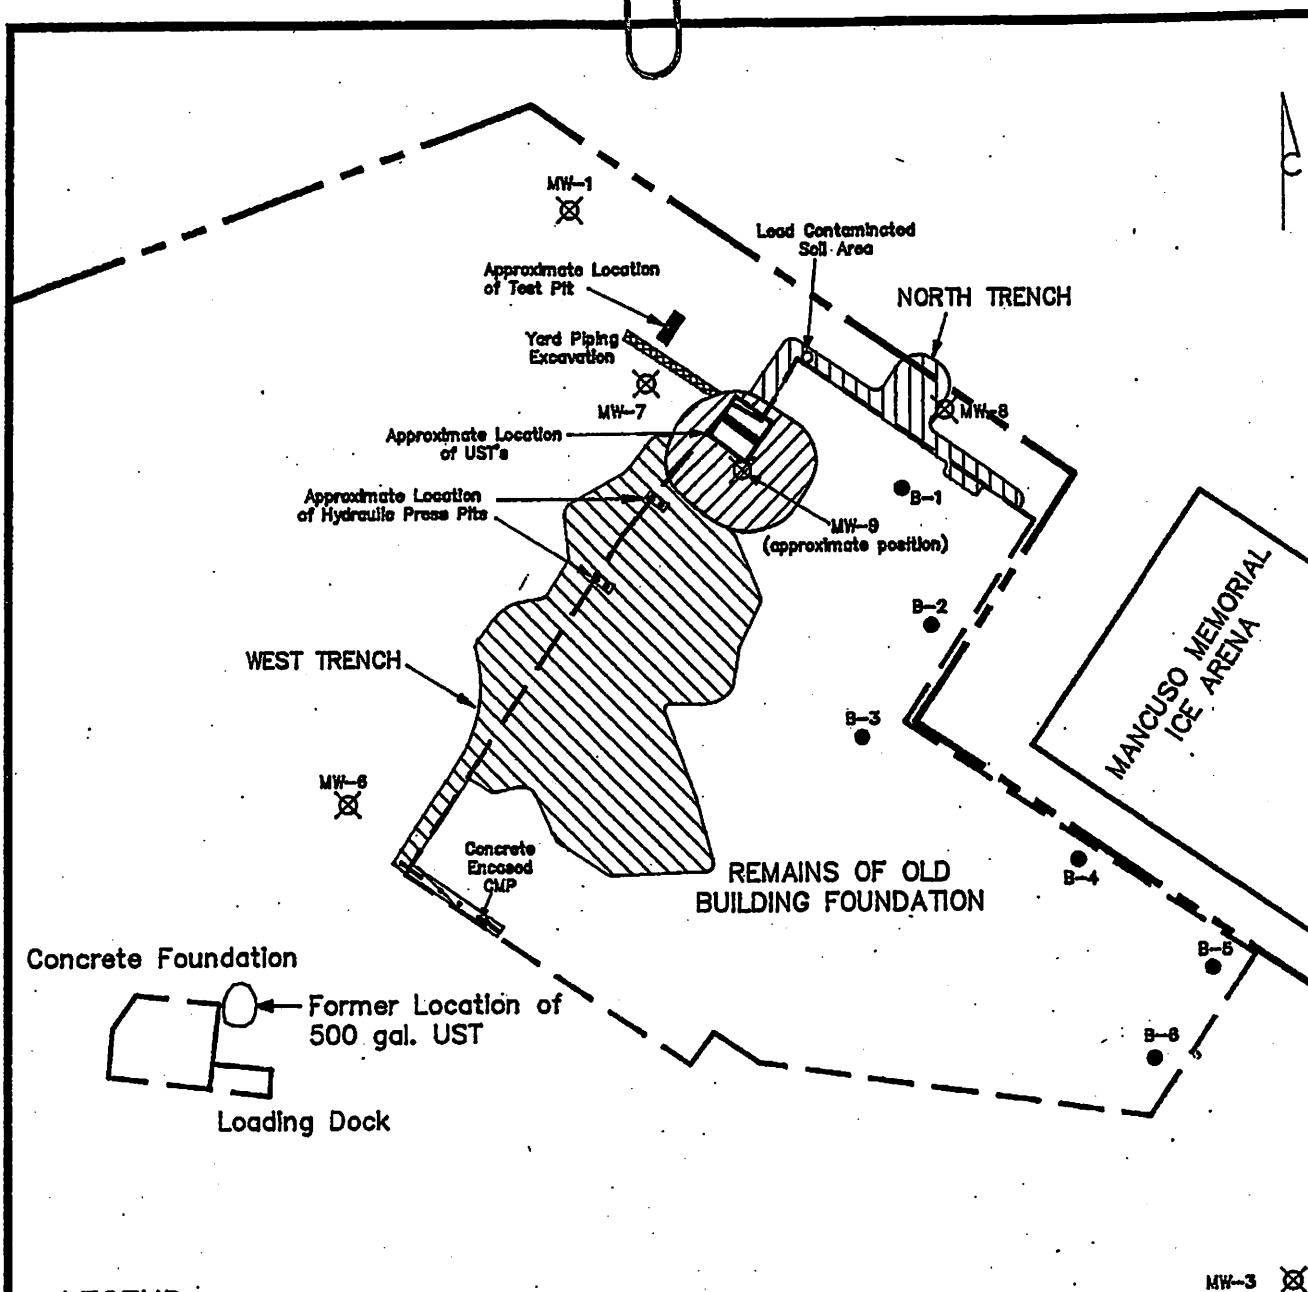
FIGURE 1-3

The borings were located so that conditions could be better defined along the east side of the pad and on the north and east side of the northwest-southeast oriented segment. Boring locations are located on the boring logs as measured from the northeast corner of the pad and are represented in plan view on Figure 1-3.

As per the NYSDEC request, the Client had a test pit constructed west of the excavation and northwest of Monitoring Well No. 7 (Figure 1-3). The test pit was located to be downgradient of the tanks and possibly the monitoring well location based upon groundwater elevations contour maps produced for the Quantitative Environmental Investigation. The test pit was excavated to a depth of 8.8-feet below ground surface and was left open for approximately 8 hours. Groundwater was noted at a depth of 7.0 feet and the pit remained open to a depth of 8.2 feet prior to backfilling. A discontinuous trace sheen was noted on the water surface within the initial 30 minutes of excavation, although no sheen was noted on inspection prior to closure. The test pit log is presented in Appendix C.
