**Appendix I**  
**STORM WATER SEWER VIDEO SURVEY RESULTS**

## Inspection Report / Inspection: 1

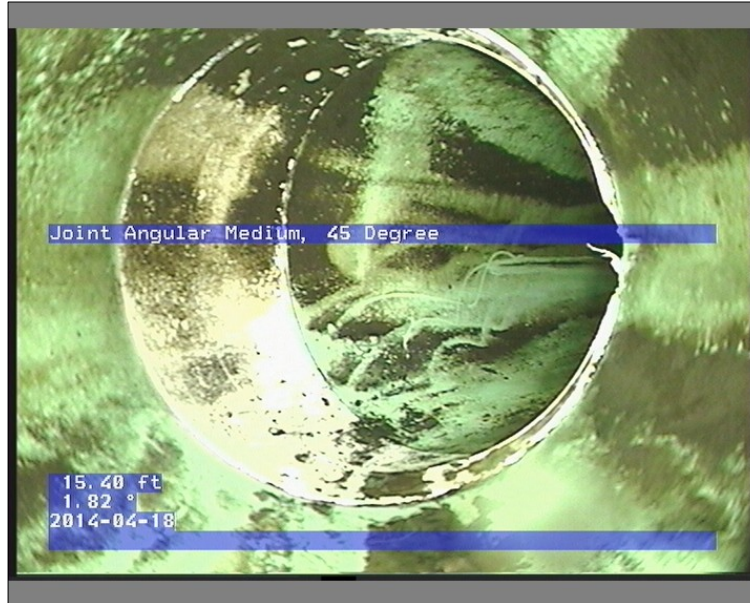
Photo: 1\_1\_3\_18042014\_091056\_A.JPG, VCR No.: X  
15.4FT, Joint Angular Medium / 45 Degree

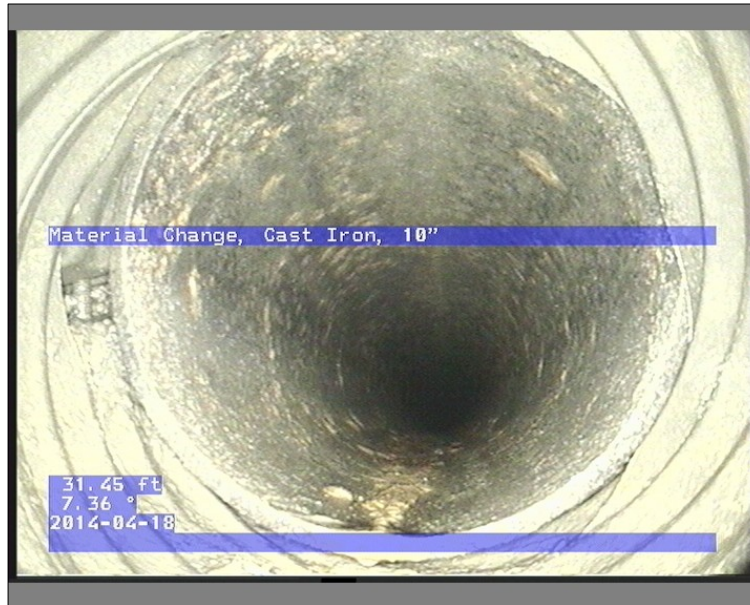
| 1:266 | Position | Code | Observation | Photo | Grade | | |
|---|---|---|---|---|---|---|---|
| | | 34.80 | MMC | Material Change, Cast Iron / 10" | 2_1_2_18042014_09<br>2632_A.JPG | | |

Photo: 2\_1\_2\_18042014\_092632\_A.JPG, VCR No.: X  
34.8FT, Material Change, Cast Iron / 10"

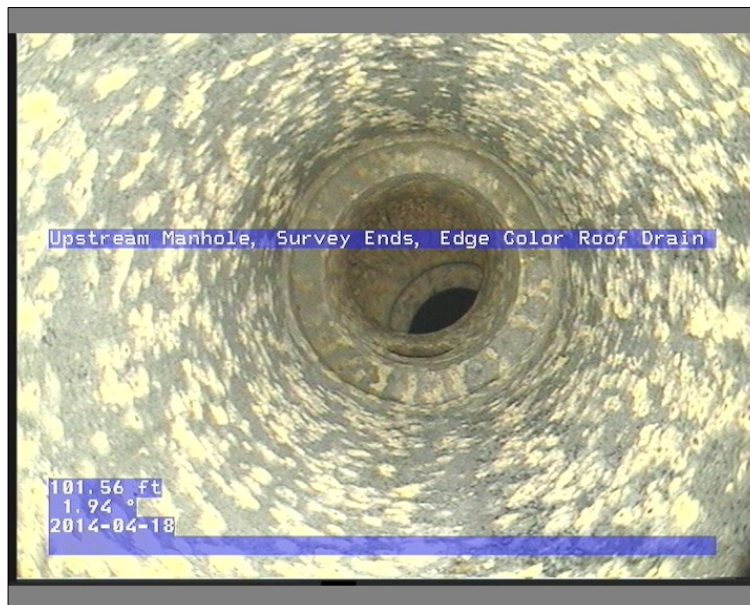
| 1:266 | Position | Code | Observation | Photo | Grade | | |
|---|---|---|---|---|---|---|---|
| | | 101.56 | AMH | Upstream Manhole, Survey Ends / Edge Color Roof Drain | 2_1_3_18042014_09<br>2846_A.JPG | | |

Photo: 2\_1\_3\_18042014\_092846\_A.JPG, VCR No.: X  
101.56FT, Upstream Manhole, Survey Ends / Edge Color Roof Drain

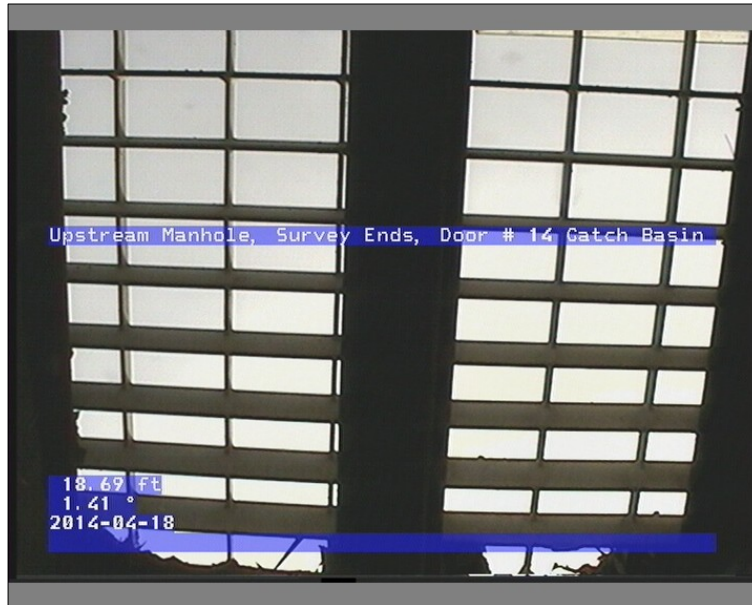
Photo: 3\_1\_2\_18042014\_100254\_A.JPG, VCR No.: X  
18.69FT, Upstream Manhole, Survey Ends / Door # 14 Catch Basin

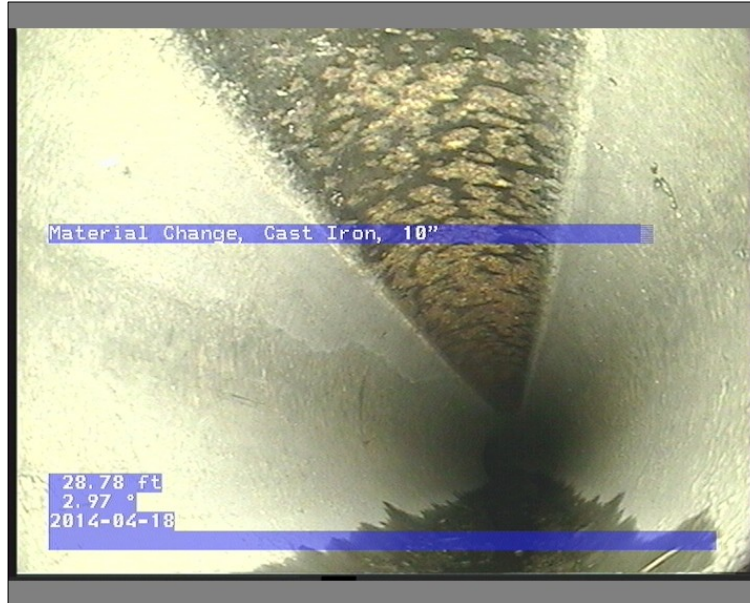
| 1:252 | Position | Code | Observation | Photo | Grade | | |
|---|---|---|---|---|---|---|---|
| | 30.57 | MMC | Material Change, Cast Iron / 10" | 4_1_2_18042014_10<br>2717_A.JPG | | | |

Photo: 4\_1\_2\_18042014\_102717\_A.JPG, VCR No.: X  
30.57FT, Material Change, Cast Iron / 10"

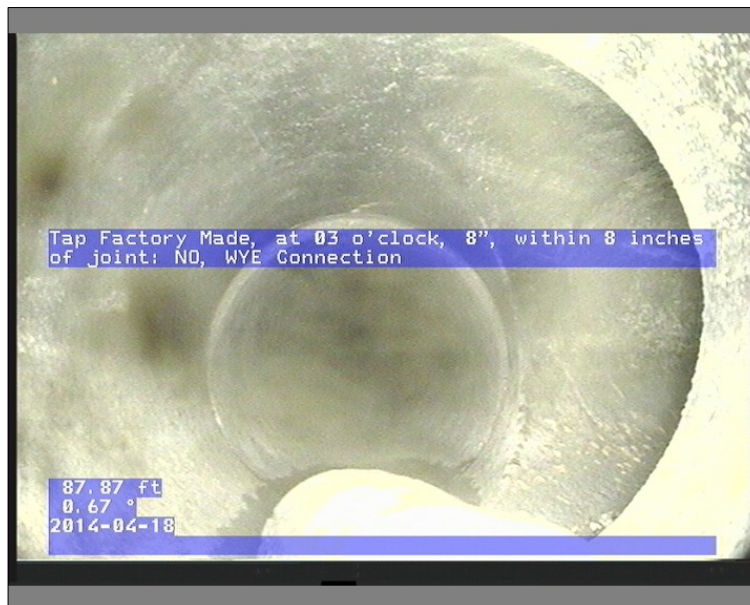
| 1:252 | Position | Code | Observation | Photo | Grade | | |
|---|---|---|---|---|---|---|---|
| | 91.30 | TF | Tap Factory Made, at 03 o'clock, 8", within 8 inches of joint: NO / WYE Connection | 4_1_3_18042014_10<br>3220_A.JPG | | | |

Photo: 4\_1\_3\_18042014\_103220\_A.JPG, VCR No.: X  
91.3FT, Tap Factory Made, at 03 o'clock, 8", within 8 inches of joint: NO / WYE Connection

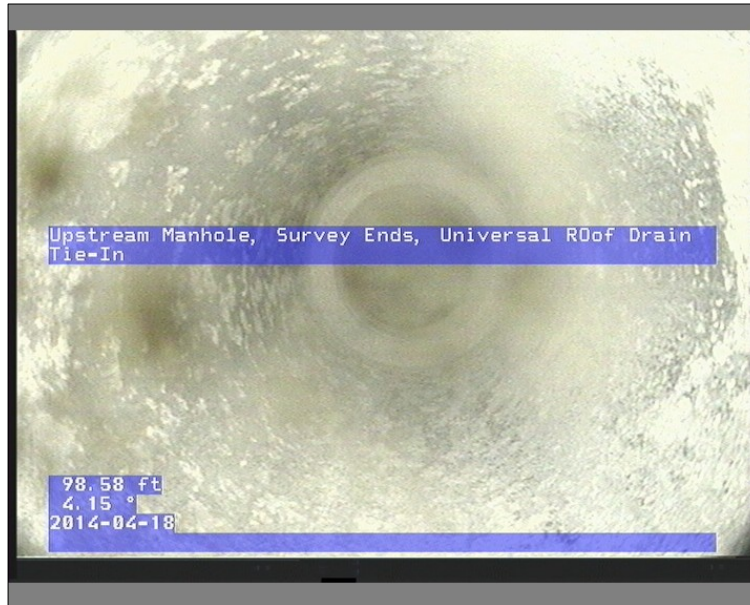
| 1:252 | Position | Code | Observation | Photo | Grade | | |
|---|---|---|---|---|---|---|---|
| | 98.58 | AMH | Upstream Manhole, Survey Ends / Universal ROof Drain Tie-In | 4_1_4_18042014_10<br>3320_A.JPG | | | |

Photo: 4\_1\_4\_18042014\_103320\_A.JPG, VCR No.: X  
98.58FT, Upstream Manhole, Survey Ends / Universal ROof Drain Tie-In

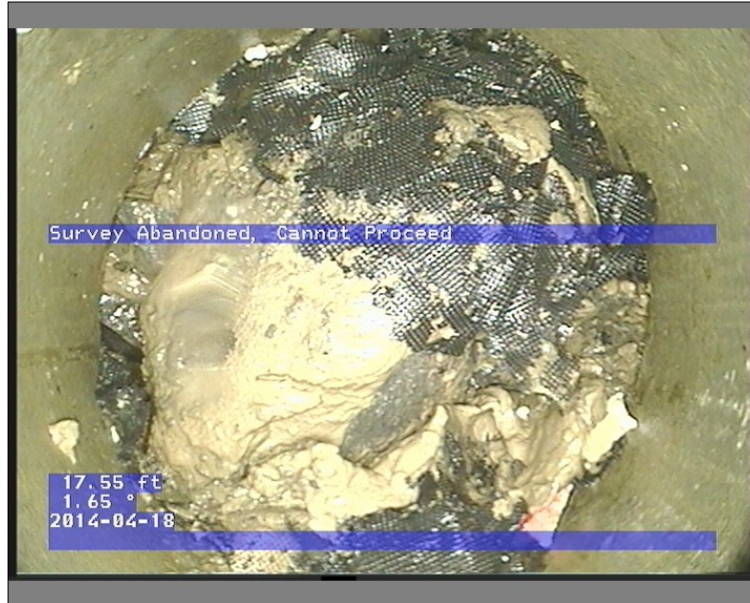
| 1:56 | Position | Code | Observation | Photo | Grade | | |
|---|---|---|---|---|---|---|---|
| | 17.92 | MSA | Survey Abandoned / Cannot Proceed | 5_1_2_18042014_11<br>0236_A.JPG | | | |

Photo: 5\_1\_2\_18042014\_110236\_A.JPG, VCR No.: X  
17.92FT, Survey Abandoned / Cannot Proceed

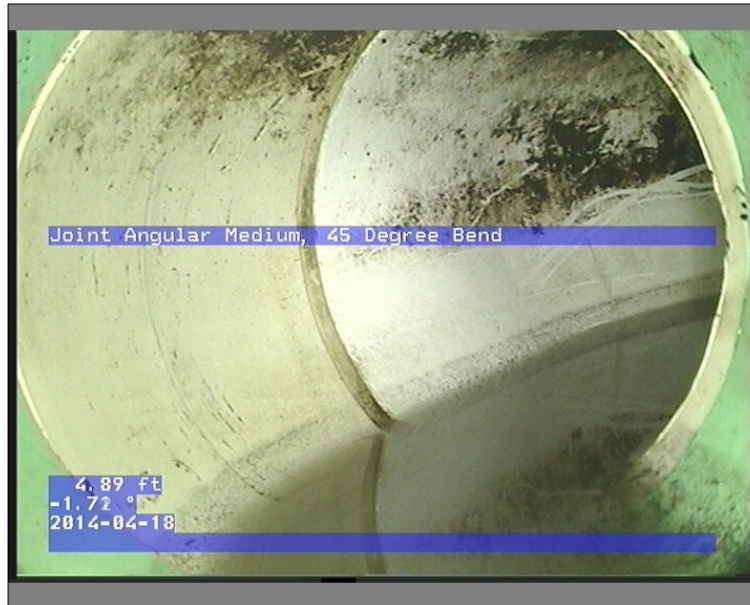
| 1:50 | Position | Code | Observation | Photo | Grade | | |
|---|---|---|---|---|---|---|---|
| | 4.89 | JAM | Joint Angular Medium / 45 Degree Bend | 6_1_2_18042014_11_2244_A.JPG | S 1 | | |

Photo: 6\_1\_2\_18042014\_112244\_A.JPG, VCR No.: X  
4.89FT, Joint Angular Medium / 45 Degree Bend

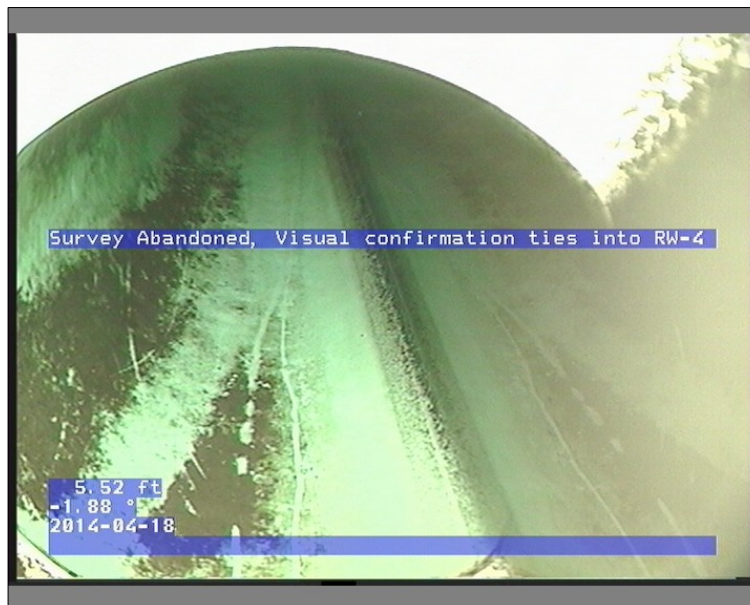
| 1:50 | Position | Code | Observation | Photo | Grade | | |
|---|---|---|---|---|---|---|---|
| | 5.52 | MSA | Survey Abandoned / Visual confirmation ties into RW-4 | 6_1_3_18042014_11_2913_A.JPG | | | |

Photo: 6\_1\_3\_18042014\_112913\_A.JPG, VCR No.: X  
5.52FT, Survey Abandoned / Visual confirmation ties into RW-4
