Appendix J
PROJECT PHOTOGRAPHS

Appendix J
Remedial Investigation Report
Former Alliance Metal Stamping and Fabrication Facility

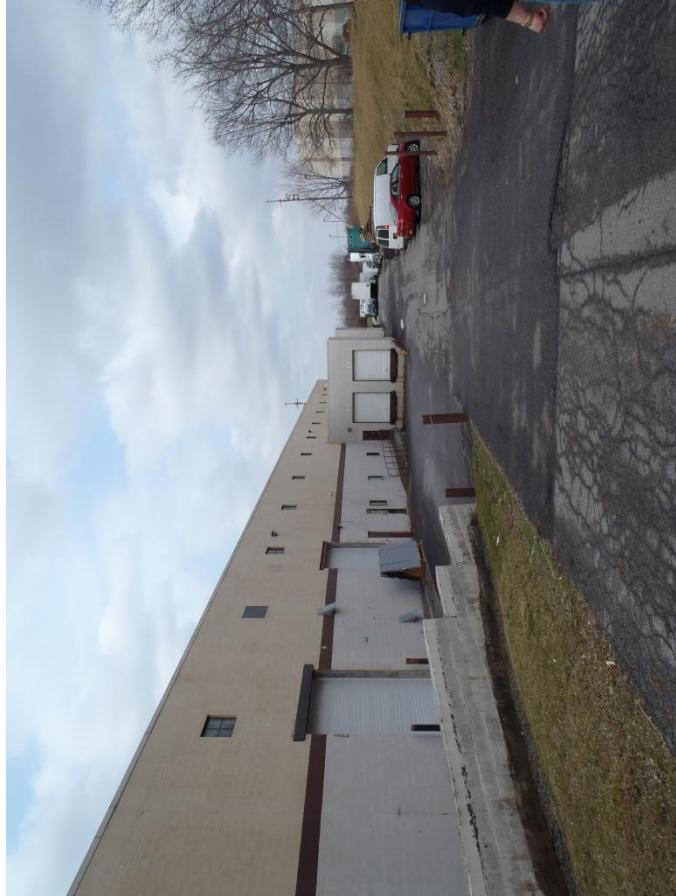
North side of Former AMSF facility, looking west

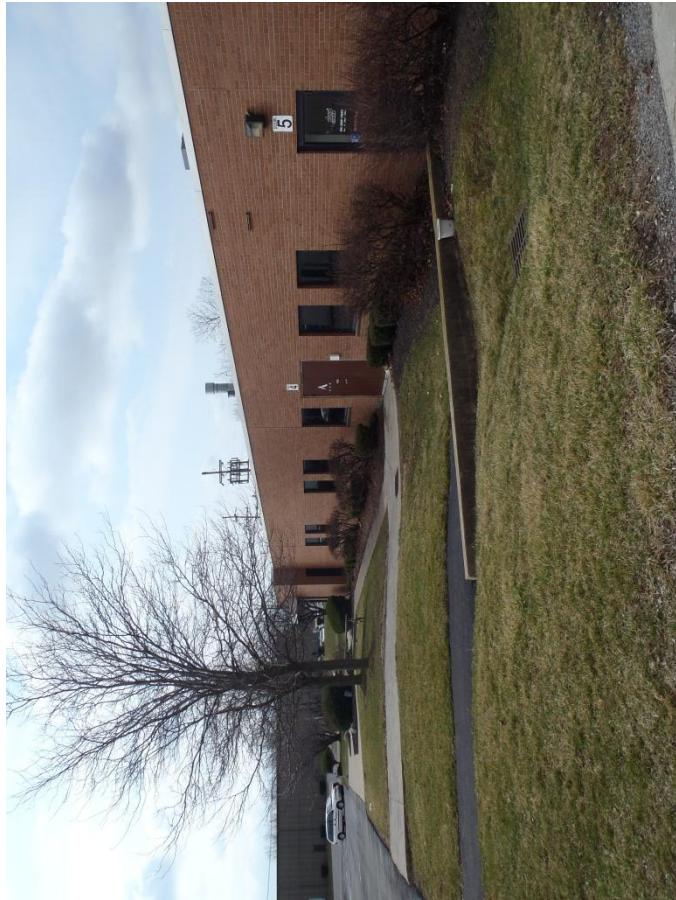
East side of Former AMSF facility, looking south

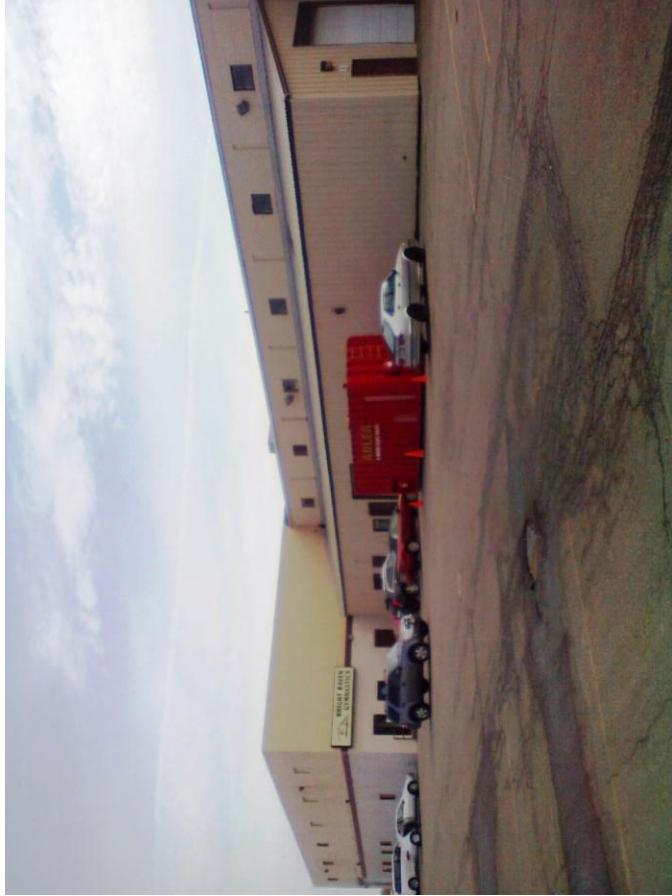
**West side of Former AMSF facility, looking northeast,
with red temporary storage tank for development
water from OU-1 monitoring wells**

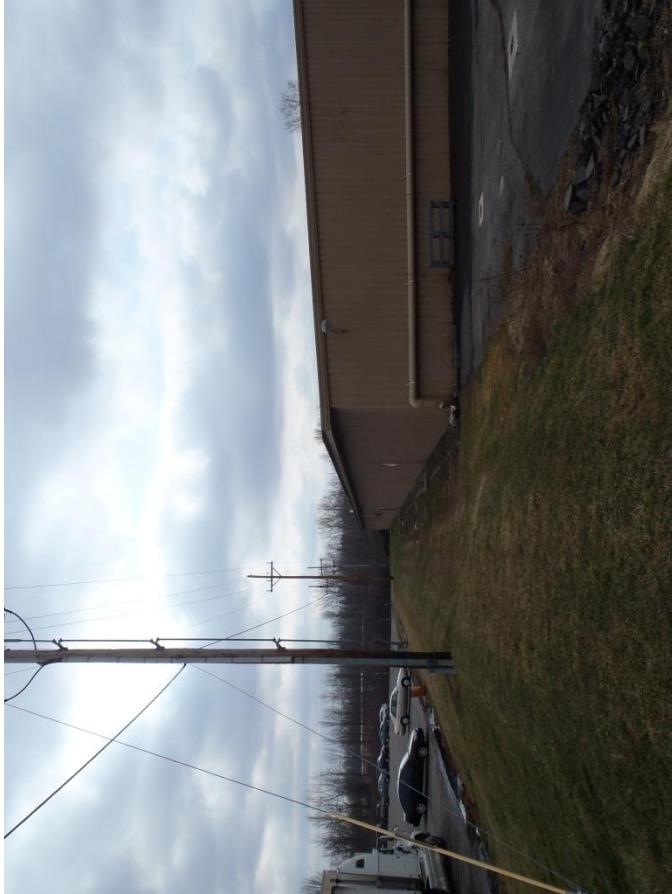
**East side of Former ITT RFM facility, looking south,
with parking lot on west side of Former AMSF facility
shown at left**

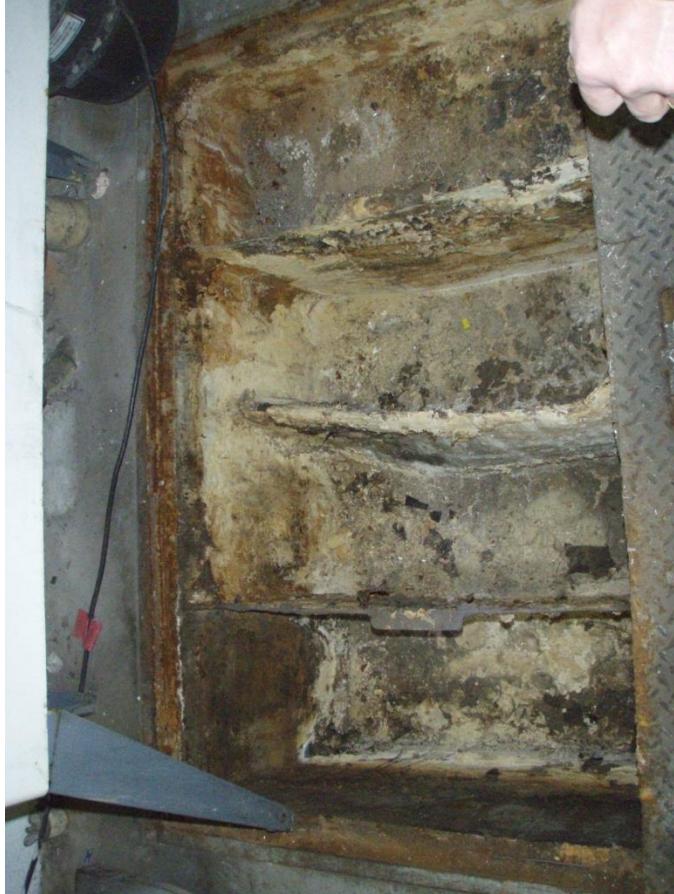
**Former spot-welder wastewater sump (Other Area 2)
located in AOC 3 west of column H7N**

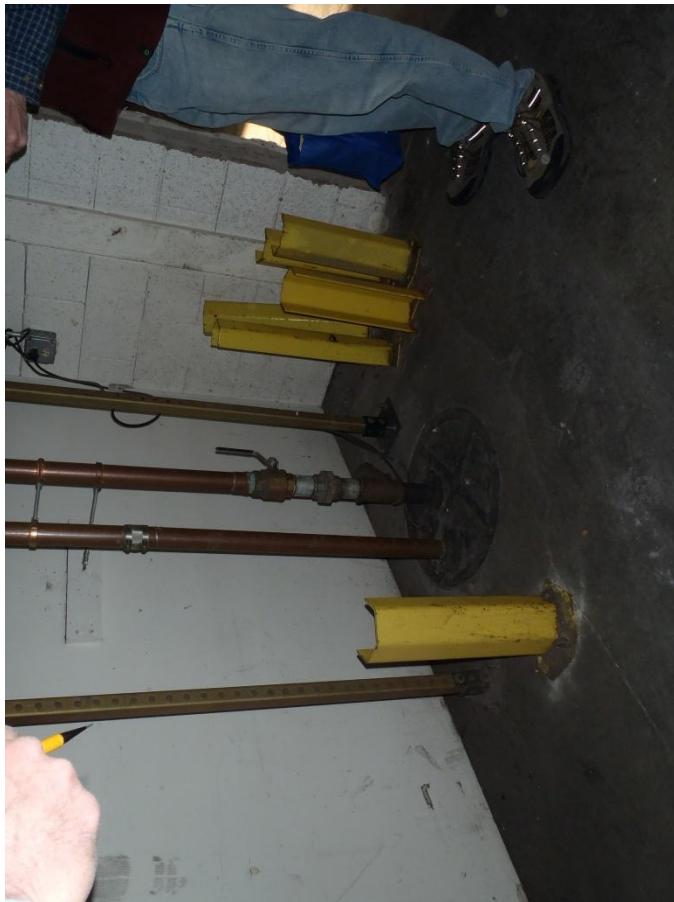
**Current sanitary wastewater sump located in AOC 3
east of column G7N and just south of SVI assessment
location AM-SVIa6**

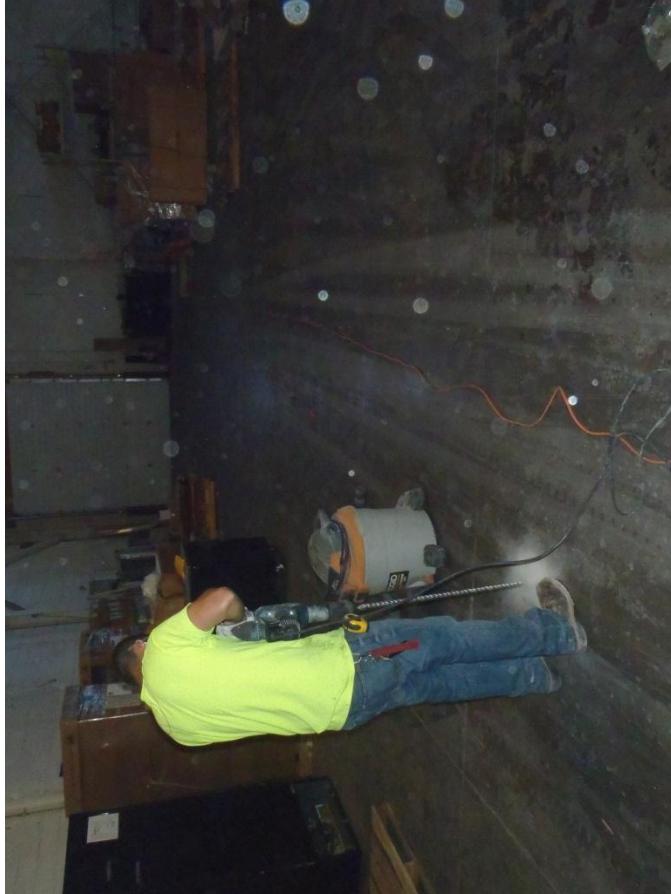
Drilling of AOC 3 soil vapor screening program sample point SEW-3

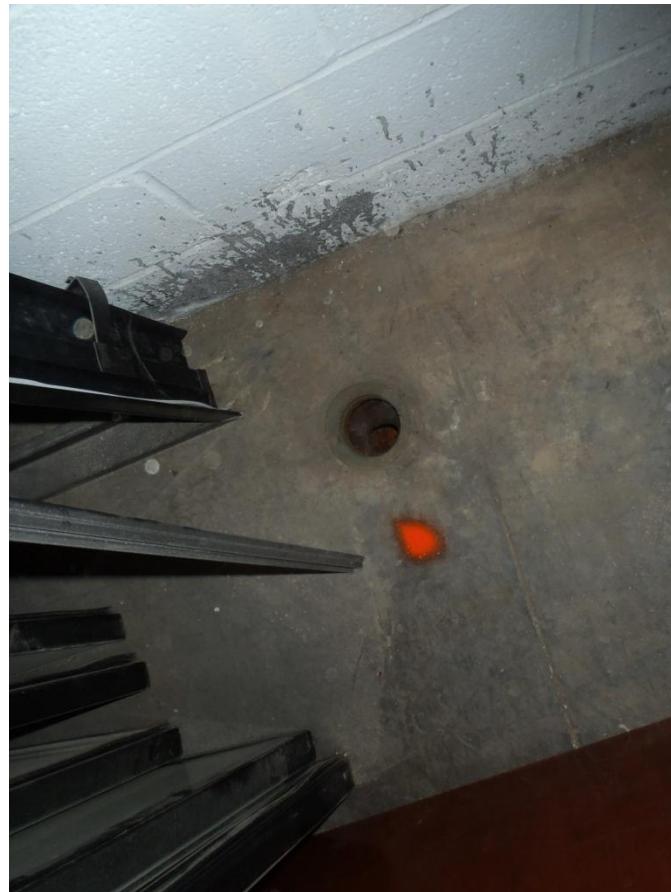
Floor drain north of column G6 in AOC 3, showing adjacent paint mark on spot for drilling of soil vapor screening program sample point SEW-2

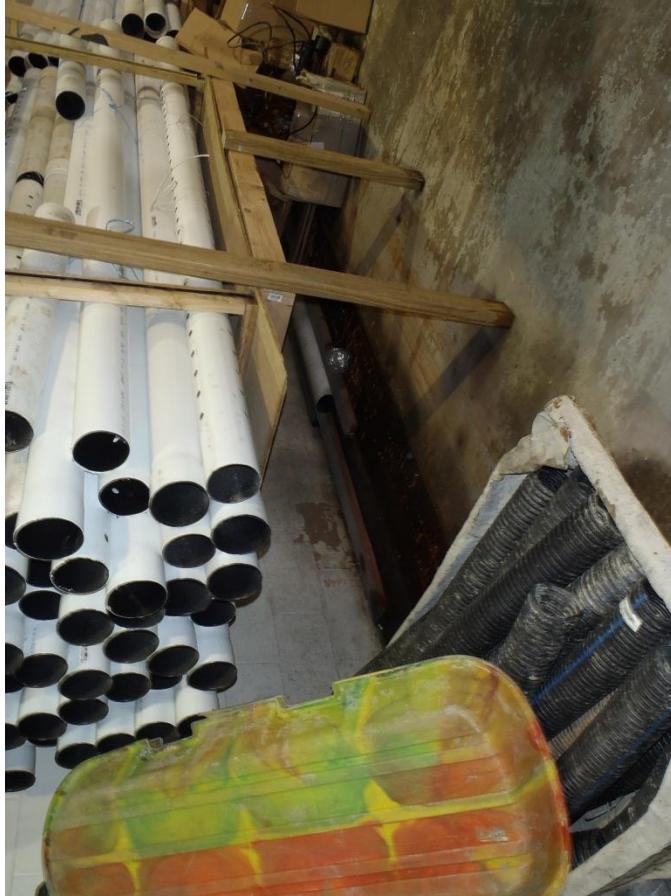
Trench drain at column C13 in Former Paint Shop (AOC 6), visible as dark stripe under shelf for piping. Investigated with soil vapor screening, sub-lab vapor, soil and groundwater sampling at several adjacent points.

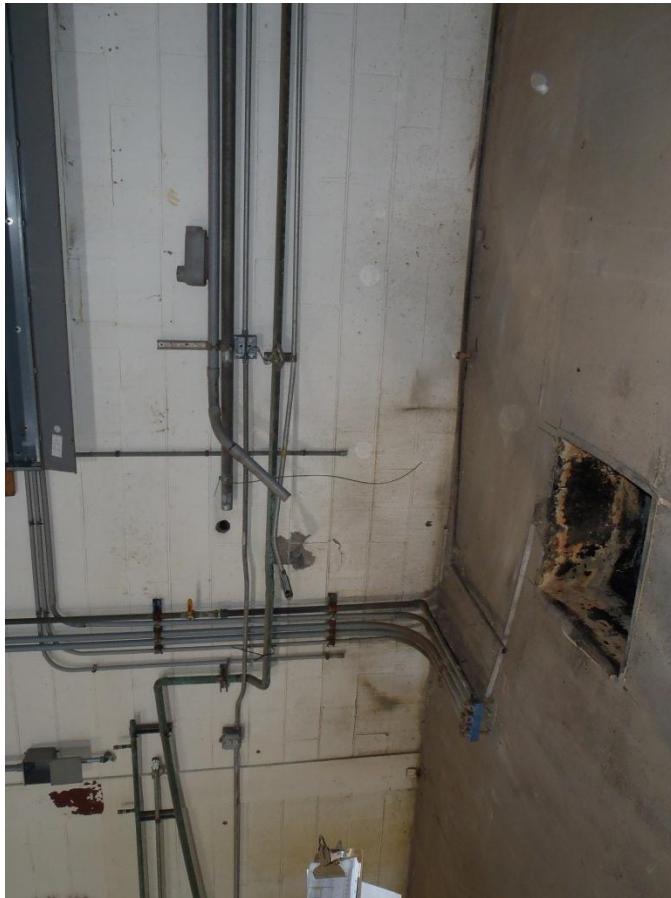
Former TCS Industries sump located in AOC 1 southeast of column G10. Investigated with soil vapor screening program sample DG-4

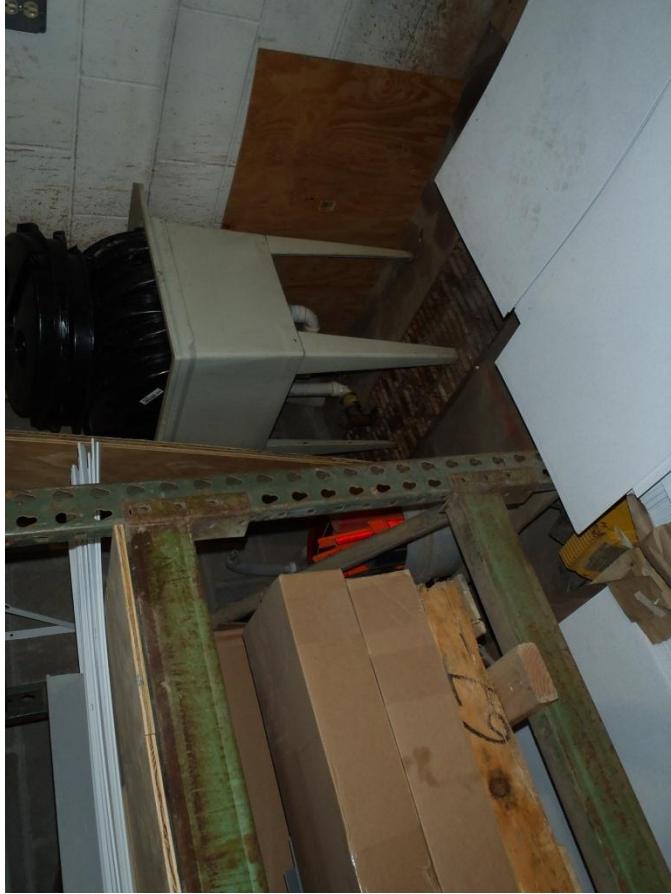
West end of trench drain in AOC 6

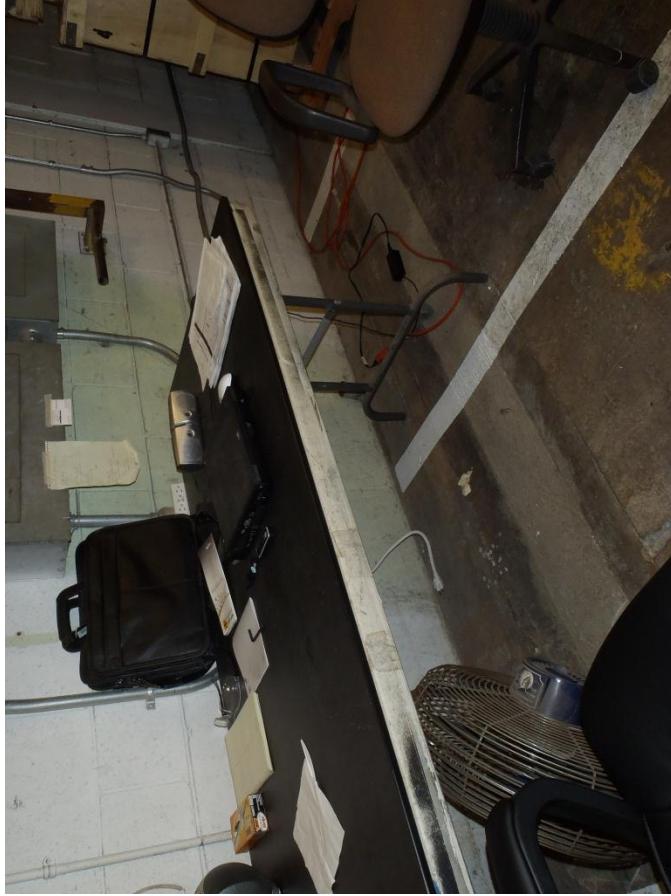
Former trench drain (filled with concrete) near column D15 in Former Spray Wash Area (AOC 8), investigated with AOC test borings and monitoring well

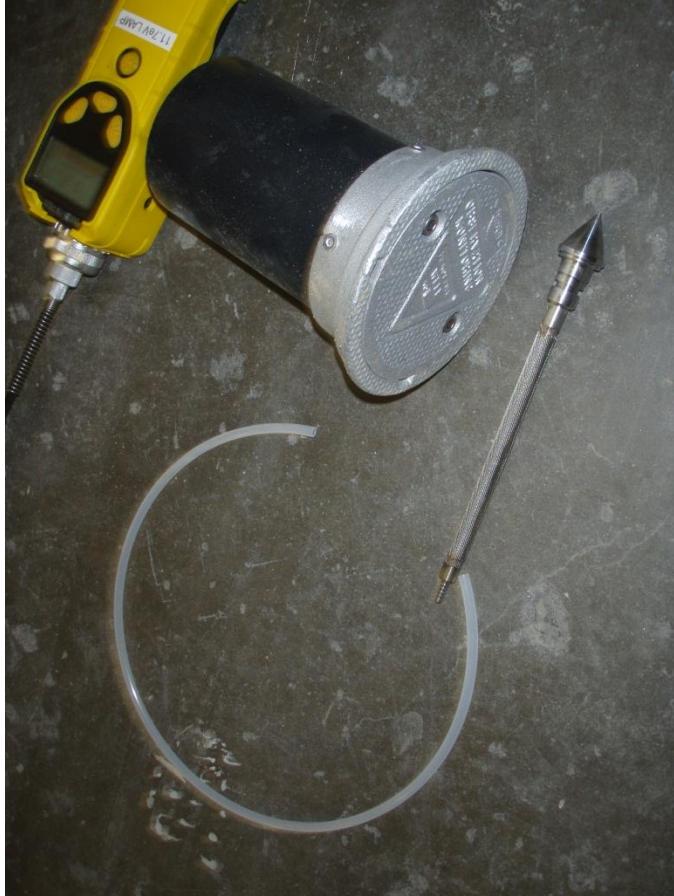
Sub-slab sampling point implant materials

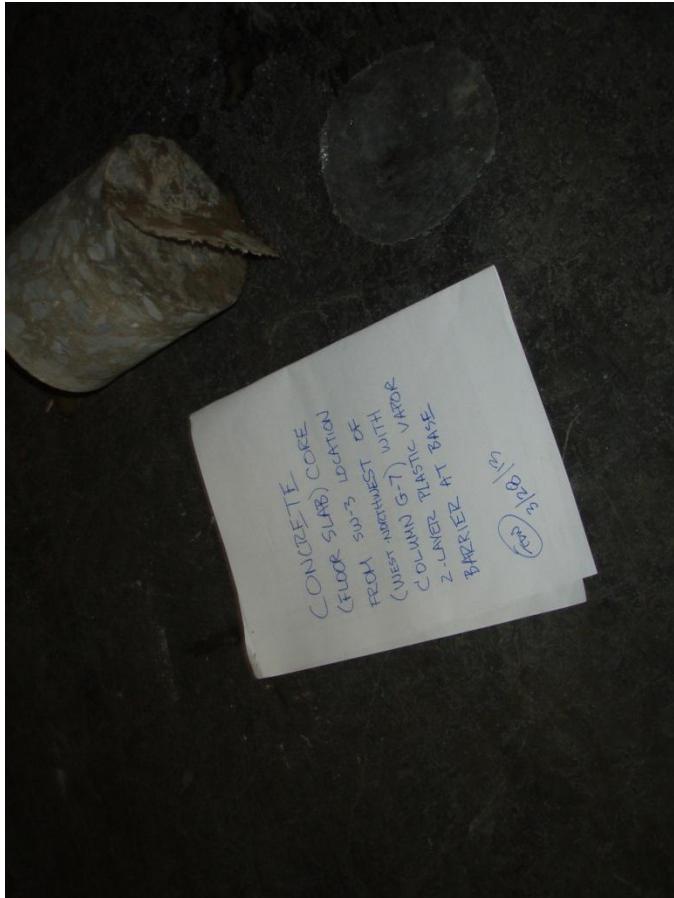
Floor slab core with two layers of plastic sheeting
(vapor barrier) adhered to bottom of slab,
AM-SVIAs5 sub-slab vapor point (AOCs 1,2 and 3)

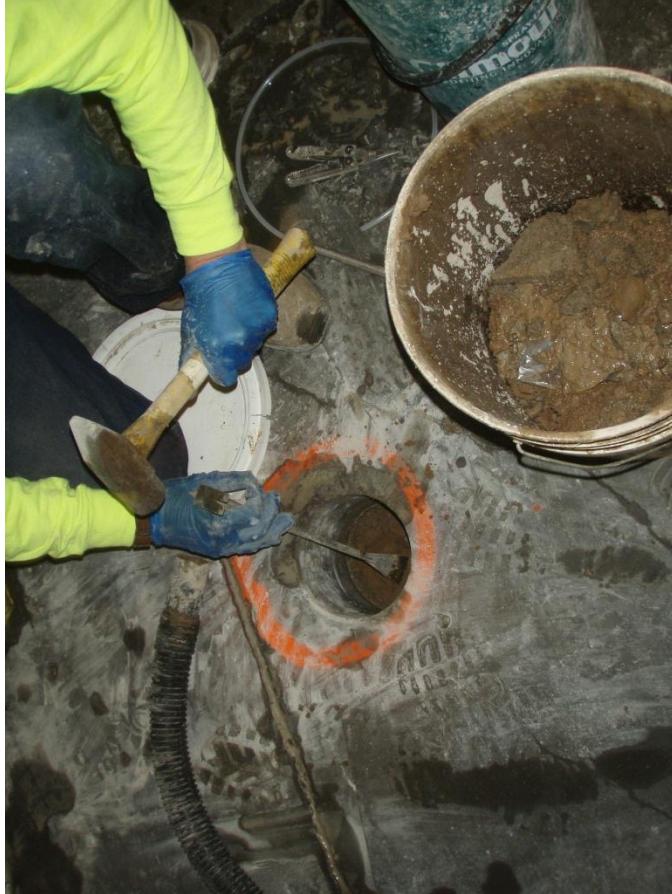
Excavating soil beneath slab for sampling point installation

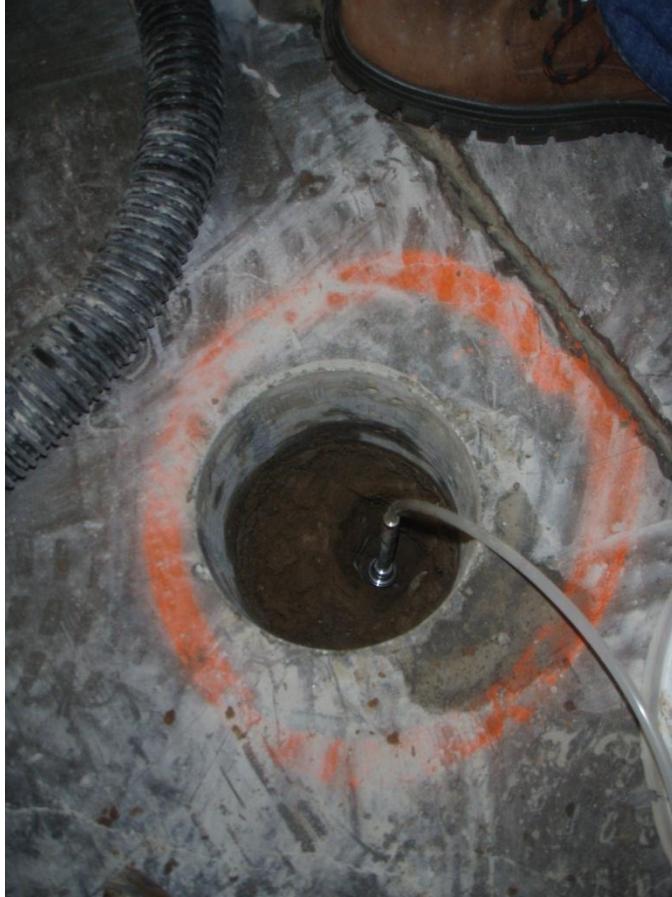
Sub-slab vapor sampling point installation

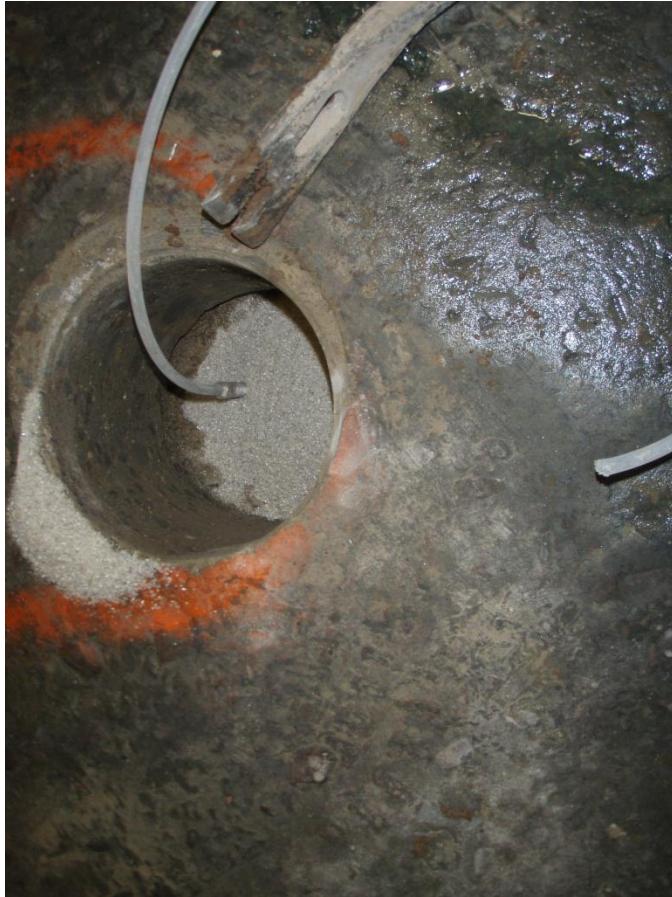
Sub-slab vapor sampling point installation

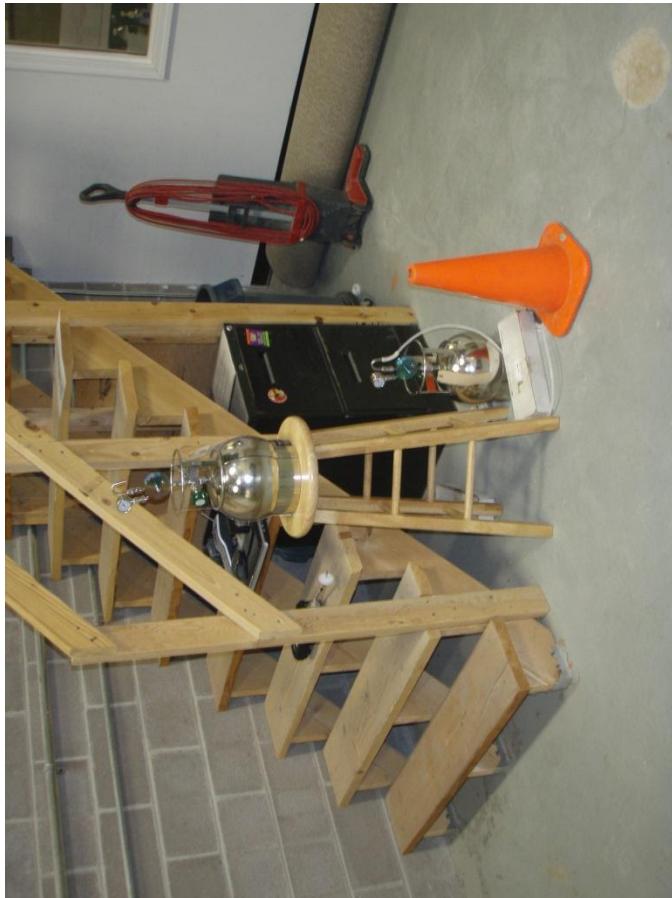
Indoor Air and Sub-Slab Soil Vapor Sampling Set-Up
at AOC 6 location AM-SVIA14
Concrete patch for test boring PS-TB-2
visible at lower right.

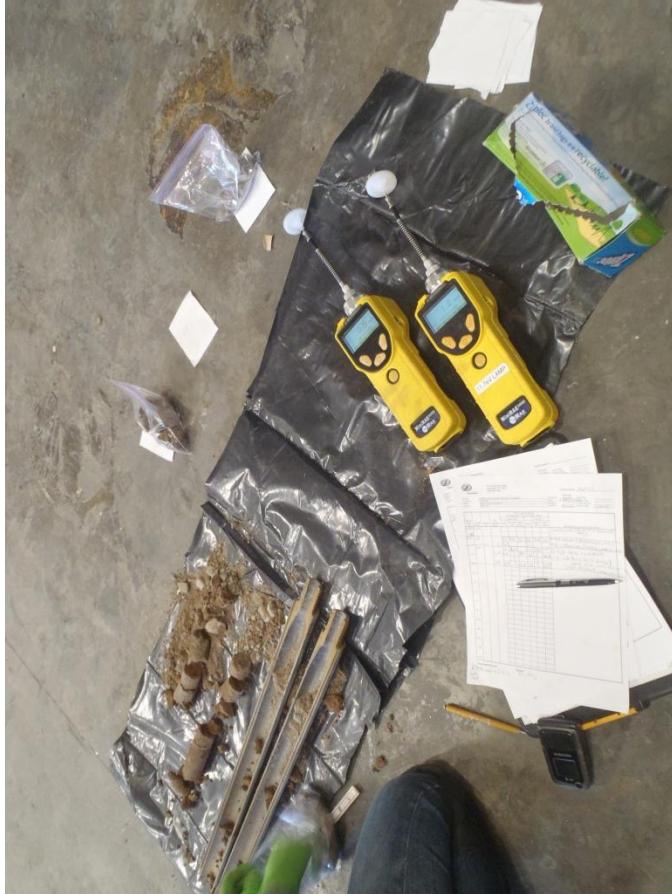
Soil sample field screening and logging

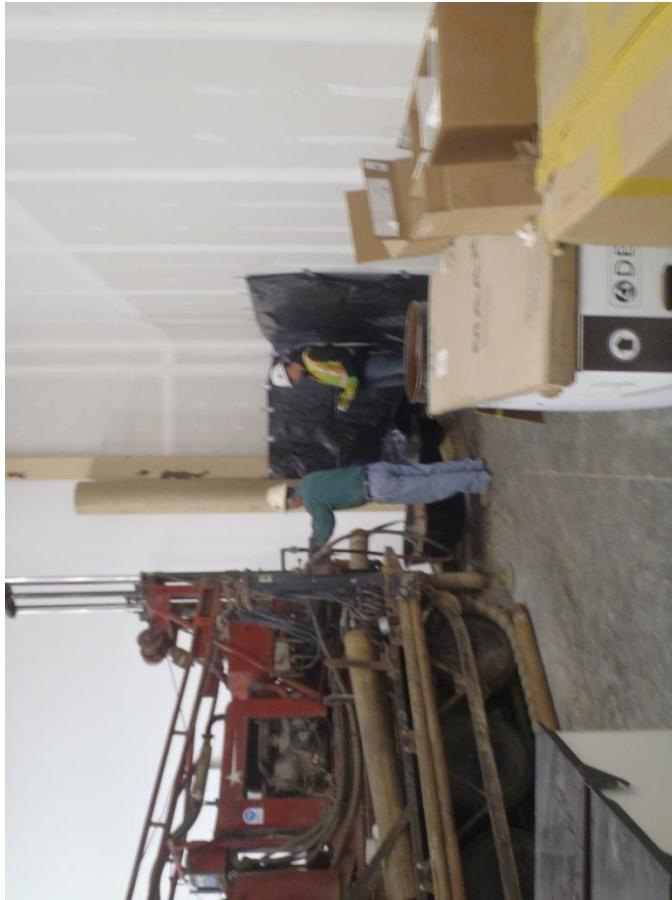
**Drill rig set-up at location for
monitoring well AMSF-MW-21 (AOCs 1, 2 and 3)**
