Periodic Review Report: November 2016 to October 2017 NYSDEC Site #C828115

Rochester Drug Cooperative Building
320 North Goodman Street
Rochester, New York

LaBella Project No. 211352

November 9, 2017

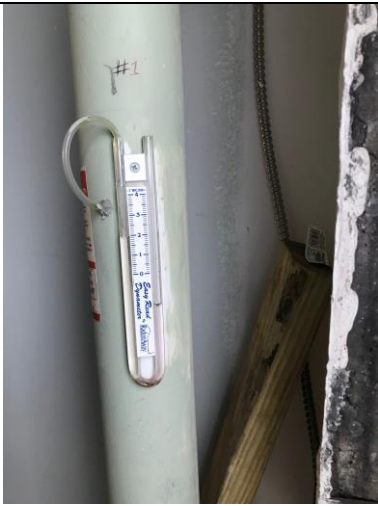
SSDS #1

Based on the inspection, the SSDS appeared to be in good working order (e.g. each manometer indicated the SSDS was working, the fan was observed to be working, and the piping appeared in good condition). Copies of the inspection forms and photographs of pertinent portions of the system are included in

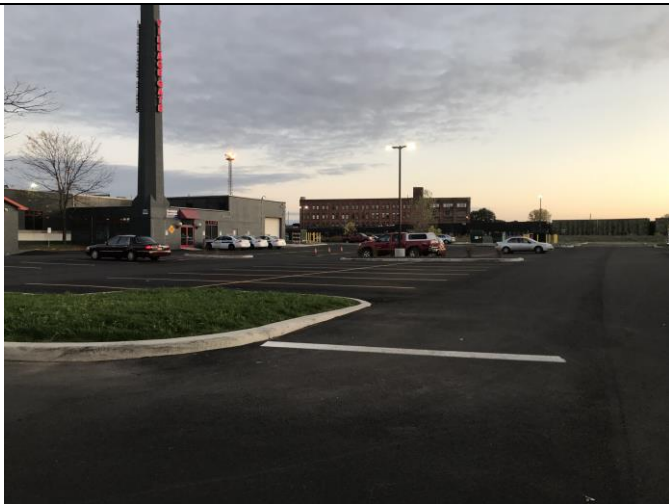
A site-wide inspection of the property was conducted on October 12, 2017 to assess the general condition of the site (e.g. commercial use, residential use, etc.) as well as asphalt paved areas located over the remedial excavations. Based on the results of the general site conditions inspection, the site remains utilized for commercial use only, and the asphalt paved areas over the remedial excavations remain in good condition. Photos of the asphalt paved area are included in Appendix A.

Parking lot over remedial excavation, facing north

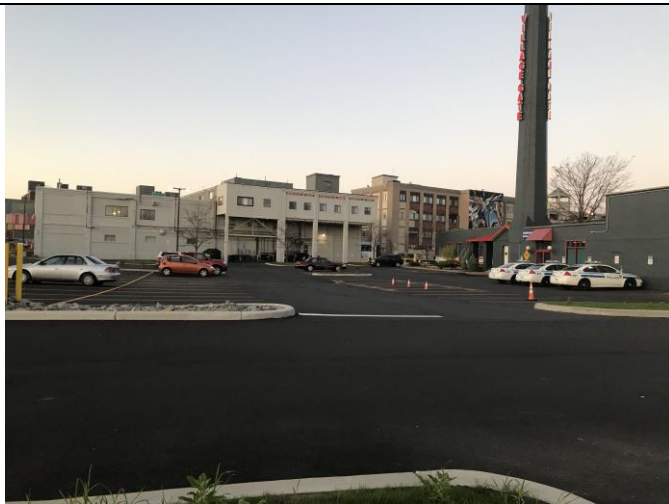
Parking lot over remedial excavation, facing south
