Periodic Review Report NYSDEC BCP Site #C828115

Reporting Period: November 2017 to October 2018

Former Rochester Drug Cooperative Building 320 North Goodman Street Rochester, New York 14607

LaBella Project No. 211352

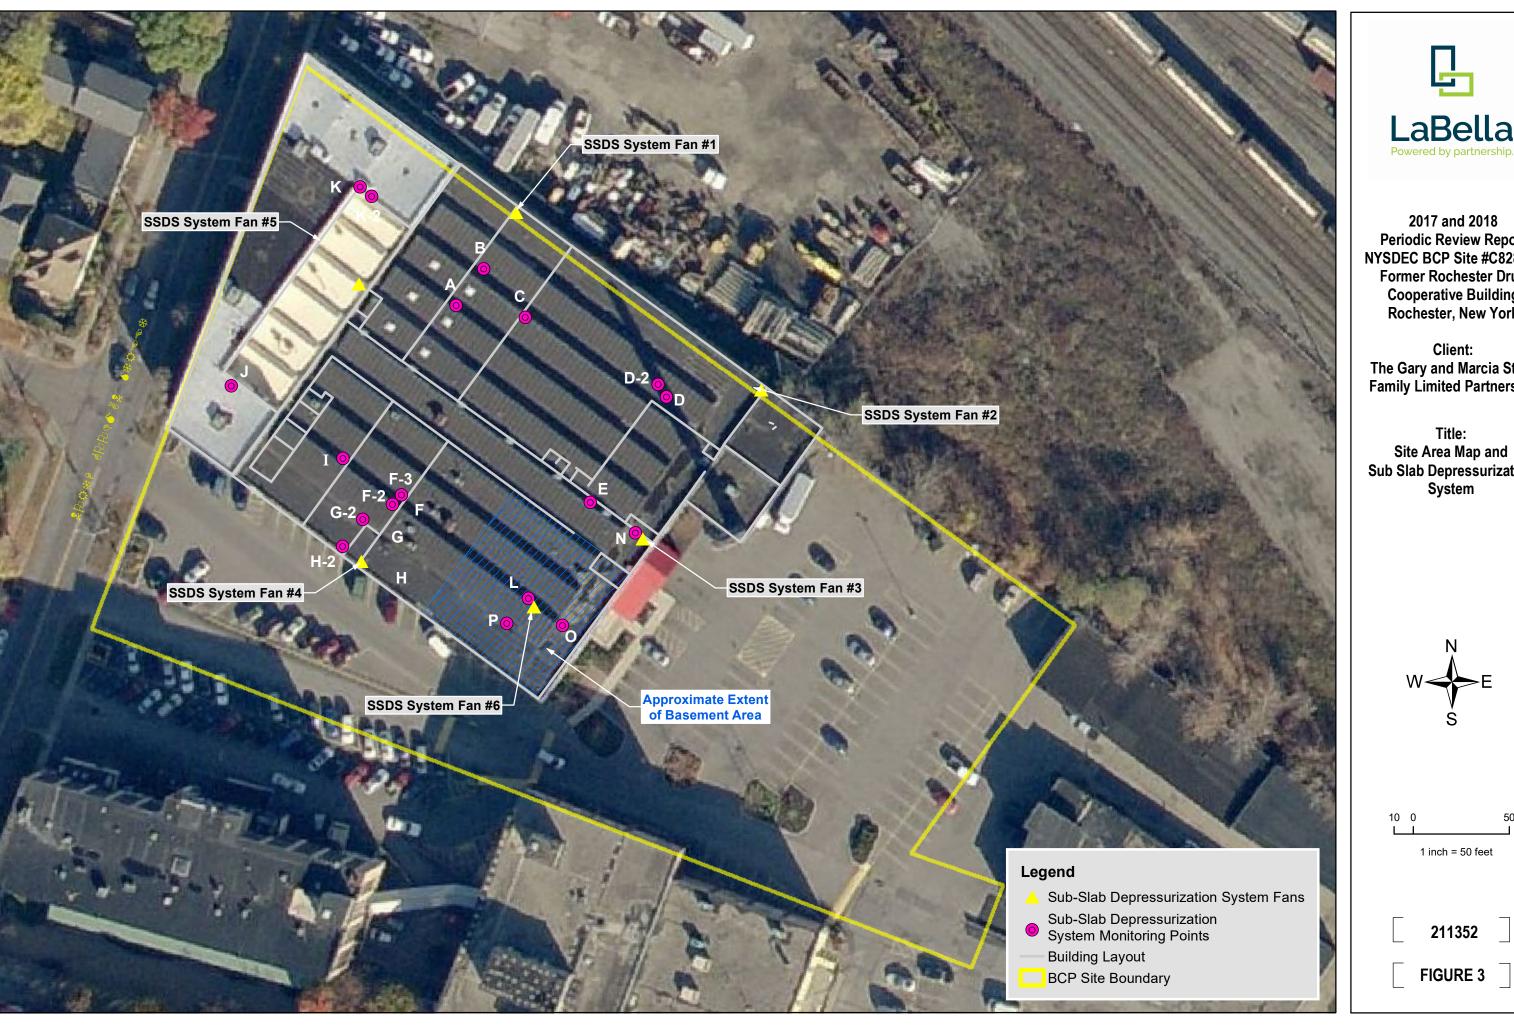
Site Area Map and Sub Slab Depressurization . System

An active Sub-Slab Depressurization System (SSDS) was installed beneath the concrete slab of the on-site building in November 2006. The SSDS was designed to depressurize the subsurface immediately below the concrete floor slab, thus restricting soil vapor intrusion into the on-site building from beneath the floor slab. Additional sub-slab depressurization fans were installed in the on-site building in 2009. Subsequent testing of these monitoring points (i.e. radius of influence testing) indicated negative pressures beneath the floor slab throughout the on-site building. The location of the SSDS components are depicted on Figure 3.

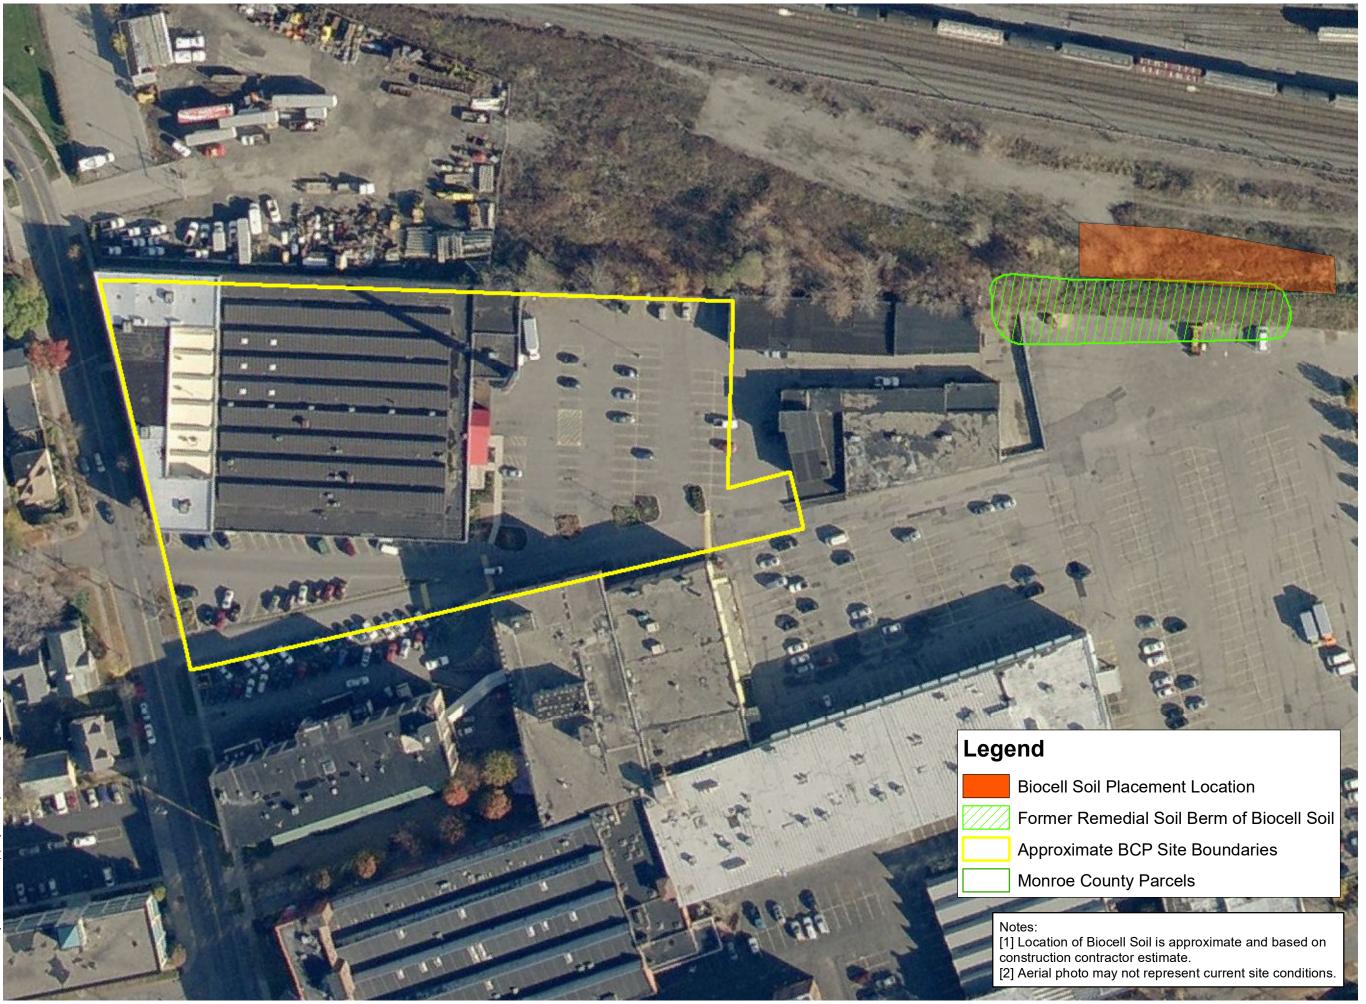
Title: Biocell Soil Placement Location

In April 2005, GeoQuest conducted an Interim Remedial Measure (IRM) Soil Removal program at the Site. As part of the IRM, an ex-situ treatment biocell was constructed, on the easterly adjacent Village Gate Square property, to treat approximately 2,103 cubic yards of petroleum-impacted soil that was excavated from the Site. This petroleum-impacted soil was placed in a "biocell" for remediation over time. Subsequent to screening and sampling the biocell soils, NYSDEC approved, in 2009, grading of the biocell soils into an existing soil berm to the east of the on-site building and covered with one (1) foot of clean soil at the former location shown on Figure 2 and subsequently the soil berm was graded and placed underneath an asphalt paved parking lot at the location shown on Figure 4.

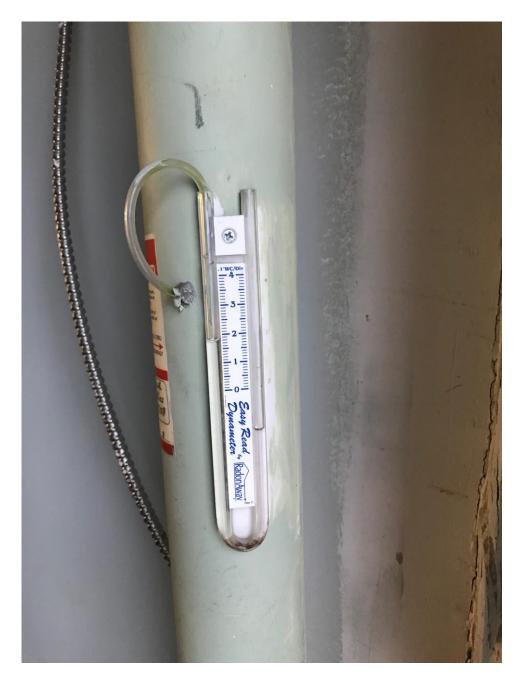
2015 - SSDS #1 manometer.

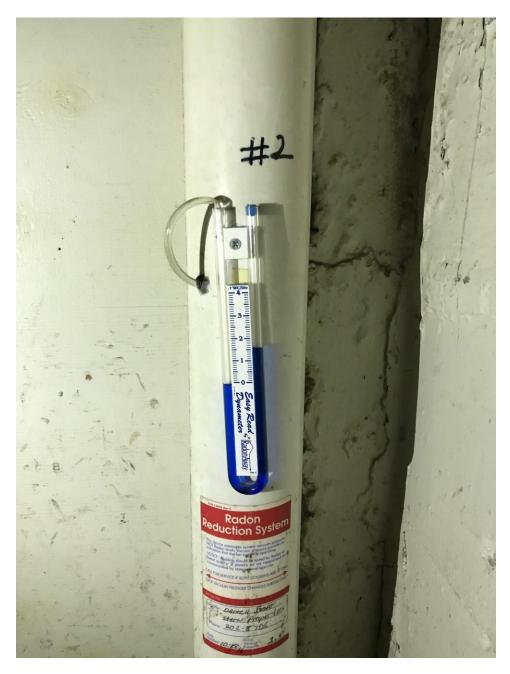
2015 - SSDS #2 manometer.

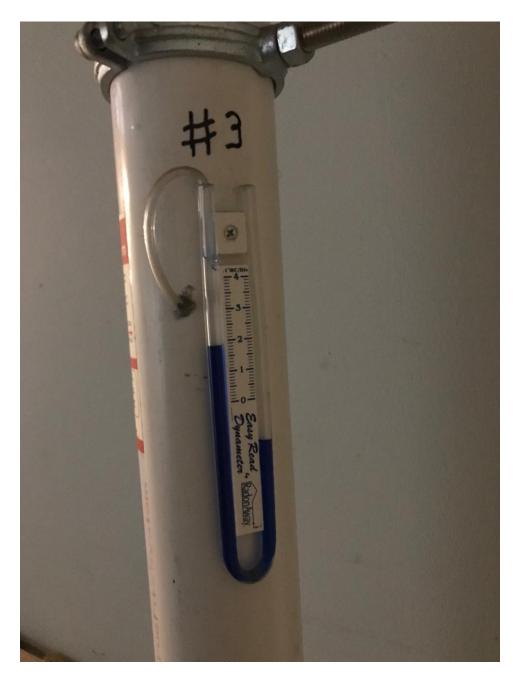
2015 - SSDS #3 manometer.

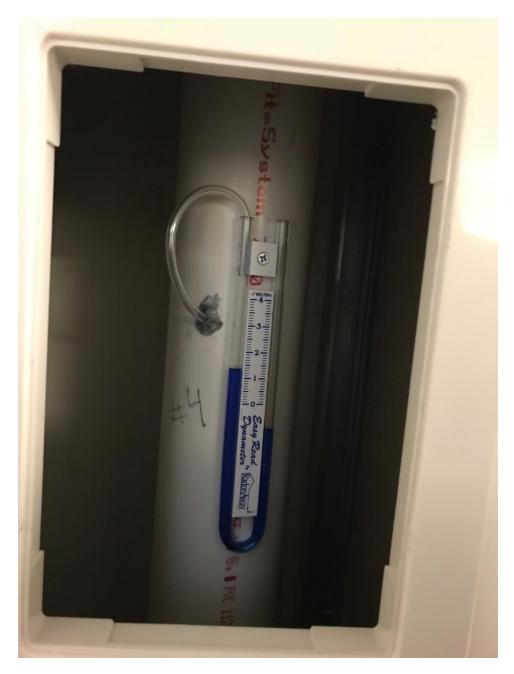
2015 - SSDS #4 manometer.

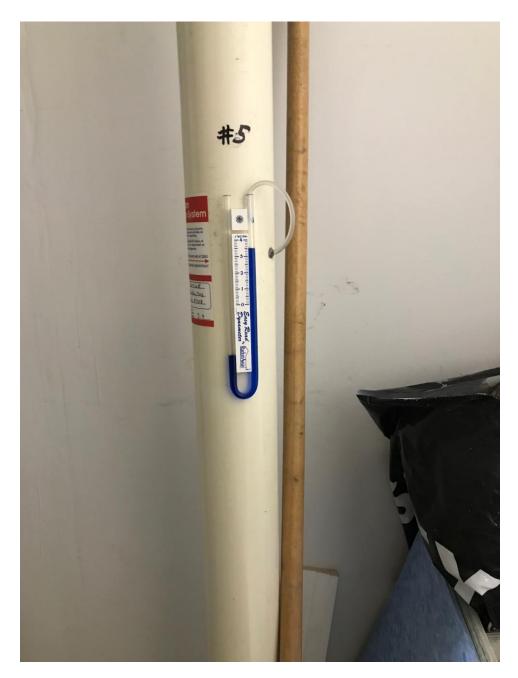
2015 - SSDS #5 manometer.

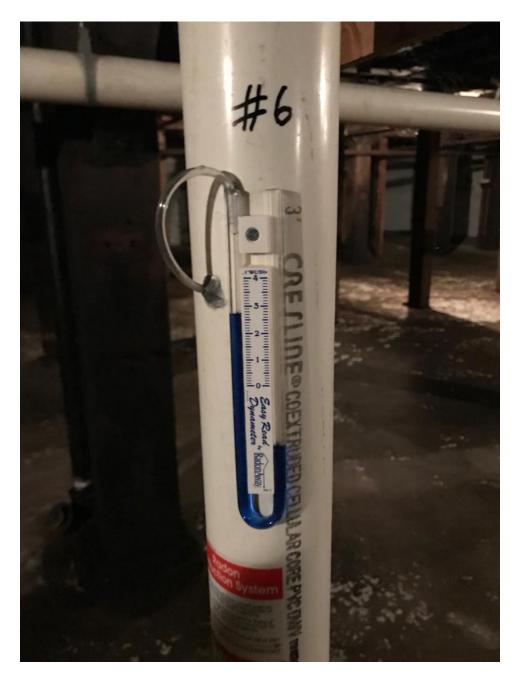
2015 - SSDS #6 manometer.
