# Periodic Review Report NYSDEC Site #C828115 October 12, 2020 to October 12, 2021

Rochester Drug Cooperative Building 320 North Goodman Street Rochester, New York

LaBella Project No. 211352

November 11, 2021

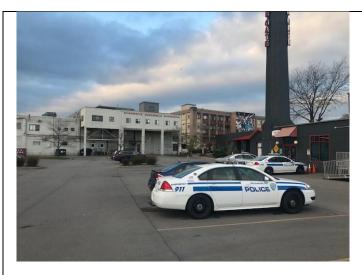
View looking northwest on south side of Site.

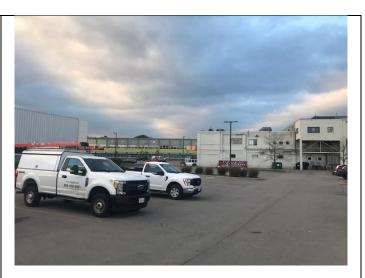
View looking west on south side of Site.

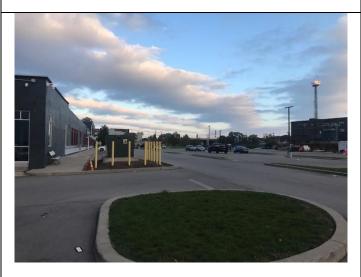
View looking northeast from south side of Site.
