**ANNUAL SITE-WIDE INSPECTION FORM
FORMER VOGT MANUFACTURING FACILITY
100 FERNWOOD AVENUE
ROCHESTER, NEW YORK
NYSDEC SITE NUMBER: C828119**

Date of Inspection: August 16, 2017 and August 31, 2017

Photolog
Site-Wide Inspection
Former Vogt Manufacturing Site
100 Fernwood Avenue, Rochester, New York
NYSDEC BCP Site #C828119
August 16, 2017 and August 31, 2017

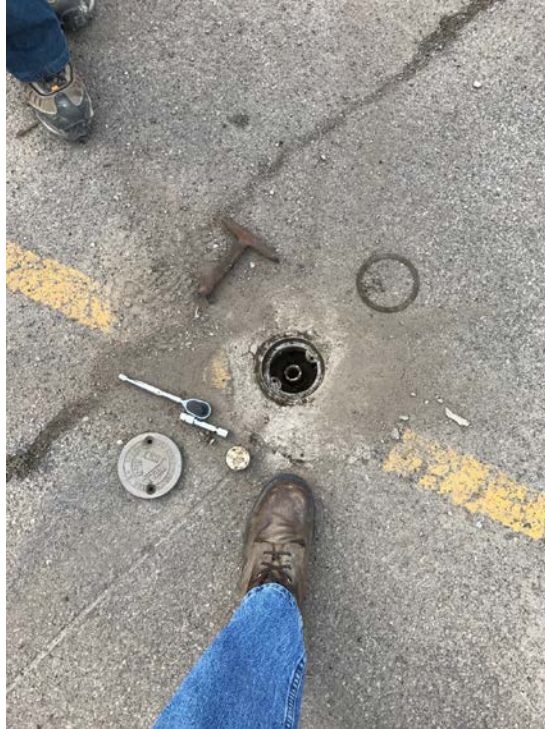
On 8-16-2017, wells MW-1, MW-2, MW-3, MW-4, MW-05, MW-8, MW-10, MW-14, MW-15, MW-16, and MW-IRM-2 appeared to be in good condition.

Monitoring Well MW-1 (8-16-2017)

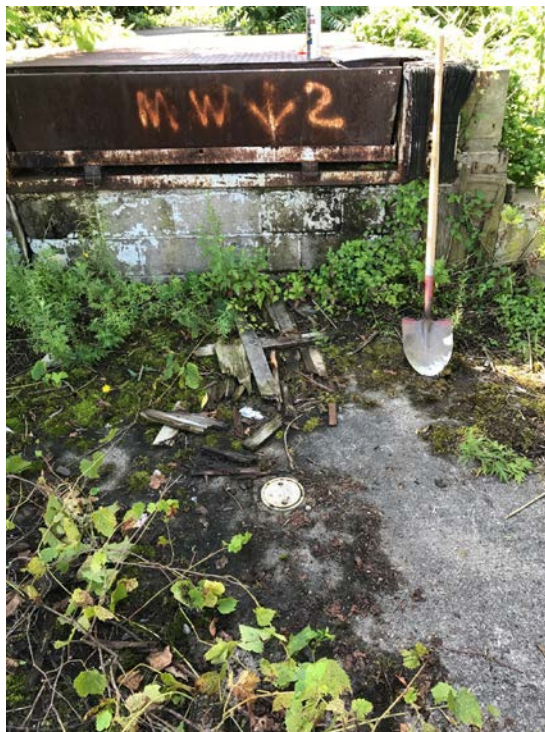
Monitoring Well MW-2 (8-16-2017)

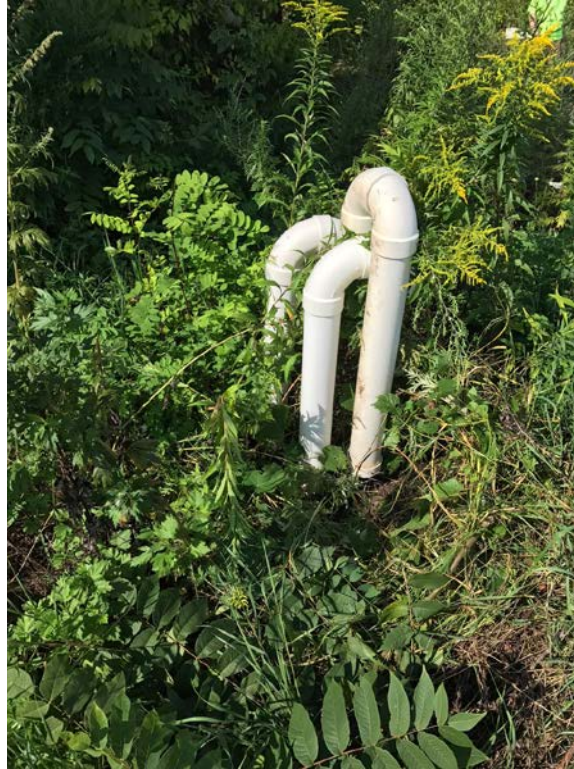
Describe damage or blockage if observed: On 8-16-2017, gooseneck Vent #1 stickup was observed unattached, wind turbines #1, #2 and #3, including PVC stick-ups were observed missing, and 4" PVC stick-up on wells MWIRM-1 and MWIRM-2 were observed damaged at ground surface. On 8-31-2017, the above items were observed to be repaired.

In-situ bioremediation system air influent vent piping, with one being unattached (8-16-2017)

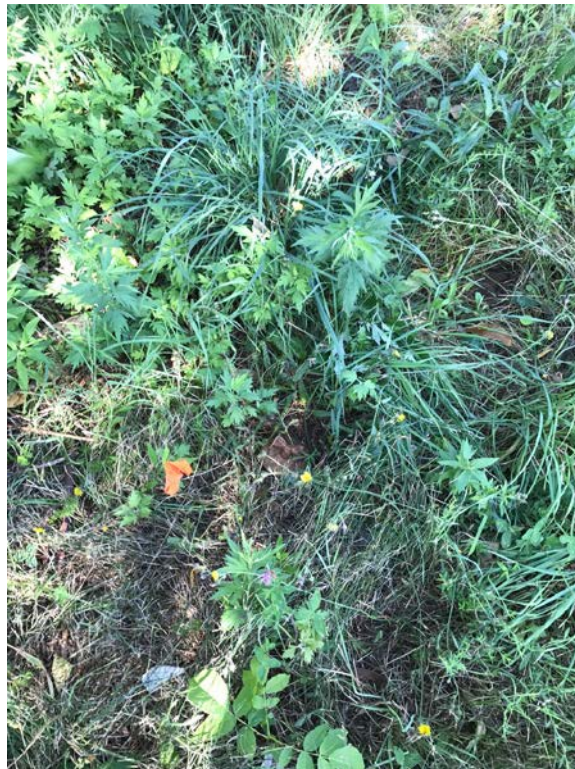
Damaged well MWIRM-1 (8-16-2017)

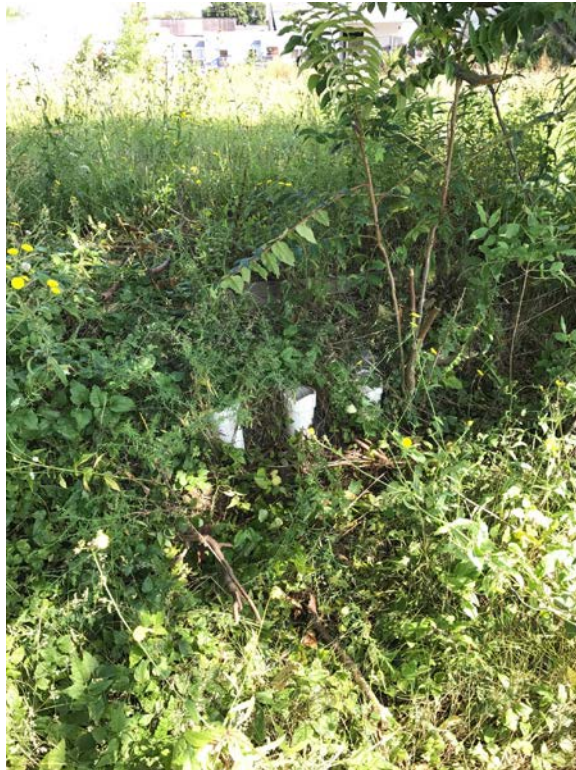
In-situ bioremediation system air effluent piping missing PVC stick-ups and wind turbines
(8-16-2017)

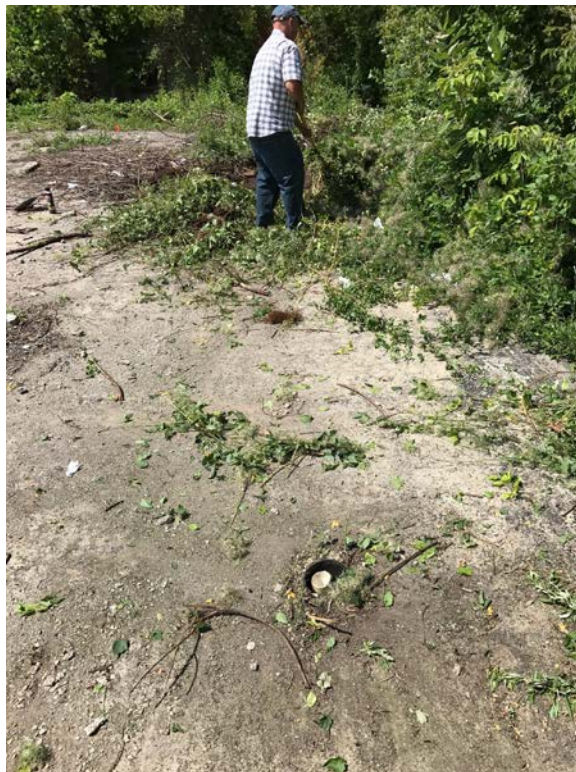
Describe damage or blockage if observed: On 8-16-2017, J-plugs were observed missing and curb boxes were observed damaged at monitoring wells MW-12 and MW-13, and the curb box was observed damaged at monitoring well MW-6. On 8-30-2017 and 8-31-2017, these wells were repaired. On 8-31-2017, new J-plugs were observed at monitoring wells MW-12 and MW-13, and new curb boxes were observed to be installed at monitoring wells MW-6, MW-12 and MW-13.

Monitoring well MW-12 with damaged curb box and missing j-plug (8-16-2017)

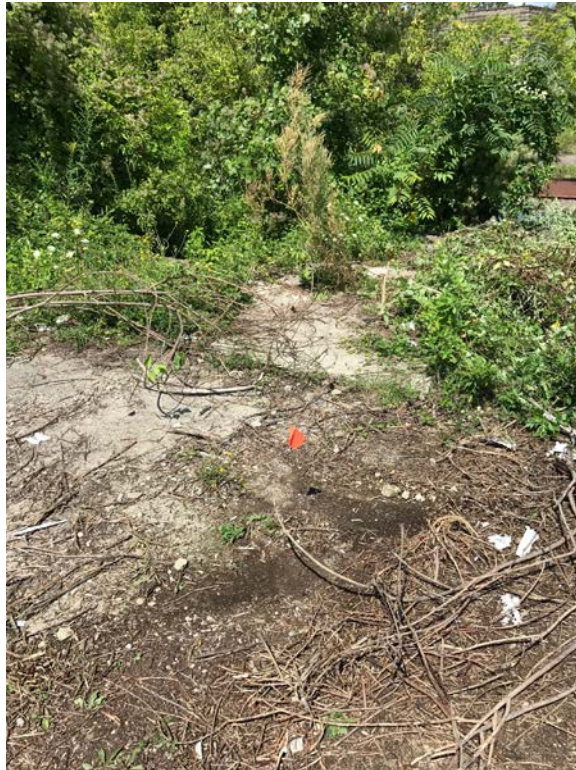
Monitoring well MW-13 with damaged curb box and missing j-plug (8-16-2017)

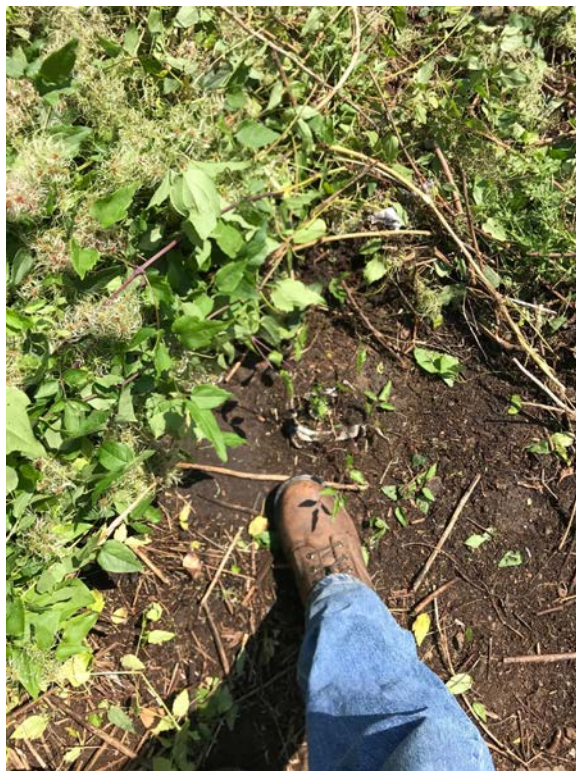
Monitoring well MW-6 with damaged curb box (8-16-2017)

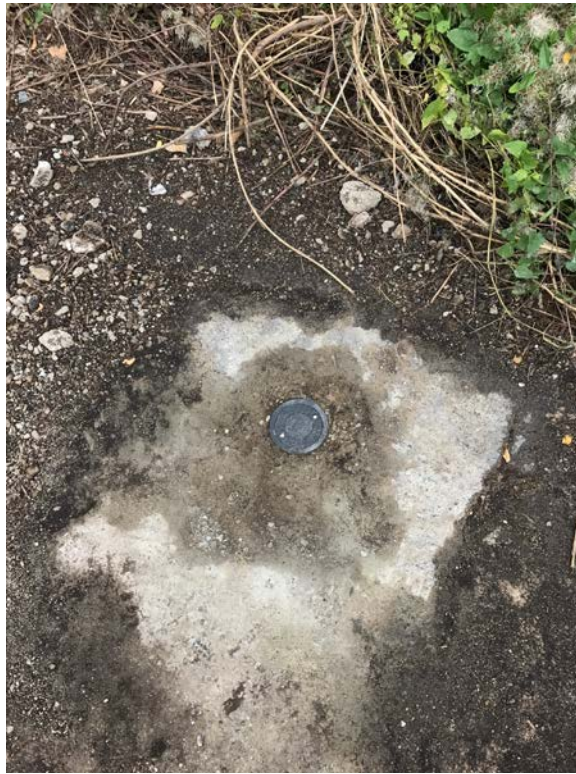
Monitoring well MW-6 with repaired curb box (8-31-2017)

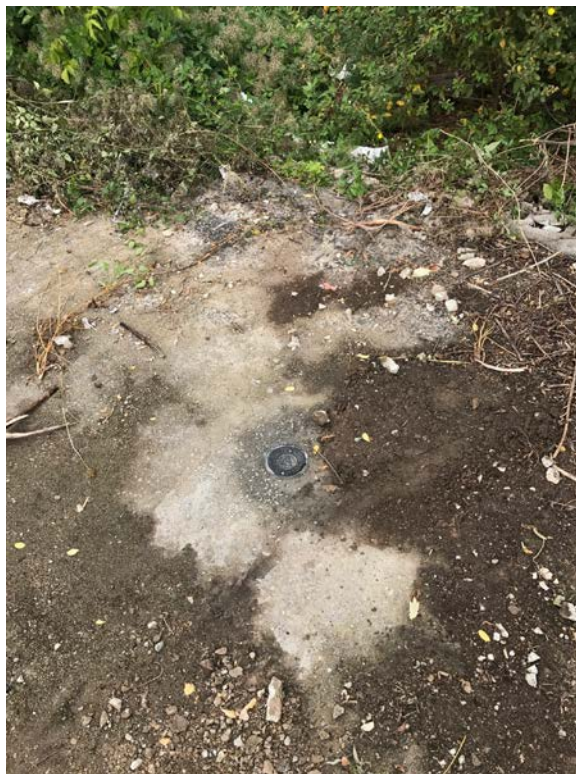
Monitoring well MW-12 with repaired curb box (8-31-2017)

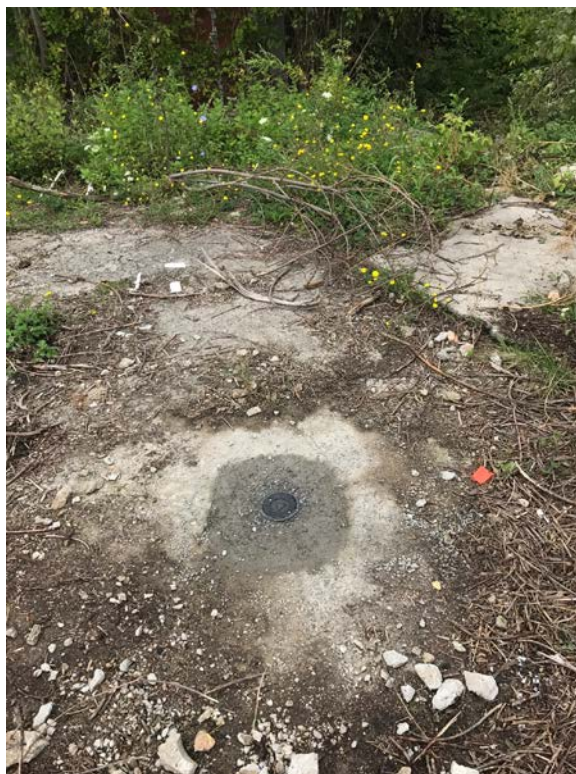
Monitoring well MW-13 with repaired curb box (8-31-2017)

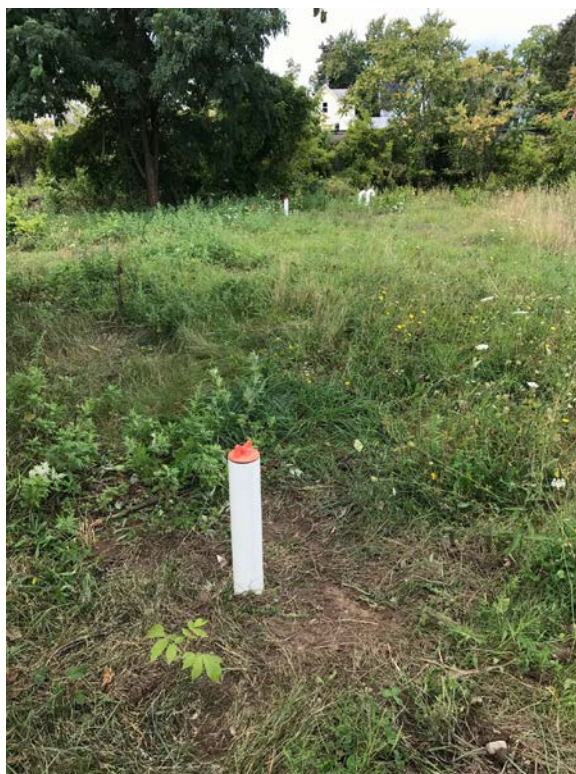
Well MWIRM-1 with repaired PVC stick-up and J-plug (8-31-2017)

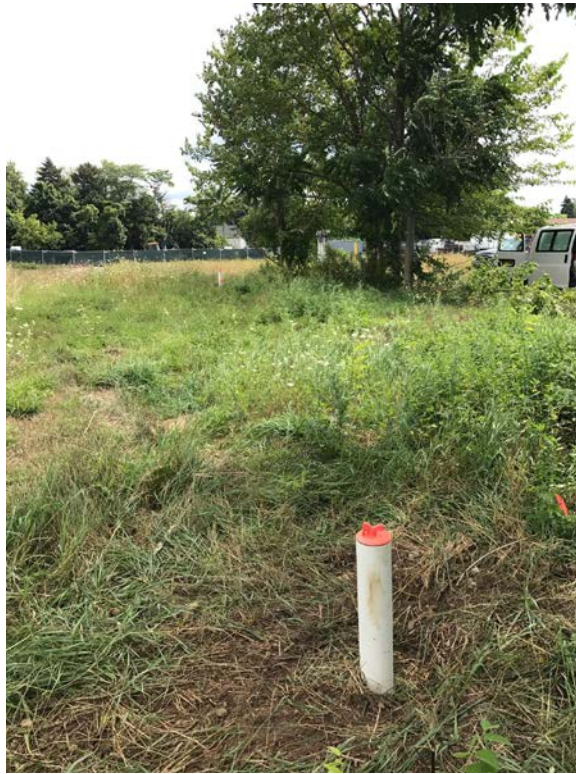
Well MWIRM-3 with repaired PVC stick-up and J-plug (8-31-2017)

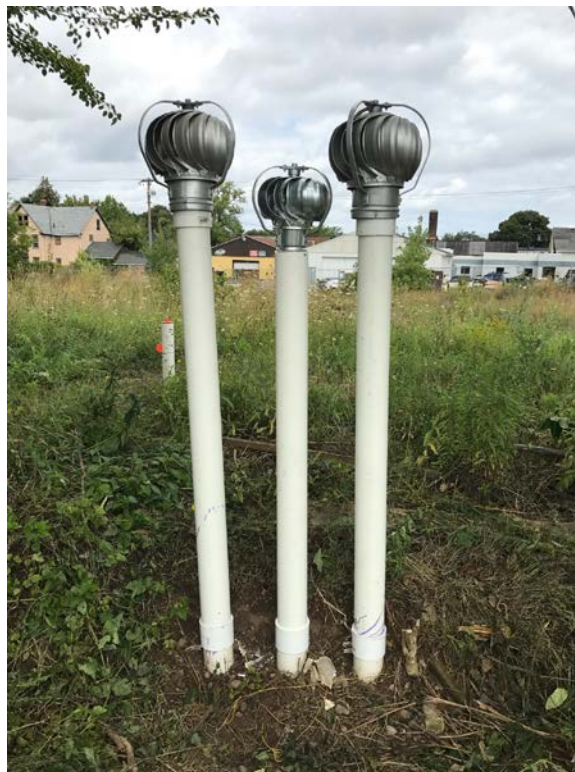
Repaired in-situ bioremediation system air effluent PVC piping and wind turbines (8-31-2017)

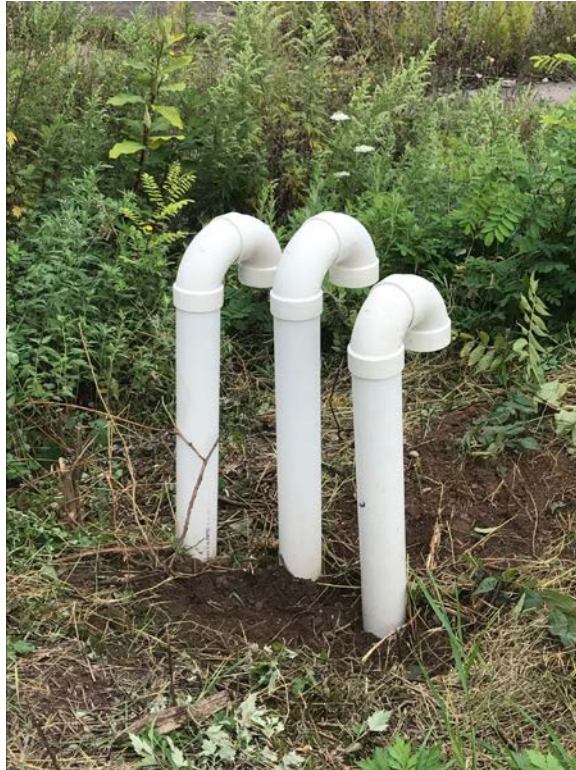
Re-attached in-situ bioremediation system air influent vent piping (8-31-2017)
