Re: 2012 Supplemental Investigation Letter Report  
500 South Union Street Site  
Spencerport, New York  
BCP Site No. C828153

**SITE PLAN**

2012 SUPPLEMENTAL INVESTIGATION  
500 SOUTH UNION STREET SITE  
SPENCERPORT, NEW YORK  
BCP SITE NO. C828153  
PREPARED FOR  
EYEZON ASSOCIATES, INC.

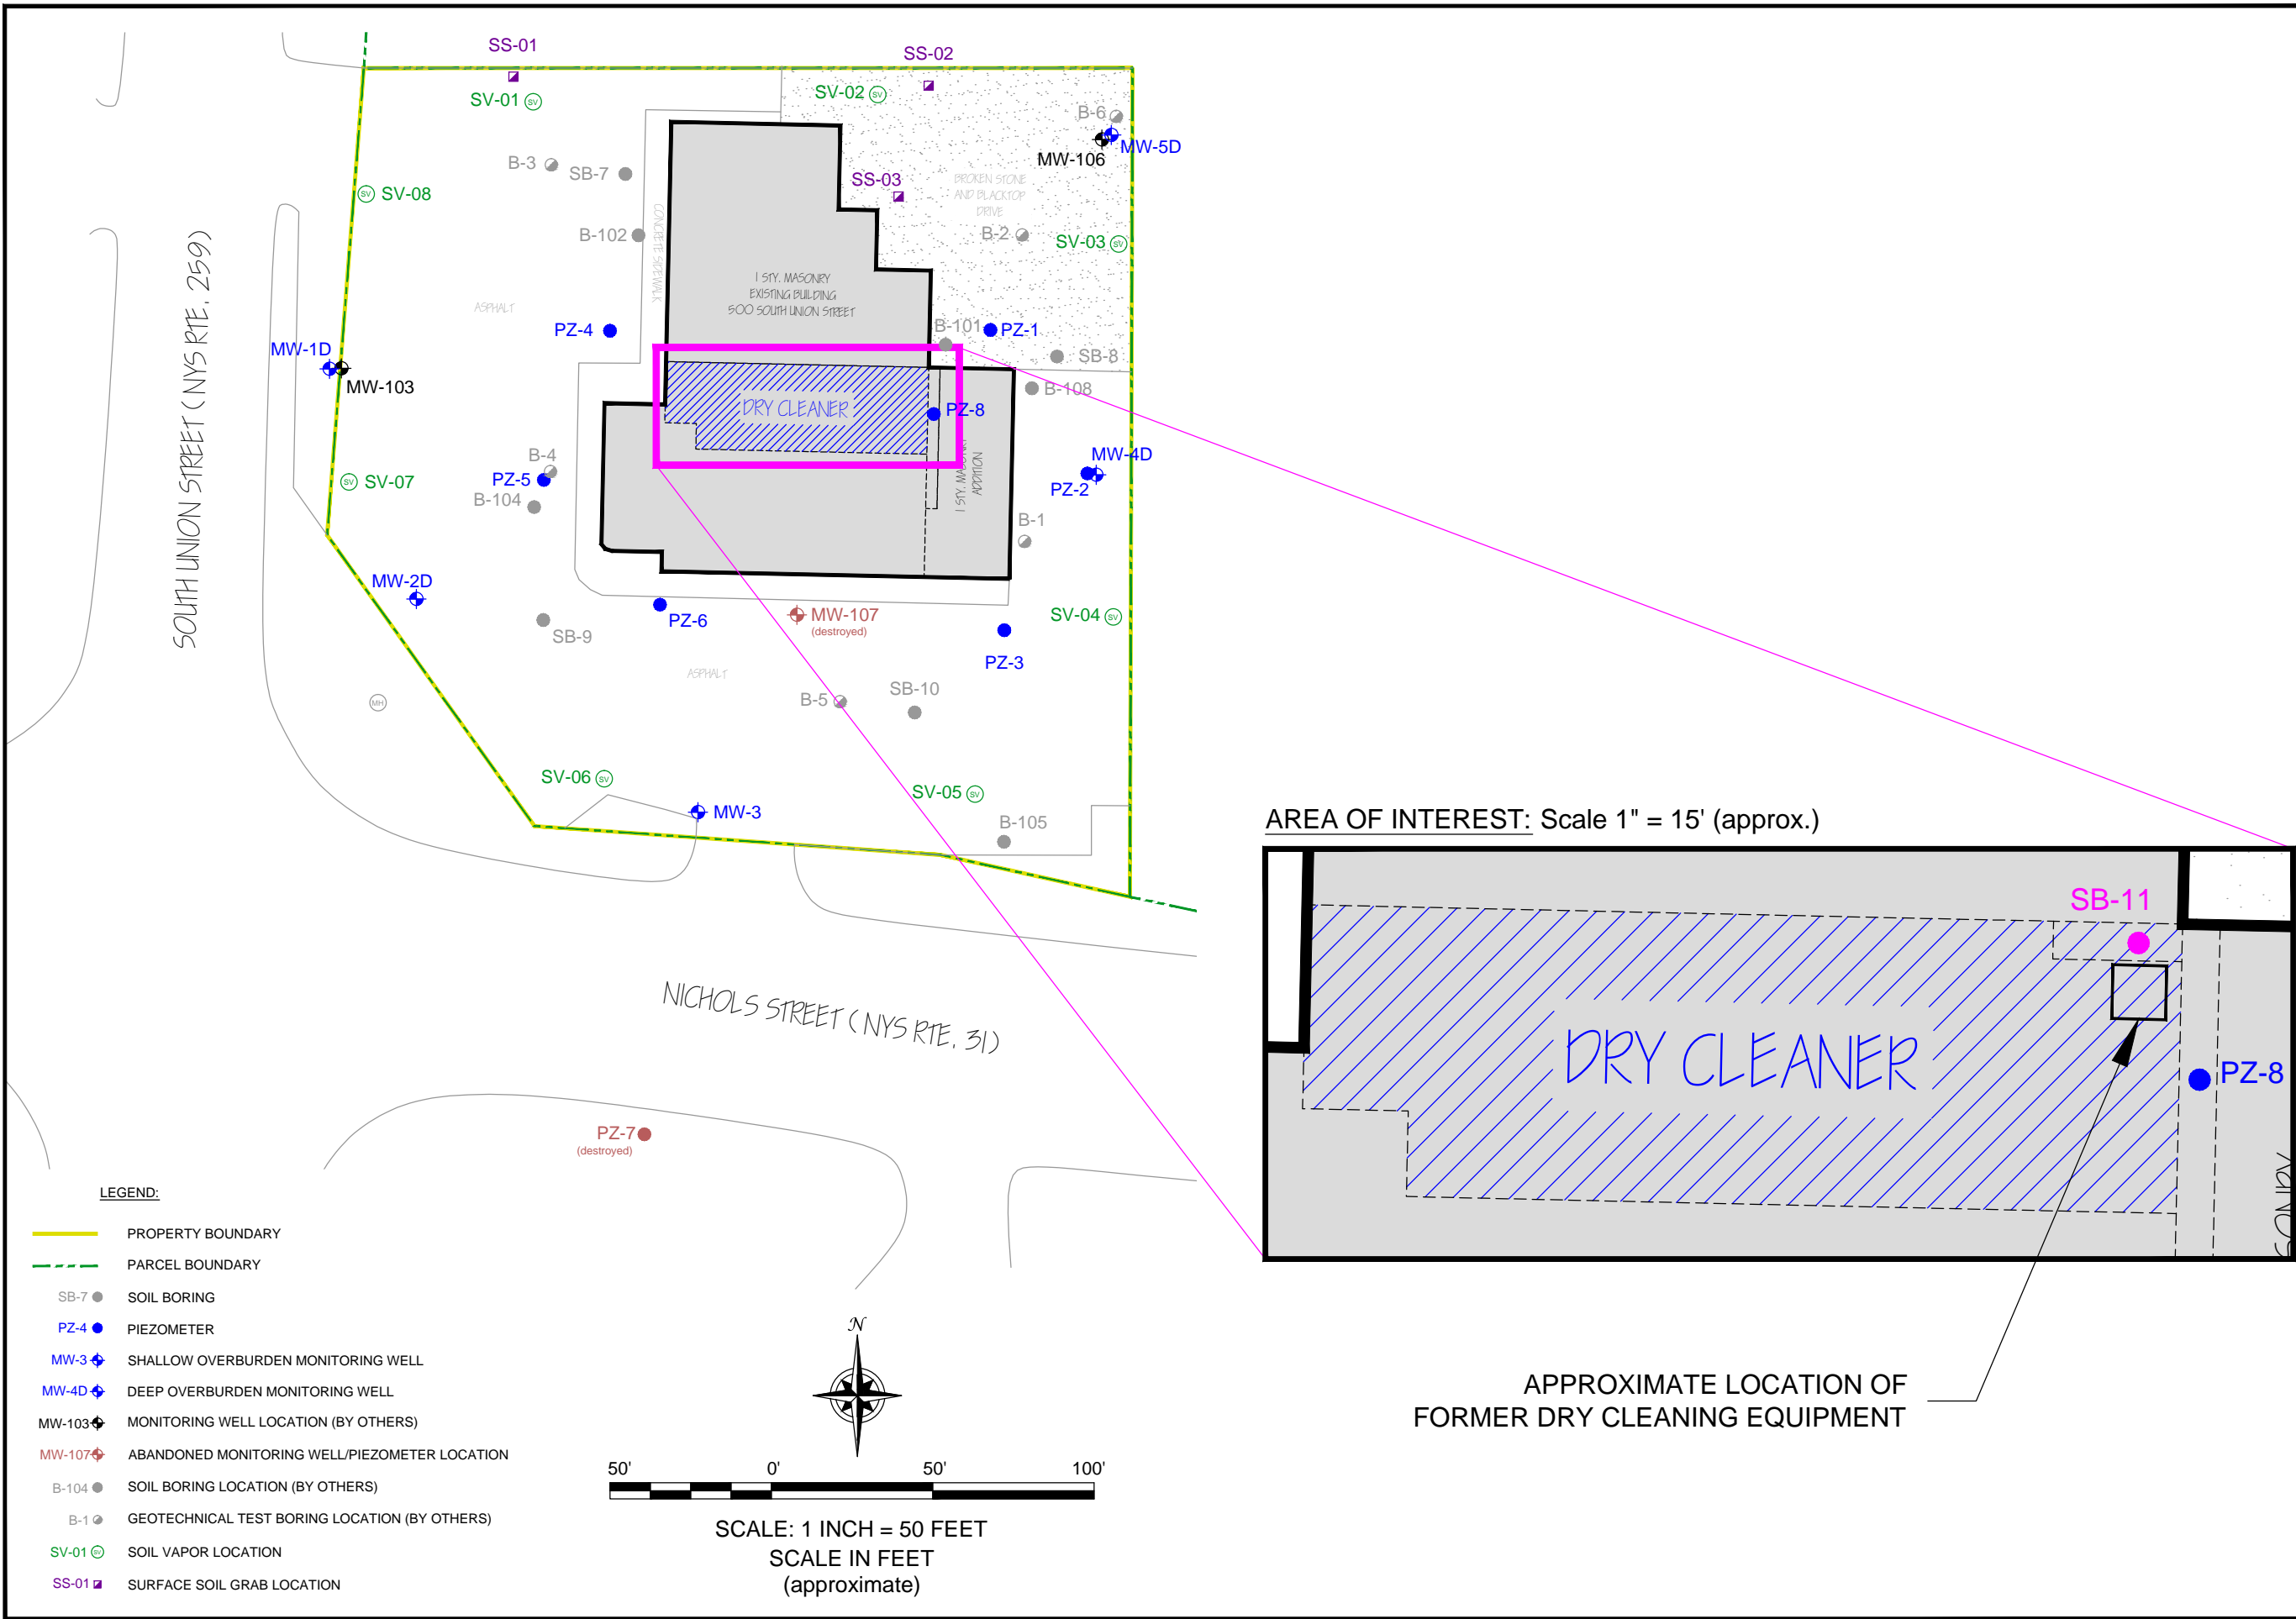
**FIGURE 1**

The 2012 Supplemental Investigation comprised the advancement of a single boring in the vicinity of the former dry cleaning equipment (see Figure 1). On two separate occasions, in June and July 2012, TurnKey personnel attempted to advance boring SB-11 inside the dry cleaner facility approximately 5 feet west the suspected location of the dry cleaning unit (see Figure 1, inset). During each attempt, a core drill followed by a direct push Geoprobe unit was used to advance the boring through the concrete floor. Space constraints within the area precluded the use of an appropriately sized drill rig to advance the boring deeper than approximately 1.5 feet below ground surface (fbgs). However the boring was advanced below the concrete floor within approximately five feet of the former dry cleaning machine.

Photoionization detector (PID) screening of drill cuttings as well as measurements obtained within the advanced borehole (e.g., subslab) did not identify concentrations above background (e.g., 0.0 ppm). No odors were observed during the soil boring. No soil samples were collected.
