Monthly Progress Report #9

Site #C828184

Former Carriage Factory

33 Litchfield Street

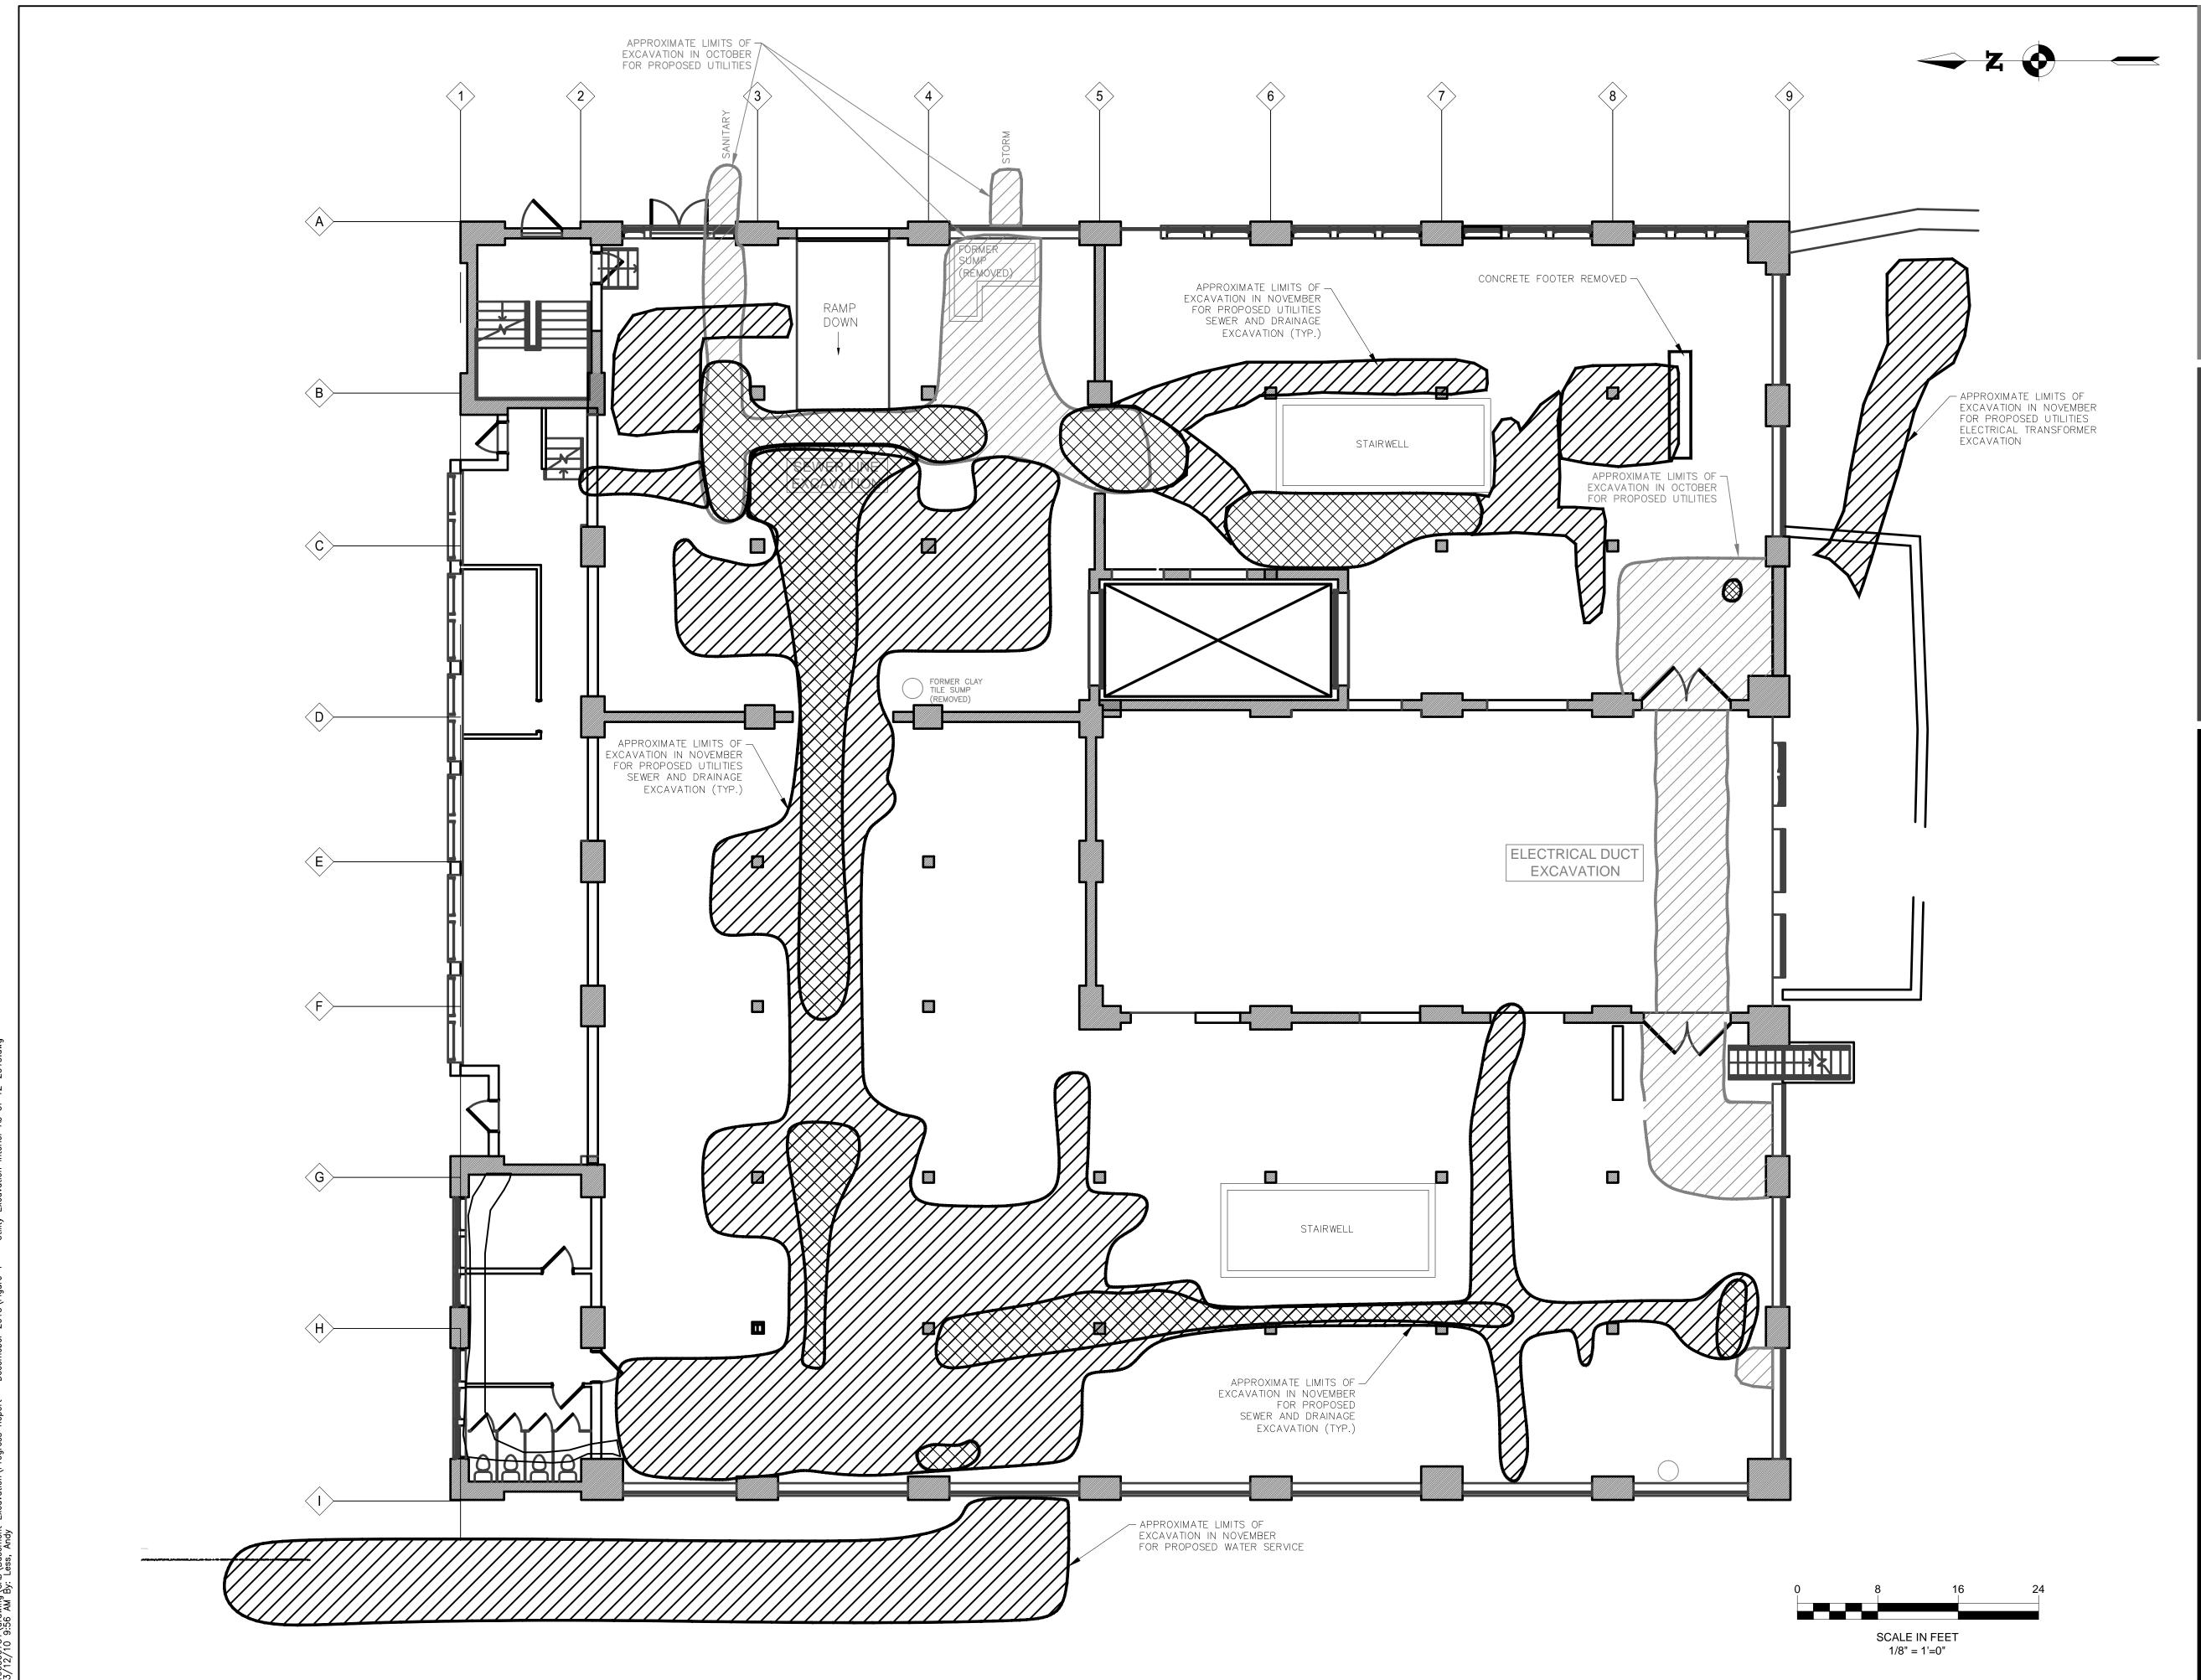
FIGURE 1

- Excavations in the basement for the installation of plumbing piping were ongoing throughout the month of November. Figure 1 shows the areas of the basement that were disturbed. Most of the excavated soil was backfilled into the trench from which it was removed. Some excavated materials were not suitable for backfill or did not fit back into the excavations. Excess materials were stockpiled in an area in the southeastern proposed parking lot and were separated into impacted (staged on and under plastic sheeting) and non-impacted piles. These staging piles are shown on Figure 2 and will be sampled for disposal once the remainder of basement excavation activities is completed. Most of the excavated soil had PID readings ranging from o-5parts per million (ppm). In several spots the soil exhibited PID readings ranging from 10 – 220 ppm. Bedrock depths ranged from ~4 ft. below finish floor elevation (bff) to ~2 ft. bff (determined by the known difference in elevation between proposed finish floor and existing stairwell foundation surfaces). Where required, bedrock was removed to achieve design grades and facilitate sufficient pitch for the piping. Areas of rock removal are shown on Figure 1. Most bedrock exhibited no PID response when fractured, however, in two locations, freshly fractured bedrock exhibited PID readings of up to 190 ppm. One of these locations is immediately below installed remedial injection piping. The second is located in close proximity to the former crock that is suspected to be a source of chlorinated solvent contamination. This is within 5 feet of monitoring well RW-2 and within 20 feet of two remedial injection piping lines. The impacted rock was removed and placed in the impacted staging pile. In several places the plumbing piping crossed or ran parallel to previously installed groundwater remediation injection piping. These instances were photo-documented and if disturbed, previously placed crushed stone was replaced beneath and above the injection piping. No bentonite seals were disturbed.

- During the period 11/12 to 11/15 a trench was excavated to carry electrical conduit that exits the building through the eastern south wall foundation and runs to the southeast to a transformer vault (Figure 1). Ten 4-inch diameter conduits were enclosed in a concrete trunk and the excavation was backfilled with native material. None of the material excavated exhibited detectable PID readings.

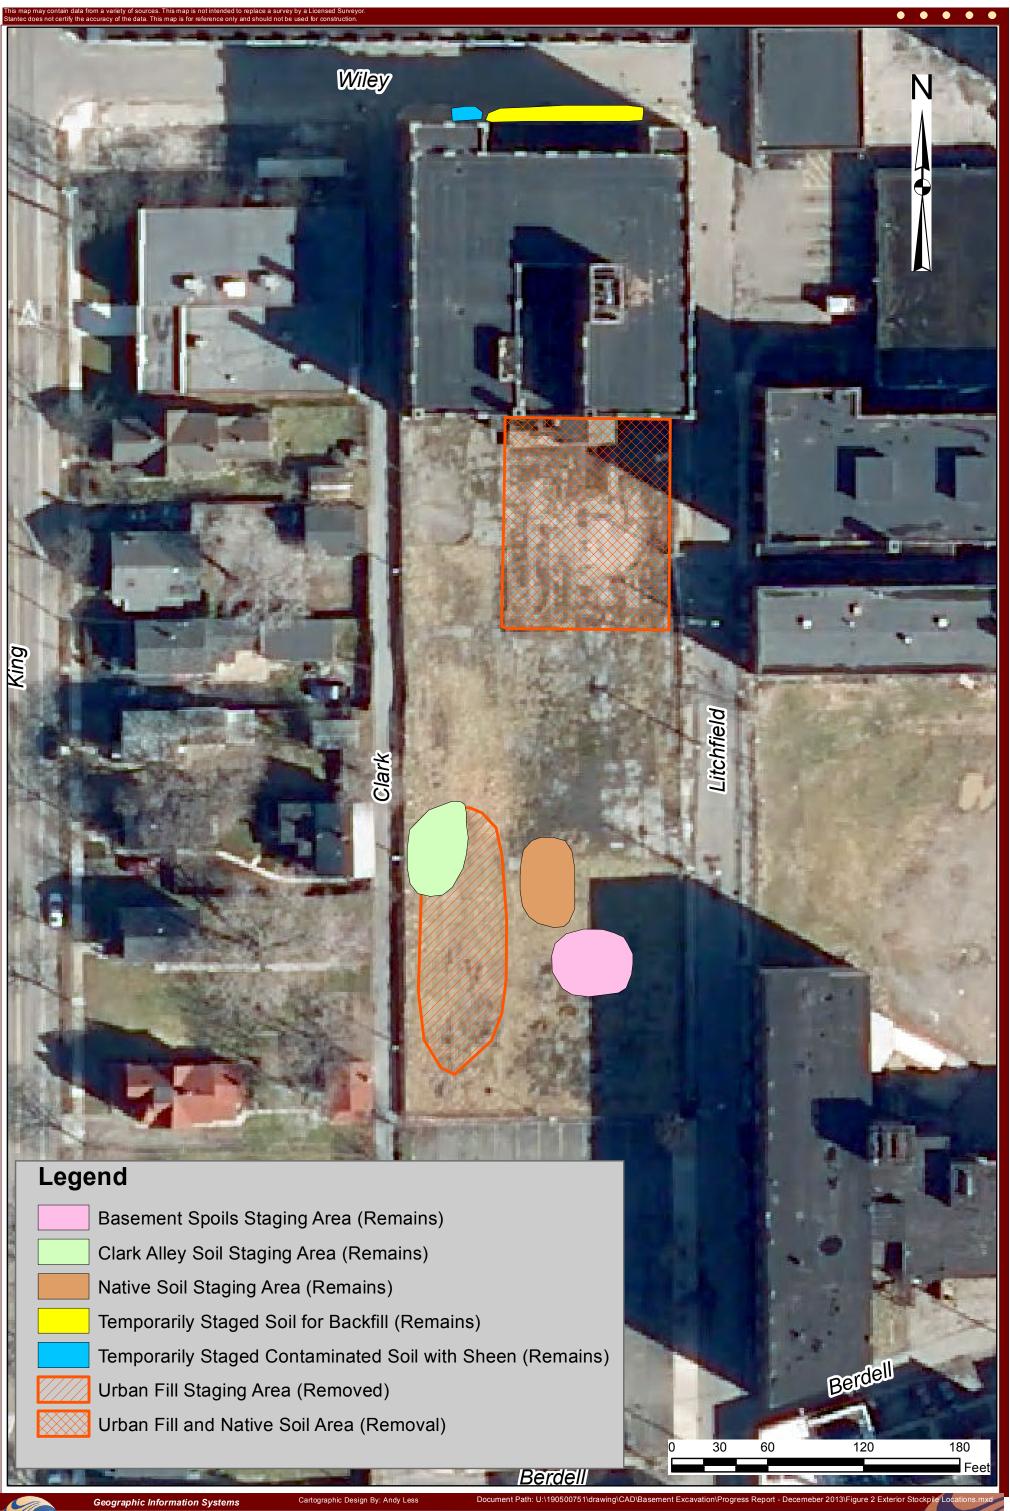
- During the period 11/19 to 11/20, 1,830.27 tons of urban fill was removed from the site and disposed at Waste Management's Mill Seat Landfill in Bergen, NY under waste profile 110956NY. The material was previously staged as shown in Figure 2 and was generated during grading activities in the central and eastern areas immediately south of the building.

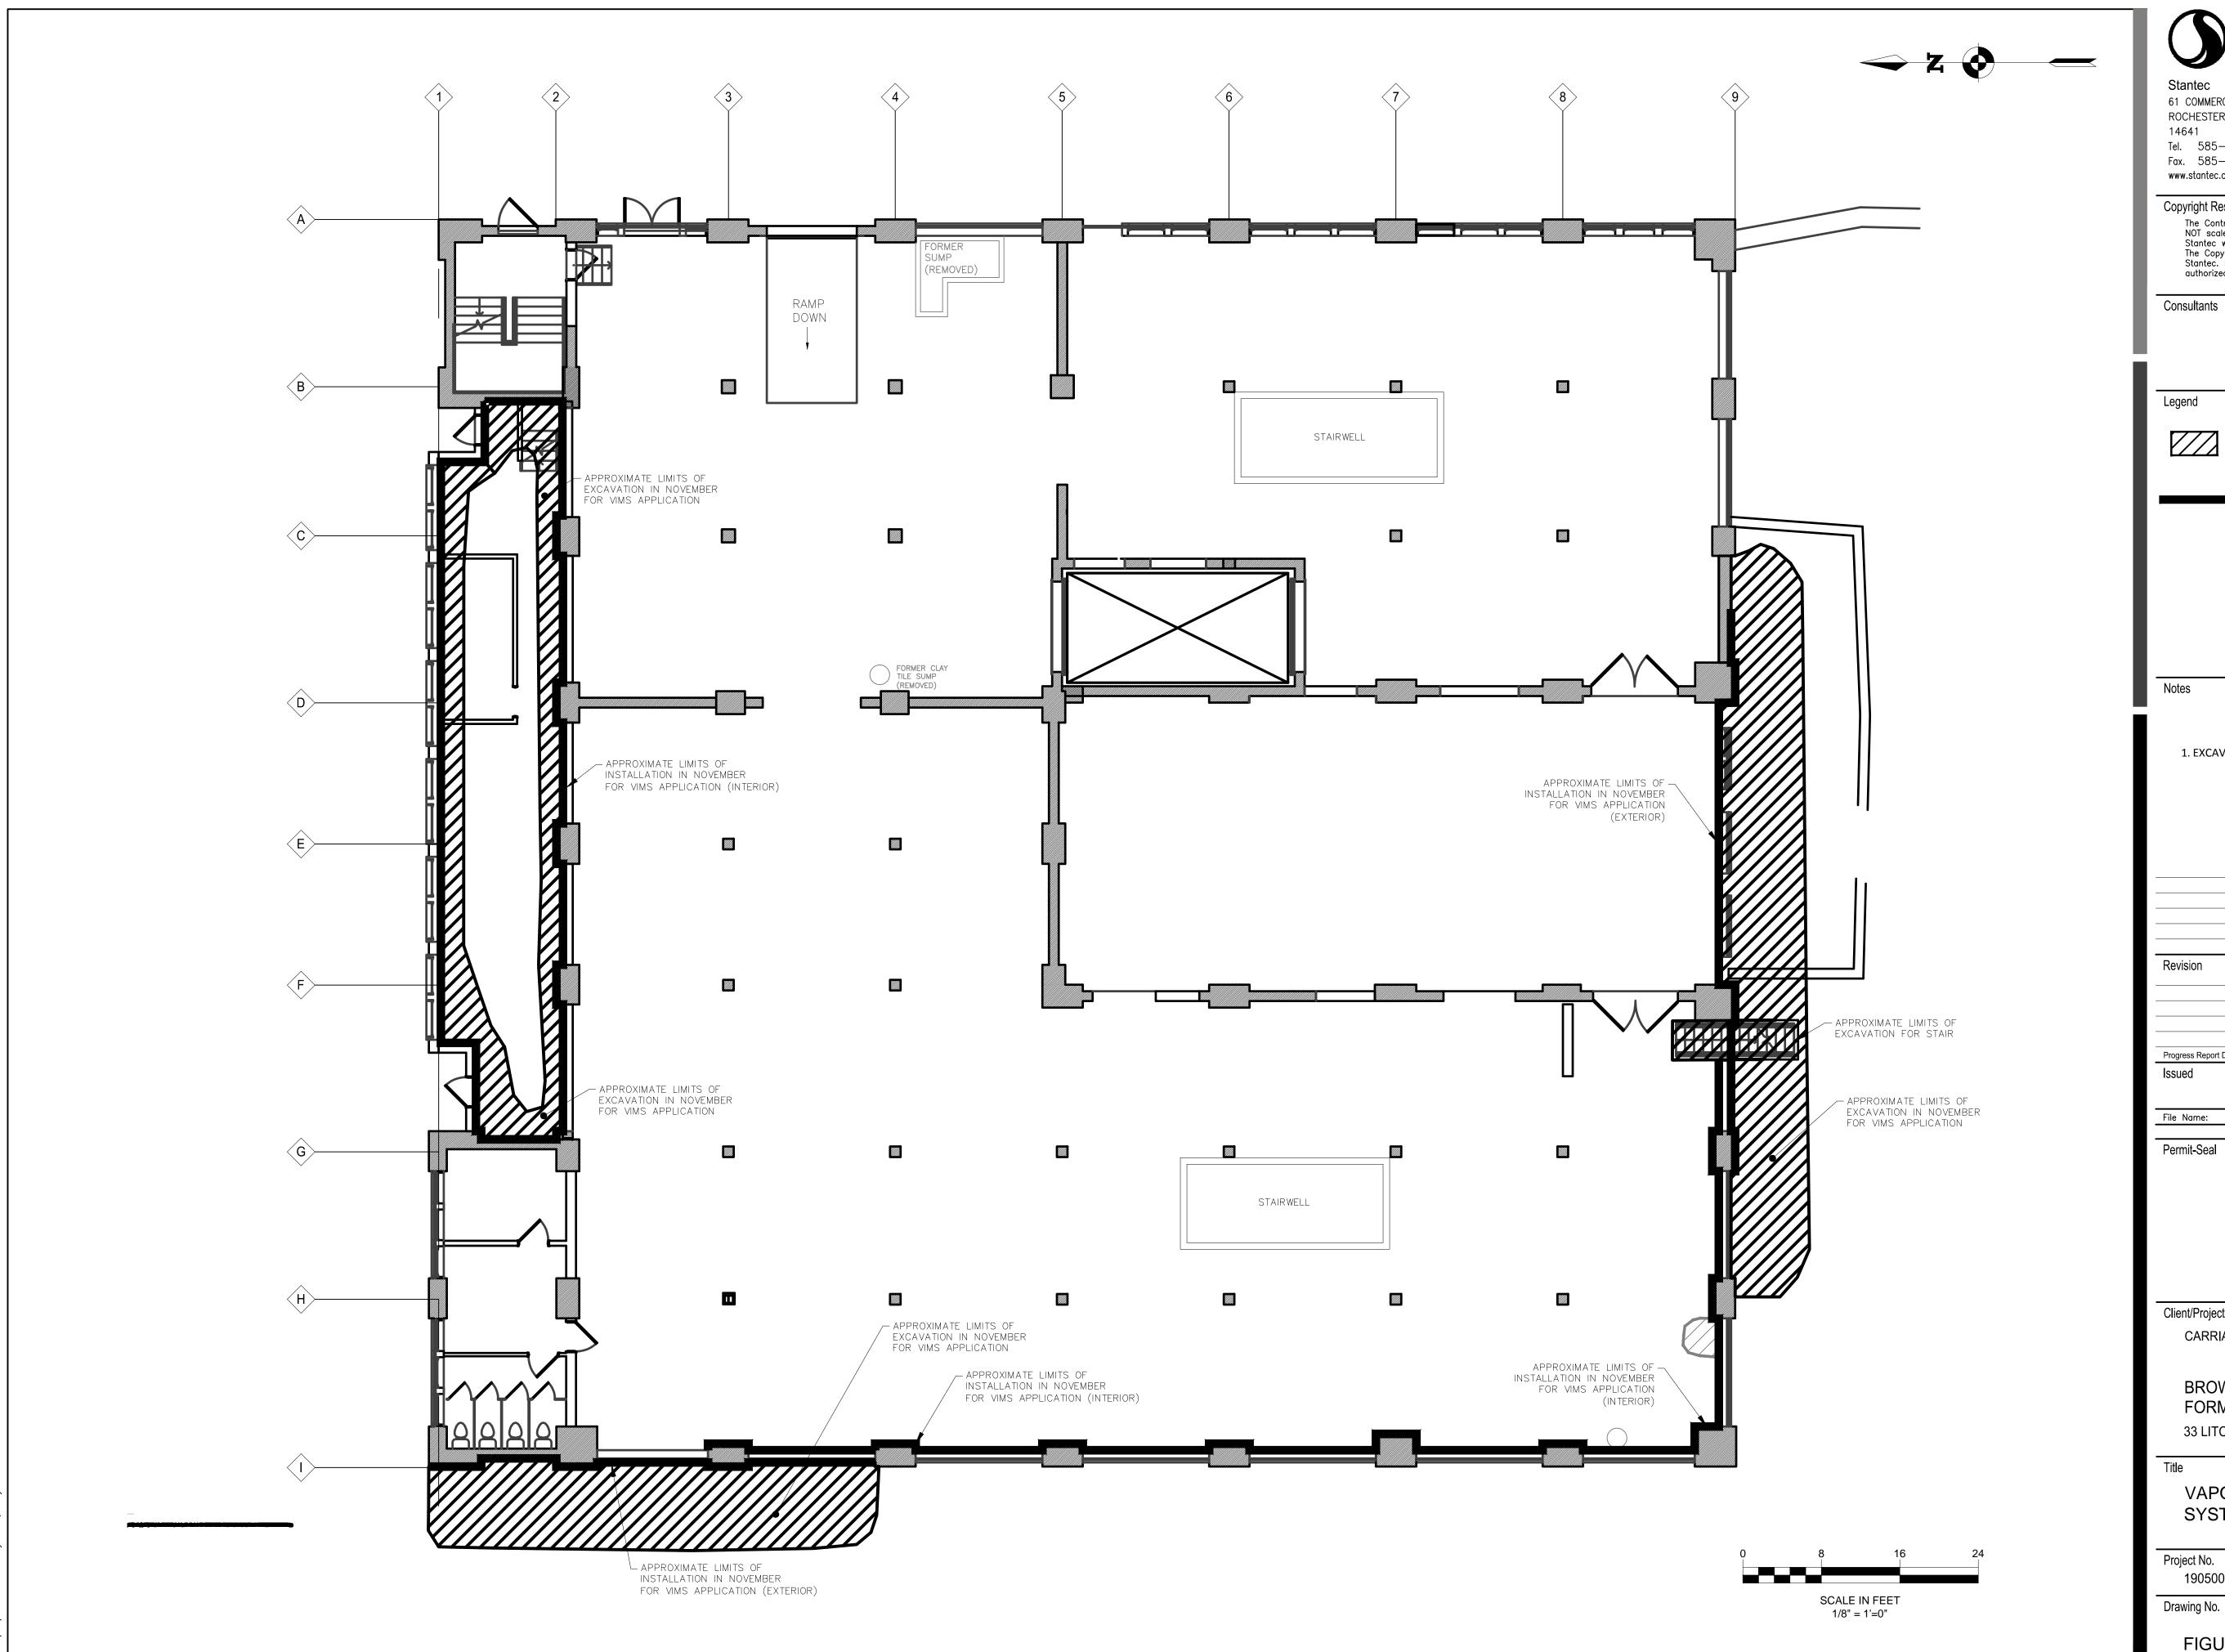
Scale Project No. **AS SHOWN** 190500751 Drawing No. Revision FIGURE 3

- On 11/16 a total of 1,940 sq. ft. of Liquid Boot membrane was applied by Terrafix, the VIMS contractor, to the exterior areas described above as well as to the west and southwest interior basement walls as specified as a component of the VIMS (Figure 3). On 11/17 the applied material passed all thickness tests taken insuring it was applied to a thickness greater than the required 60 mils.

- On 11/18 the west and south excavations made for the Liquid Boot application were backfilled with native material. A 1/8" thick protection board was placed between the Liquid Boot material and the backfill to prevent sharp edges from penetrating the VIMS. One tear in the Liquid Boot material was noted on the west wall within 2 feet of the ground surface. This location was documented and will be addressed during the next mobilization of the Liquid Boot application contractor.

- On 11/27 the Liquid Boot material applied to the west interior wall was observed to be leaking water and generating bubbles in two areas adjacent to both the newly installed water service and the roof drainage outlet to Clark Alley. The roof drainage has since

been tied into the sewer and this issue is being addressed. The damaged Liquid Boot material will be repaired during the next mobilization of the VIMS contractor.

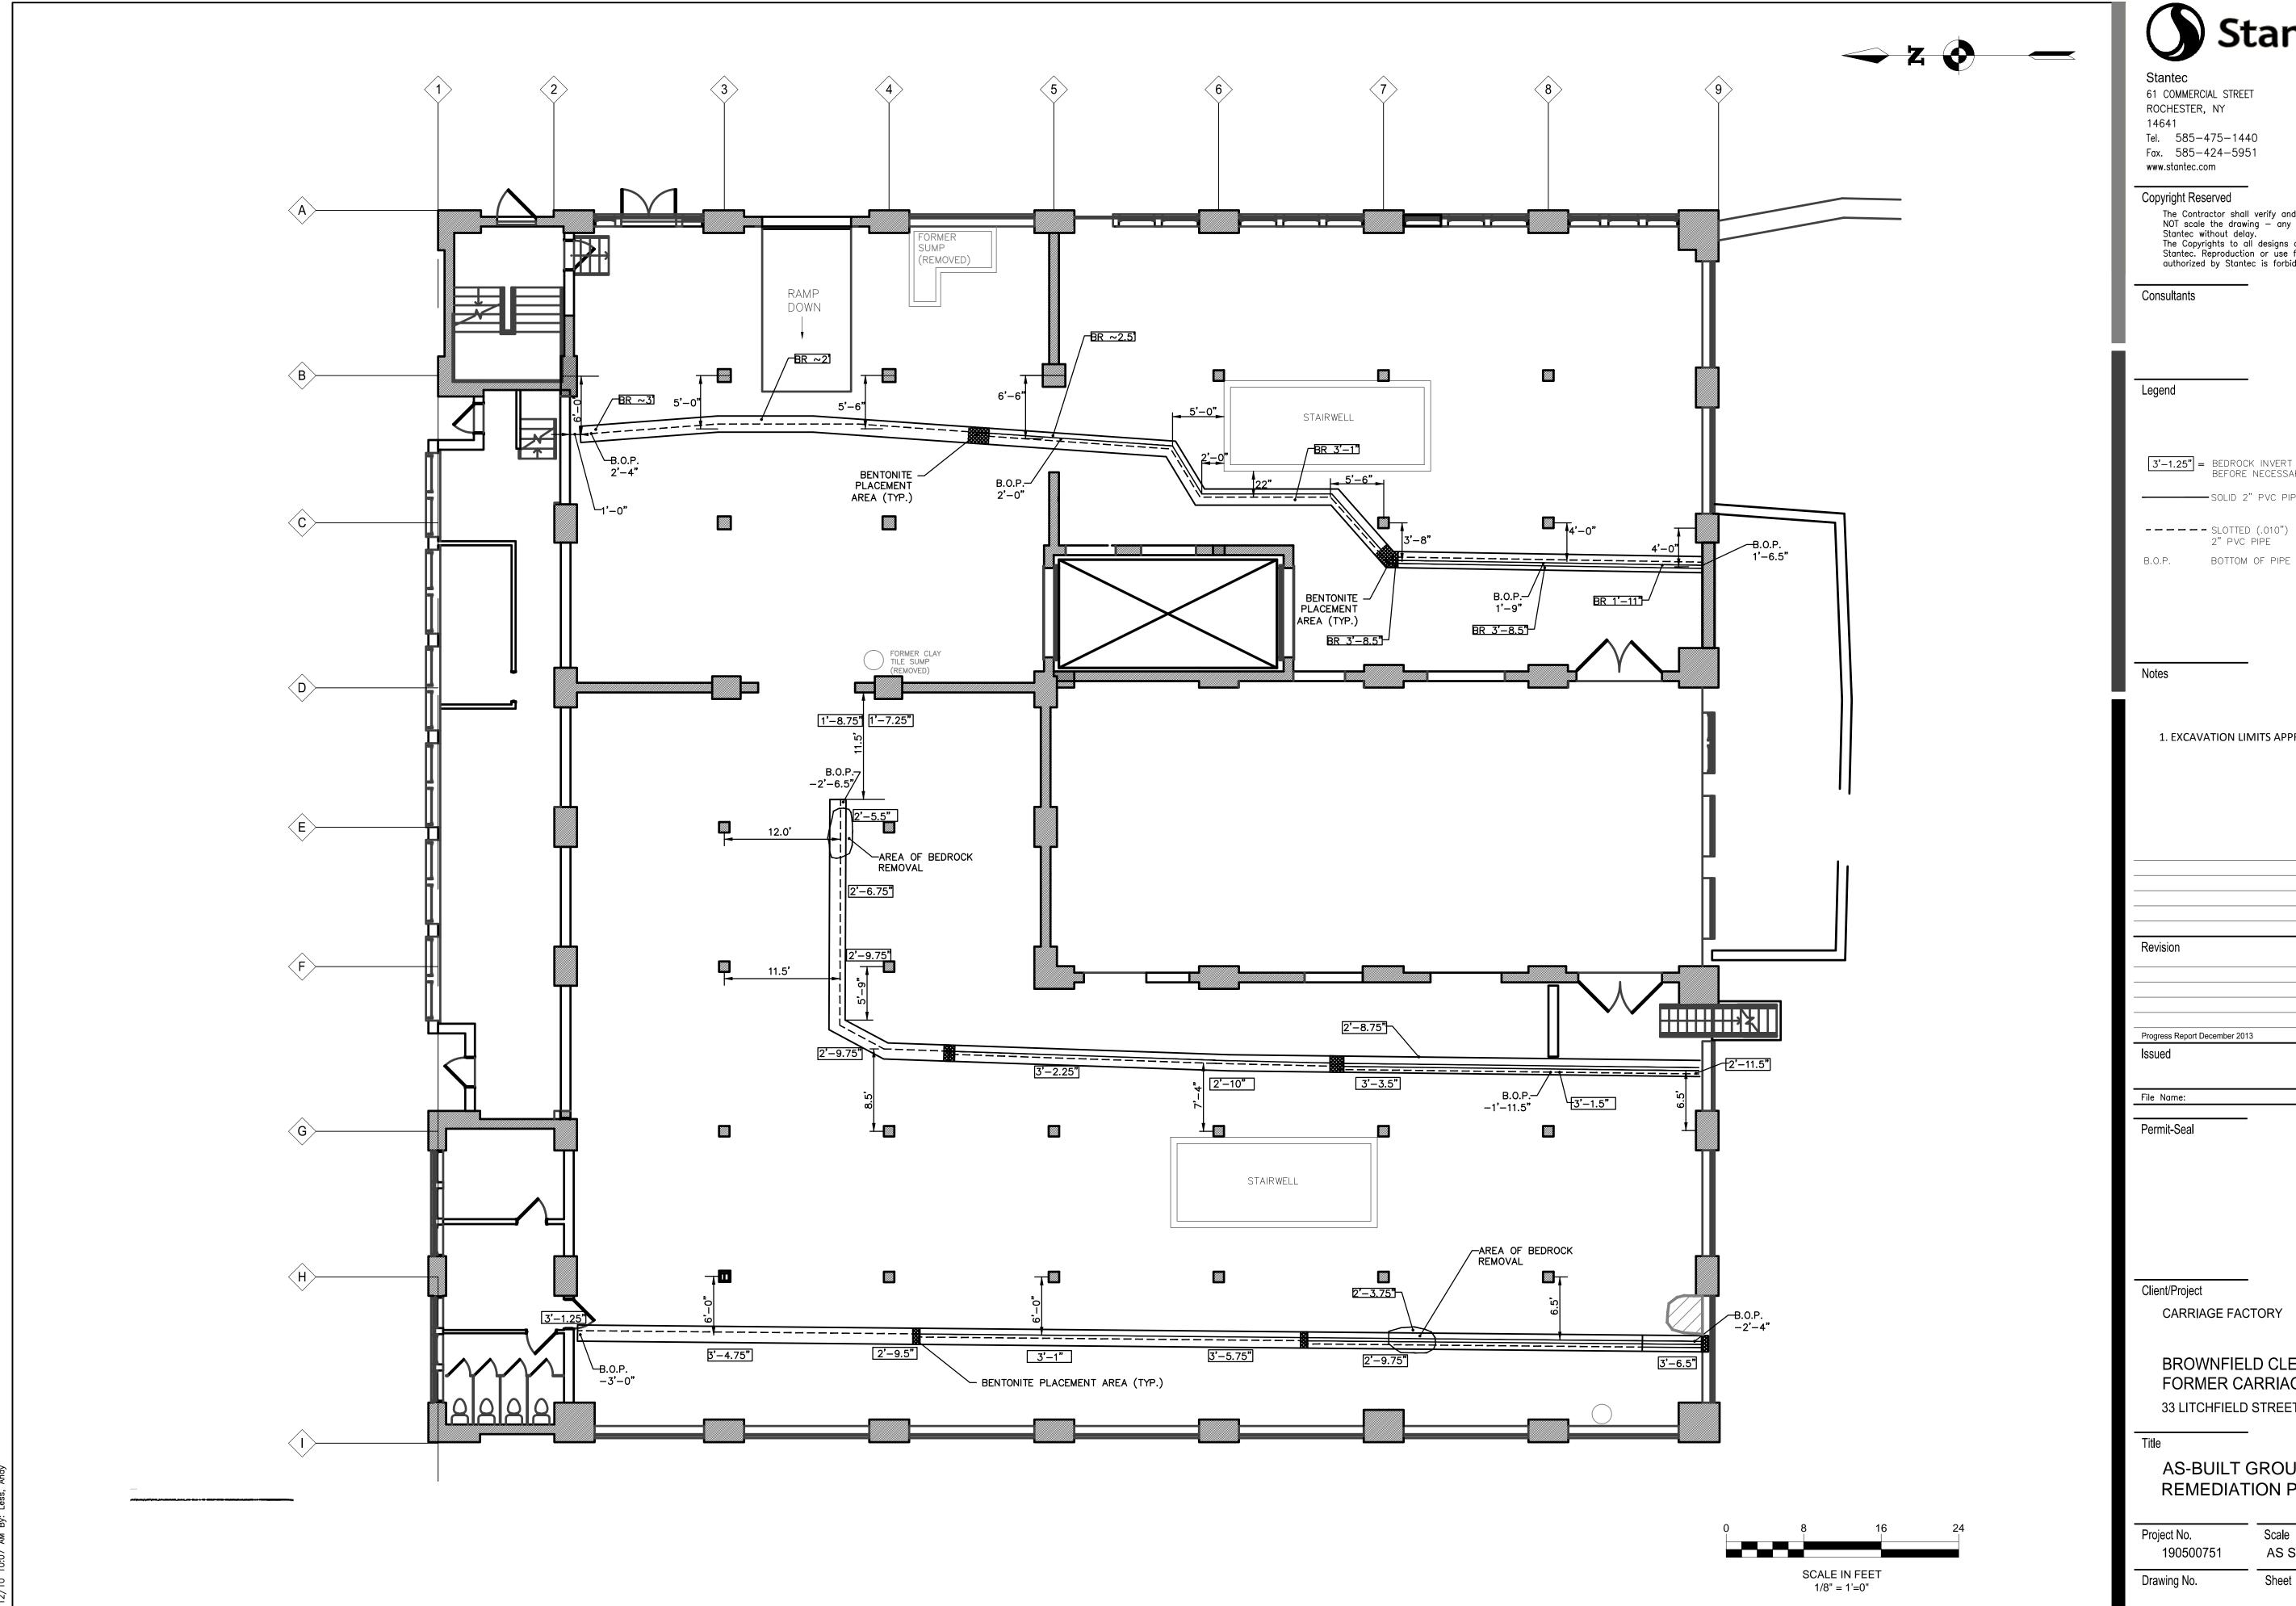
Project No. Scale **AS SHOWN** 190500751 Drawing No. Revision FIGURE 4

- During the period 11/8 11/11, the middle leg of the proposed groundwater remediation system piping that was partially installed in September was completed. A hole was cored through the southern building wall and the lines were temporarily stubbed and capped outside the wall. Since the hole was cored through foundation material, the void space around the pipes was sealed with concrete for structural reasons, as discussed with and approved by the NYSDEC project manager, instead of the proposed bentonite. See Figure 4 for an as-built plan of the remediation piping.

- During the period 11/12 11/13, the easternmost leg of the proposed groundwater remediation system piping was installed as shown in Figure 4. Due to the limited space available between bedrock and finish floor elevation, the remediation piping was installed above storm and sanitary drain piping, as discussed with and approved by the

NYSDEC project manager, in order for the drain piping to maintain sufficient pitch. In all excavations where plumbing piping crossed beneath the location of the remediation piping, the plumbing trench was excavated to bedrock and was backfilled with crushed stone to provide the required pathway for the future injected remediation solution to reach bedrock. The trench excavated for the remediation piping was also excavated to bedrock and backfilled with crushed stone. In accordance with the design, bentonite seals were placed where one injection pipe ends and another becomes perforated. As with the middle leg, the hole cored through the south wall to bring the injection piping outside was filled with concrete since it was cored through the wall footer.
