June 18, 2015

Re: May 2015 Progress Report
3750 Monroe Avenue, Pittsford, New York
NYSDEC BCP Site #C828187
LaBella Project No. 213131

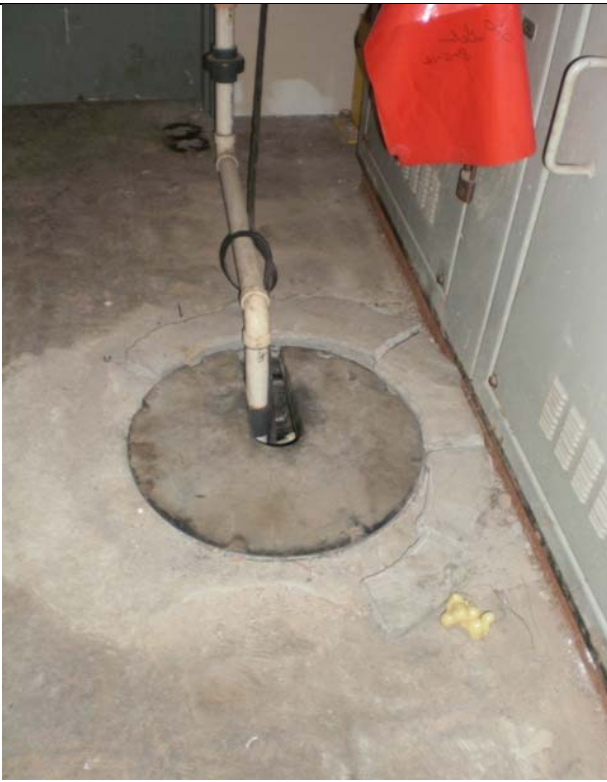
Sump in electrical room, prior to sealing, as found on May 13, 2015 with non-airtight cover.

<u>Additional Task</u>	<u>Status</u>
Assess and, if deemed necessary, seal the sump located in the electrical transformer room in the southwestern portion of the Site building.	Sump was sealed with plastic sheeting and check valve assembly on May 13, 2015 (see attached photos).
Perform backdraft testing on the natural gas-fired hot water heater located in the Concentrix Call Center.	Smoke test performed on June 10, 2015. Observed natural updraft of smoke into hot water heater flue.
Explore Site building for additional natural gas-fired hot water heaters.	Visually assessed hot water heaters associated with restrooms and break rooms in various tenant spaces, and interviewed tenant contacts regarding the presence of natural gas-fired hot water heaters. Other than the hot water heater located in the Concentrix Call Center space (see above), all other observed hot water heaters are electric, and tenant contacts do not report the presence of natural gas-fired hot water heaters in their spaces.

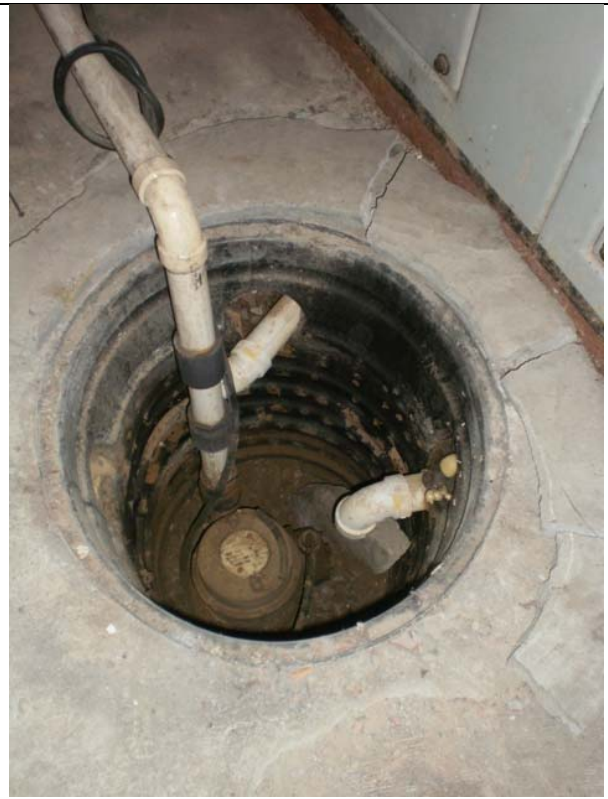
Interior of sump in electrical room, prior to sealing, with non-airtight cover removed.

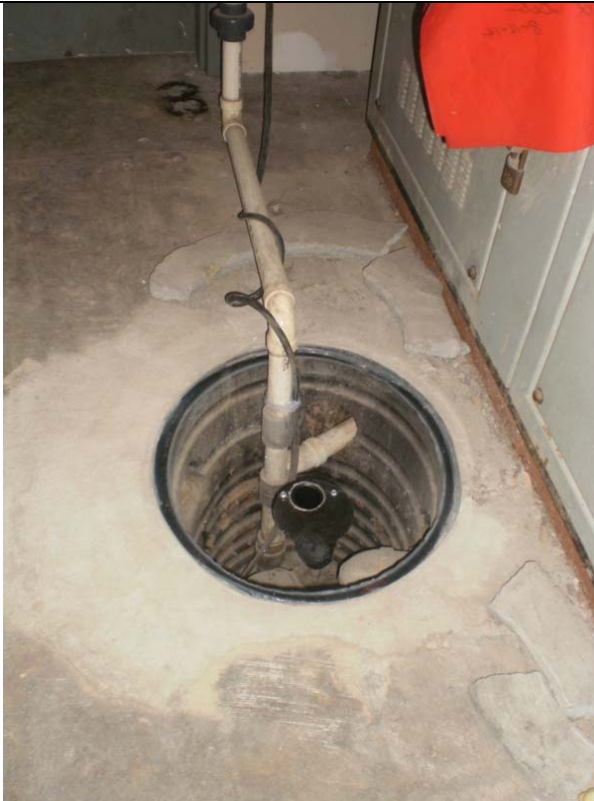
Sump in electrical room after it was sealed with plastic sheeting and check valve assembly on May 13, 2015.

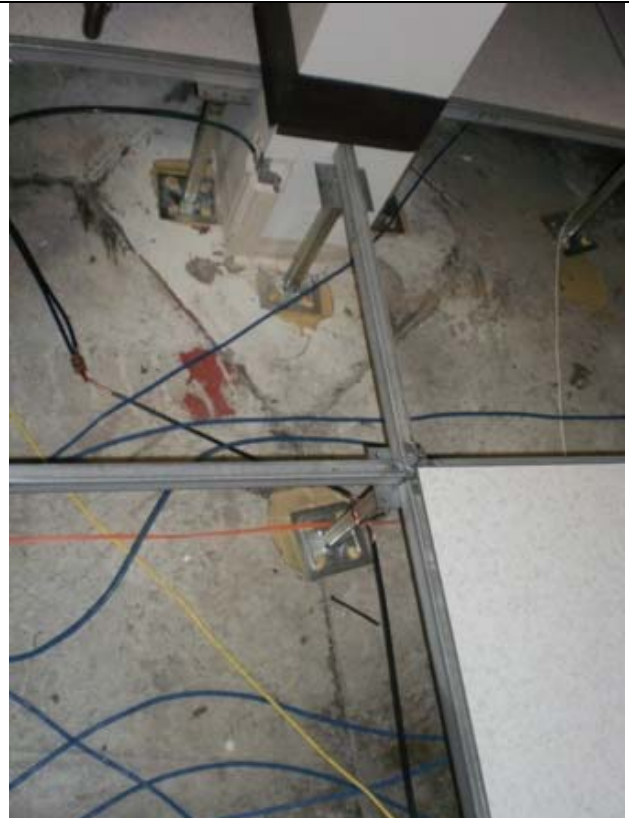
- While investigating May 13th positive PFE measurements along the Town Court's common wall with VoltDelta's computer server room, LaBella and Mitigation Tech found that the server room has an elevated floor and the space beneath this raised floor (and above unfinished bare concrete floor slab with expansion joints and saw cuts) is highly positively pressurized for cooling the electrical/computer equipment. In an attempt to improve performance of the SSDS, on June 3rd Mitigation Tech sealed accessible expansion joints and saw cuts in the concrete floor slab below the raised floor in the VoltDelta server space (see attached photos).

Prior to sealing, typical expansion joints in the concrete floor slab below the raised floor in the VoltDelta server space.

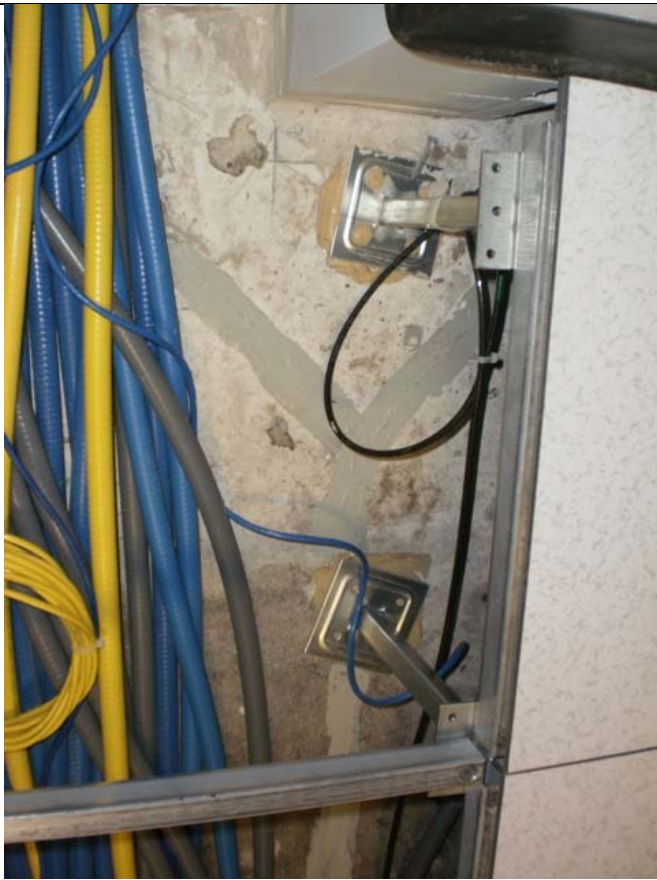
After sealing, expansion joints in the concrete floor slab below the raised floor in the VoltDelta server space.

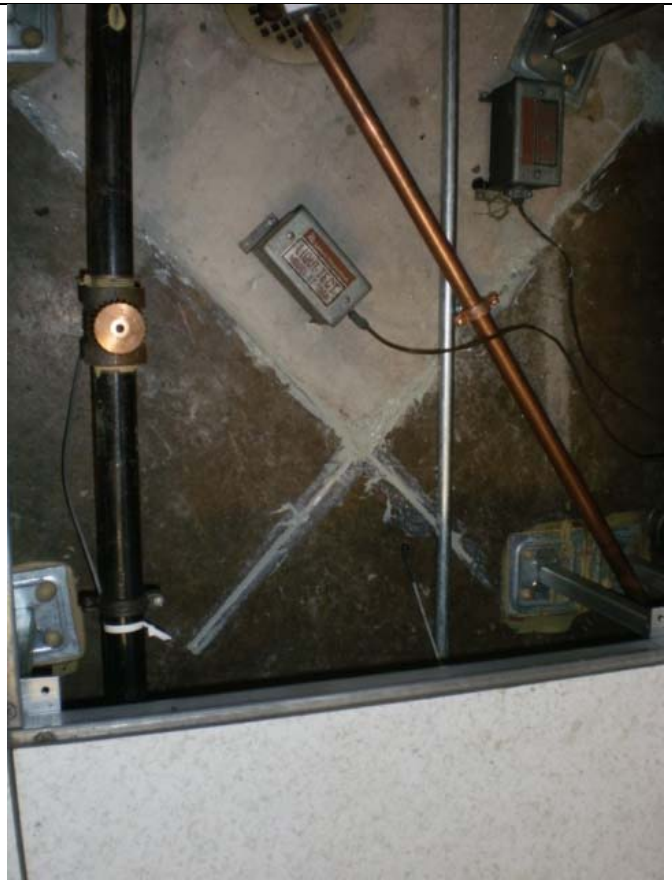
After sealing, saw cuts in the concrete floor slab below the raised floor in the VoltDelta server space.

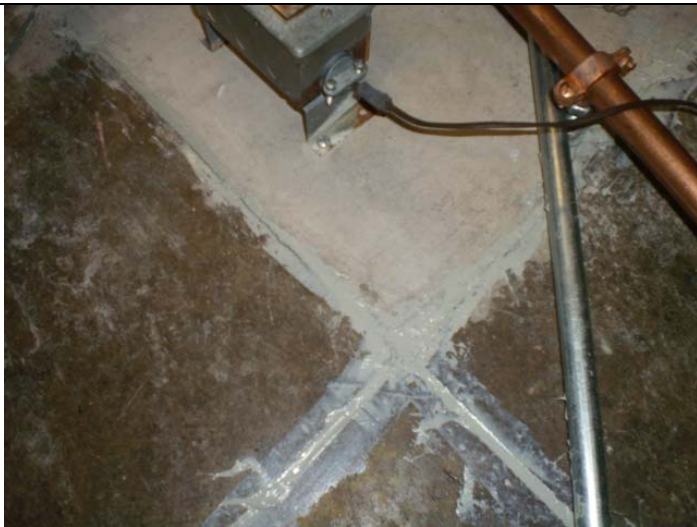
After sealing, saw cuts in the concrete floor slab below the raised floor in the VoltDelta server space.

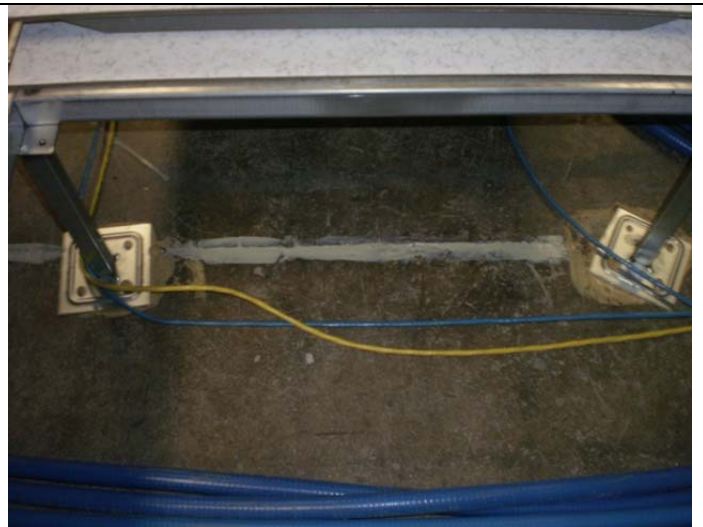
After sealing, an expansion joint in the concrete floor slab below the raised floor in the VoltDelta server space.
