PHASE I ENVIRONMENTAL ASSESSMENT REPORT

EASTMAN KODAK COMPANY
C-PLANT
100 CARLSON ROAD
ROCHESTER, NEW YORK 14653

MCLAREN/HART PROJECT N^o: 14-0802291-001-001

MARCH 31, 1995

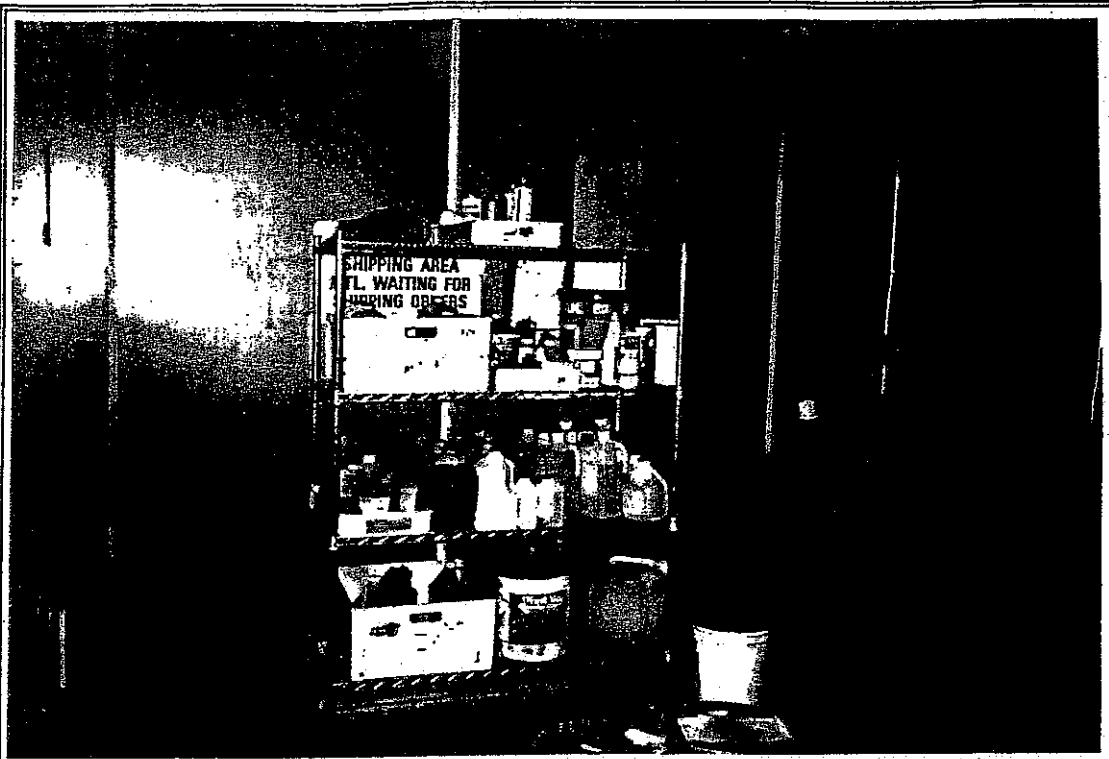
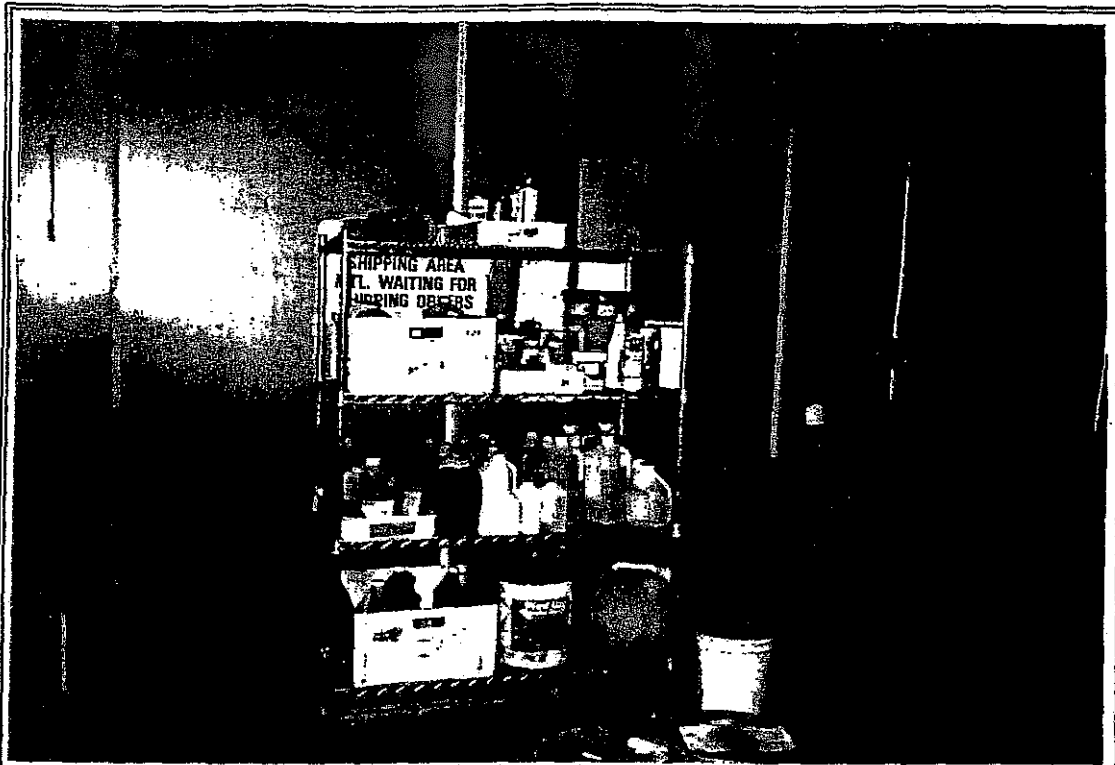
McLaren/Hart observed limited amounts of hazardous materials and chemicals stored at the Property. These materials were stored in containers ranging from very small vials to 55 gallon drums (Photographs N^os 1 and 2). Floor drains were not observed near these materials. All of these hazardous materials/chemicals were undergoing inventory and appropriate segregation for disposal off-site, at the time of the site inspection. Therefore, these materials/chemicals are discussed further in Section 7.7, Hazardous Waste.

PHOTOGRAPH 01: Hazardous material storage.

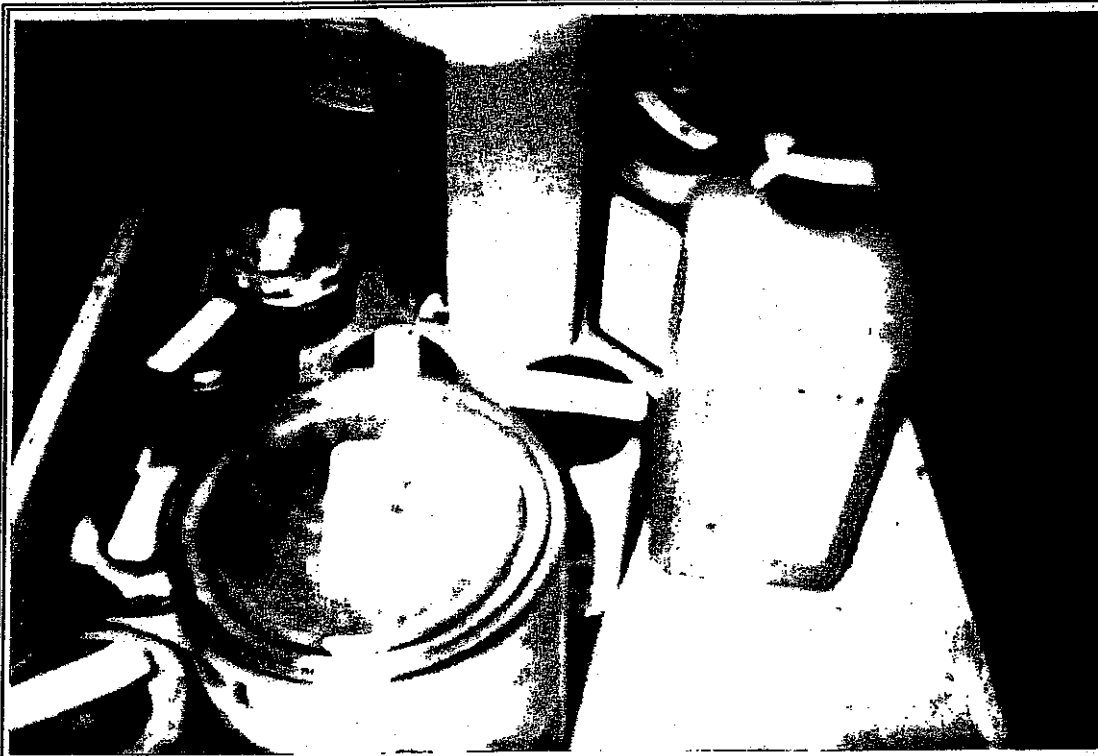
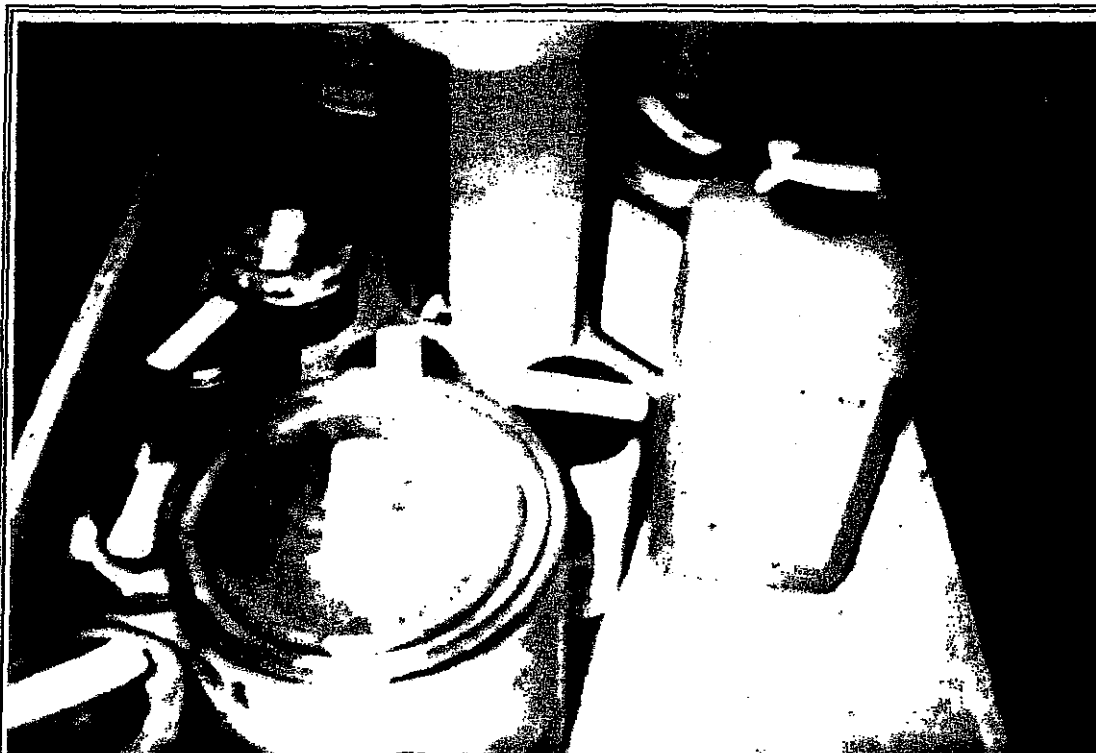
PHOTOGRAPH 02: Hazardous materials inventory for disposal as hazardous waste.

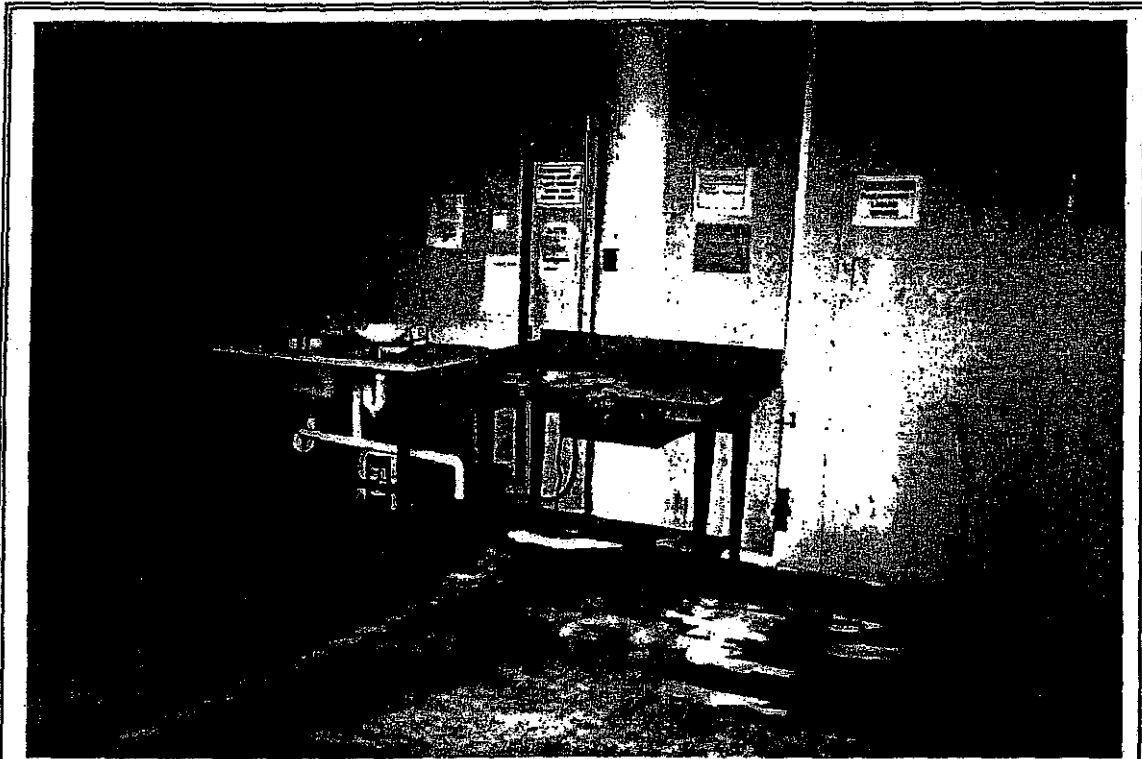
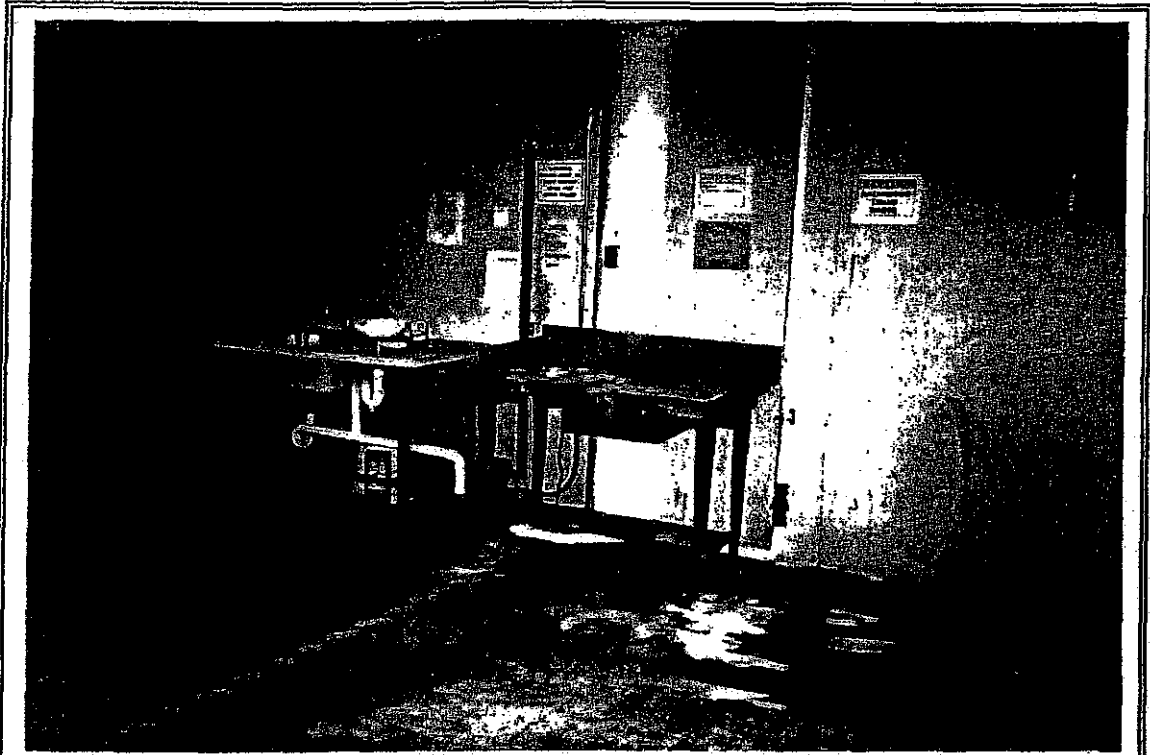
During the site inspection, it was observed that operations conducted at the Property do not currently generate regulated quantities of hazardous waste, which significantly reduces the potential environmental and regulatory risks presented by hazardous waste. The Property was observed mostly vacant at the time of the site inspection and hazardous waste associated with former EKC operations is not produced. Former operations that generated hazardous waste included photographic fixer and developer containing silver (Photograph N^o 3).

PHOTOGRAPH 03: Former hazardous waste generation area (Photographic Fixer).

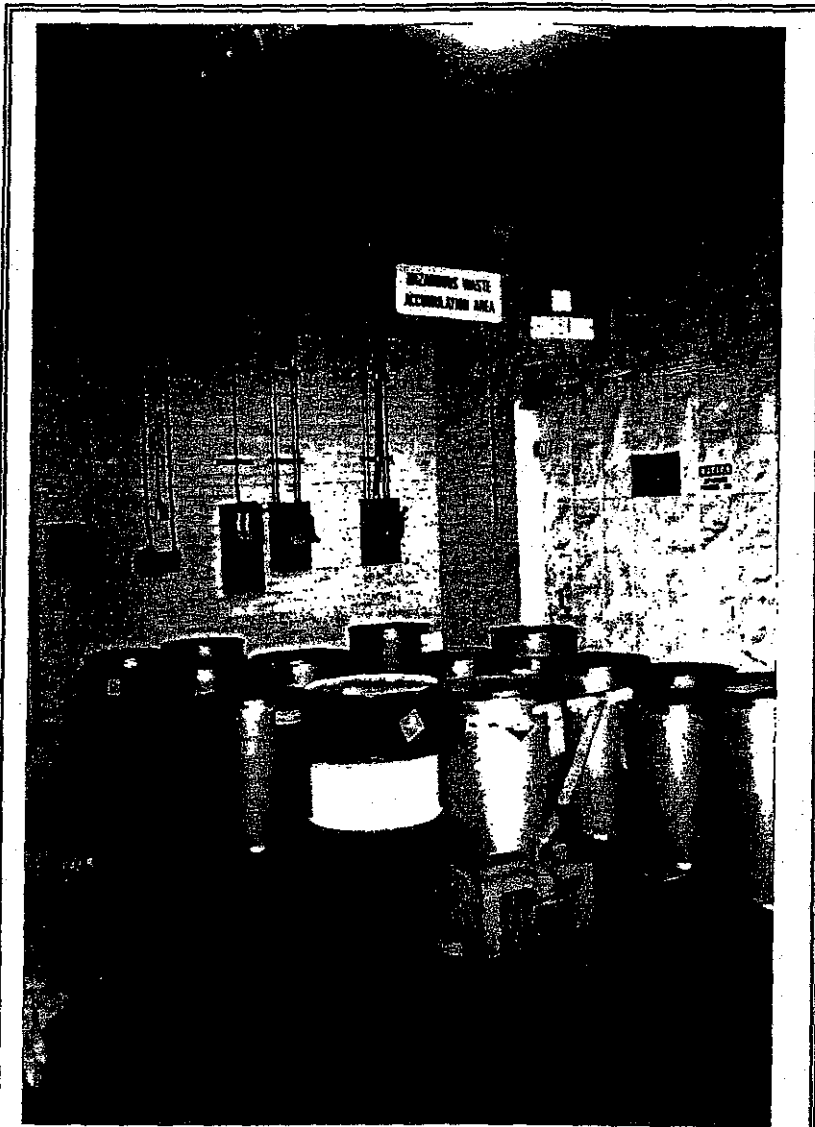
Limited quantities of hazardous wastes (shelf life exceeded) were observed at the Property, during the site inspection, undergoing inventory and segregation for eventual off-site disposal. One (1) less than 90 day hazardous waste accumulation area (Photograph N^o 4) was observed at the Property. This area appeared neat and orderly at the time of the site inspection, however was not equipped with secondary containment. Since all wastes at the Property are slated for removal from the Property, McLaren/Hart recommends daily visual inspections of the storage area to confirm potential releases are not occurring. Hazardous waste located at the Property is being handled directly by EKC and will be transported by EKC to the EKC owned and operated incinerator located at Kodak Park. Based on McLaren/Hart's review of EKC files, all appropriate documentation appears in-place for the former generation and disposal of hazardous wastes. Therefore, the disposal of hazardous waste does not currently appear to pose an environmental concern to the Property.

PHOTOGRAPH 04: Current <90 hazardous waste accumulation area.
