# Periodic Review Report

Canandaigua Multi-Brownfield Site  
Lakeshore Drive and Booth Street,  
Canandaigua, New York 14424  
NYSDEC Site No. C835025

LaBella Project No. 2181278

February 11, 2022

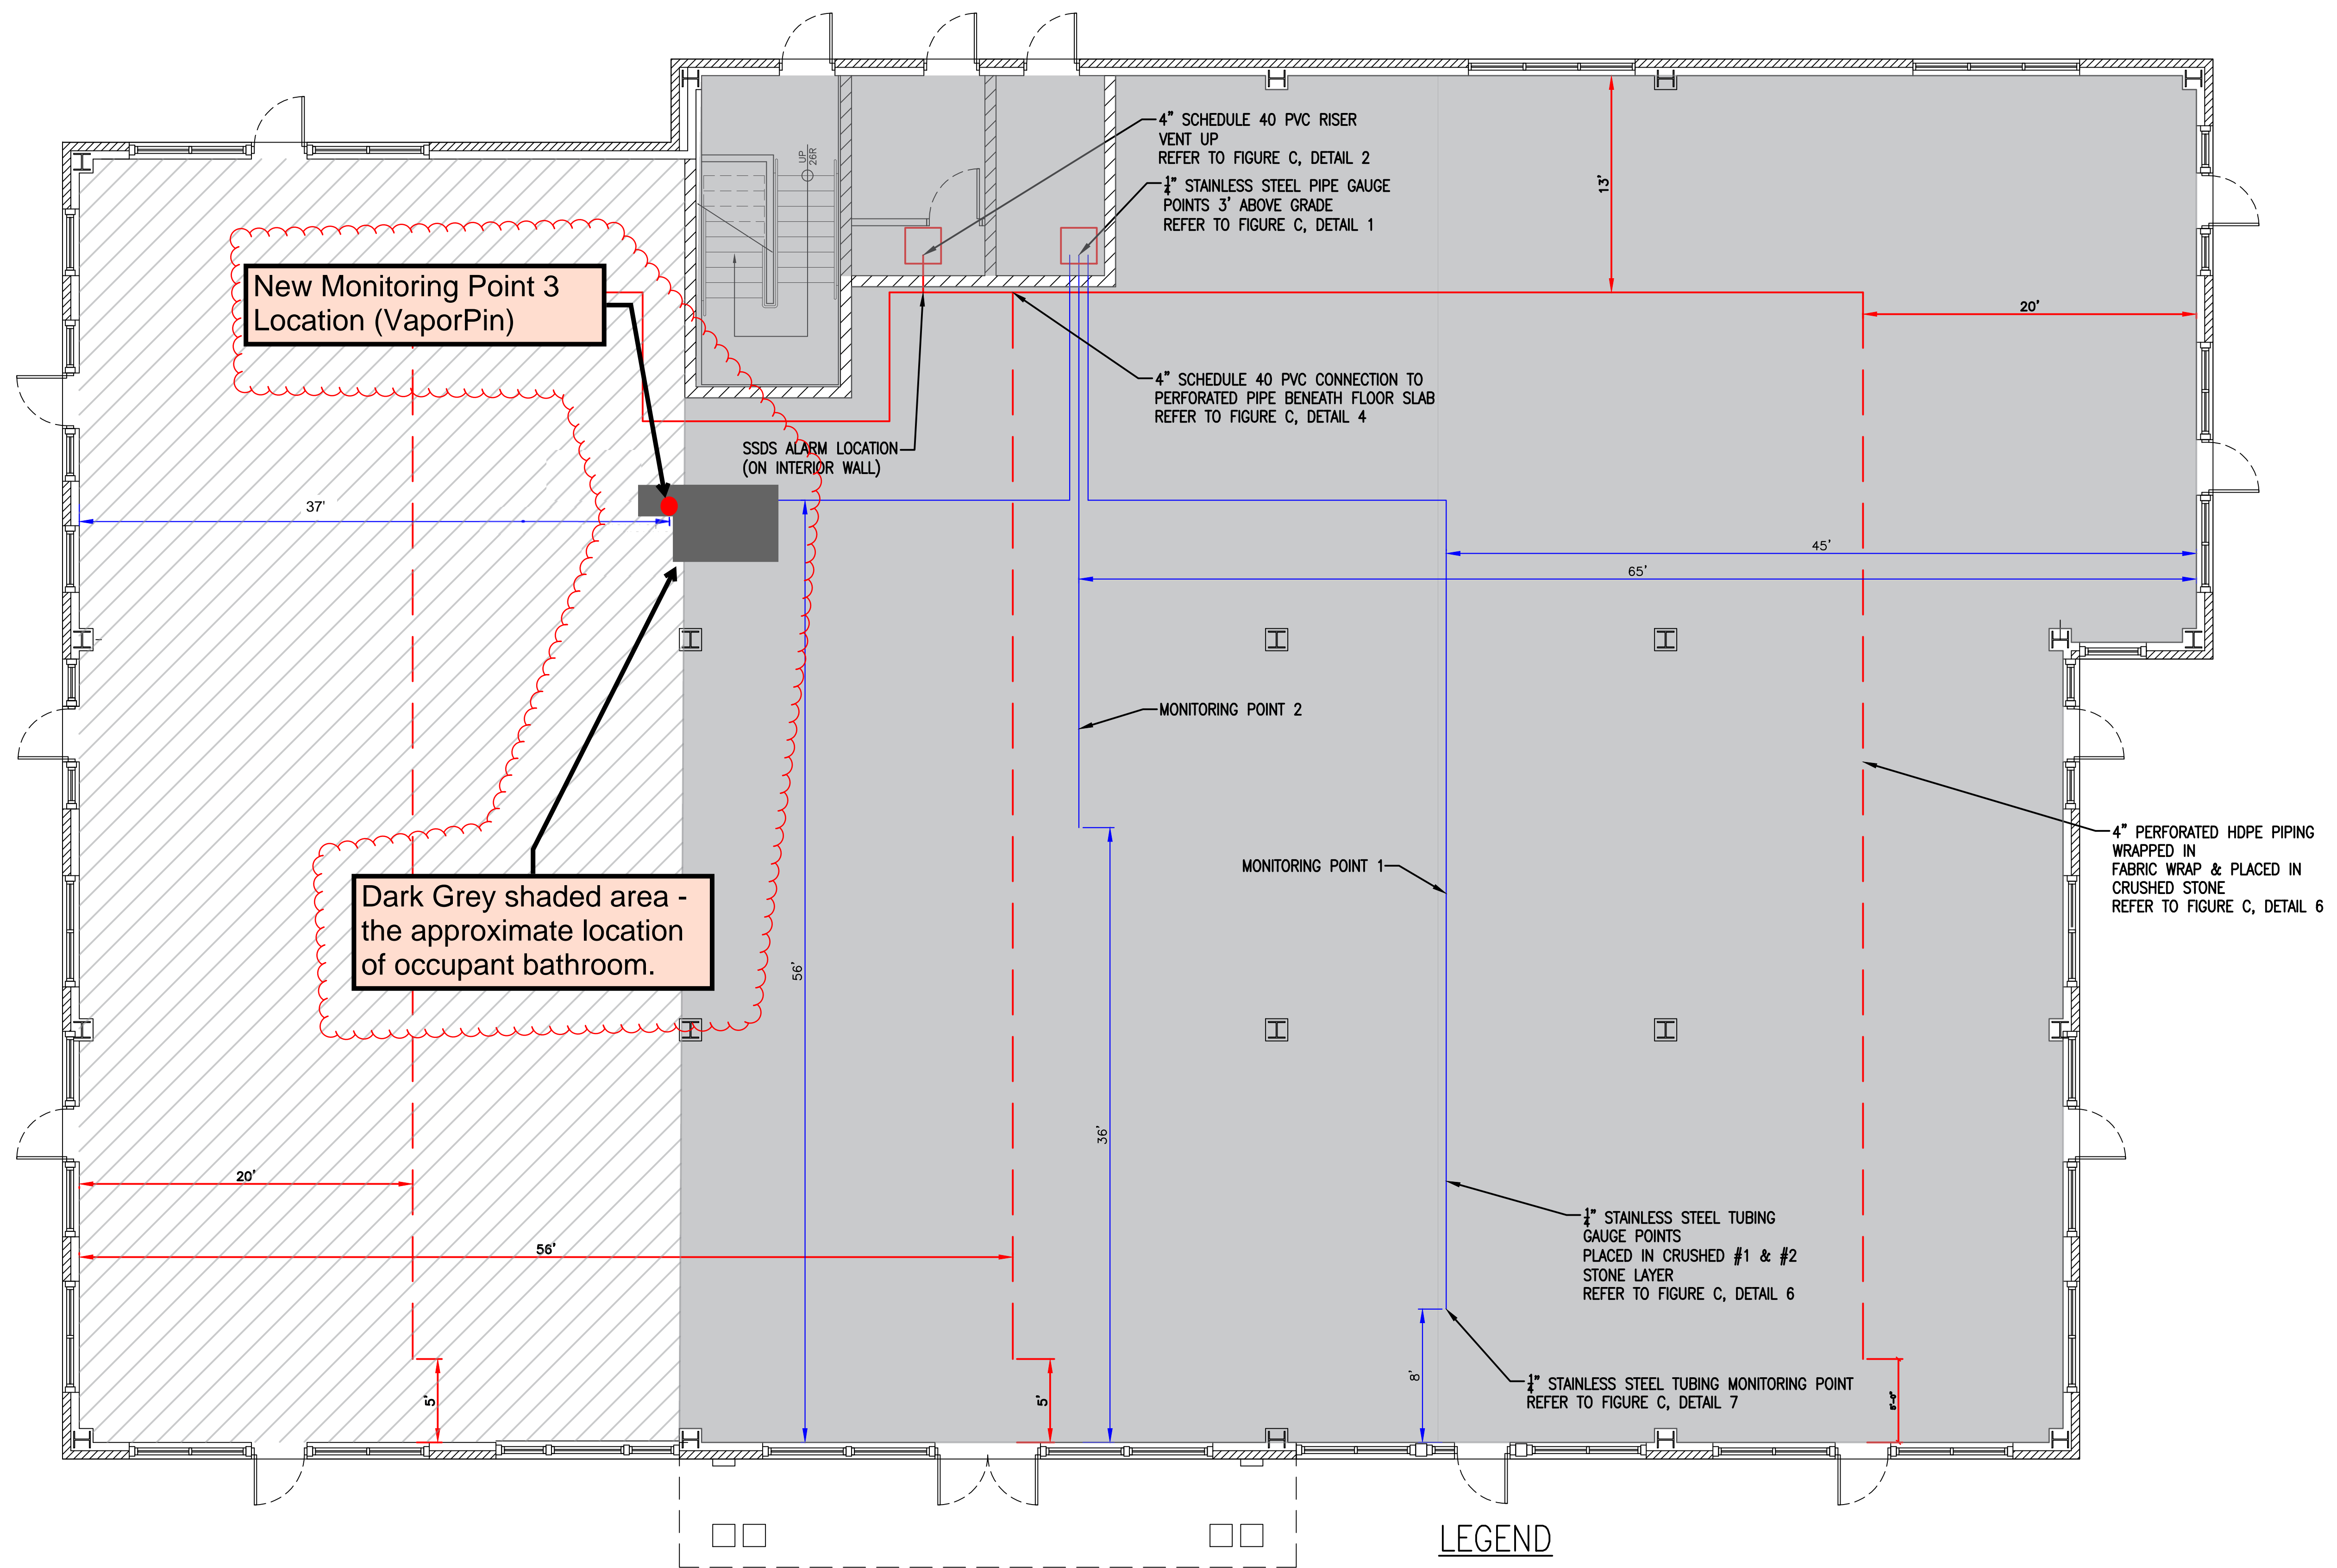
PROJECT/DRAWING NUMBER  
 2181278  
 FIGURE B-2

Clouds denotes updates to As-Built Drawings

- 4" SCHEDULE 40 PVC PIPE
- - - 4" PERFORATED HDPE PIPE
- 1/4" STAINLESS STEEL TUBING
- 6" CONCRETE FINISH FLOOR SLAB WITH 15 MIL STEGO POLY SHEETING UNDER SLAB, REFER TO FIGURE C, DETAIL 6
- Newly poured concrete slab. Space is currently occupied by storefront.

NOTE:  
 1. BASE DRAWING FROM HANLON ARCHITECTS PERMIT SET SHEET S100 DATED JANUARY 29, 2016  
 2. THIS DRAWING REPRESENTS AS-BUILT FOR THE SUB-SLAB DEPRESSURIZATION SYSTEM ONLY.  
 3. DEVIATIONS FROM THE DESIGN DATED JULY 21, 2015 INCLUDE THE FOLLOWING: A 12 INCH PEA STONE TRENCH WAS NOT CONSTRUCTED AROUND THE PIPING, RATHER 8 INCHES OF CRUSHED #1 & #2 STONE WAS PLACED THROUGHOUT THE ENTIRE AREA BUILDING ABOVE THE STRUCTURAL SLAB. (NOTE THE TOP SLAB IS PARTIALLY POURED).
