Subject: Asbestos Inspection Report  
Steuben Fulton Street Facility  
Corning, New York

## **SURVEY FOR ASBESTOS-CONTAINING MATERIALS**

**Steuben Glass  
Fulton Street Building  
Corning, New York 14830**

**CONDUCTED:** March 20<sup>th</sup>, 2006

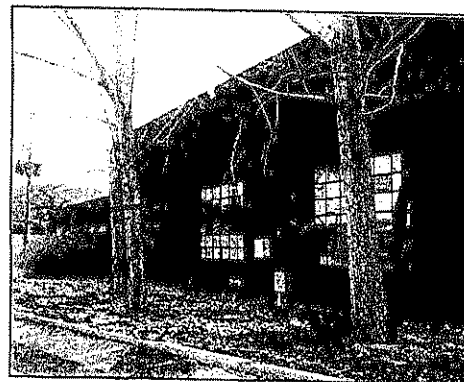
CES personnel identified and quantified a total of approximately one-hundred four linear feet (104 LF) of green and white window caulk around the perimeter of several windows on the northern, southern and eastern exterior of the structure. This type of caulk is typically considered to be a non-friable organically bound material and was noted to be in good condition at the time of CES's inspection. All exterior caulk on windows associated with the structure should be treated as asbestos containing. Please note that not all windows associated with the structure actually have caulk material present, accounting for the relatively low quantity of caulk identified.

View of windows along the eastern exterior of the subject structure with asbestos-containing caulk.

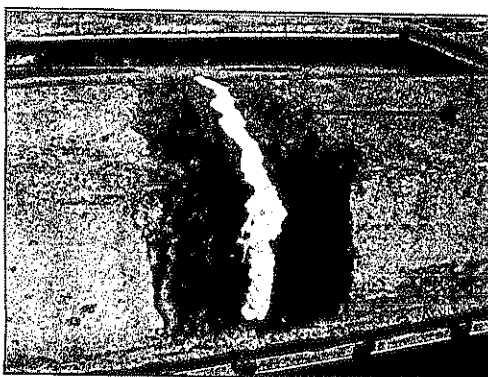
CES personnel identified and quantified approximately five square feet (5 Ft<sup>2</sup>) of asbestos-containing black flashing material with paper mesh on Roof Area R-1. The flashing was observed on five (5) separate locations along the perimeter of the roof. This type of flashing material is generally considered to be a non-friable organically bound material. The flashing was observed to be intact and in good condition.

View of asbestos-containing flashing material with paper mesh located at five (5) separate locations along the perimeter of Roof Area R-1.

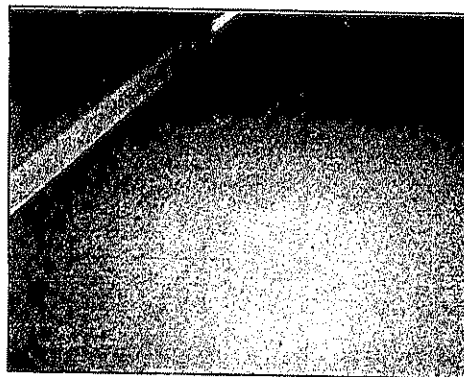
Asbestos-containing 9"x9" floor tile and mastic (excluding the mastic in Area 1-3) was identified throughout the structure over concrete flooring. CES identified and quantified approximately two-thousand two-hundred square feet (2,200 Ft<sup>2</sup>) of the various floor tiles and mastics. These types of floor tiles and mastics are typically considered to be non-friable organically bound materials. In general, the floor tiles and mastics were observed to be intact and in good condition at the time of inspection efforts completed by CES. Please note the 9"x9" floor tile was noted to be painted in many of the areas.

View of painted and unpainted asbestos-containing 9"x9" brown white floor tile and associated mastic.

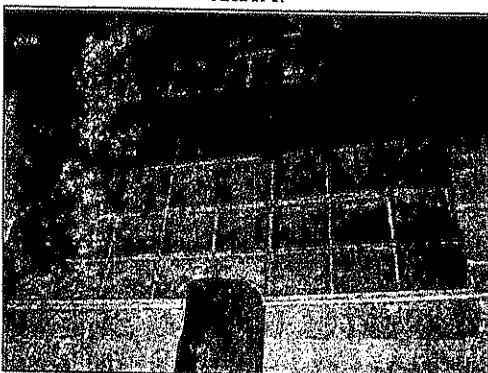
CES personnel identified and quantified thirty-one linear feet (31 LF) of red caulk around the perimeter of a block style window located in Areas 1-4 and 1-17. This type of caulk is typically considered to be a non-friable organically bound material and was noted to be in good condition at the time of CES's inspection.

View of asbestos-containing red caulk located on the interior side of the block window located in Area 1-4 and 1-17.

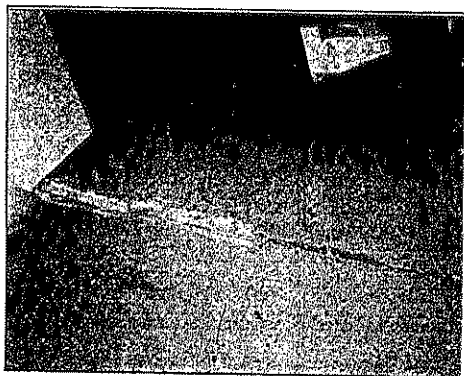
View of asbestos-containing 9"x9" butterscotch floor tile located in Area 1-3.
