Periodic Review Report

NYSDEC Site #C851049

October 31, 2023 to October 31, 2025

Former Corning Hospital
176 Denison Parkway East & 171 & 201 East First Street
Corning, New York

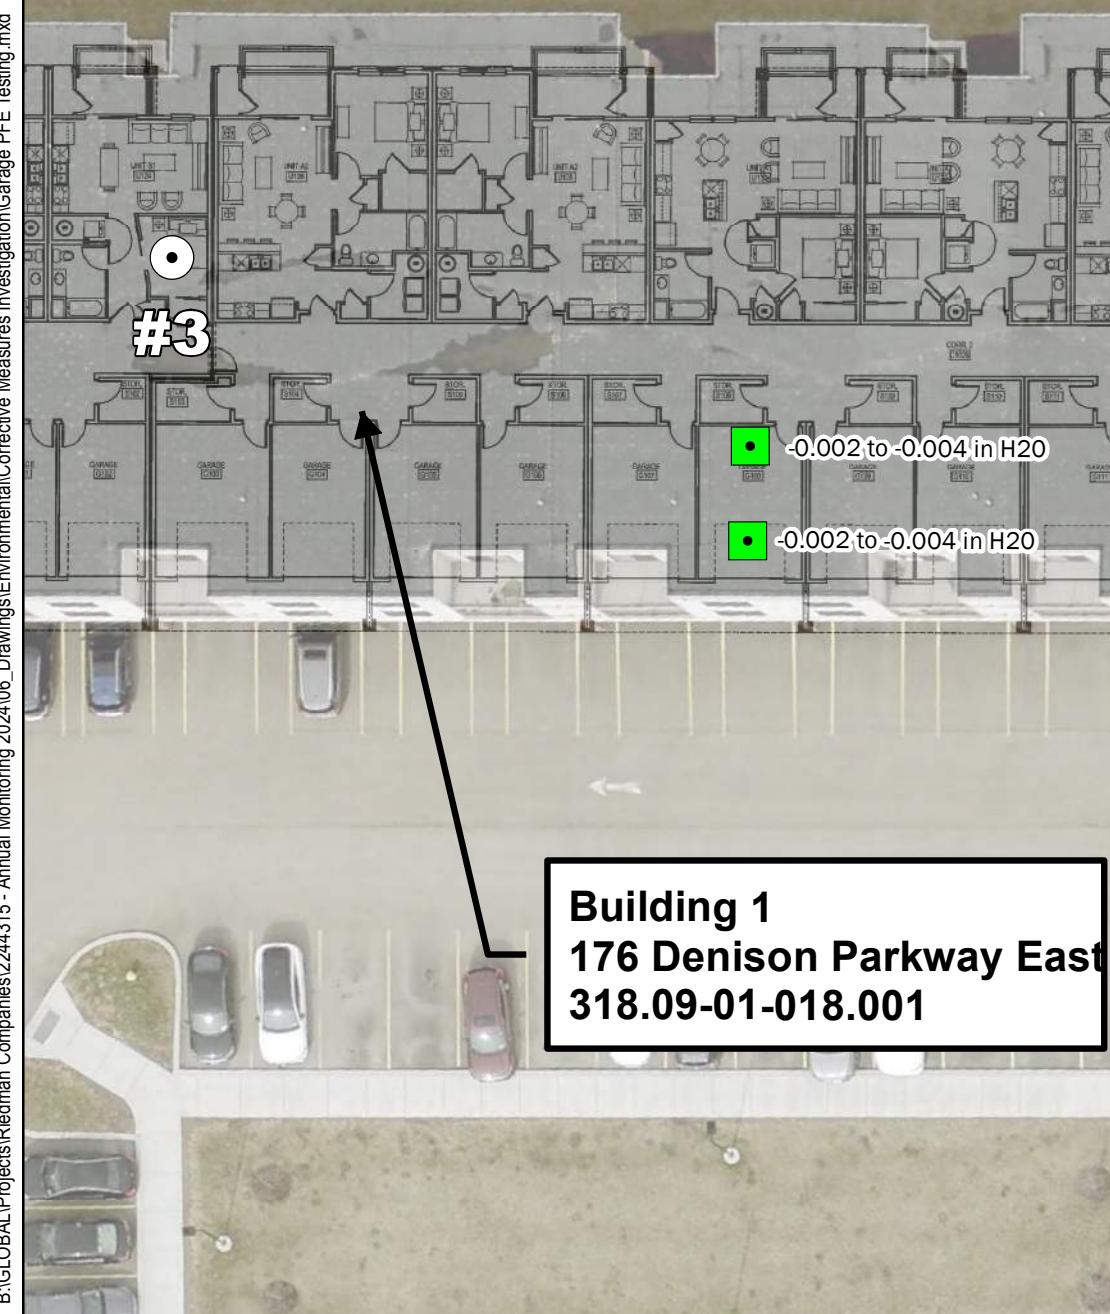
FIGURE 6

During differential pressure monitoring at the PFE points, the differential pressure did not remain steady and appeared to fluctuate at any given moment. Differential pressure readings observed in garage 116 were generally between -0.001 and -0.005 IWC with slight variations based on which point in the space was being observed. In the garage space for unit 108 differential pressure readings typically fluctuated between -0.002 and -0.004 inches H₂O. Fluctuations may be attributed to wind or wind gusts outside as garages are typically not airtight which can lead to wind-induced pressure changes during the differential pressure reading. Based on the readings observed, it appears that a negative pressure (i.e., vacuum) was achieved beneath the slab in the garage spaces tested.

**Additional
 Corrective Measures
 Temporary Garage
 PFE Testing
 Locations and
 Readings**

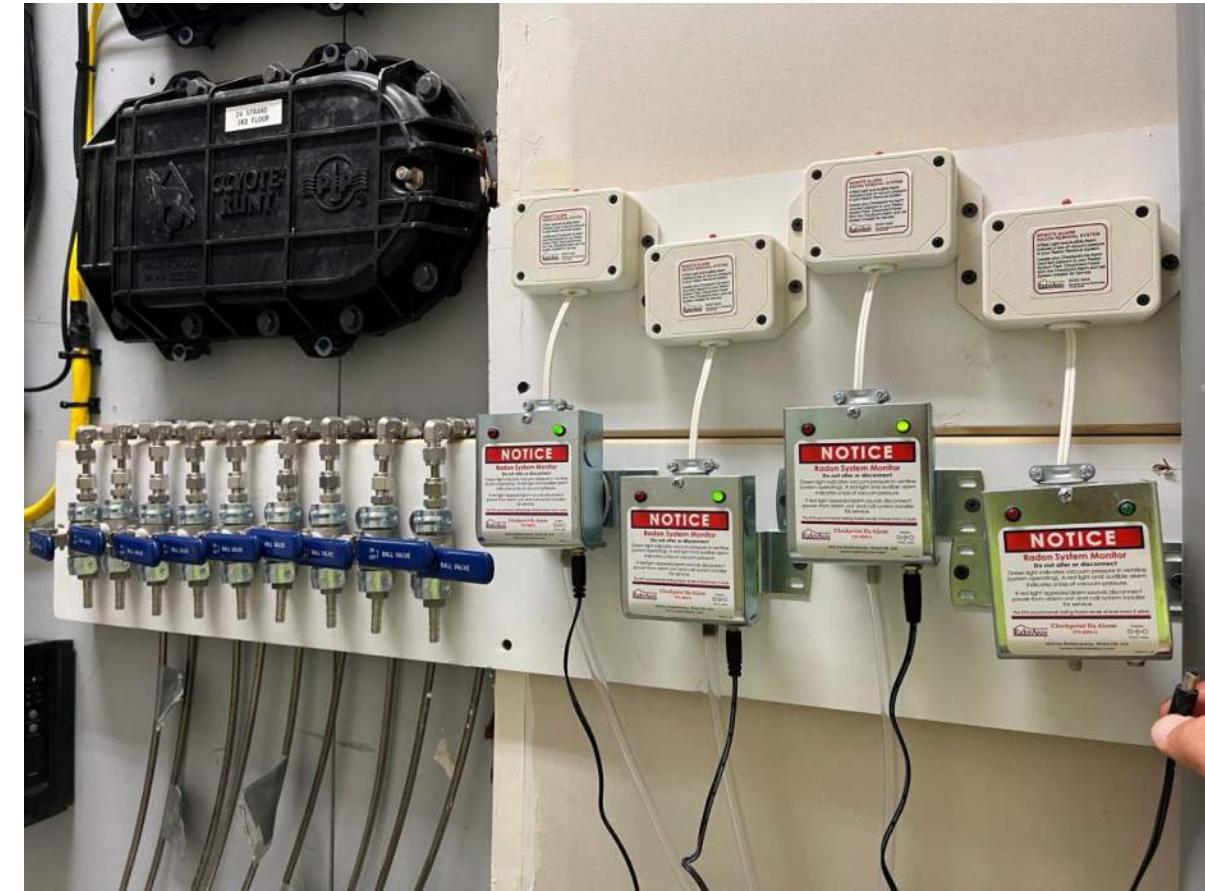
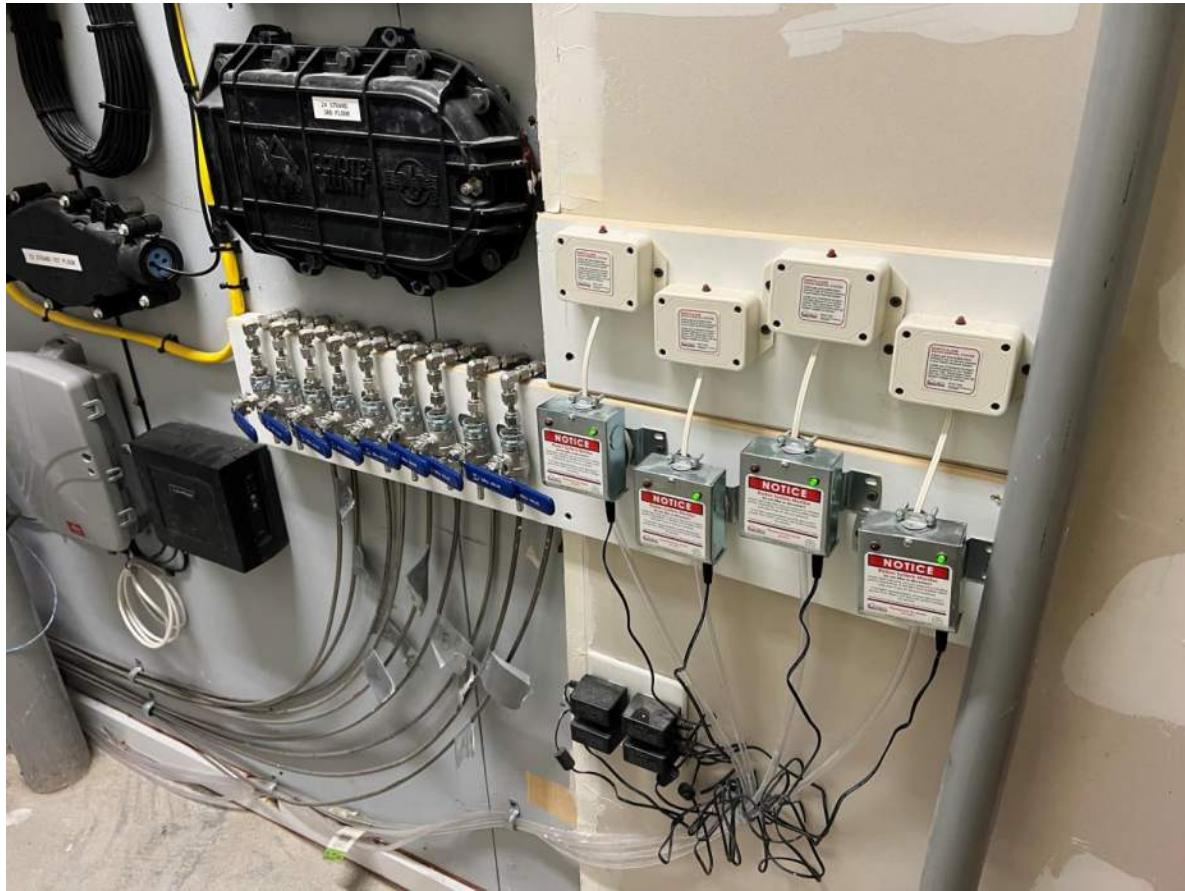
As indicated in Table 2, pressure field extension (PFE) monitoring point 5 had positive readings, and monitoring points 1 and 7 had readings of 0.000 inches of water column during the October 18, 2024 inspection. Monitoring points 5 and 7 had positive readings during the September 19, 2025 inspection. As a result of these readings corrective measures were requested by the NYSDDEC and are further described in Section 5. The cause of these readings may be due to potential damaged piping and is unlikely an issue with the operations of the SSDS.

10/18/24 – Building 1 Alarms and PFE Monitoring Points

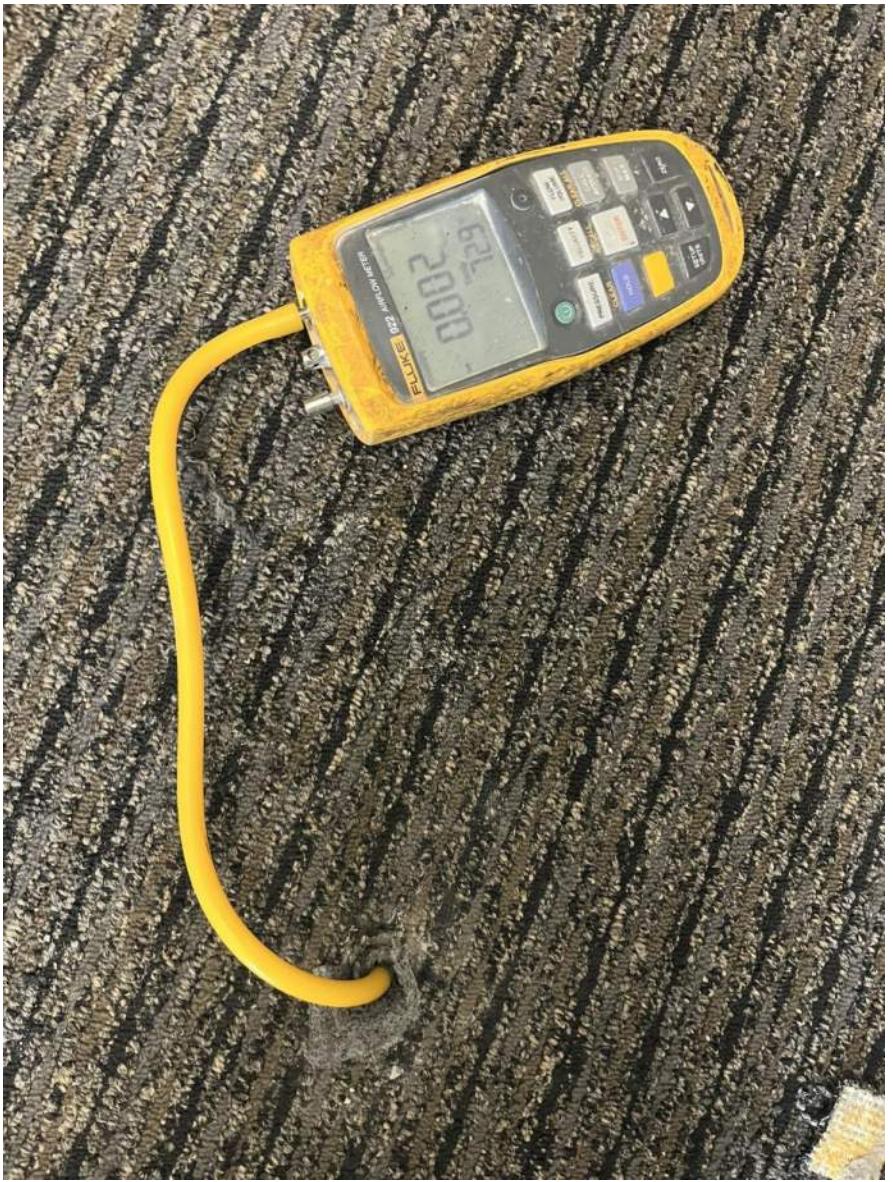
The east stairwell in Building 1 does not appear to be depressurized, however, this space is not continuously occupied and is often supplied with fresh outdoor air as the doorway is utilized for entrance into the building by its occupants. Additionally, PFE monitoring point 5 does not appear to be functioning properly; however, the other areas such as the hallway and garage spaces in the east end of Building 1 were observed to be properly depressurized.

9/19/25 - View of East Stairwell PFE testing during additional suction point.

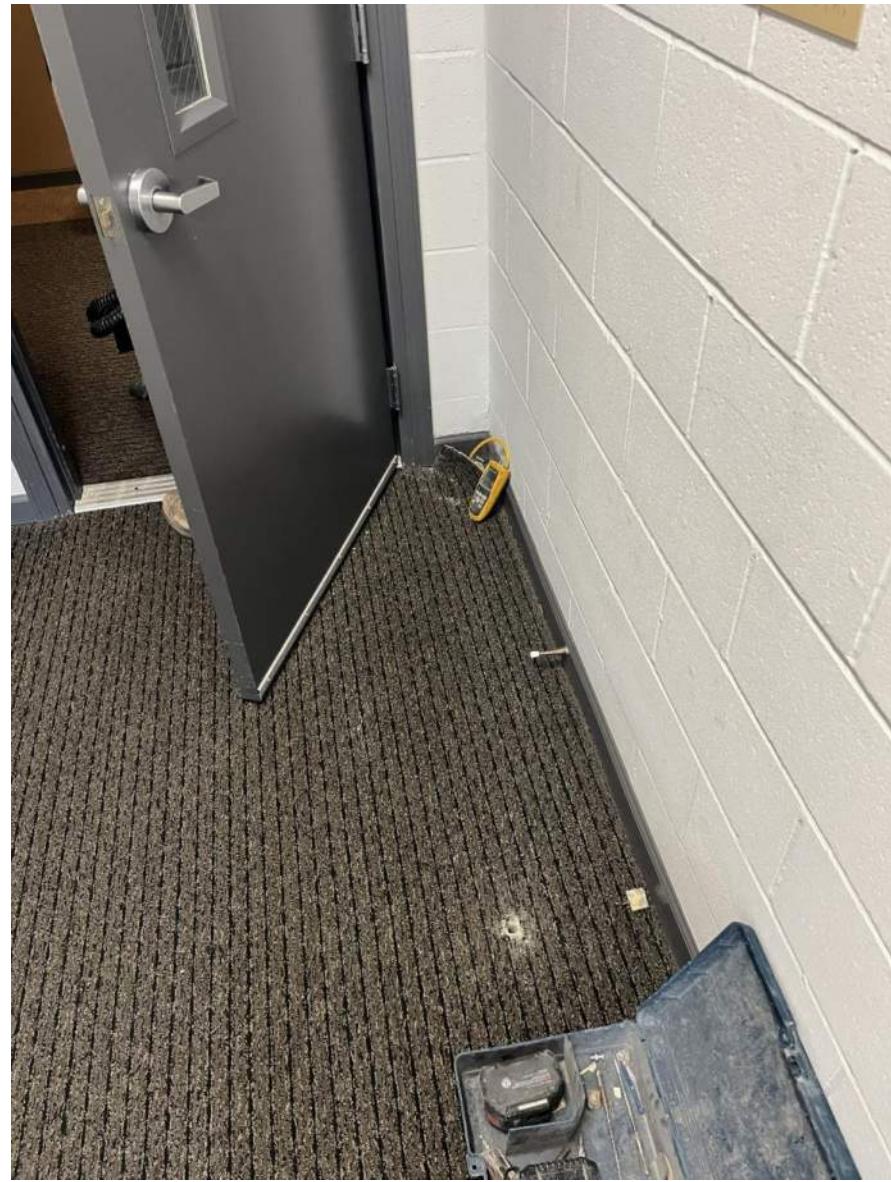
9/19/25 - View of PFE testing in Building 1 east stairwell

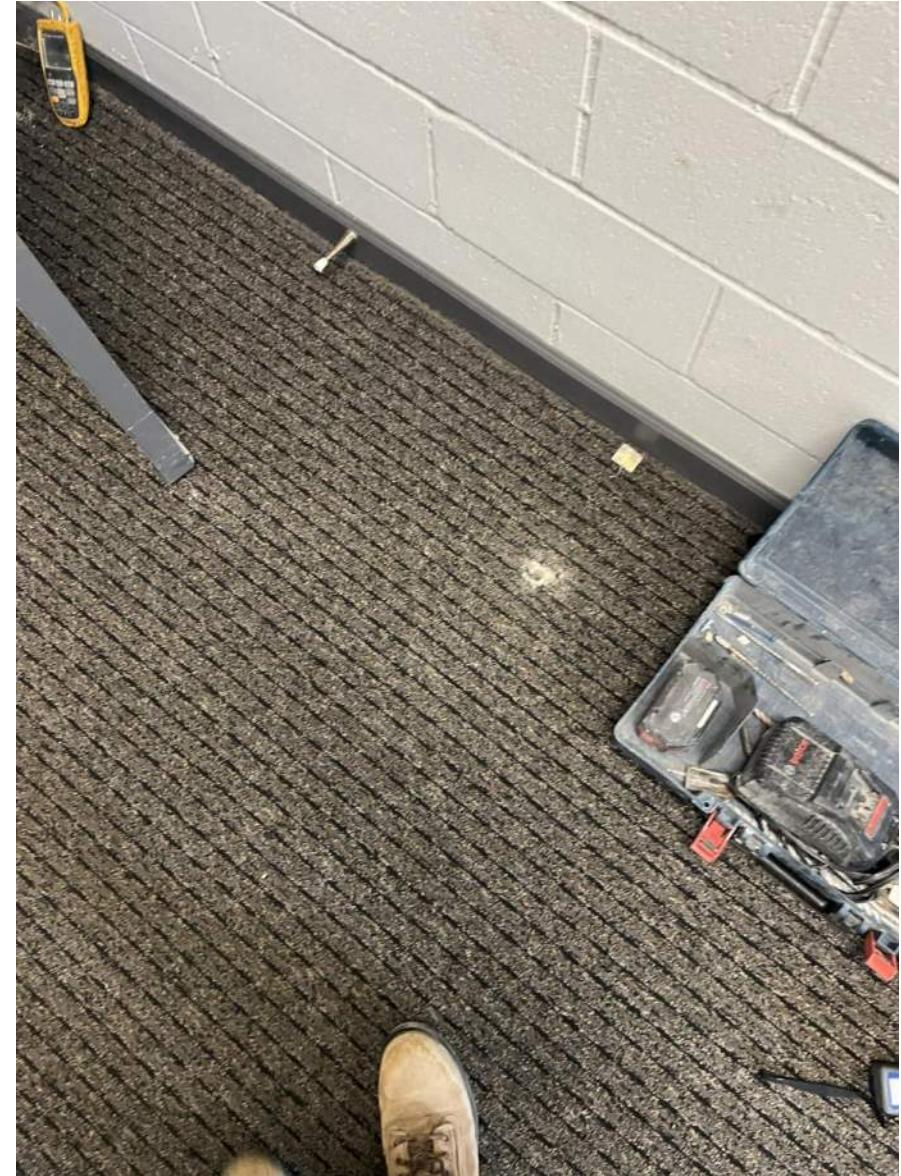
In the testing completed in July as part of the Corrective Measures Work Plan no system influence (i.e., 0.0 IWC or positive pressure) was noted in the hallway just outside the stairwell and at the east end of the hallway. However in testing completed as part the Supplemental Corrective Measures, it was found that the system does appear to be properly influencing these areas. Based on review foundation plans for the building and of the locations of the points in July it is likely that the points installed were advanced in areas of thickened slabs and therefore were not advanced deep enough to penetrate the slab.

9/19/25 - View of PFE newly drilled PFE test holes in Building 1 east stairwell
