Periodic Review Report

June 1, 2020 to June 1, 2023

Scott Rotary Seals Site
BCP Site No. C905036
Olean, New York

June 2023

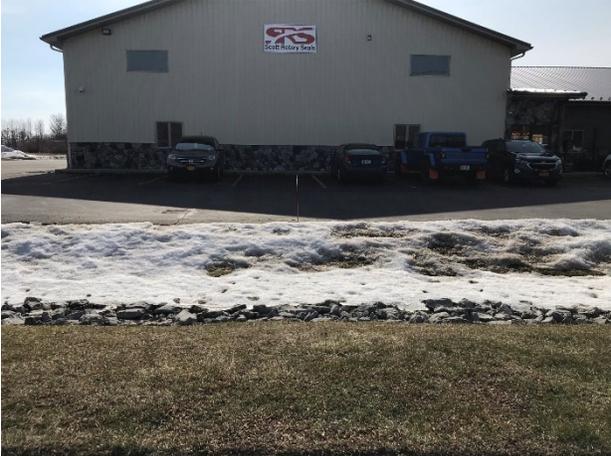
- Photo 1: Front of Scott Rotary Seals (SRS) Building showing vegetative and asphalt cover (looking southeast)
- Photo 2: Entrance to SRS Building from Franklin St. showing asphalt and concrete cover (looking east)
- Photo 3: West side of SRS Building showing vegetative and stone cover (looking northeast)
- Photo 4: South side of SRS Building showing vegetative cover (looking north)

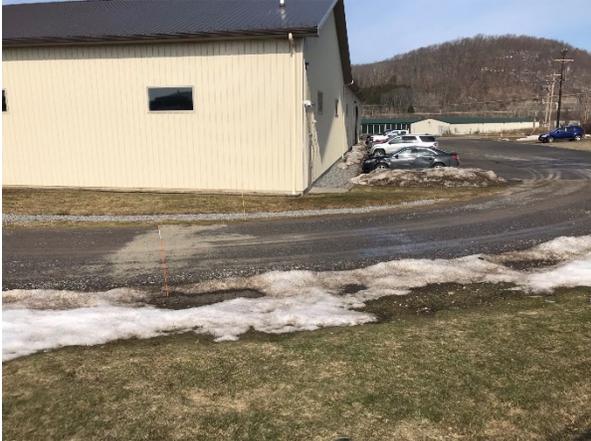
- Photo 5: Rear side (south) of SRS Building showing vegetative and stone cover (looking west)
- Photo 6: East side of SRS Building showing stone and asphalt cover (looking southwest)
- Photo 7: East side of SRS Building showing vegetative cover and storm water detention basin (looking south)
- Photo 8: Northeast corner of SRS Building showing concrete and asphalt cover (looking west)

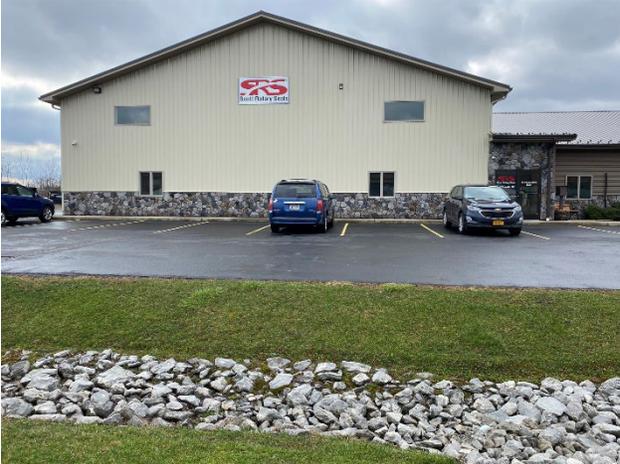
- Photo 1: Front of Scott Rotary Seals (SRS) Building showing vegetative and asphalt cover (looking southeast)
- Photo 2: Entrance to SRS Building from Franklin St. showing asphalt and concrete cover (looking east)
- Photo 3: West side of SRS Building showing vegetative and stone cover (looking northeast)
- Photo 4: South side of SRS Building showing vegetative cover (looking north)

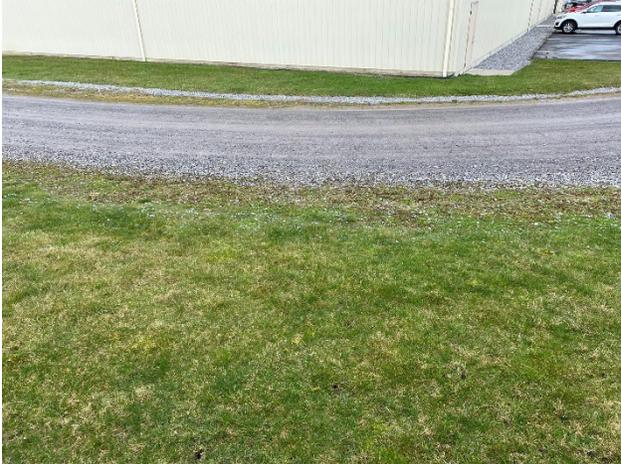
- Photo 5: Rear side (south) of SRS Building showing vegetative and stone cover (looking northwest)
- Photo 6: East side of SRS Building showing stone and asphalt cover (looking southwest)
- Photo 7: East side of SRS Building showing vegetative cover and storm water detention basin (looking south)
- Photo 8: Northeast corner of SRS Building showing concrete and asphalt cover (looking west)

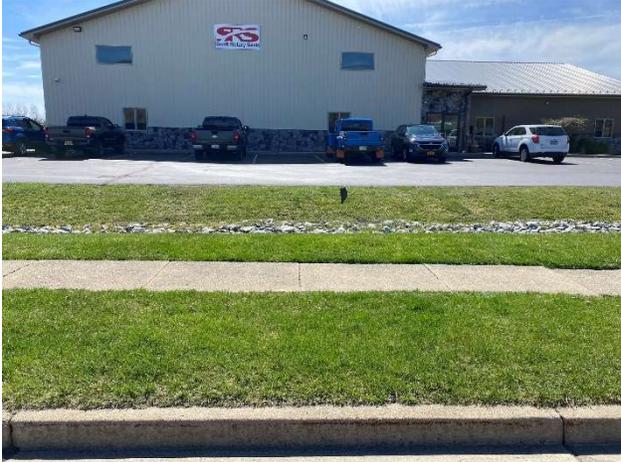
- Photo 1: Front of Scott Rotary Seals (SRS) Building showing vegetative and asphalt cover (looking southeast)
- Photo 2: Entrance to SRS Building from Franklin St. showing asphalt and concrete cover (looking east)
- Photo 3: West side of SRS Building showing vegetative and stone cover (looking north)
- Photo 4: South side of SRS Building showing vegetative cover (looking northeast)

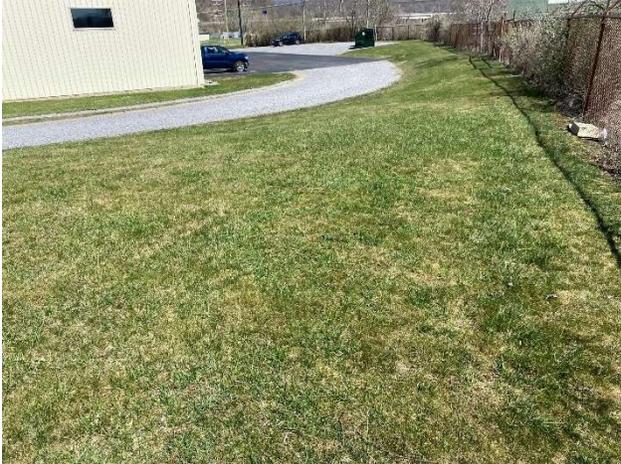
- Photo 5: Rear side (south) of SRS Building showing vegetative and stone cover (looking northeast)
- Photo 6: East side of SRS Building showing stone and asphalt cover (looking northeast)
- Photo 7: East side of SRS Building showing vegetative cover and storm water detention basin (looking south)
- Photo 8: Northeast corner of SRS Building showing concrete and asphalt cover (looking west)
