# Periodic Review Report

**Reporting Period: June 1, 2023  
to June 1, 2026**

Scott Rotary Seals  
BCP Site No. C905036  
Olean, New York

June 2026

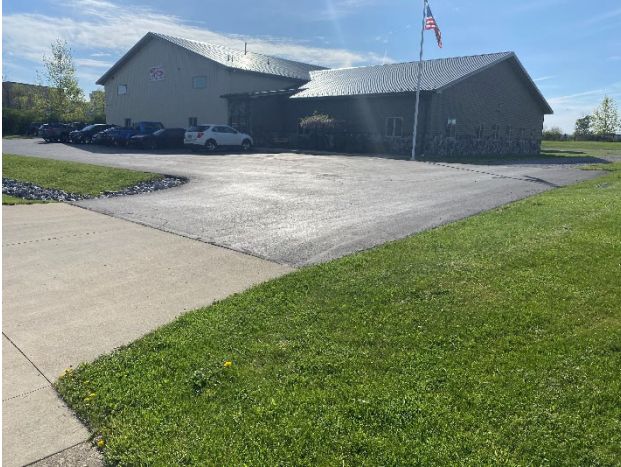
**Photo 1:**

- Photo 1: Front of Scott Rotary Seals (SRS) Building showing vegetative and asphalt cover (looking southeast)
- Photo 2: Entrance to SRS Building from Franklin St. showing asphalt and concrete cover (looking east)
- Photo 3: West side of SRS Building showing vegetative and stone cover (looking south)
- Photo 4: South side of SRS Building showing vegetative cover (looking north)
-

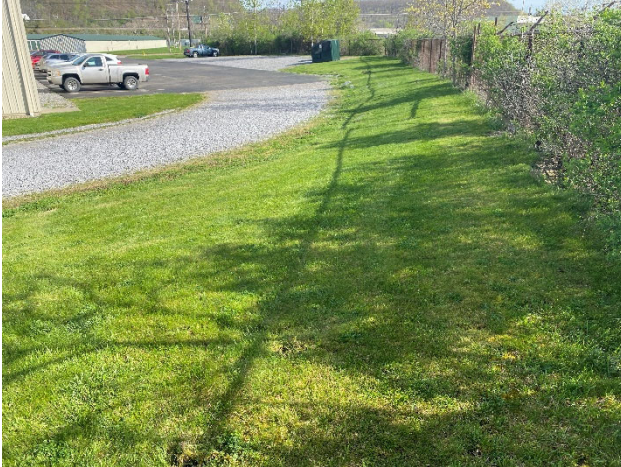
**Photo 5:**

- Photo 5: Rear side (south) of SRS Building showing vegetative and stone cover (looking northeast)
- Photo 6: East side of SRS Building showing stone and asphalt cover (looking north)
- Photo 7: East side of SRS Building showing vegetative cover and storm water detention basin (looking south)
- Photo 8: Interior of SRS Building showing concrete floor
-

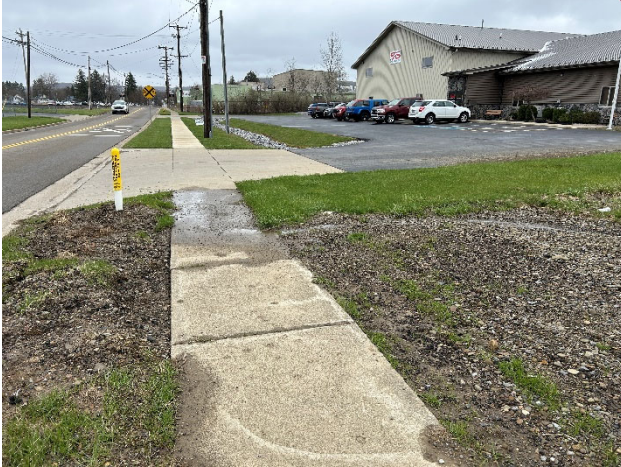
**Photo 1:**

- Photo 1: View along Franklin Street from northwestern corner of Site showing the NYSEG work from October 2024; no intrusive work occurred on the BCP Site (looking northeast)
- Photo 2: View of the western end of the Scott Rotary Seals (SRS) building showing the vegetative, concrete, and asphalt covers (looking southeast)
- Photo 3: Front view of the SRS building, asphalt cover, and storm water swale (looking southeast)
- Photo 4: View of the vegetative cover and south side of the SRS building from the southwestern corner of the Site (looking north)

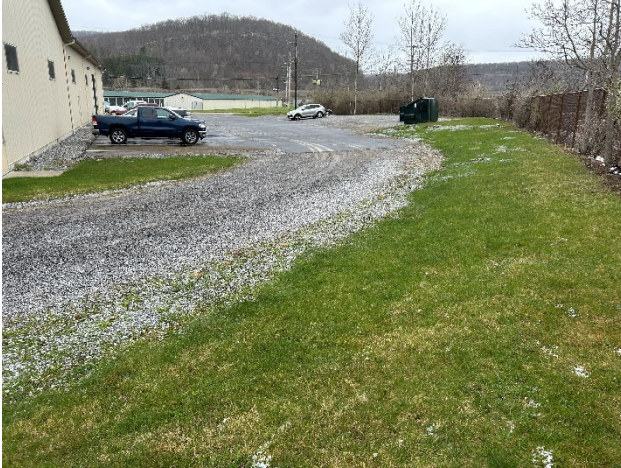
**Photo 5:**

- Photo 5: View of the south side of the SRS building showing the vegetative and stone covers (looking northwest)
- Photo 6: View of the east side of the SRS building showing stone and asphalt covers (looking north)
- Photo 7: View of the vegetative and asphalt covers and storm water detention basin (looking southwest)
- Photo 8: View of intact concrete floor inside the SRS building

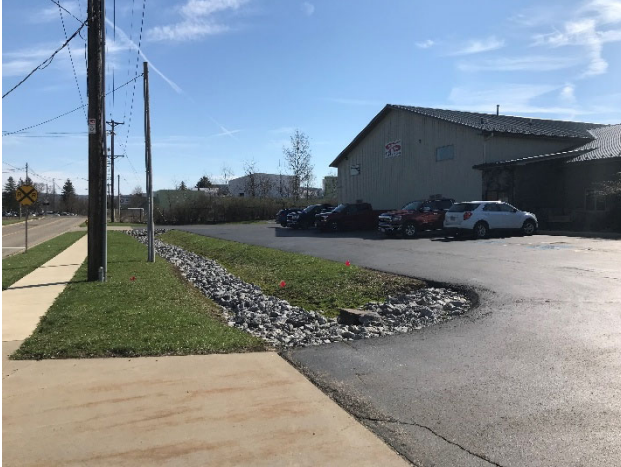
**Photo 1:**

- Photo 1: View of Scott Rotary Seals (SRS) building, storm water swale, and asphalt and vegetative covers from northwestern corner of Site (looking northeast)
- Photo 2: View of SRS building and vegetative, concrete, and asphalt covers from northwestern corner of Site (looking southeast)
- Photo 3: View of front of SRS building, asphalt cover, and storm water swale (looking southeast)
- Photo 4: View of vegetative cover and south side of SRS building from southwestern corner of Site (looking north)

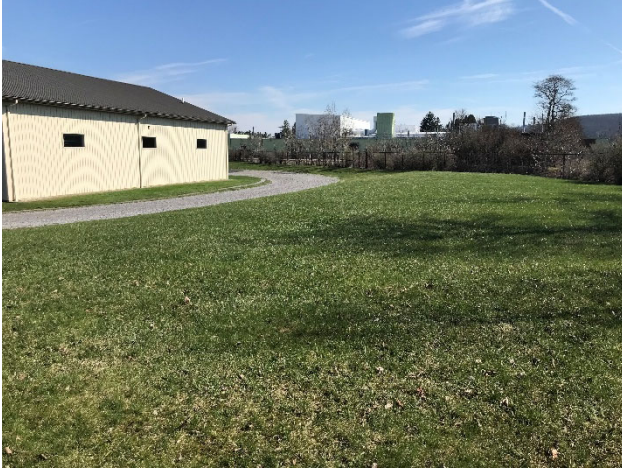
**Photo 5:**

Photo 5: View of south side of SRS building and vegetative and stone covers (looking northeast)

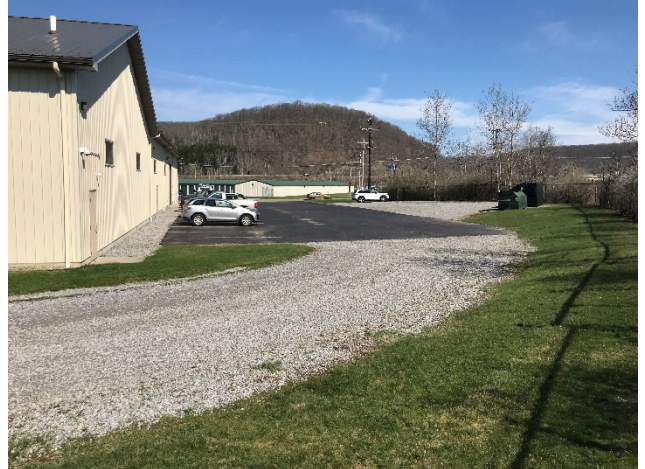
**Photo 6:**

Photo 6: View of south side of SRS building and vegetative and stone covers (looking northwest)

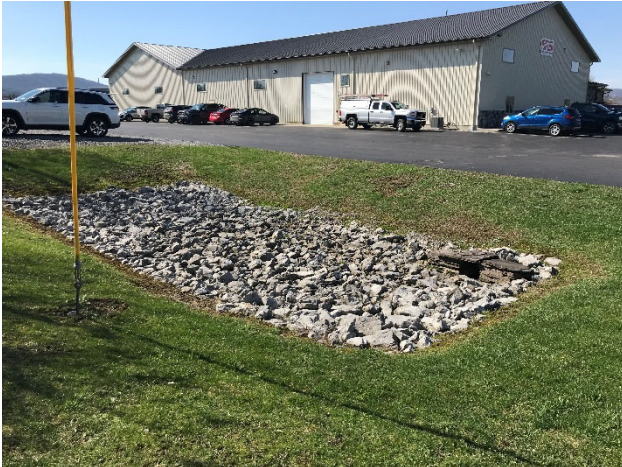
**Photo 7:**

Photo 7: View of vegetative and asphalt covers and storm water detention basin from northeastern corner of Site (looking southwest)

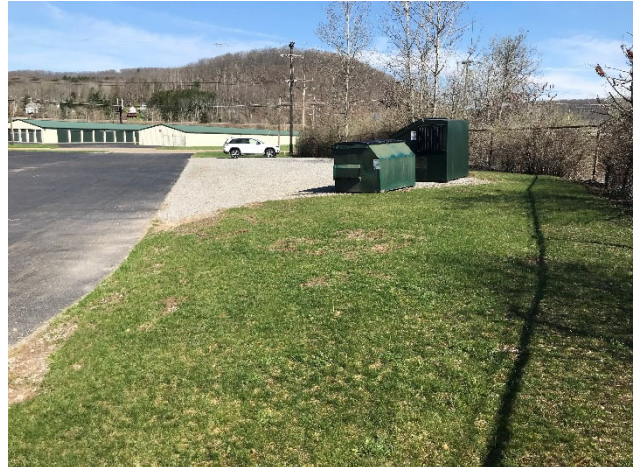
**Photo 8:**

Photo 8: View of stone, asphalt, and vegetative covers and on-Site refuse containers (looking north)

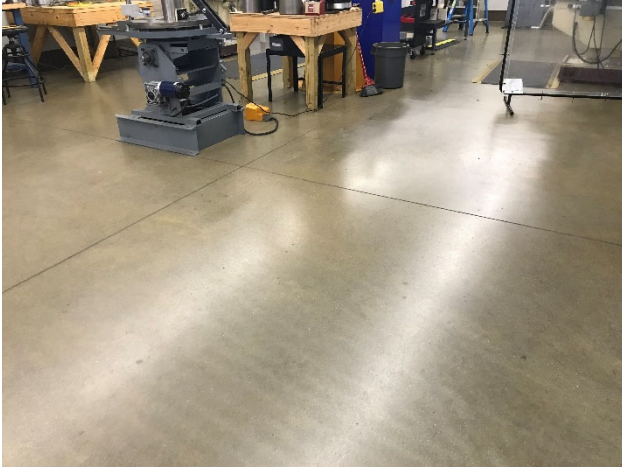
**Photo 9:**

Photo 9: View of intact concrete floor inside SRS building

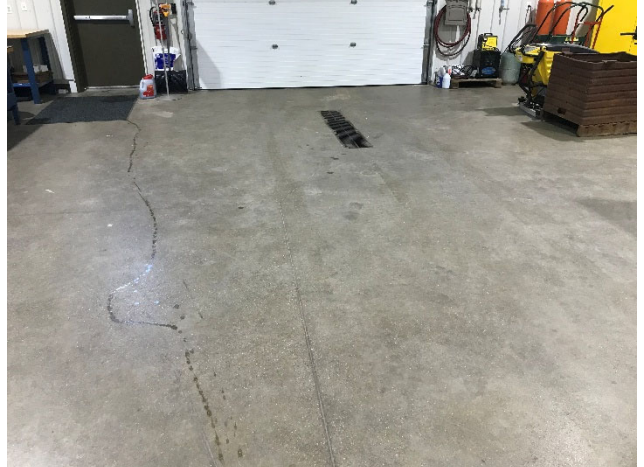
**Photo 10:**

Photo 10: View of intact concrete floor inside SRS building

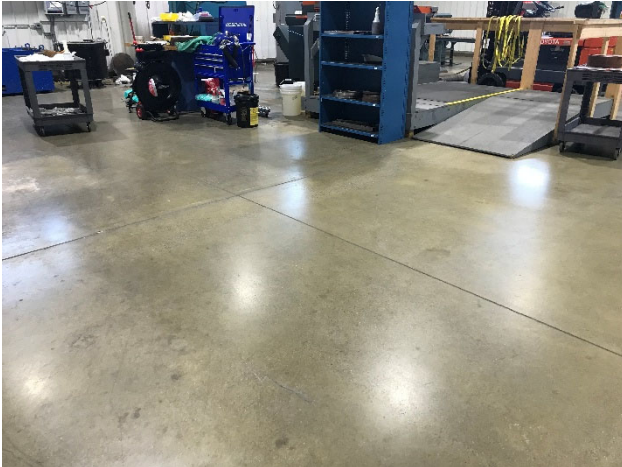
**Photo 11:**

Photo 11: View of intact concrete floor inside SRS building

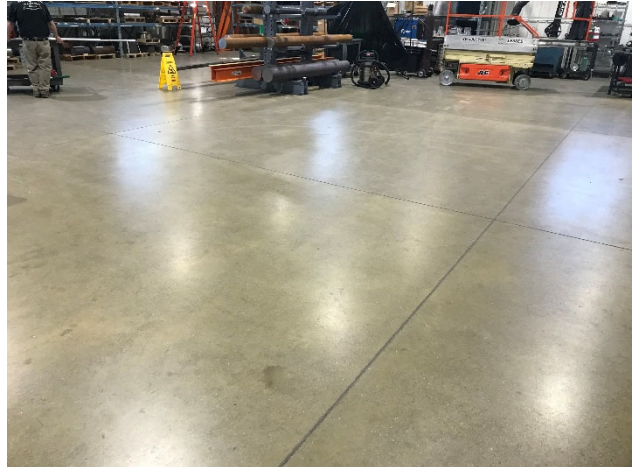
**Photo 12:**

Photo 12: View of intact concrete floor inside SRS building
