SITE INSPECTION REPORT

Site Name: 211 Franklin Street

Site Number: C905038

Inspection Date: June 5, 2026

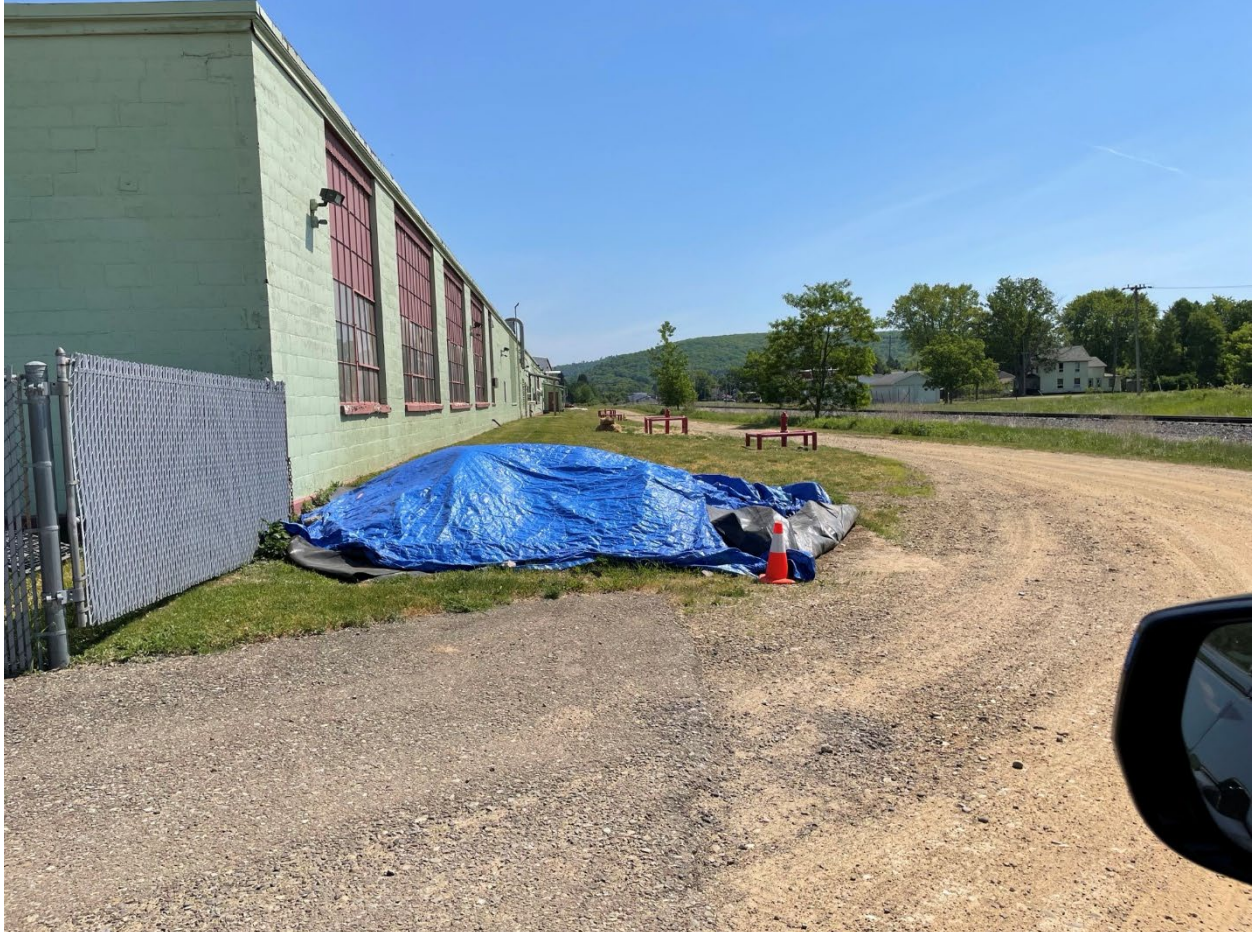
- Site cover in acceptable condition although some ruts in the driveway along the south side of the facility require monitoring.
- Electric vehicle chargers have been installed on the northern side of the facility. A battery pad was not observed as previously described during the last site inspection.
- Excess imported soil (previously approved) stockpile remains covered on southern side of the facility.

Covered excess imported backfill material stockpile on southwestern portion of facility. Material import request was previously approved.

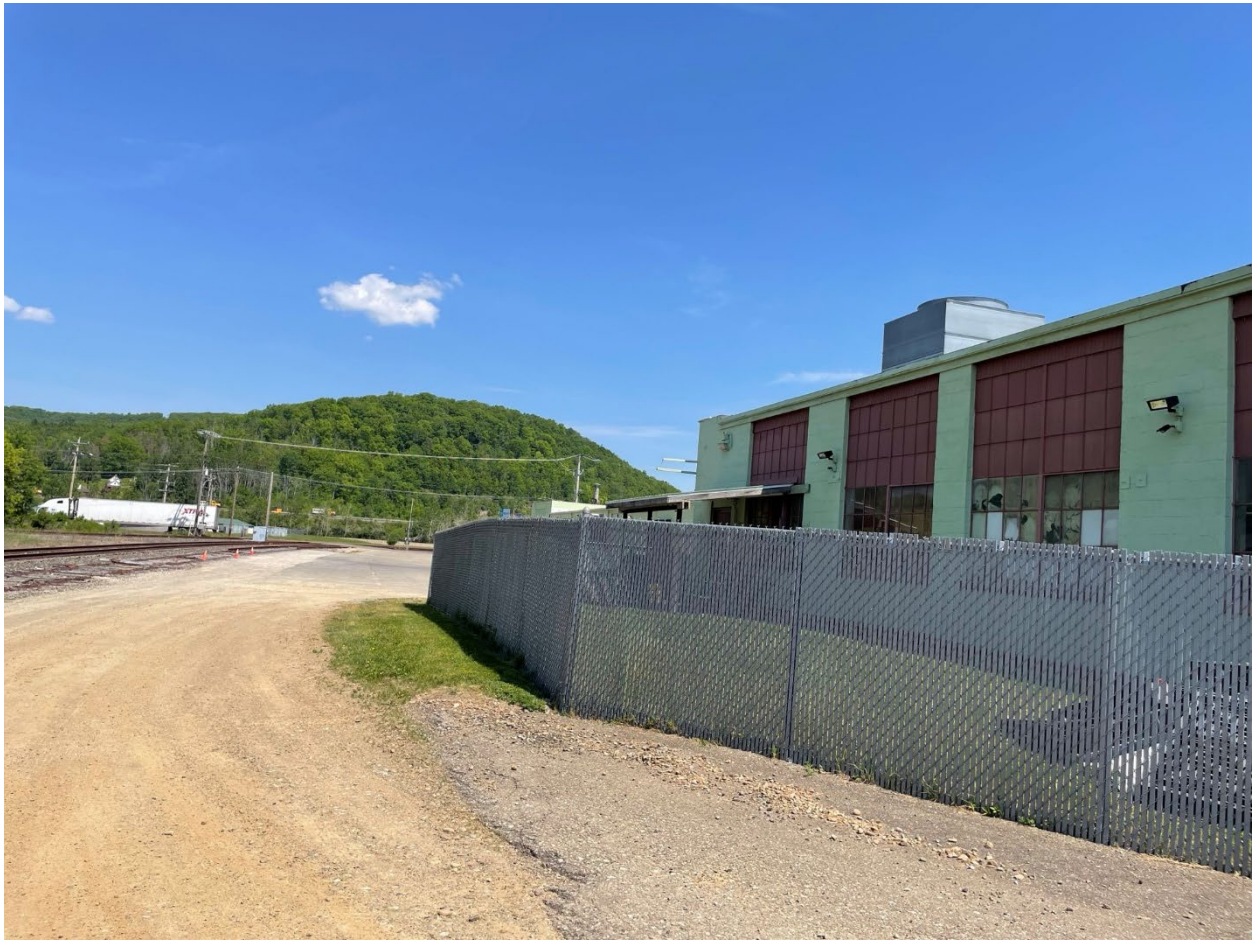
Site/cover conditions facing north.

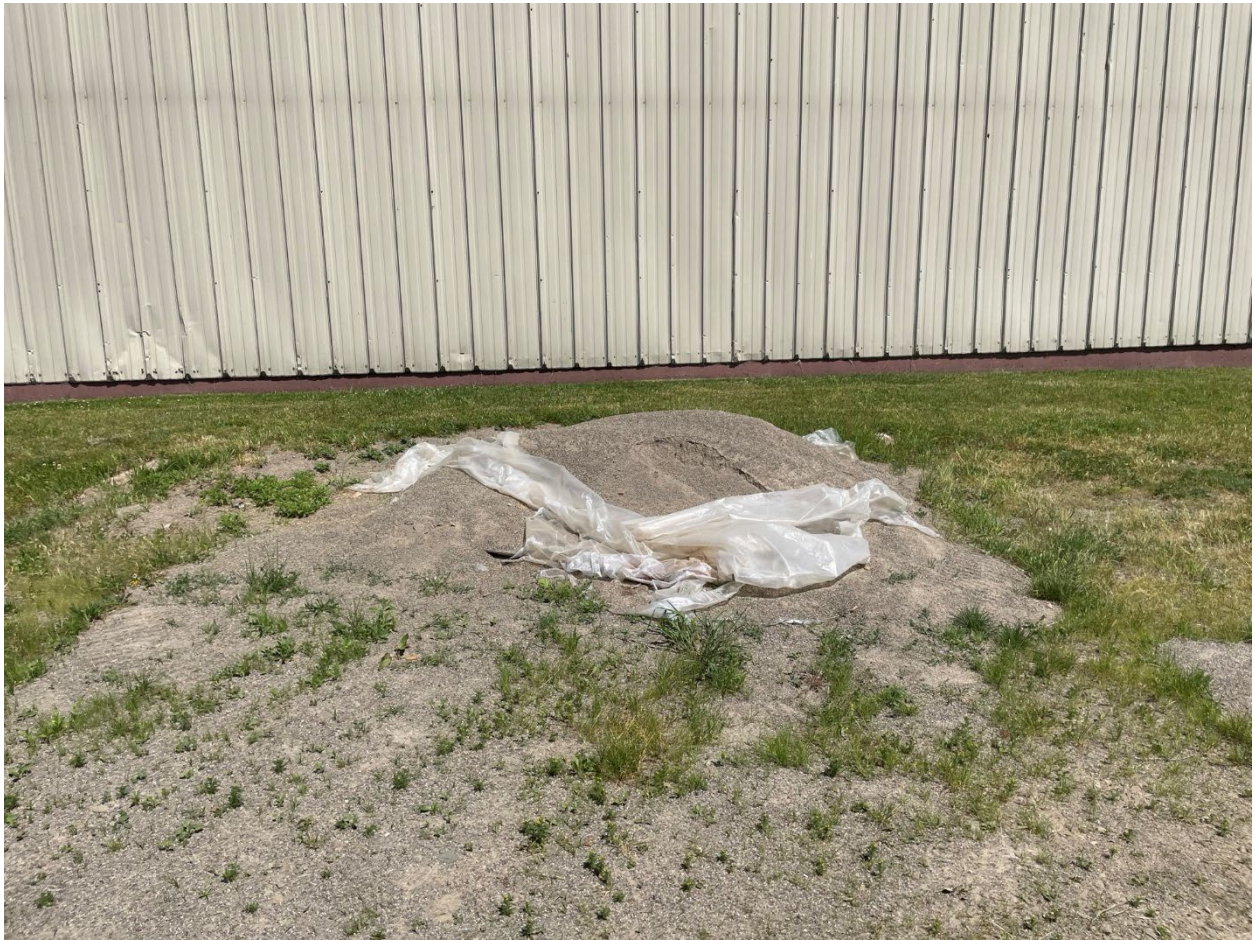
Stockpile of pea gravel for driveway repairs.

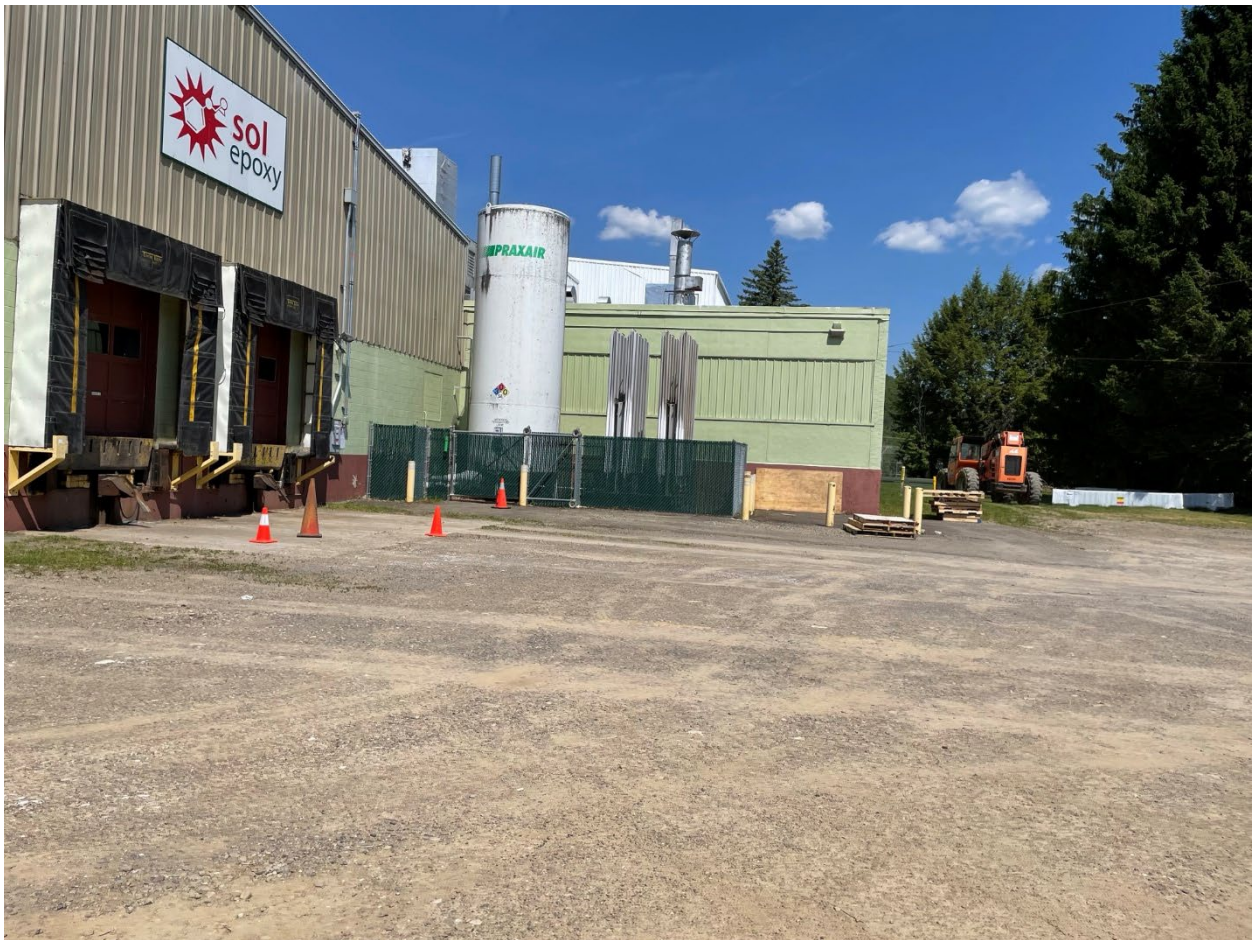
Site/cover conditions west side of facility facing north. Active work was observed to be occurring on the roof on this date.
