**PHASE I ENVIRONMENTAL SITE  
ASSESSMENT REPORT**

**FORMER WATSON MANUFACTURING COMPANY PROPERTY  
335 HARRISON STREET  
JAMESTOWN, NEW YORK**

June 21, 1999

CHA Project No. 8473

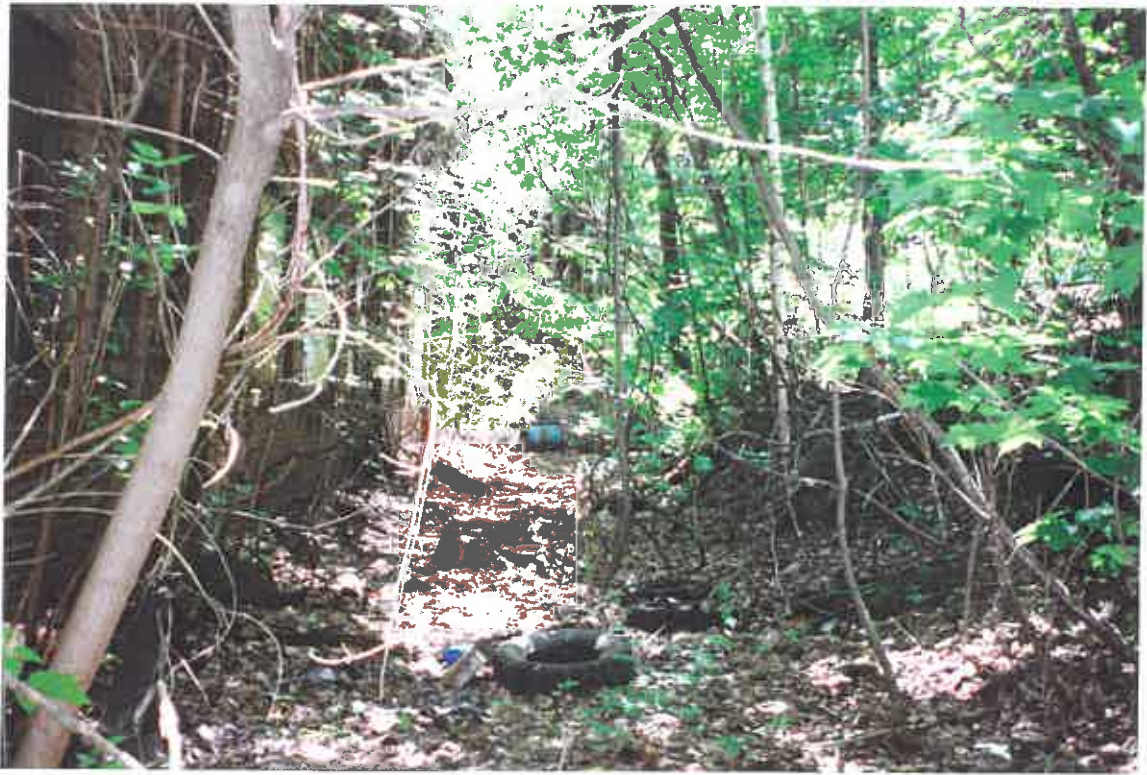
Photo #3: Miscellaneous containers north of the building.

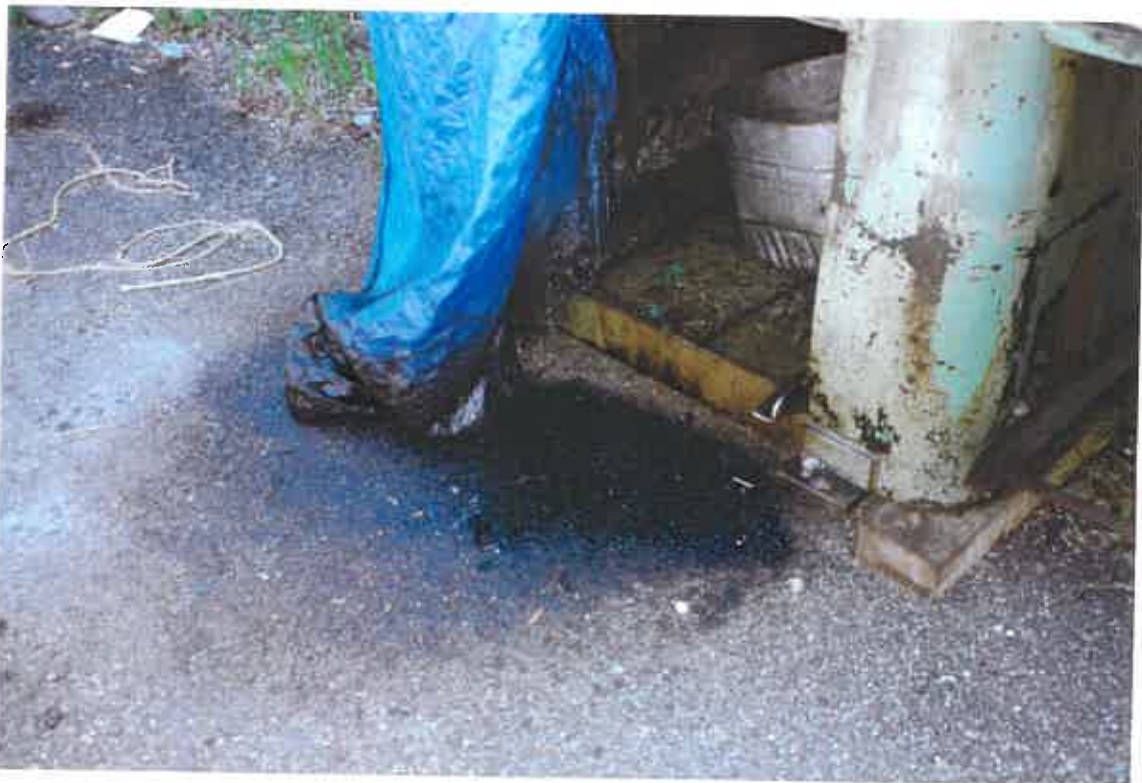
- Stained floor surfaces were observed in several rooms inside the buildings and on the exterior ground surface. This staining appears to be associated with operation and removal of metal working and machining equipment at the facility.

Photo #4: Staining of the parking area, east of the building.

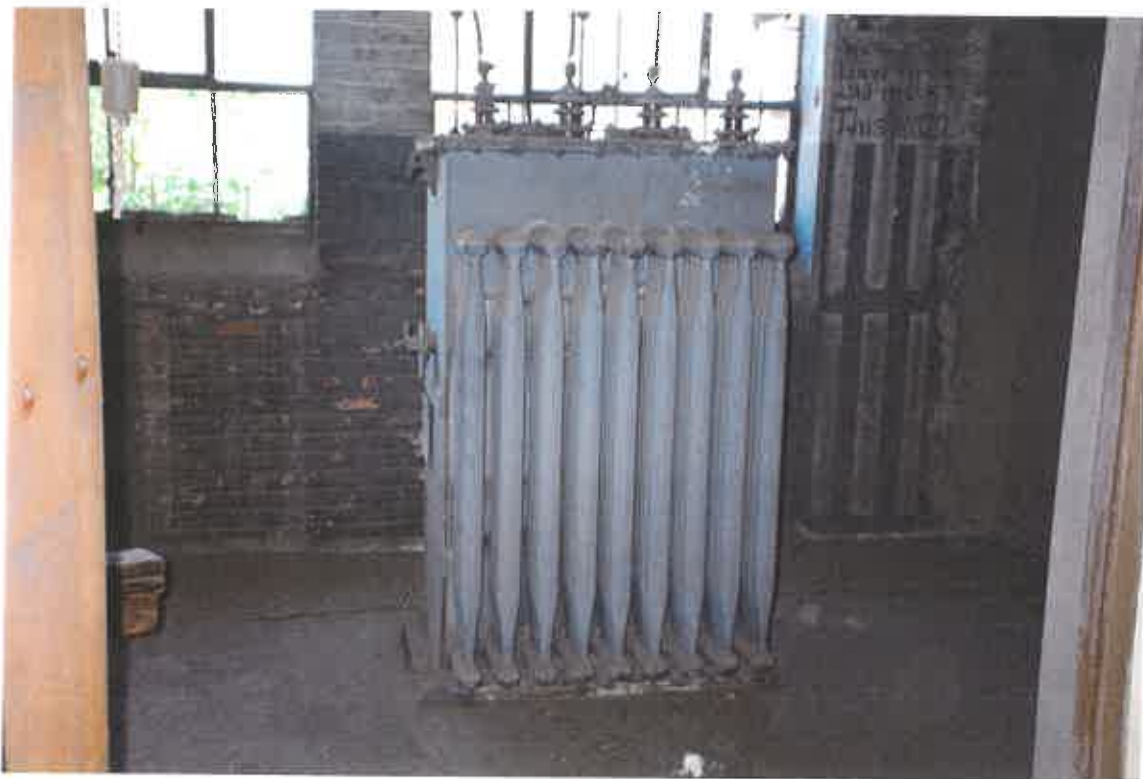
A 277 KVA floor mounted transformer manufactured by the Pennsylvania Transformer Division of the McGraw Edison Company was identified on the first floor of building 1A. According to the transformer label, it has a 150-gallon capacity for dielectric fluid. Since the unit was not labeled as non-PCB containing, the dielectric fluid may contain PCBs. However, no evidence of leakage was noted on the floor in the vicinity of the transformer. This unit was in service at the time of the site inspection, but was reportedly sold during the equipment auction held at the site. As such, it is slated to be removed from the building when power is no longer needed on-site for salvaging operations.

- One floor mounted transformer (currently in use) was observed on the first floor of building 1A. The transformer is listed as having a 150-gallon capacity for dielectric fluid, which may contain PCBs. This transformer has reportedly been sold and is slated to be removed from the building.

Photo #5: Transformer located on the first floor of building 1A.

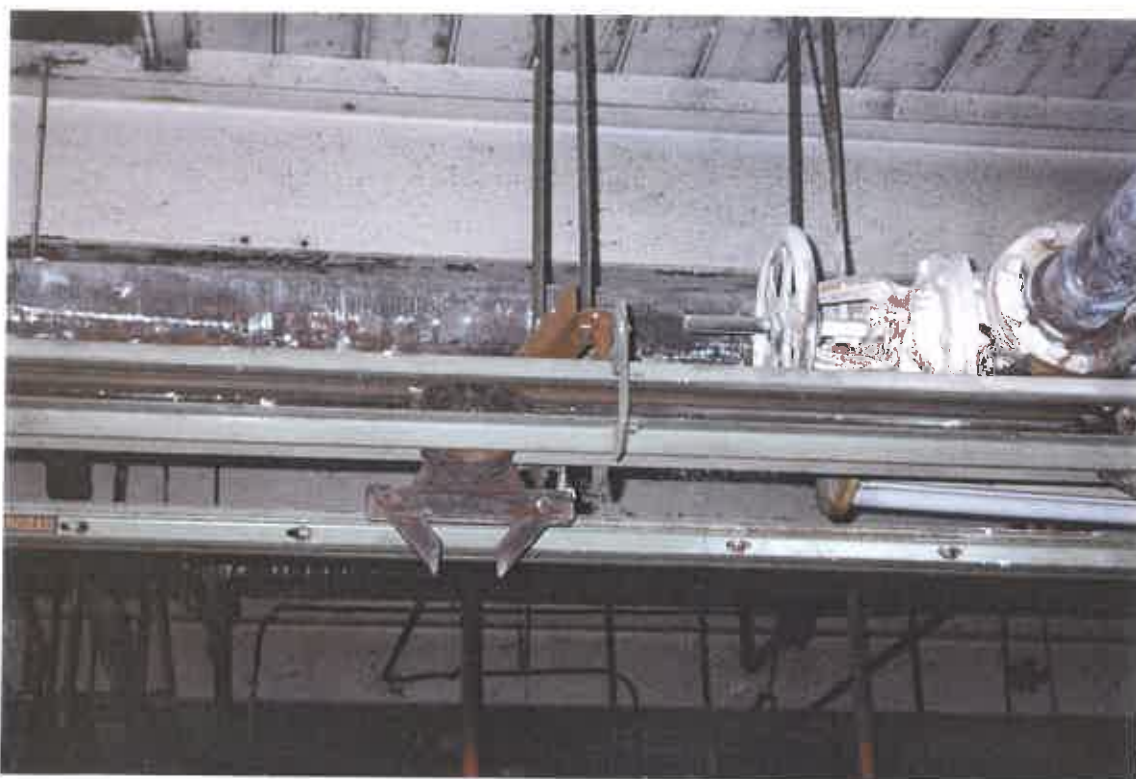
Photo #6: Remnants of pipe wrapping on overhead pipe in building 1A.

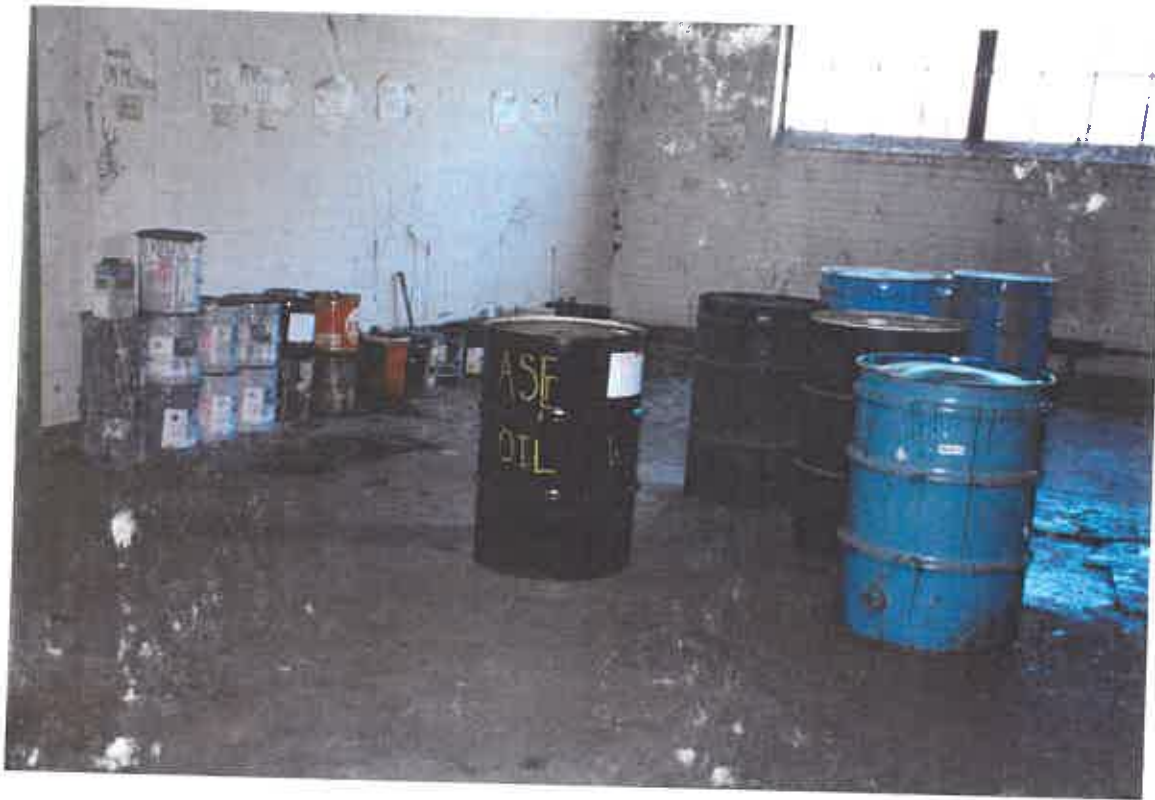
Photo #7: Miscellaneous containers in the paint storage room in building 1B.

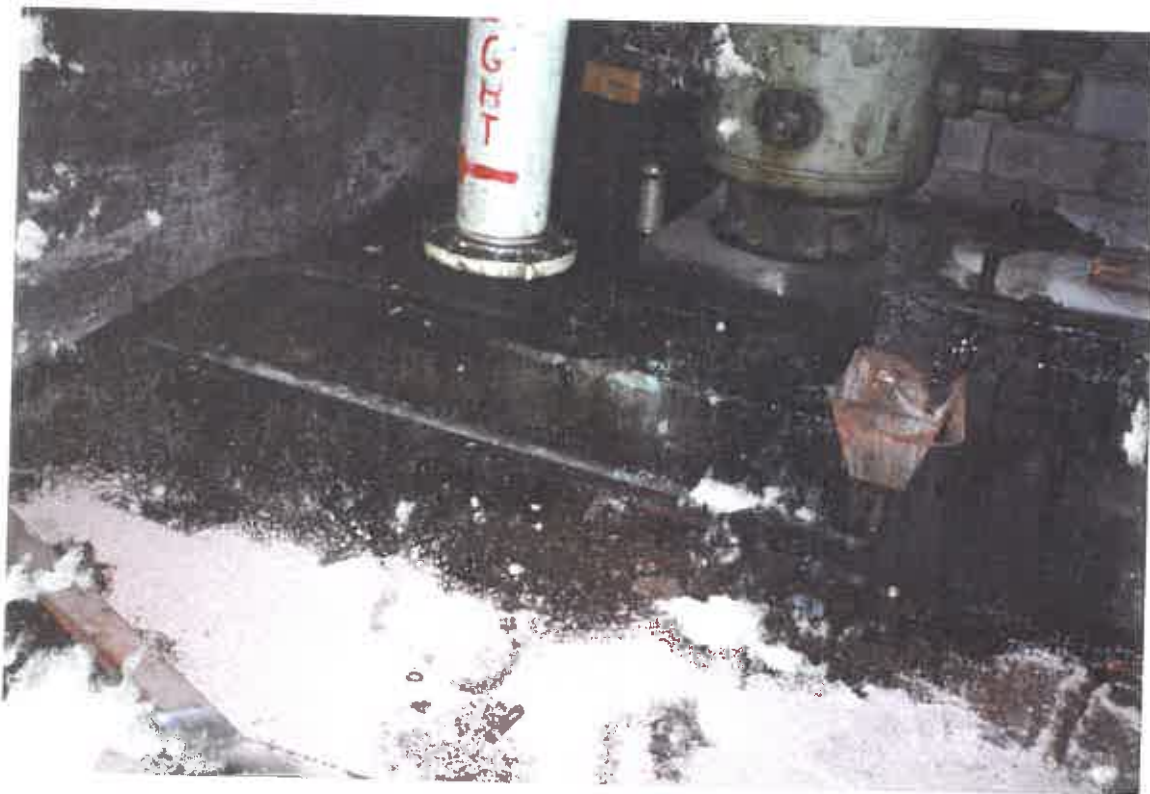
Stained floor surfaces were observed in several rooms in the building. This staining appears to be associated with operation and removal of machining equipment at the facility. The floor appeared to be in good condition, and therefore, this staining is not interpreted to be indicative of any discharges to the environment. Additional staining was noted in the parking area to the east of the building. This staining appeared to have occurred from the spillage of oil from machinery being removed from the property and leakage from the forklifts and other equipment used to remove the machinery from the building. One area along the northern end of the first floor of buildings 1A had oil spilled on the floor, reportedly from the leakage/failure of a compressor. At the time of the inspection the compressor was removed and speedy dry was applied on portions of the spill. A pool of product, however, remained on the floor.

P' .#8: Oil stained floor in building 1A.
