**Re: Supplemental Site Investigation  
Harrison Street Site (C907045)  
Jamestown, New York**

SUPPLEMENTAL INVESTIGATION  
251-289 HARRISON STREET SITE  
JAMESTOWN, NEW YORK

## SITE PHOTOGRAPHS

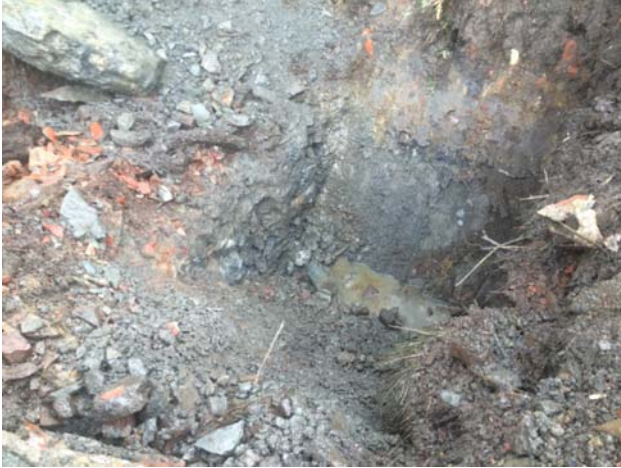
**Photo 1:**

| Location | Soil Sample Interval (fbgs) | Depth (fbgs) and USCS Soil Classification (visual-manual) | Field Observations / Notes |
|---|---|---|---|
| TP-3 | 1-3 | 0 - 0.5 Brown top soils.<br>0.5 - 7.0 Black fill material consisting of cinders with brick, glass and rock fragments, wet. | <b>Oil-like product observed on groundwater, petroleum-like odors identified.</b> |

Photo 1: View of TP-3, note the oil-like product on the perched groundwater along with black fill materials.

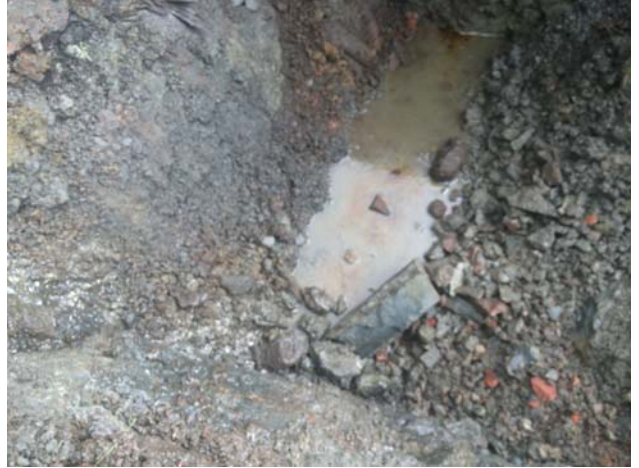
**Photo 2:**

Photo 2: Another view of the oil-like product at TP-3 at six feet below ground surface (fbgs).

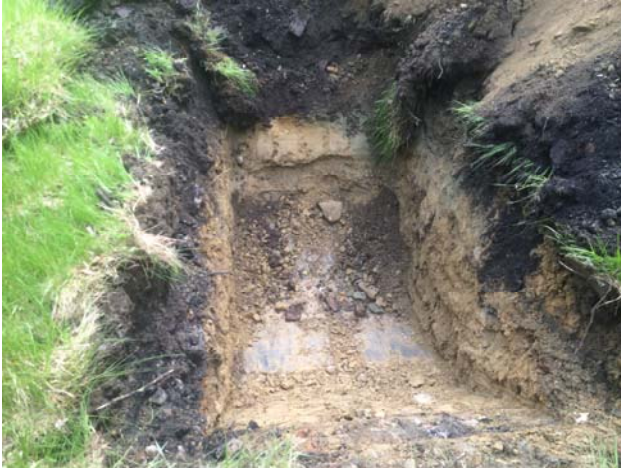
**Photo 3:**

| Location | Soil Sample Interval (fbgs) | Depth (fbgs) and USCS Soil Classification (visual-manual) | Field Observations / Notes |
|---|---|---|---|
| TP-4 | 1-3 | 0 - 0.5 Brown top soils.<br>0.5 - 3.0 Black Fill material consisting of sand, ash and cinders with brick and glass fragments, wet.<br>3.0-7.0 Brown fine sand with gravel, wet.<br>7-10 Gray sand, moist to wet. | <b>Black petroleum-like staining observed in fill materials.</b> |

Photo 3: View of TP-4, note the black fill material from 1 to 3 fbgs.

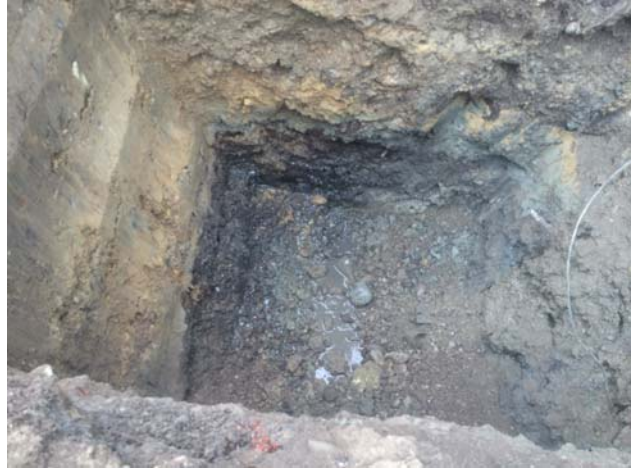
**Photo 4:**

| Location | Soil Sample Interval (fbgs) | Depth (fbgs) and USCS Soil Classification (visual-manual) | Field Observations / Notes |
|---|---|---|---|
| TP-6 | 3-4 | 0 - 0.5 Fill material consisting of silty gravel.<br>0.5 - 1.0 Concrete.<br>1.0-3.0 Brown fill material consisting of sand, gravel and trace brick.<br>3.0-4.0 Black fill material consisting of sand with trace brick. | <b>Strong petroleum-like odor noted in fill materials.</b><br><br>Equipment refusal encountered at 4.0 fbgs apparently due to concrete floor. |

Photo 4: View of TP-6, note the stained fill material from 3 to 4fbgs.
