# ENGINEERING INVESTIGATIONS AT INACTIVE HAZARDOUS WASTE SITES

## PRELIMINARY SITE ASSESSMENT

Bisonite Paint Company Site No. 915010

Town of Tonawanda Erie County

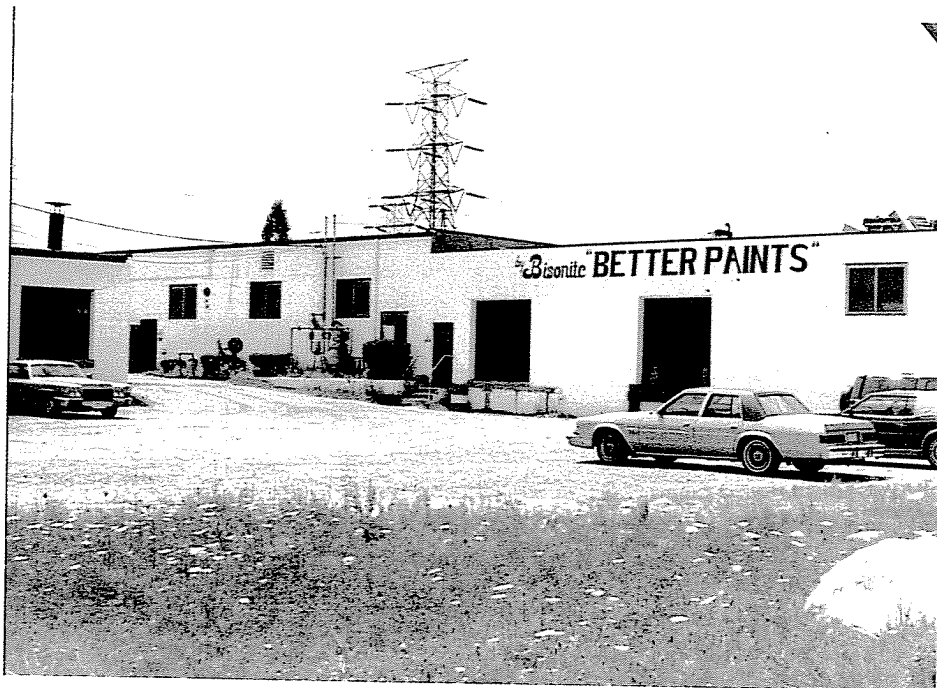
Photo No. 1

- 1) The Bisonite Paint Company plant. Direction: Southwest
- 2) On the western side of the filled in lagoon area. Direction: East
- 3) Southern side of the filled in lagoon area. Direction: Northeast
- 4) The southern side of the lagoon and a drum storage area in the background.  
Direction: East
- 5) Northern side of the old varnish plant with a drum storage area. Direction: West
- 6) Area of landspread waste solvents (Southern side of the plant). Direction: West
- 7) Drum storage area on the loading dock. Direction: Northeast
- 8) Old varnish plant, no longer in use. Several drums are located in and around the building. Direction: Northwest
- 9) Storage area for old processing tanks. Direction: South
